TS-PIC-92020  
April 1992

# **EPA Site Analysis**

## **Better-Brite Plating**

### **DePere, Wisconsin**

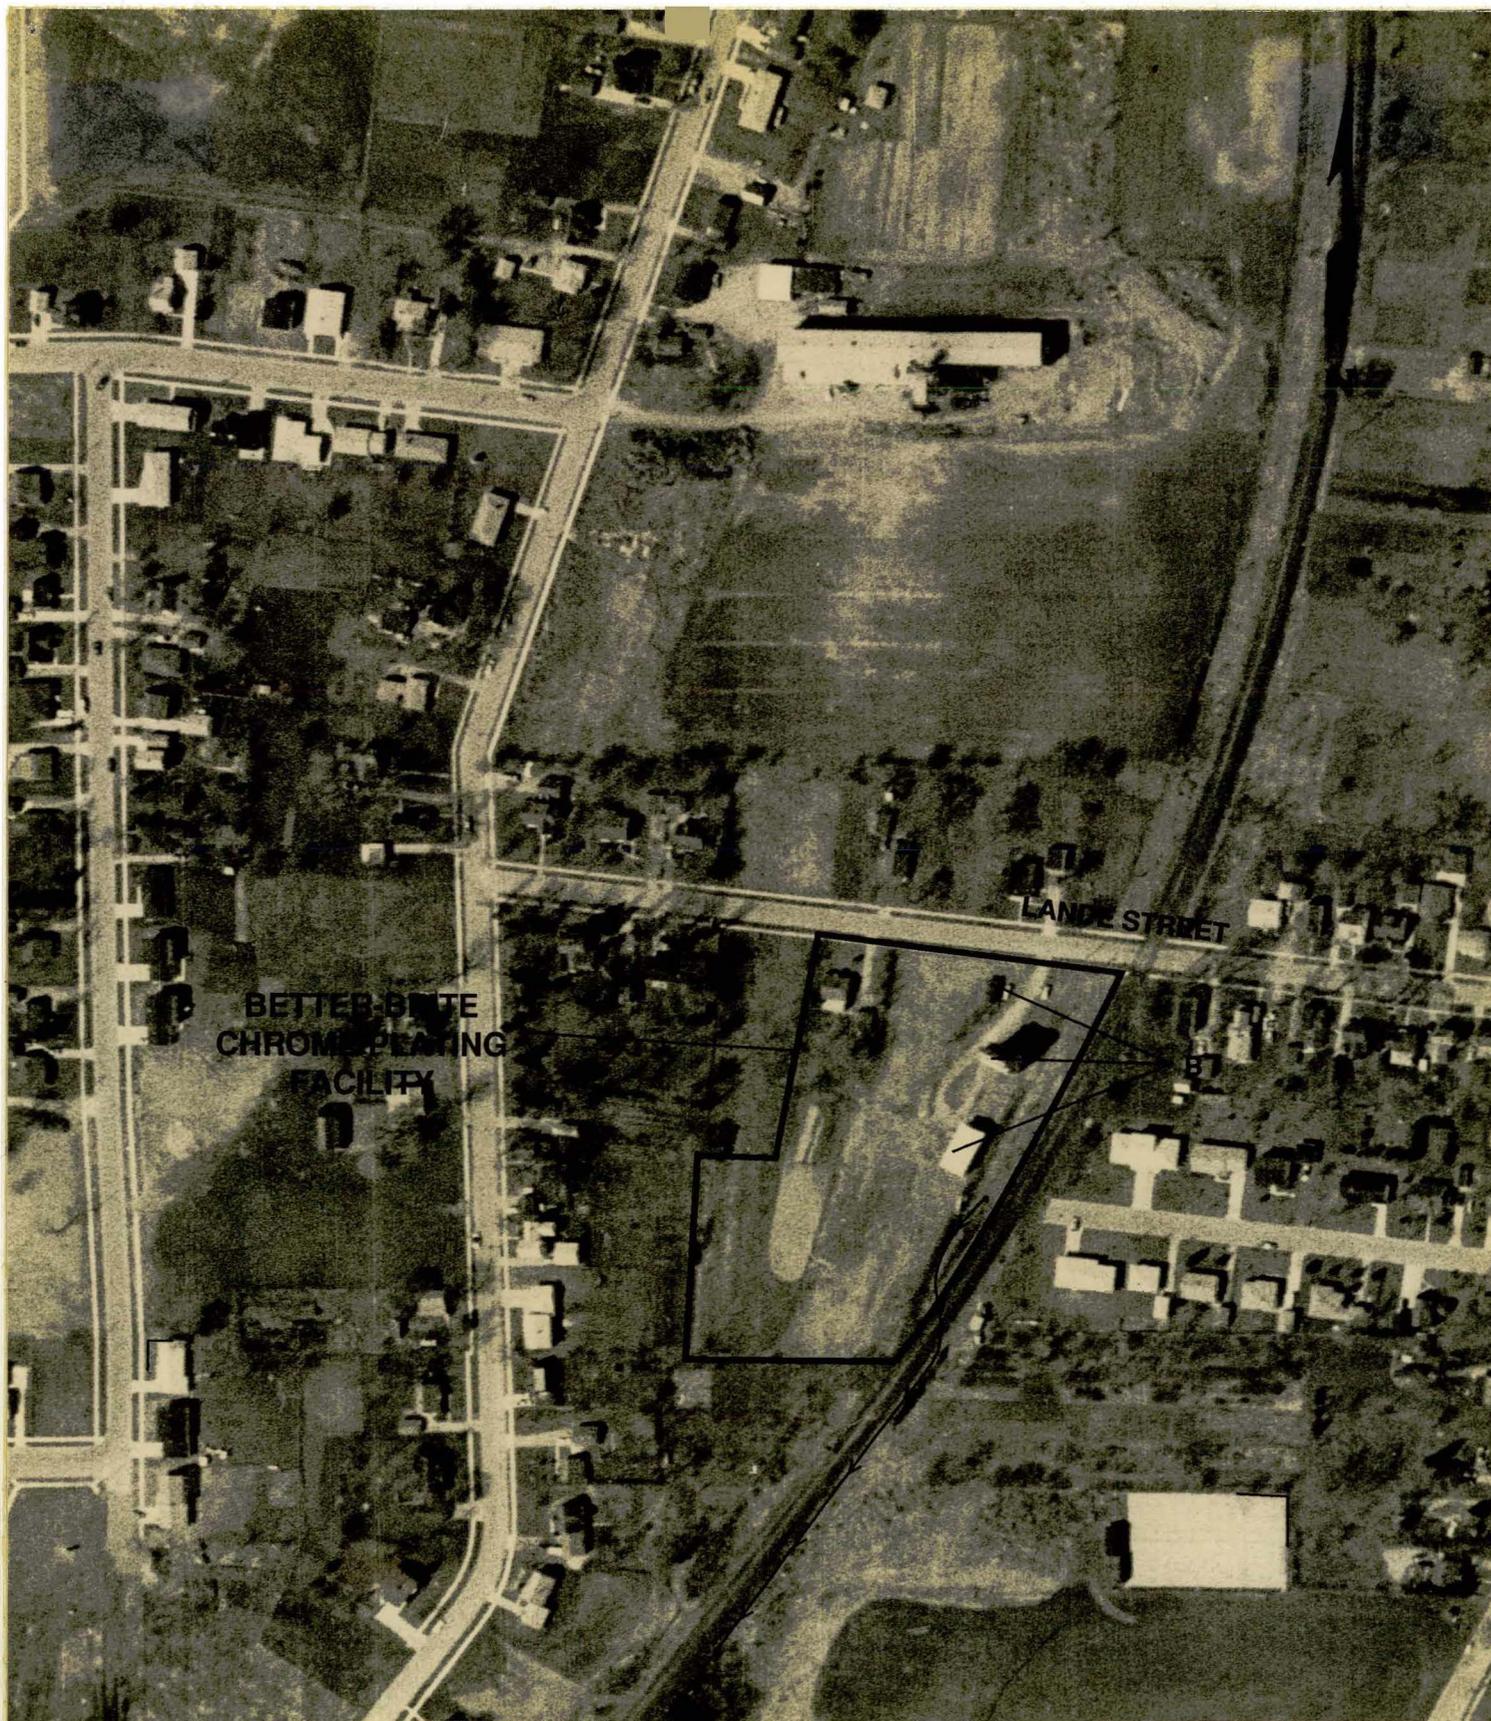
**FIGURE 2  
BETTER-BRITE PLATING**

April 17, 1971 (Figure 2)

The site consists of a private residence, three small utility buildings (B), and a railroad siding. Two vehicles are seen along the driveway, and an unidentifiable object is on the railroad siding (none annotated). Channelized drainage is noted along the east edge of the site. The drainage flows under the railroad tracks and continues south toward a wetland area (not annotated).

No features or activities related to chrome plating are noted this year; Better-Brite does not yet own the property.\*

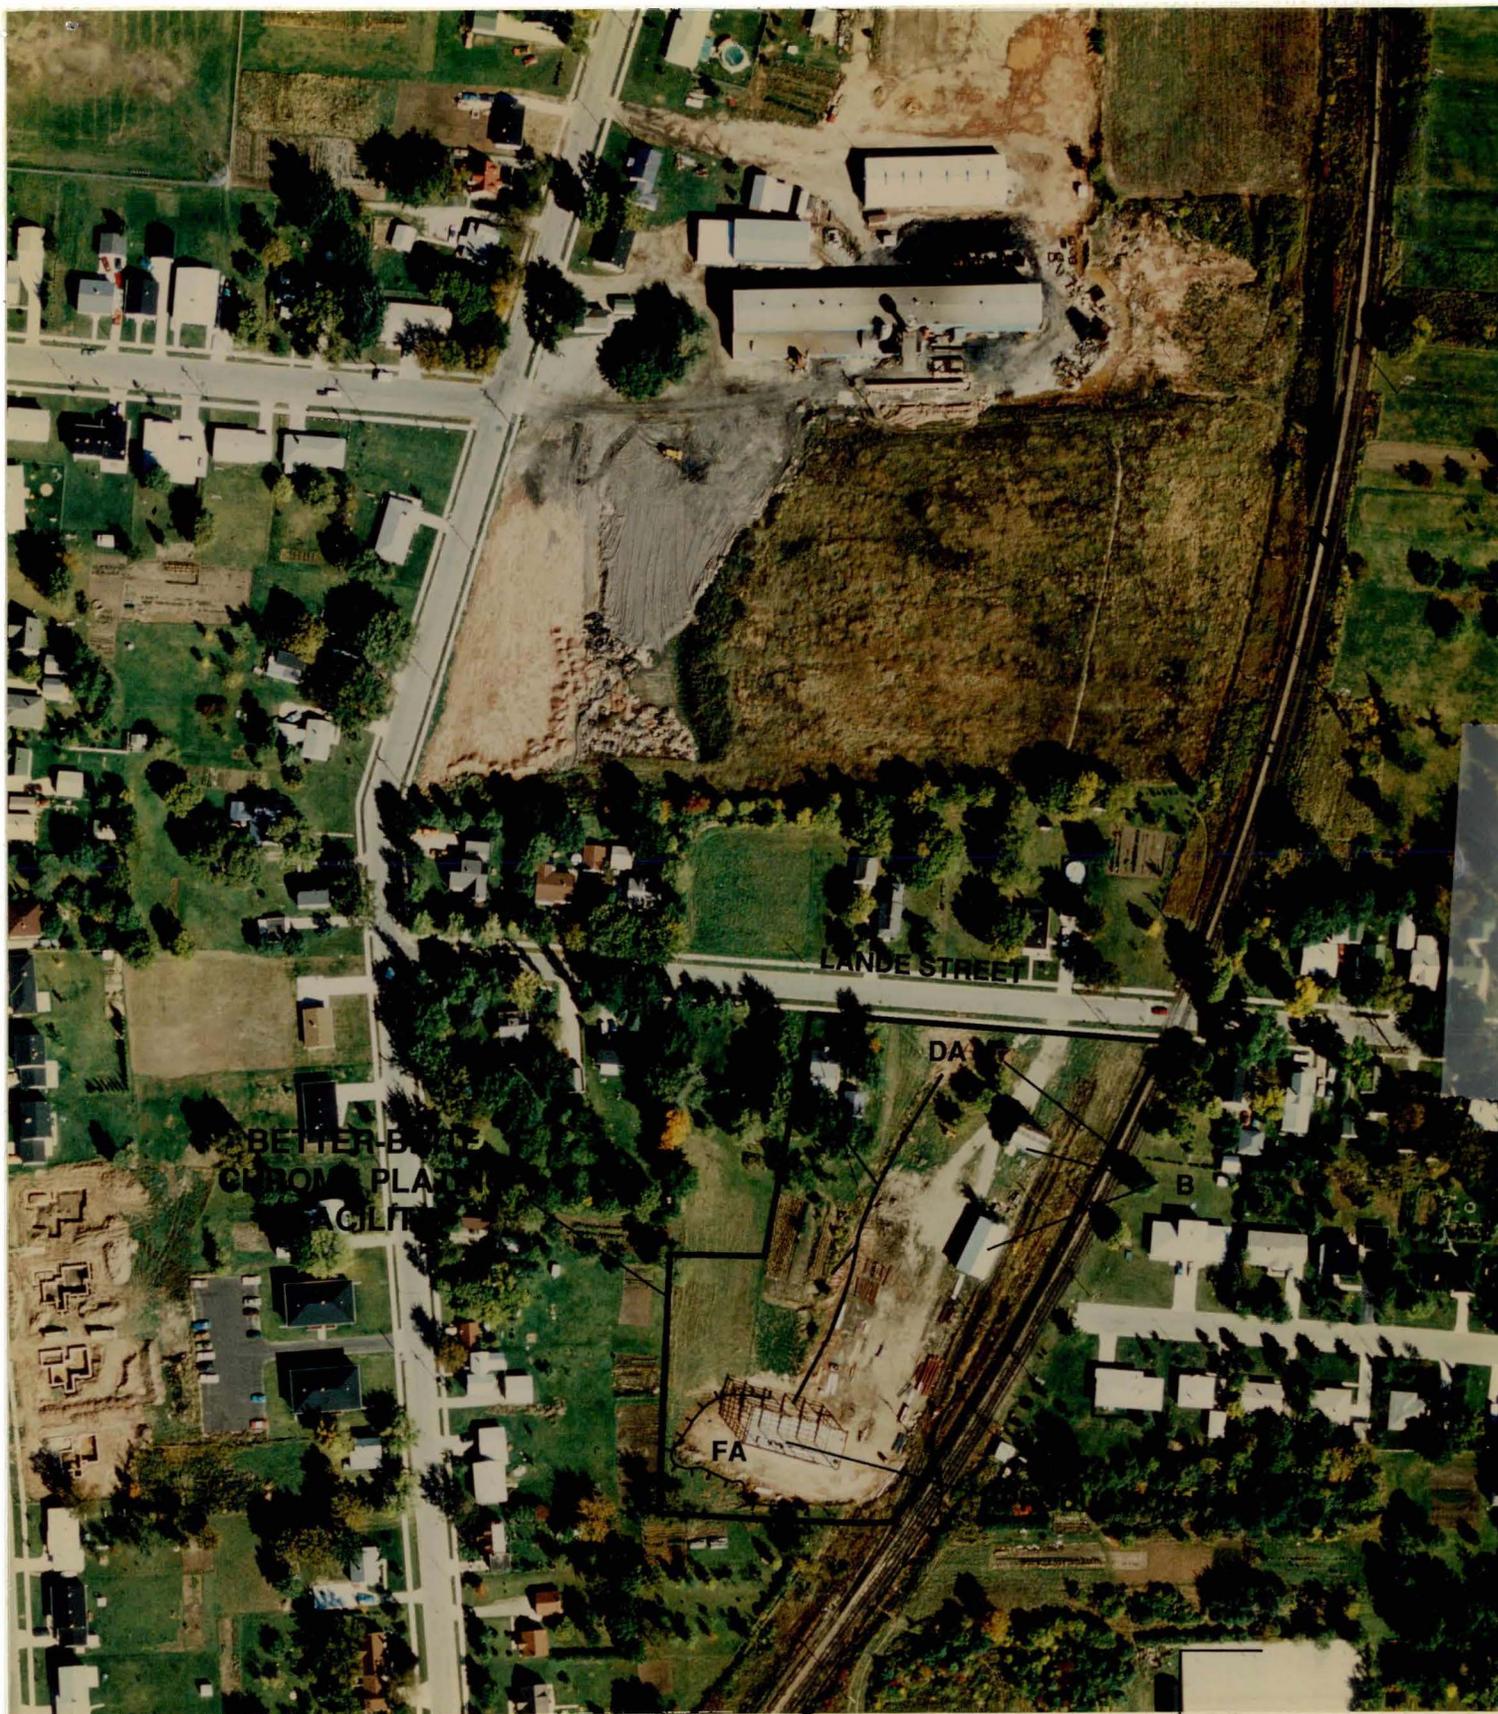
**FIGURE 3  
BETTER-BRITE PLATING**

September 30, 1973 (Figure 3)

The site property was deeded to Better-Brite earlier in 1973.\* The production building is under construction, and linear construction materials are seen onsite. The private residence is being used as a business office by Better-Brite.\*

Disturbed Area (DA) - Seen adjacent to Lande Street, probably related to utility installation.

Trench (TR) - Runs between the disturbed area and the production building; probably related to utility installation.

Fill Area (FA) - A portion of the south end of the site has been filled, probably to facilitate construction of the production building.

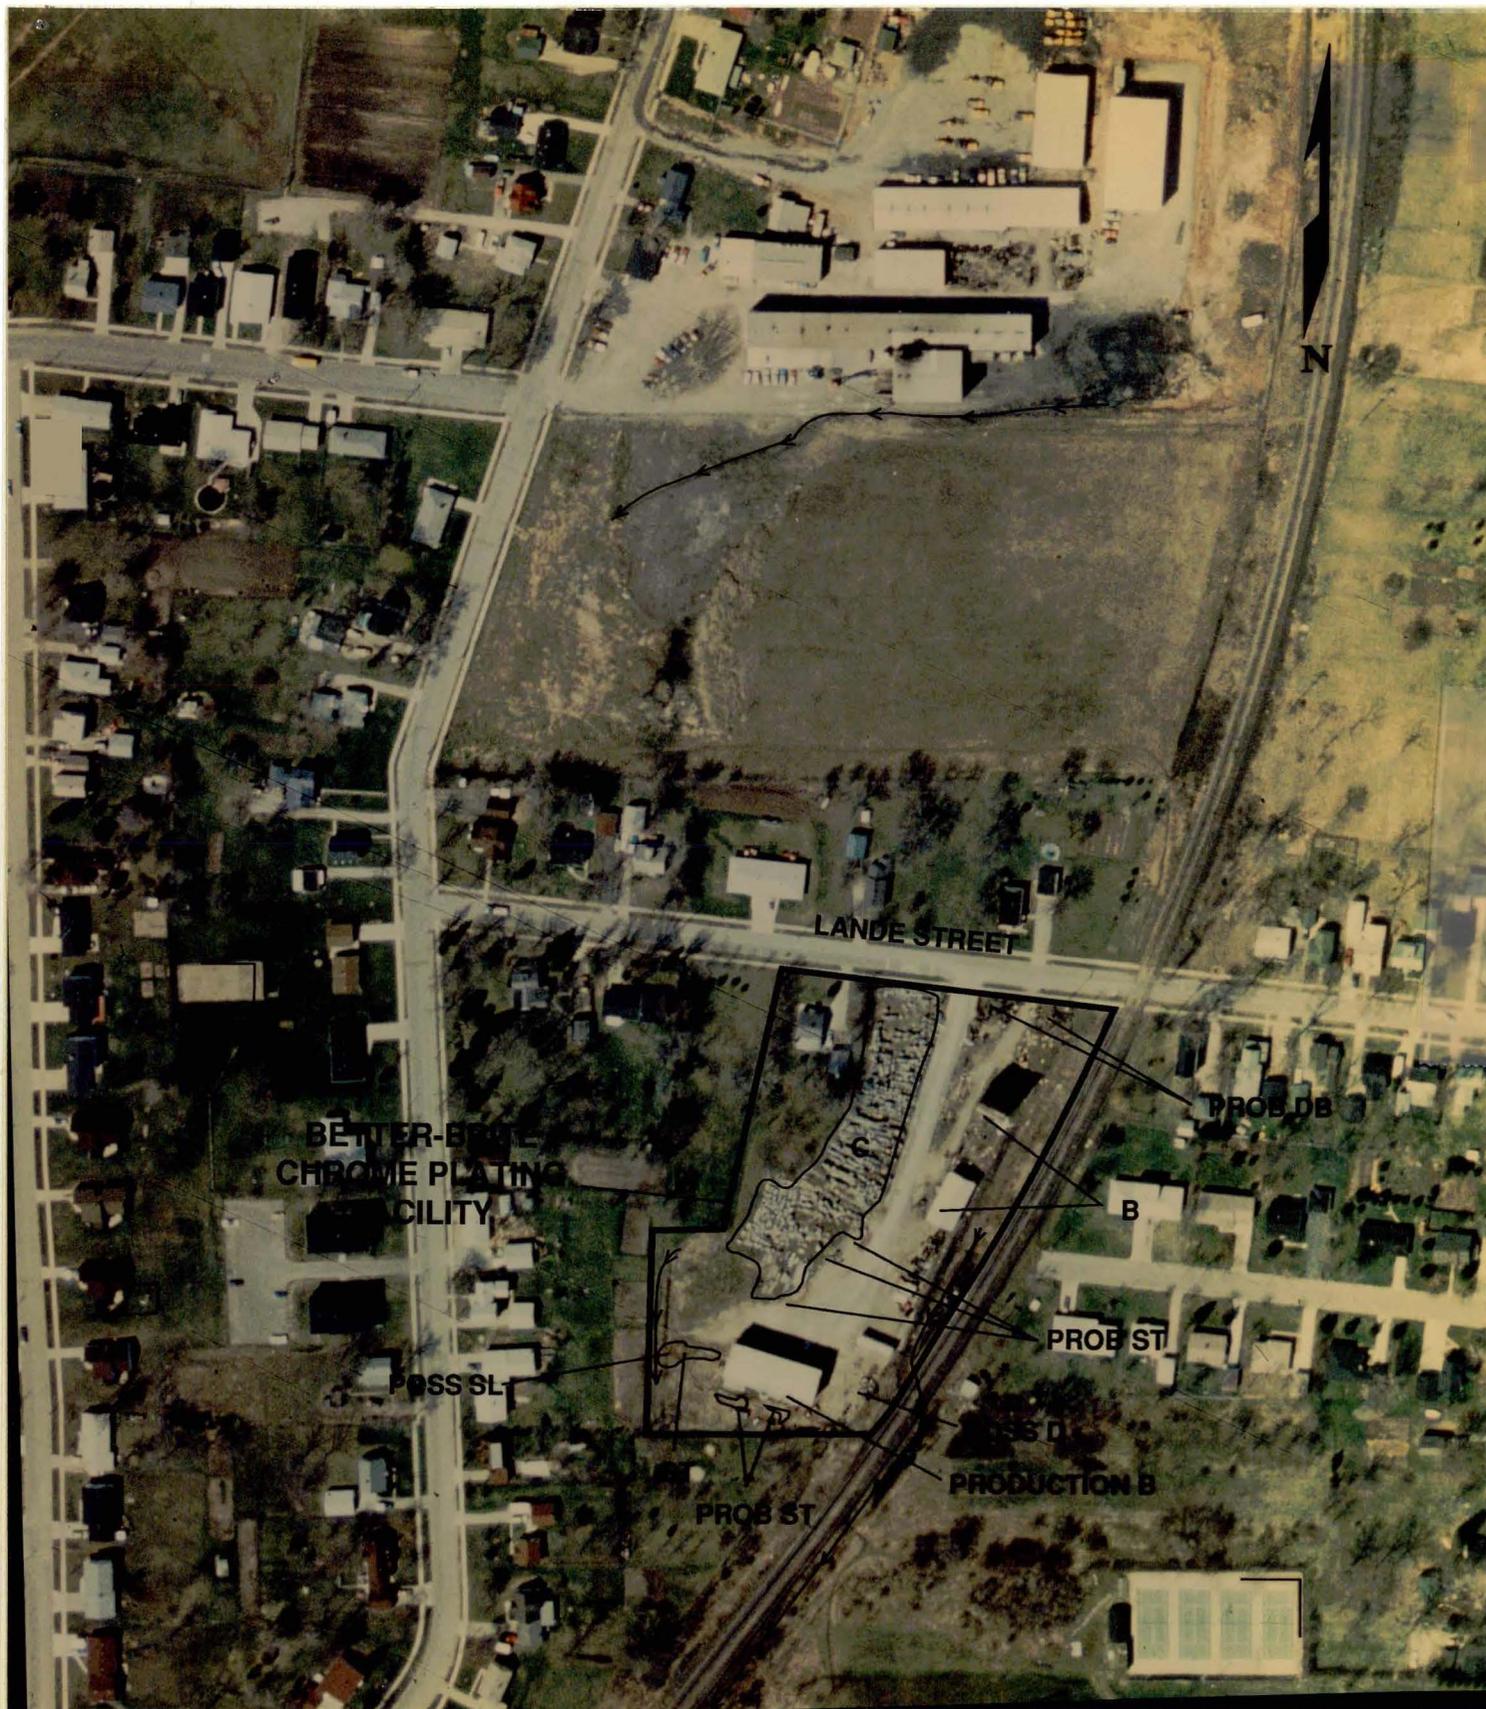
**FIGURE 4  
BETTER-BRITE PLATING**

April 27, 1978 (Figure 4)

Chrome plating operations are underway.\* The northernmost of the three small utility buildings seen in 1971 has been removed.

Disturbed Area (1973) - No longer visible; its former location is covered with containers.

Trench (1973) - No longer visible. This was probably filled; most of its former location is covered with containers.

Fill Area (1973) - No longer active; remains unchanged since 1973.

Probable Debris (DB) - Consists of two small collections of what appears to be dismantled/discarded equipment.

Containers (C) - A collection of at least 1,000 light-toned containers occupies approximately 0.30 hectare (0.74 acre). The containers are crate-like in appearance and most are stacked two or three high.

Possible Drums (D) - Seen as a small group in the southeast corner of the site.

Stain, Probable Stains (ST) - Three dark-toned probable stains are noted adjacent to the large collection of containers. This may indicate container leakage. Two other dark-toned probable stains originate from the south side of the production building. A large brown stain is flowing downhill from the west side of the production building towards a drainage channel.

Possible Standing Liquid (SL) - Noted within the large brown stain at the west end of the production building.

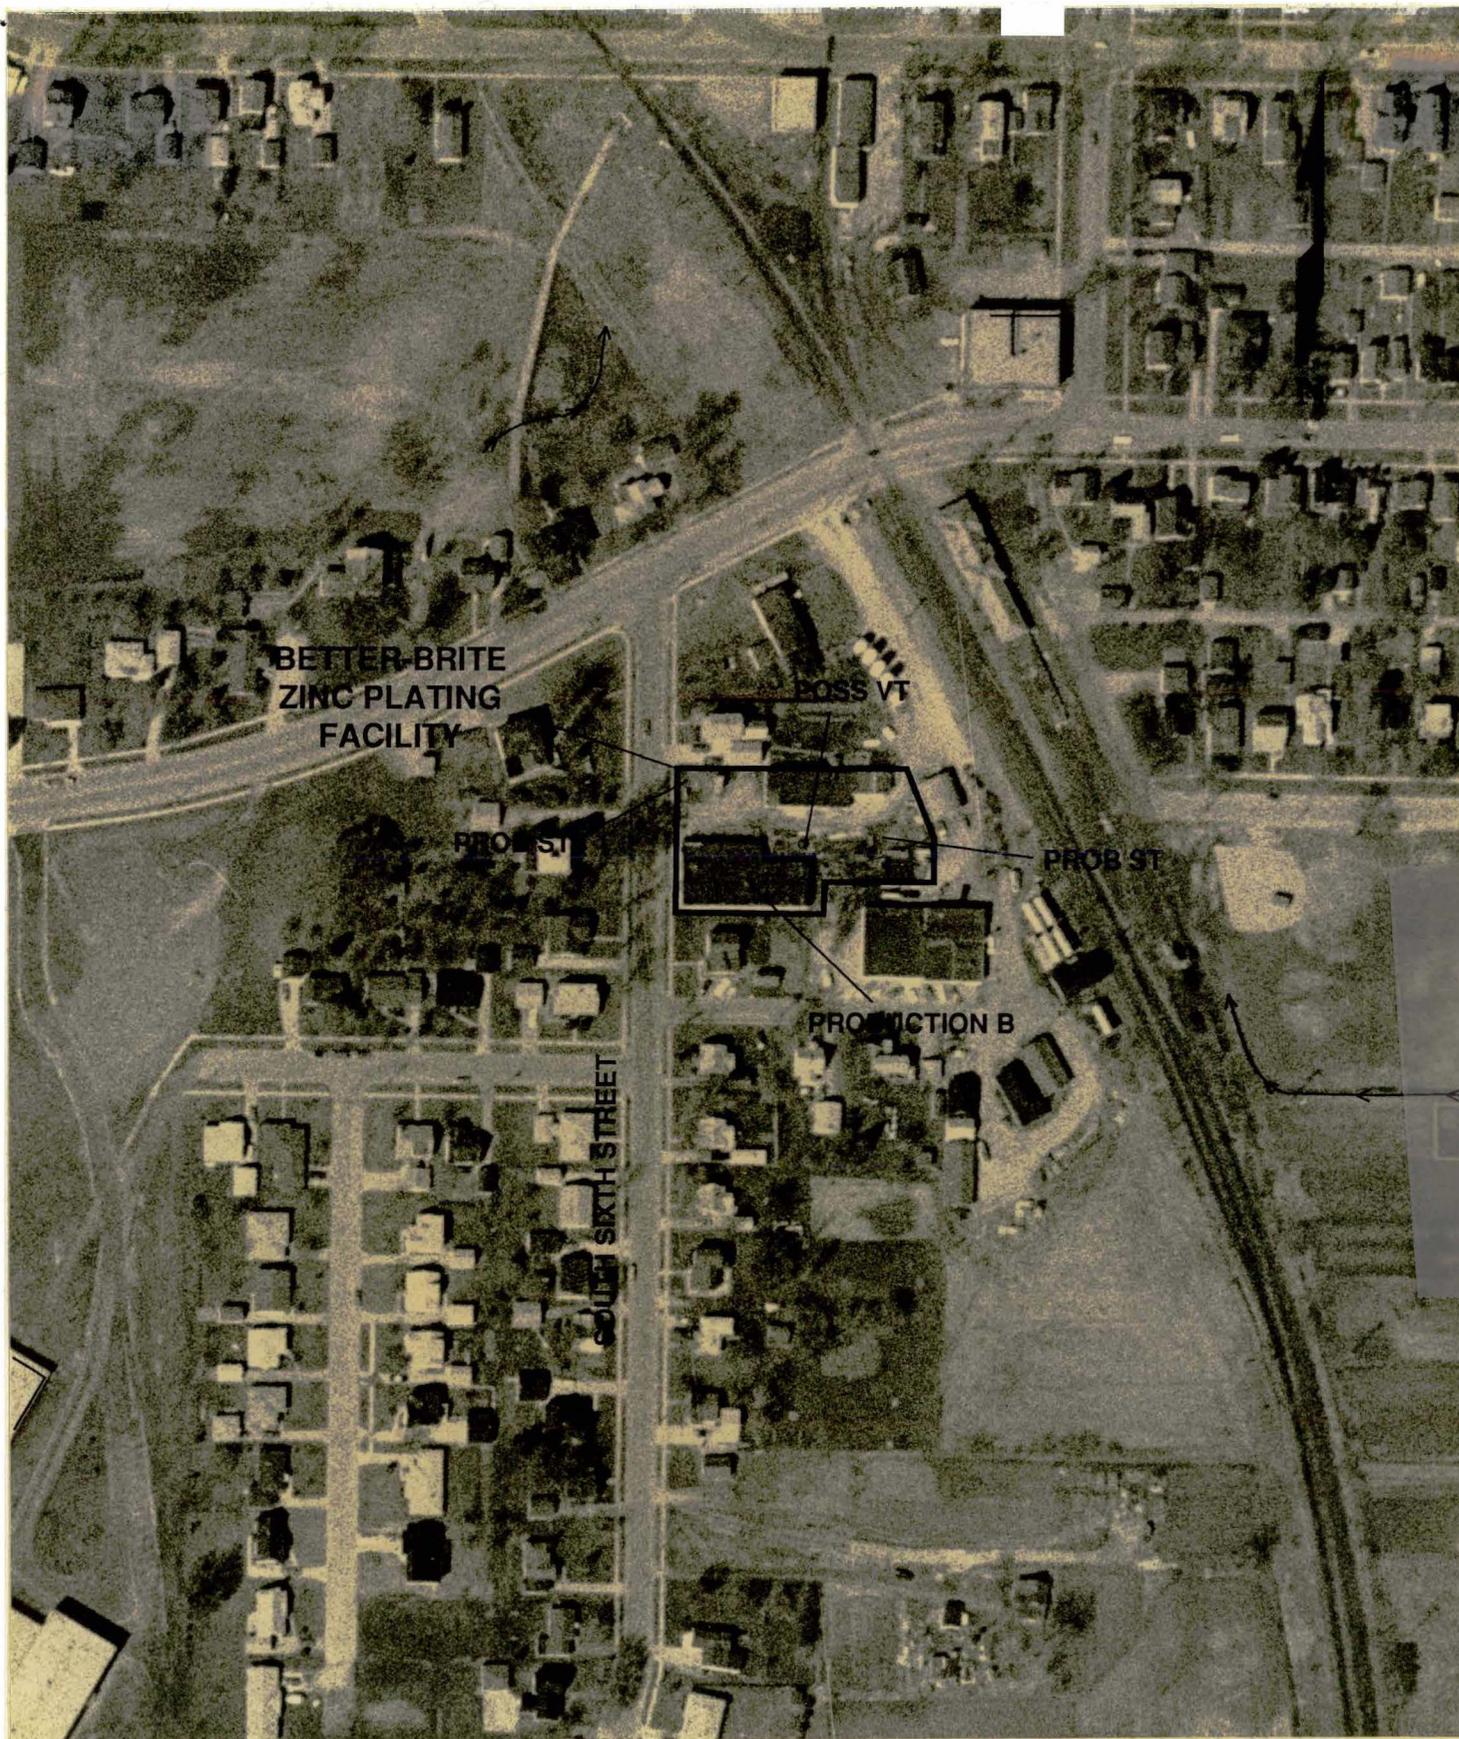
**FIGURE 5  
BETTER-BRITE PLATING**

April 17, 1971 (Figure 5)

Plating operations appear to be active. The site consists of a production building and another building that appears to be a warehouse.

Probable Stains - Dark-toned probable stains are noted in the northwestern and eastern portions of the site.

Possible Vertical Tank (VT) - Located just north of the production building.

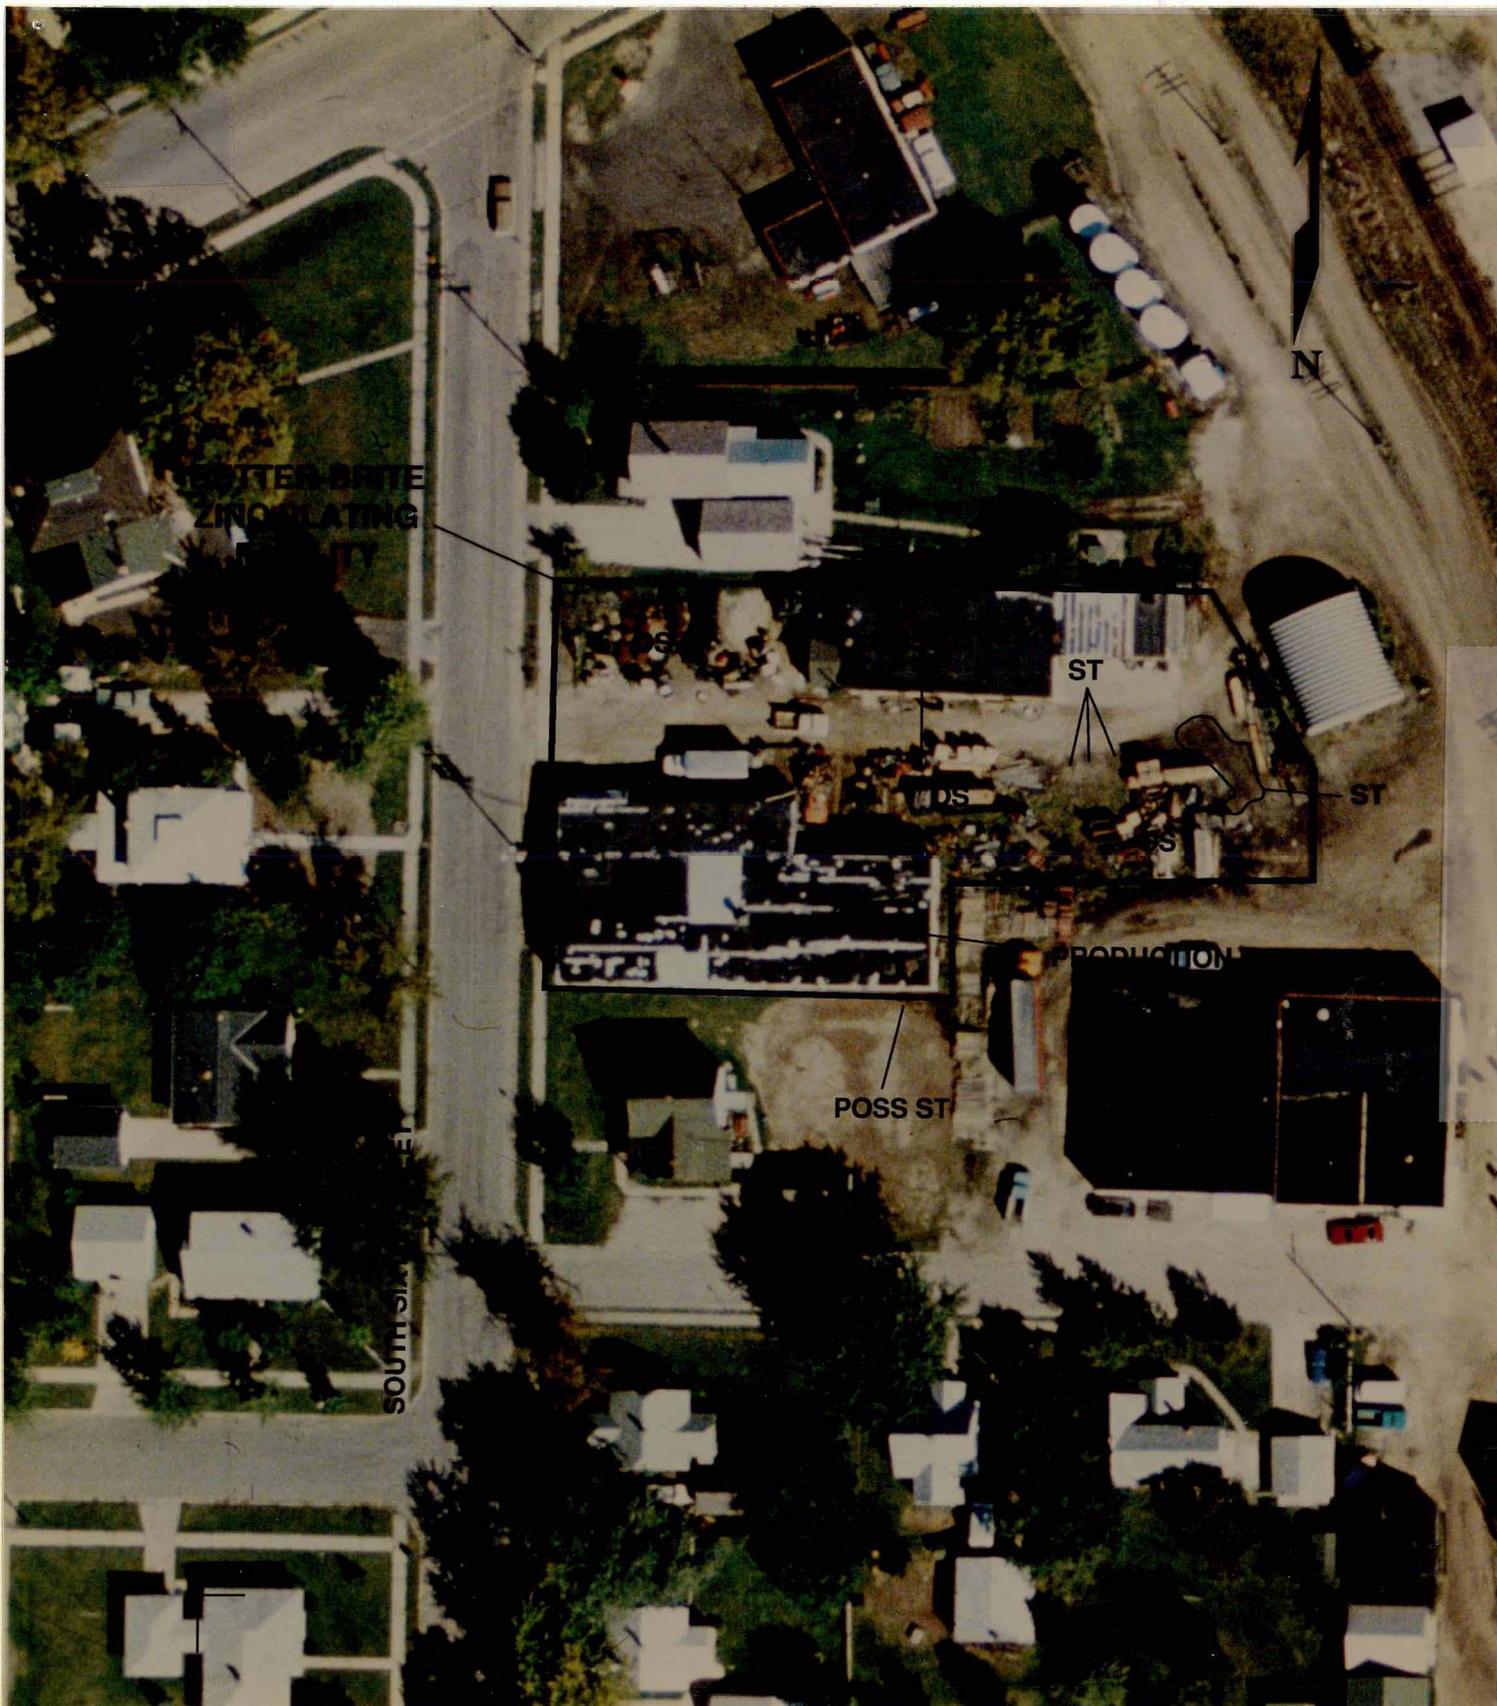
FIGURE 6  
BETTER-BRITE PLATING

September 30, 1973 (Figure 6)

The basic site configuration has not changed since 1971.

Possible Vertical Tank (1971) - No longer present.

Possible Drum - Seen in the approximate center of the site.

Open Storage (OS) Areas - Three distinct open storage areas are seen onsite. All of them appear to contain equipment and/or raw materials.

Stains, Possible Stain - Three small dark-toned stains are noted west of a large dark-toned stain. The large stain is in the same general location as a dark-toned probable stain seen in 1971. A small dark-toned possible stain is seen along the south side of the production building. A dark-toned probable stain seen in the northwest corner of the site in 1971 is no longer present.

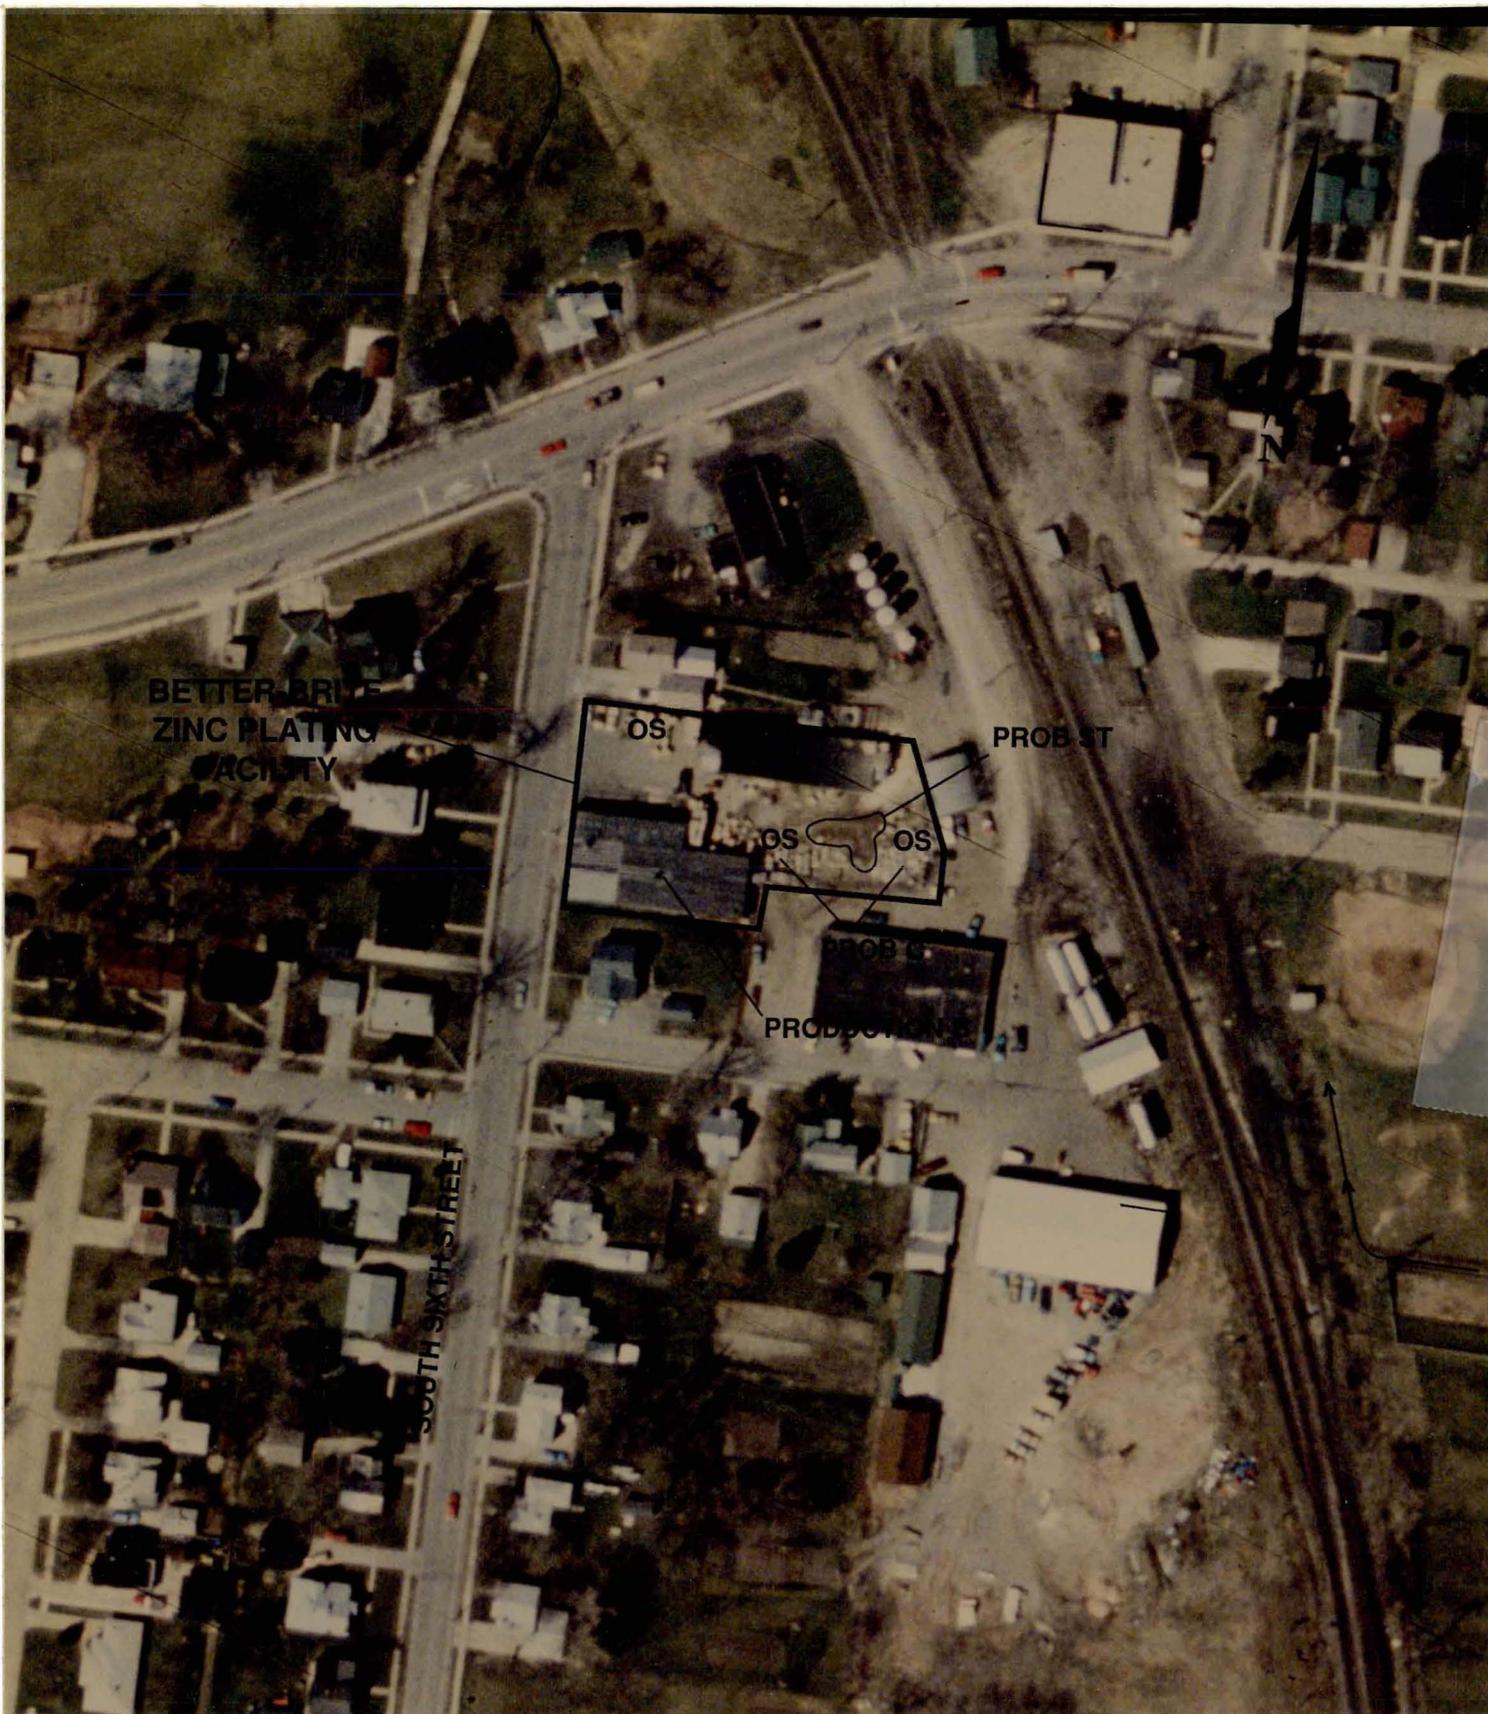
FIGURE 7  
 BETTER-BRITE PLATING

April 27, 1978 (Figure 7)

The basic site configuration remains unchanged since 1973.

Possible Drum (1973) - No longer present.

Open Storage Areas - The three open storage areas noted in 1973 are still present; stored materials consist mainly of equipment. Two open storage areas include probable containers.

Probable Stain - A dark-toned probable stain is in the same general location as several stains seen in 1973. The dark-toned possible stain seen along the south edge of the production building in 1973 is no longer visible.

Probable Containers - These are light-toned and appear to be square; possibly crates.
