March 27, 2017

Subject: Polychlorinated Biphenyls (PCBs) in Rain Garden – Investigative Actions

As requested by Madison Kipp Corporation (MKC), TRC has been investigating the presence and possible migration of polychlorinated biphenyls (PCBs) to the rain garden just north of the MKC facility which is located at 201 Waubesa Street, Madison, Wisconsin (the site, Figure 1). This letter summarizes the most recent actions taken to investigate potential source(s) of PCBs found in the rain garden.

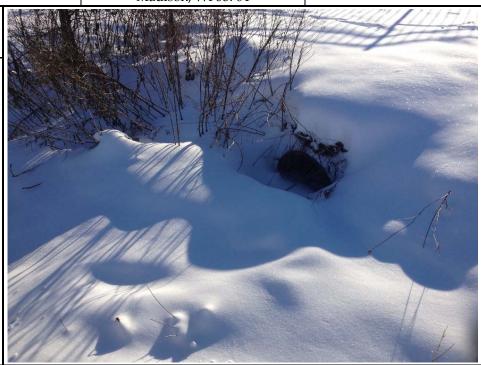
Photo No. Date
1 12/19/2016

Outfall into the Rain Garden pre-excavation (Facing Southeast).

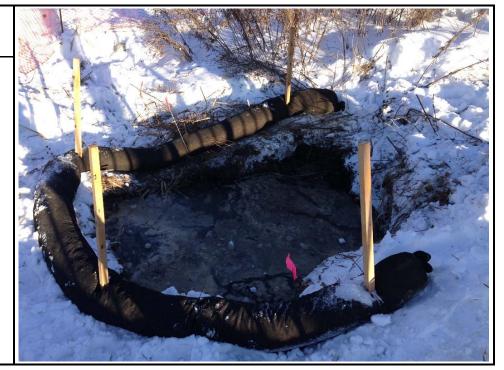
Photo No. Date
2 12/19/2016

Outfall area following the Rain Garden excavation completed on 12/19/16 (Facing East).

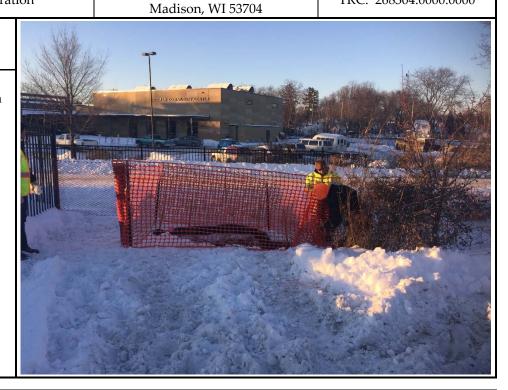
3 12/19/2016

Outfall area following the Rain Garden excavation completed on 12/19/16 (Facing North).

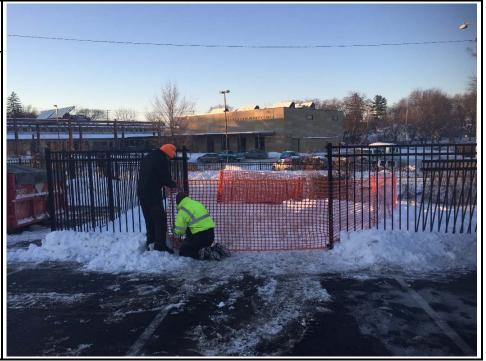
Photo No. Date
4 12/19/2016

Outfall area following the Rain Garden excavation completed on 12/19/16 (Facing North).
