Vapor Intrusion at a Former Dry Cleaner in Southeast Wisconsin

**Working with
State and Local
Health
Departments**

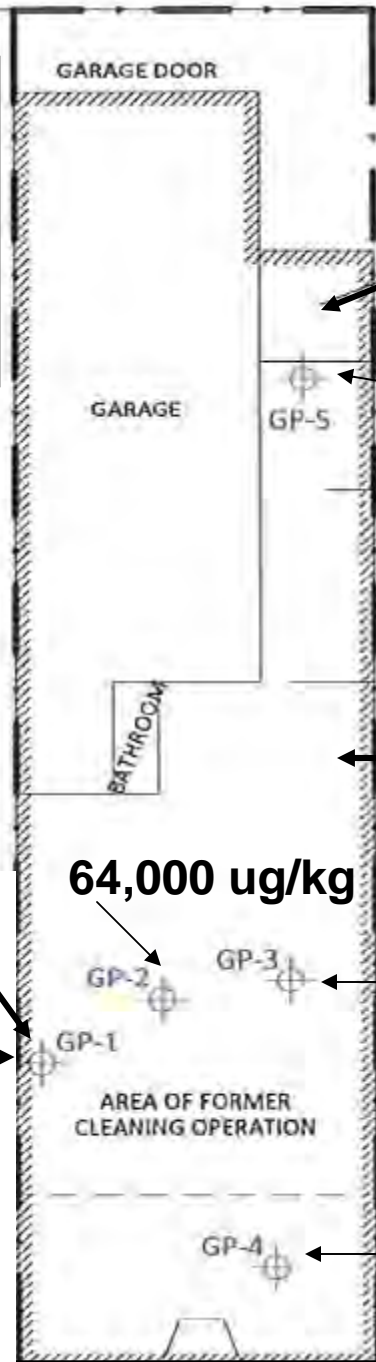
Shallow soil – PCE concentrations

Boiler room – former drum storage

18,000 ug/kg

Staining on floor

Hole in floor

64,000 ug/kg

1,900 ug/kg

48 ug/kg

32 ug/kg

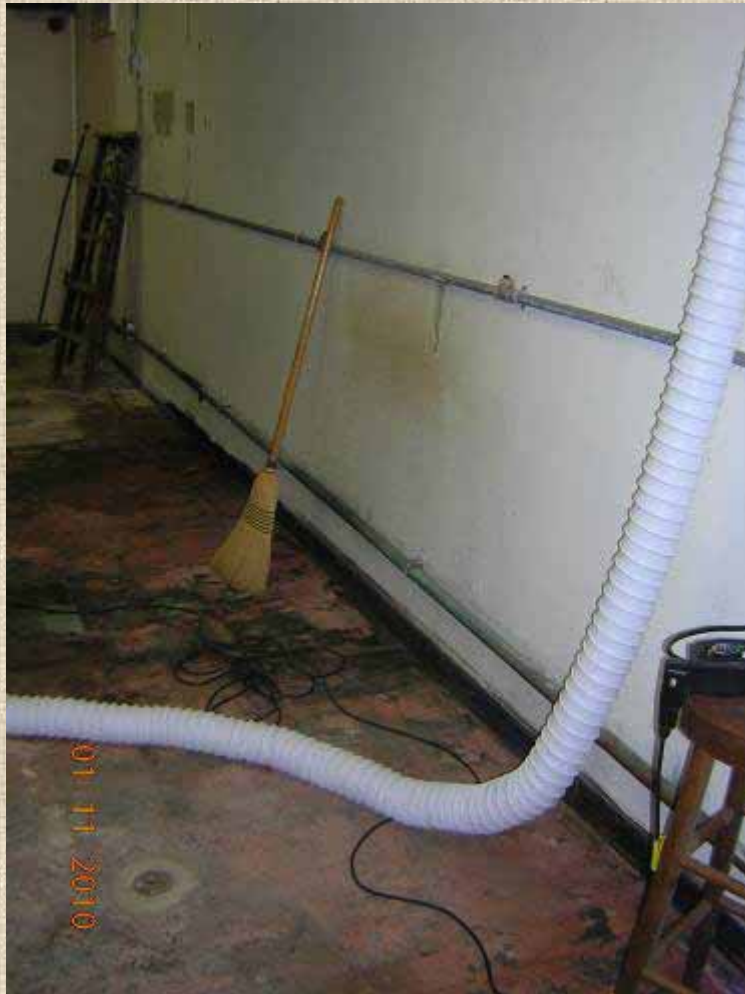
**East wall – floor stained
– GP3 in bottom left
corner (1,900 ug/kg PCE)**

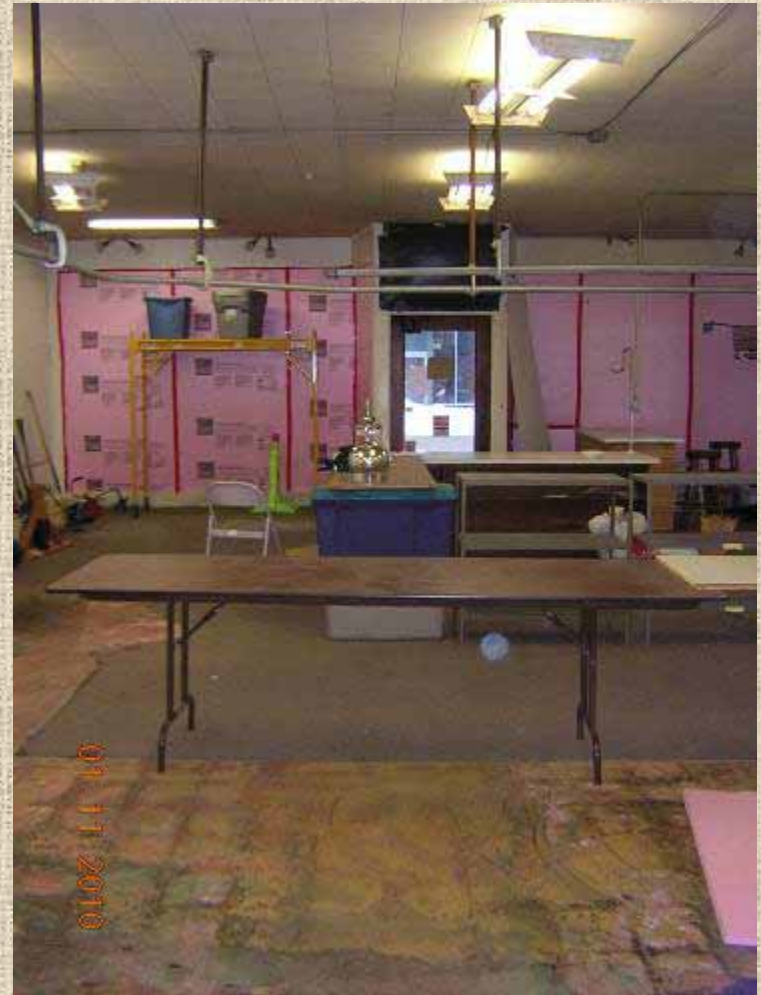
**South end – front of
store**

Standing on the approximate location of GP-5

(18,000 ug/kg PCE)

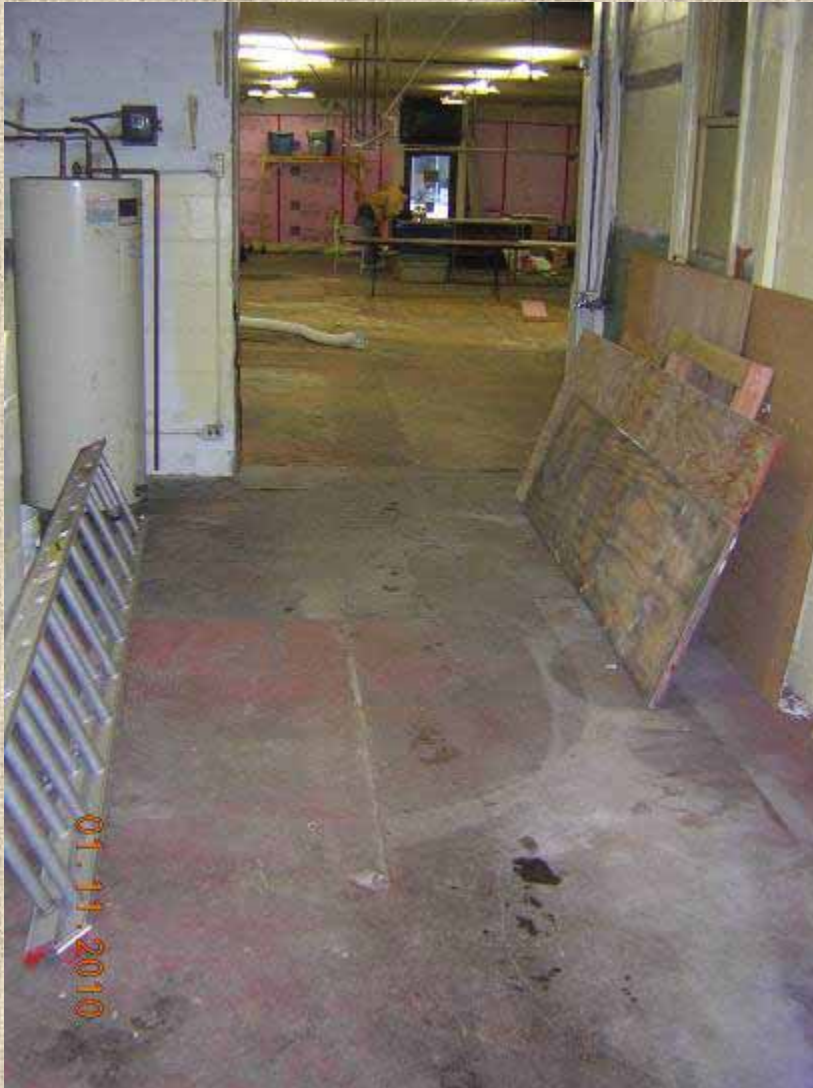
Looking south towards store front area

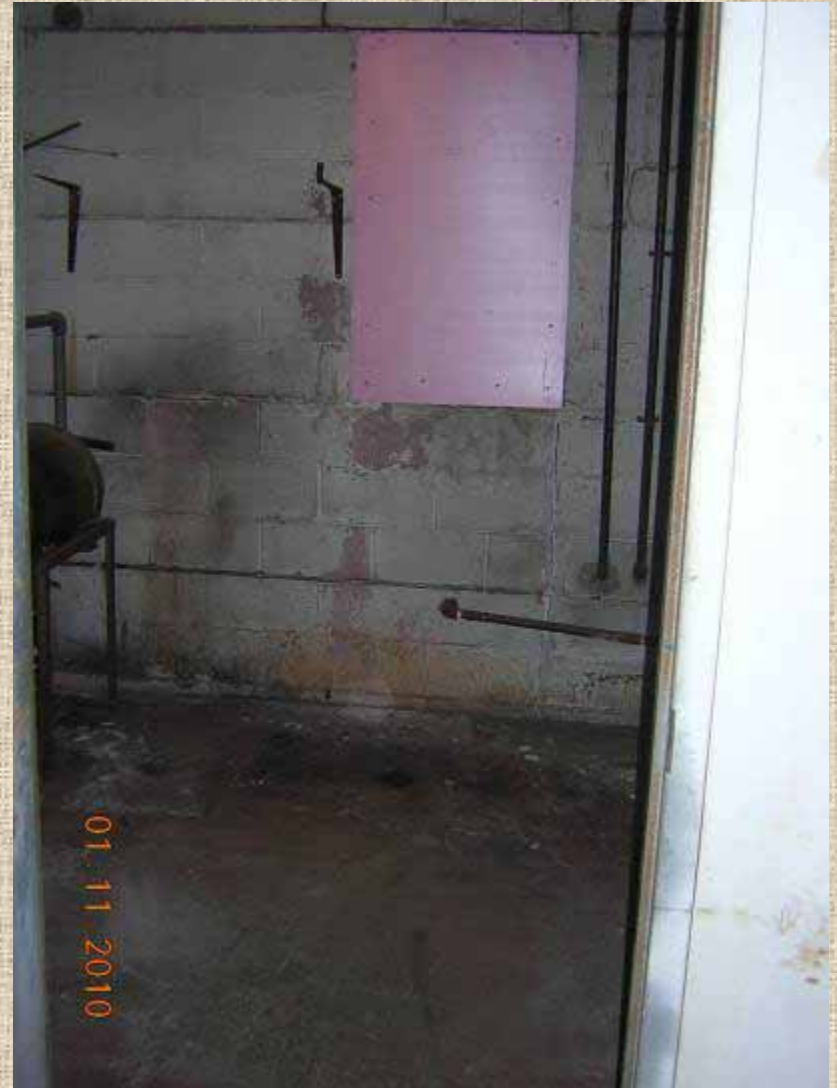
Looking north into boiler room

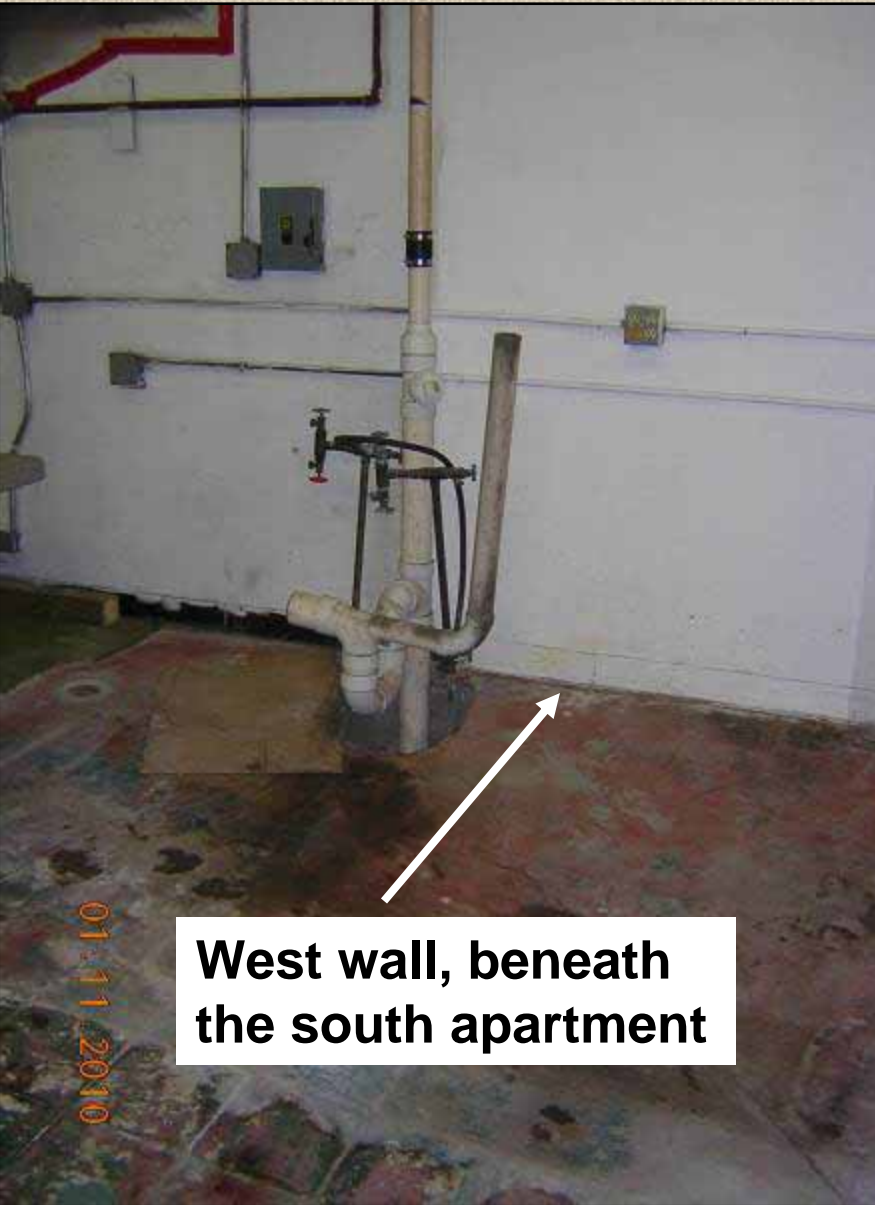
Sewer Repair resulted in floor opening – direct pathway for vapor migration

**Sealed
hole
around
sewer
pipe on
first level**

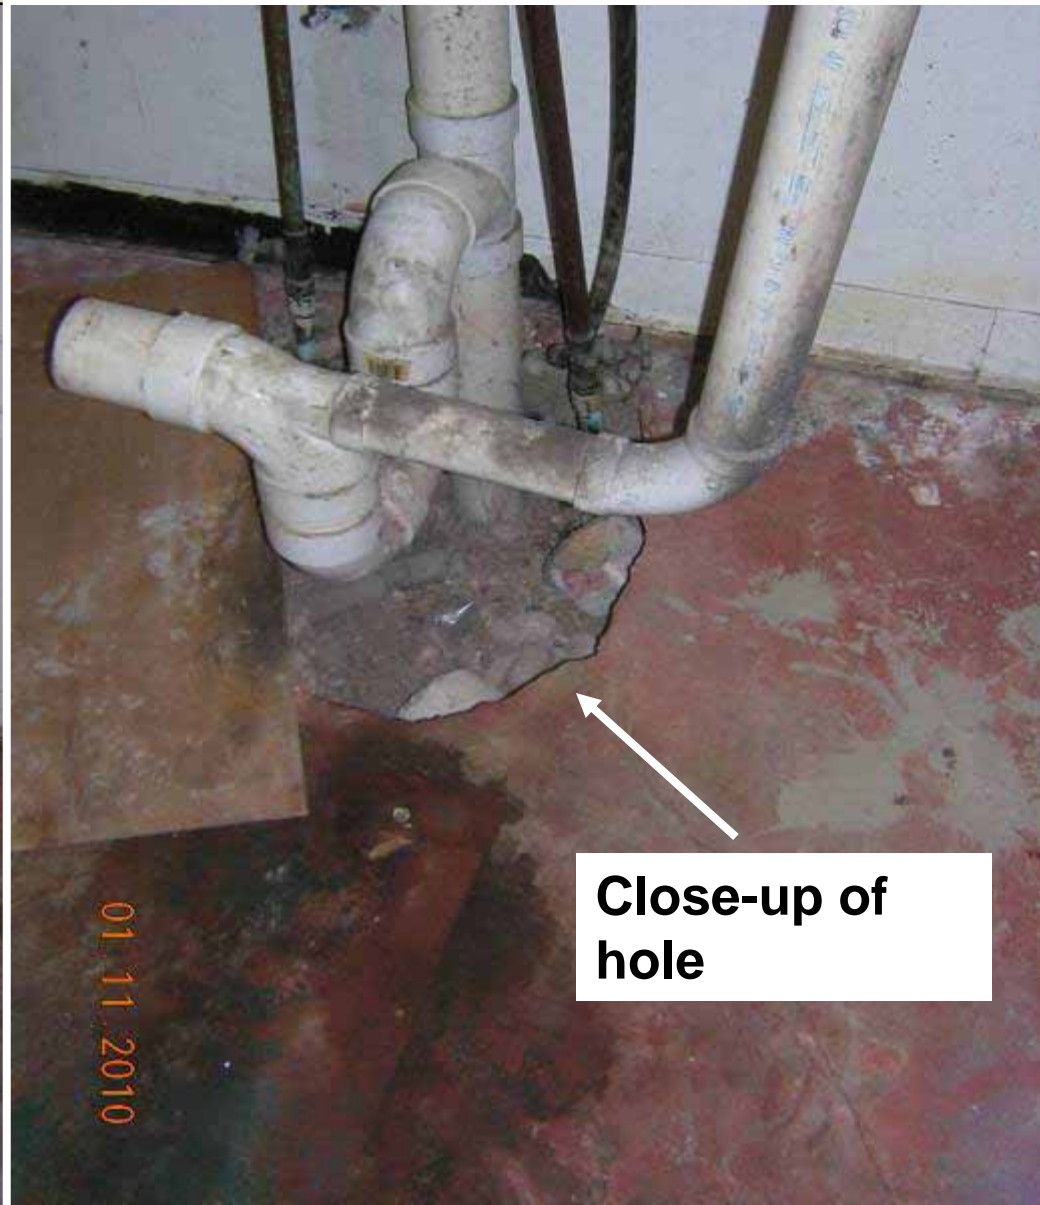
West wall, beneath the south apartment

Close-up of hole
