October 13, 2011

Re: Madison Kipp Corporation – Chlorinated Organic Contamination Issues

Additional Monitoring Points Recommended by Ken Wade

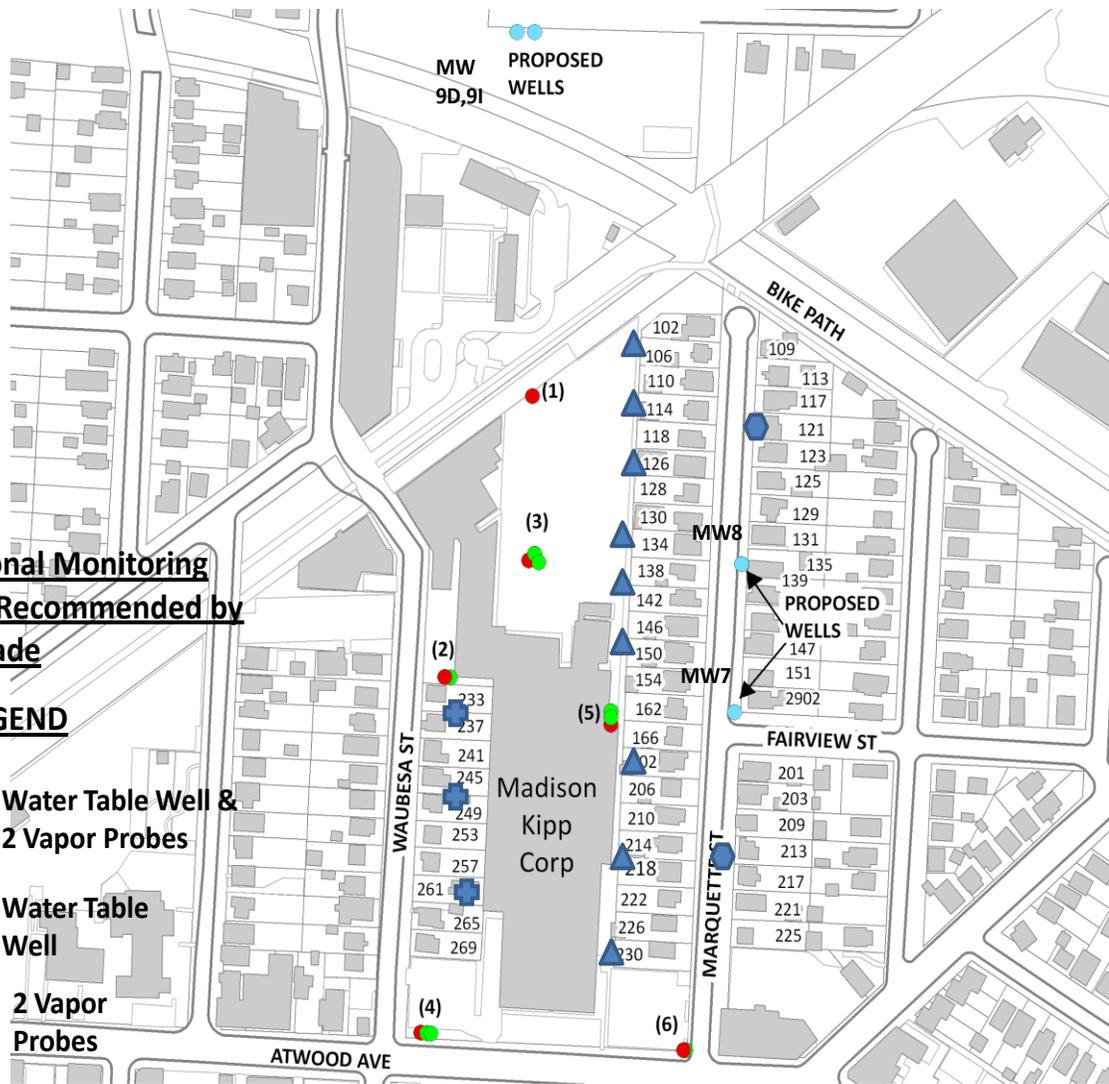
In order to minimize risk to adjacent residents the significant vectors for contaminant movement to the residents must be monitored so that remedial activities can be taken wherever warranted. I recommend additional monitoring points as shown on the attached figure. I have proposed that nine additional subsurface monitoring points (as shown by the blue triangles) be established along the Madison Kipp boundary with the back yards of the Marquette St. residents. Each of the points would include a water table well to be analyzed for VOCs. Detection of PCE greater than 5 $\mu\text{g/l}$ in the groundwater would indicate the presence of significant risk of associated soil vapor contamination for adjacent residents. Each point should also include a pair of soil vapor probes to be monitored for VOCs. It is critical that one probe should be screened in the unsaturated sand layer immediately underlying the clay soils. Another probe should be screened at the same depth as the adjacent house foundation (basement floor or slab).

I propose two additional water table wells along Marquette Street, one north of MW8 and one south of MW7. These wells will help to better define both the water table gradient and potential contaminant migration directions, but will also confirm the preliminary results of MW7 and MW8 that the water table contaminants that pose the greatest risk to residents have not migrated east of Marquette St.

I propose three additional pairs of soil vapor probes to be located in the back yards of the residents along Waubesa St. that are immediately adjacent Madison Kipp (shown as blue crosses). These probes should be constructed and monitored as the probe pairs recommended above.
