Subject: Dam Inspection Report for LITTLE FALLS DAM,
Field File No. 55.01, Key Sequence No. 54, St. Croix County.

Dam Inspection Report

Little Falls Dam

Inspection Date: October 17, 2011

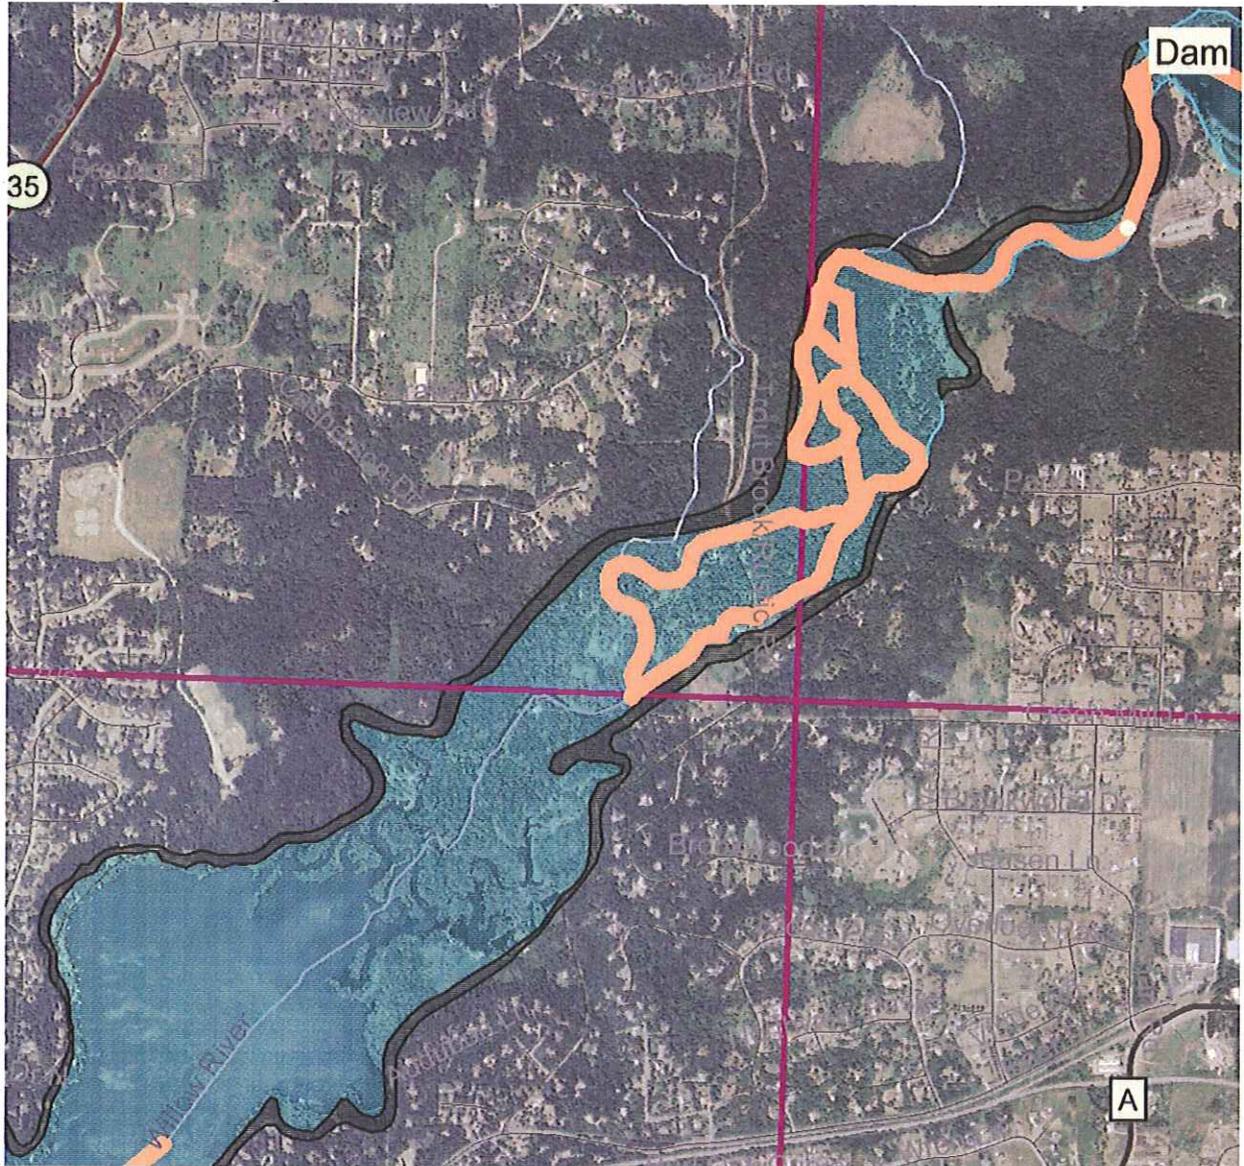
The Flood Insurance Rate Map above does not indicate that there is development in the 100 year flood plain elevation down stream of the dam, but this would need to be confirmed.

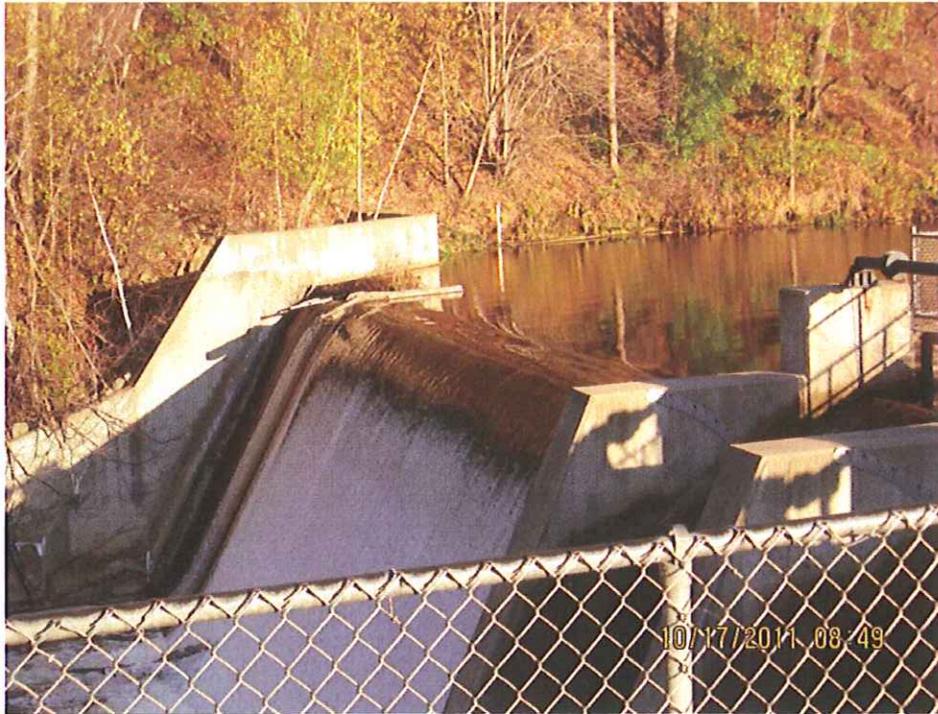
The spillway pictured above is the primary spillway

The fix crest spillway appears to have been reconstructed in recent years. The condition of the spillway appeared to be adequate but a thorough inspection could not be done because the impoundment was at full pool and the spillway was flowing.

10. The next inspection of the dam should include a draw down to expose the Tainter gate components, the face of the concrete dam, the concrete at pinions and surrounding the Tainter gates, and the concrete making up the spillway.

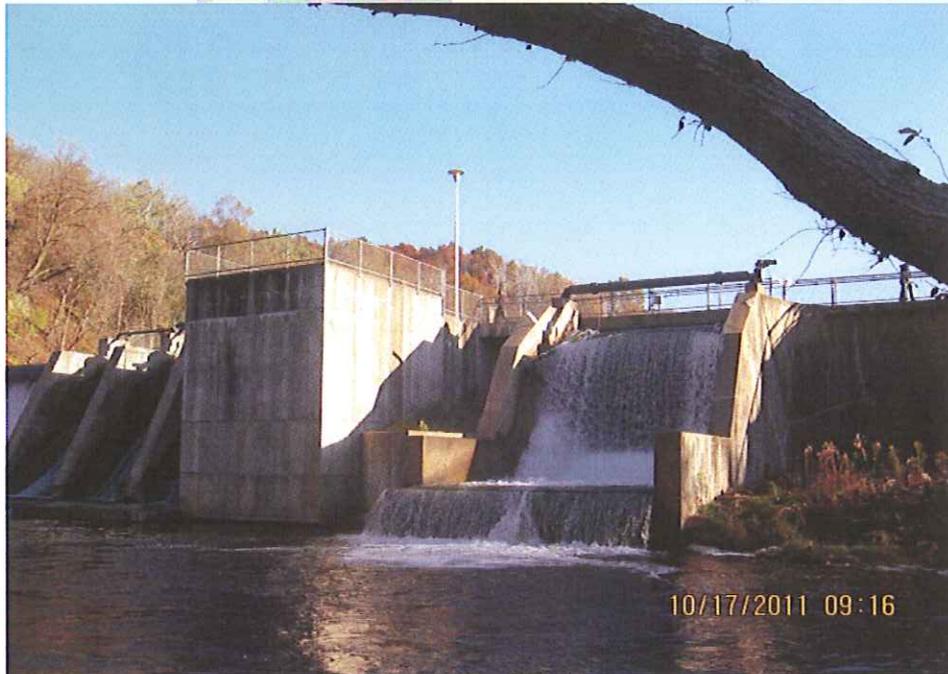
One large Tainter gate and three smaller Tainter gates are used as auxiliary spillways. The larger Tainter gate above has flow over topping the gate.

The four Tainter gates have been repaired or modified in recent times, in the last 20 years or so, and appeared to be free of corrosion. Flow was going over the top of the larger Tainter gate at the time of the inspection so the trunnion arms, trunnion pins and bearings, vertical ribs, and arm bracing could not be inspected..

7. The IOM should include a frequency for operating (exercising) the gates.
8. The IOM plan should include a method of gate operation that minimizes flow over the top of the Tainter gates.

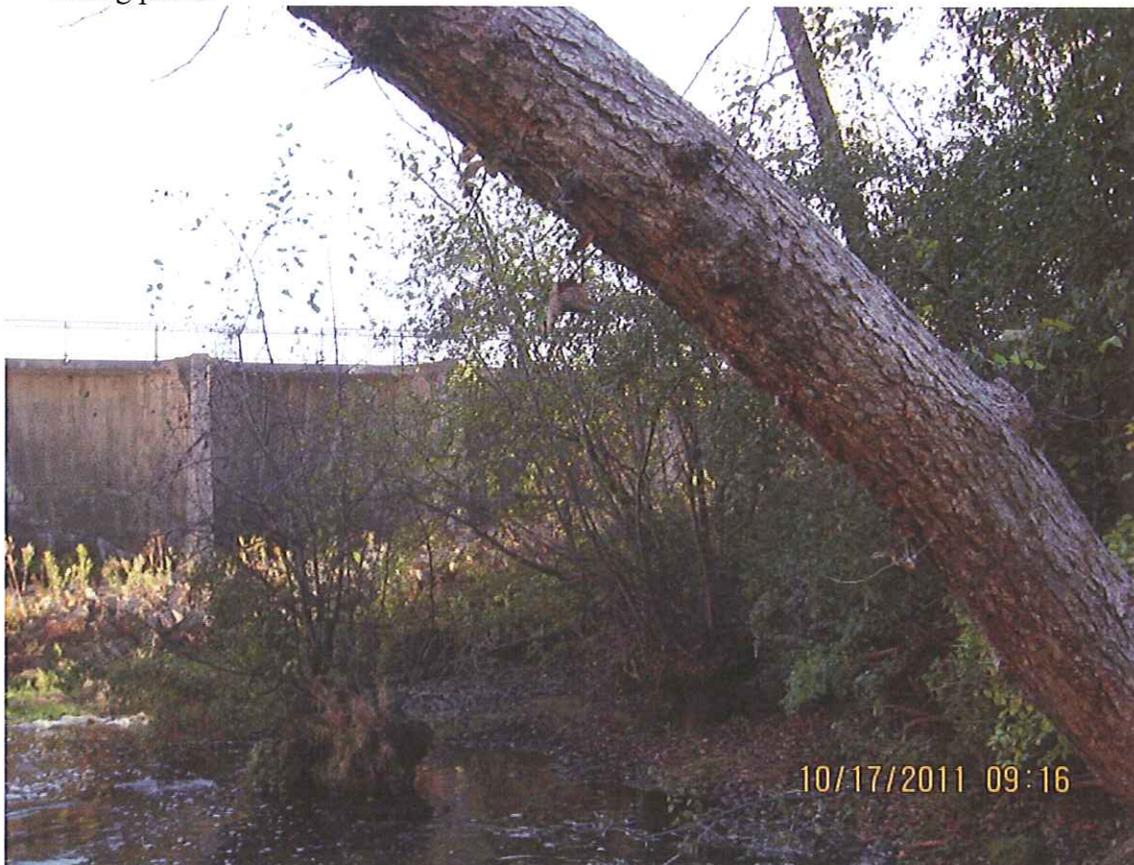
- A. Vegetation – There is some woody vegetation on the downstream embankment on the left hand side looking down stream. The vegetation makes it difficult to see if there is seepage taking place.

5. The woody vegetation needs to be removed from the dam if it has not already been done.
6. The IOM plan should include a frequency and method of measuring flow from the "V" notch weir used to measure seepage and a system to document and trend flows.

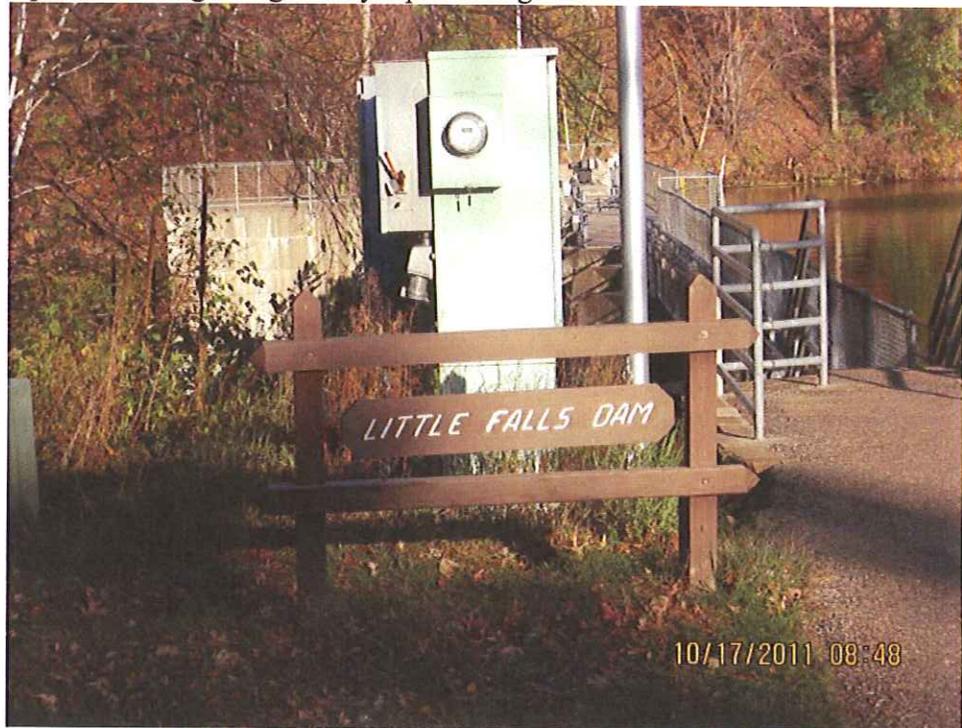
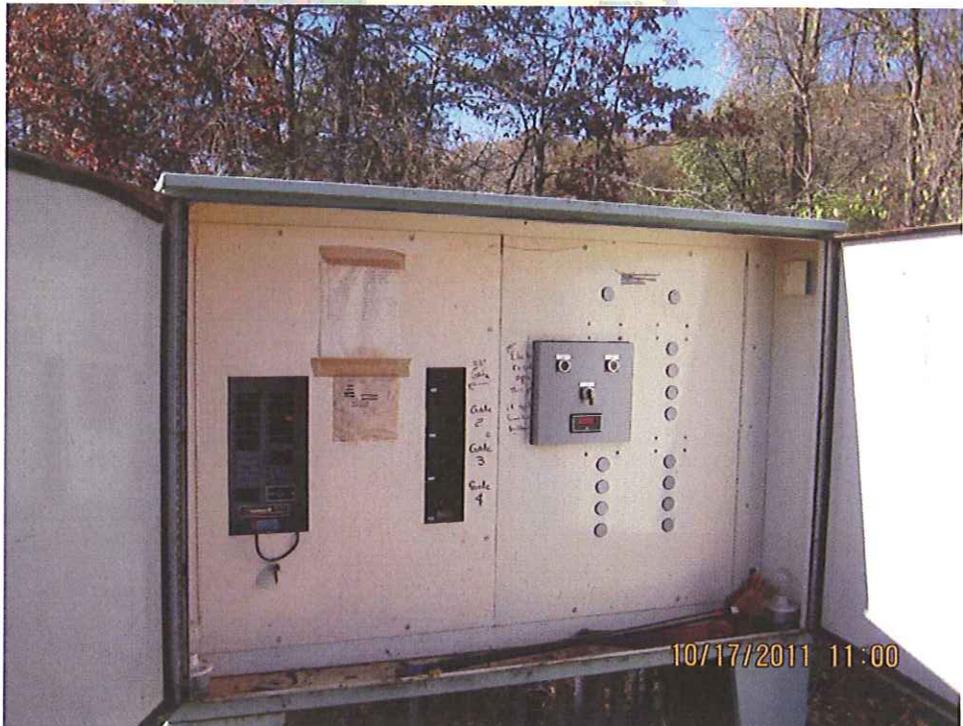
There is some corrosion in the panel. This can happen if the panel heater fails. The heater helps to remove the moisture.

9. The EAP and IOM should include the location of the portable generator, how it gets to the dam, and how it is connected and operated to energize the motor control panel.

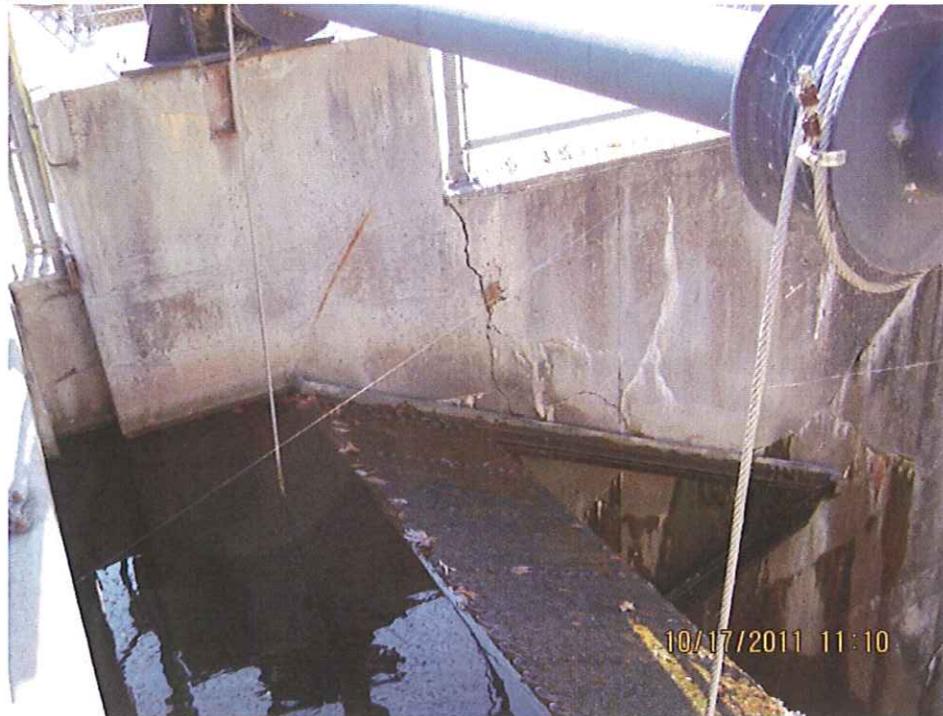
The concrete around the pinions of the Tainter gates should also be inspected. There are cracks at the pinions and some heaving of concrete in the walkway across the abutment of the Tainter gate and former powerhouse.

There are cracks from the cable winder down to the trunnion pin and beyond. This is next to the former power house area. Note that there is no way to access the trunnion pin and bearing for lubrication. The same situation exists for all four gates.

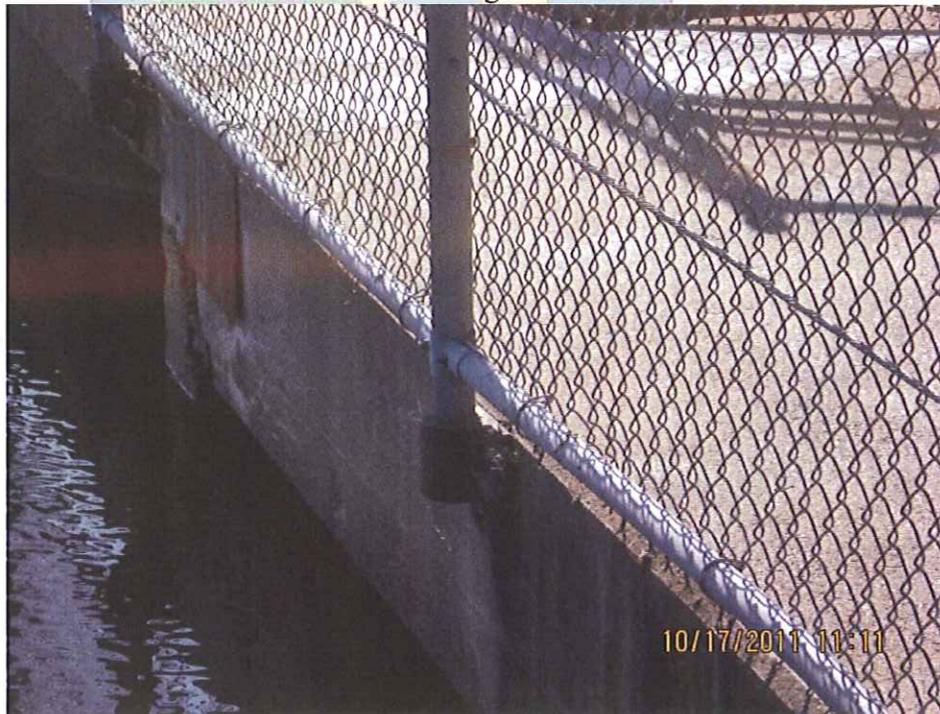
Concrete patching on the walkway, the lighter colored material, and shifting of the concrete at the crack near the water line.

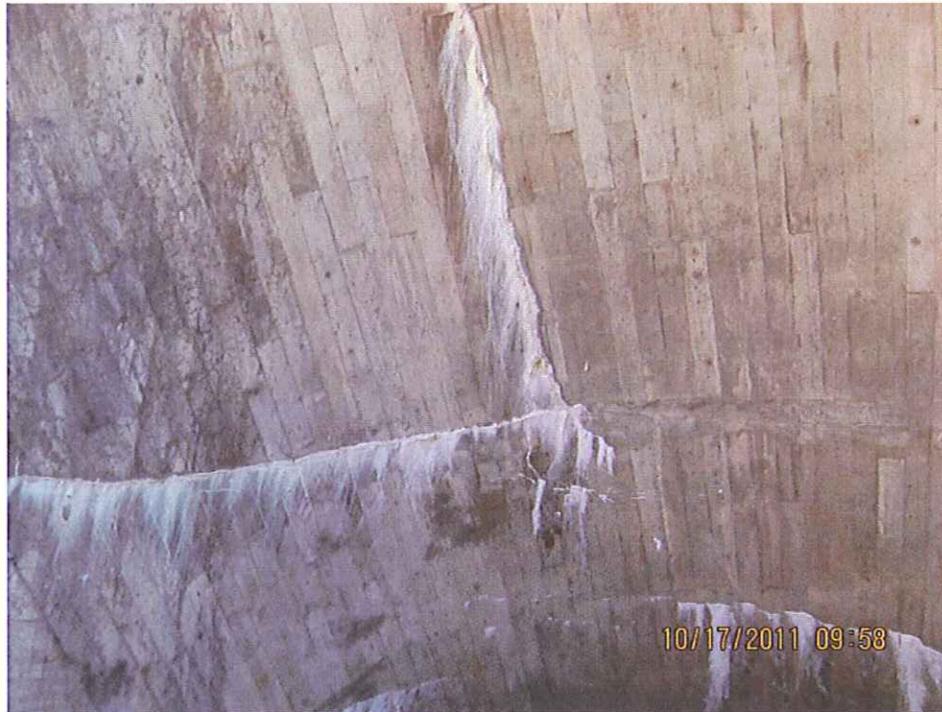
The next inspection of the dam by an engineer is scheduled for 2013. The inspection should include an inspection of the face of the dam to check on the condition of the concrete. The weeping on the backside of the concrete may be a sign of a problem on the front of the dam. I would recommend that the inspection be after a complete draw down of the impoundment.

This is one of the concrete arches of the dam. The concrete has small cracks and cracks with leaks that are leaving effervescence. This is typical of all of the arches.

11. The dam owner should prepare a capital expenditure plan for the replacement and or repairs of the concrete after the next dam inspection that includes a draw down.

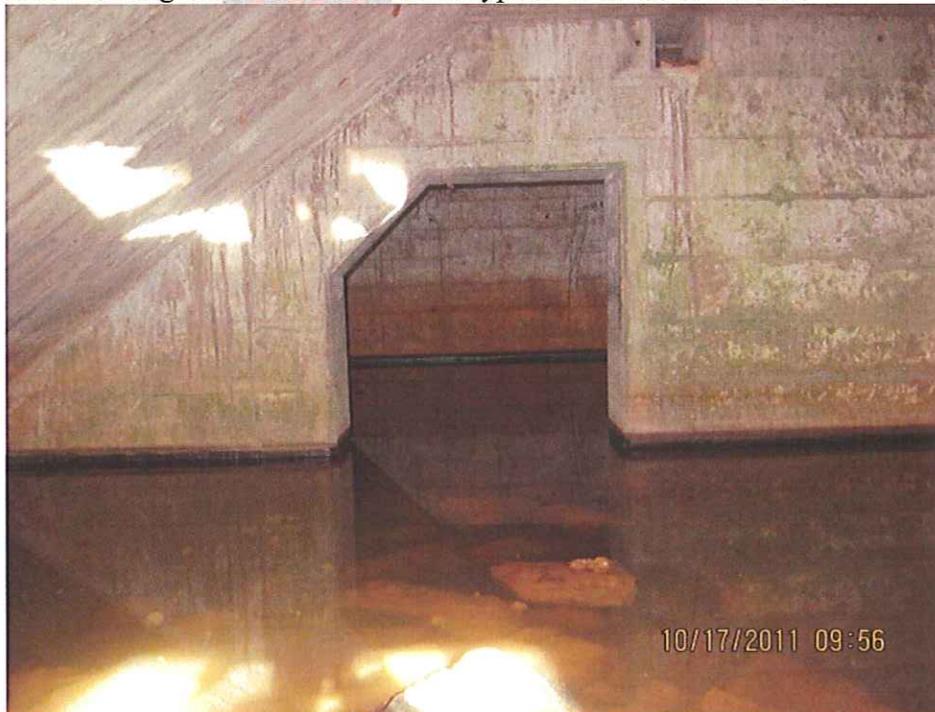
This is the concrete below the left Tainter gate looking north to the former power house wall. The concrete appeared sound with no noticeable cracks or leaking.

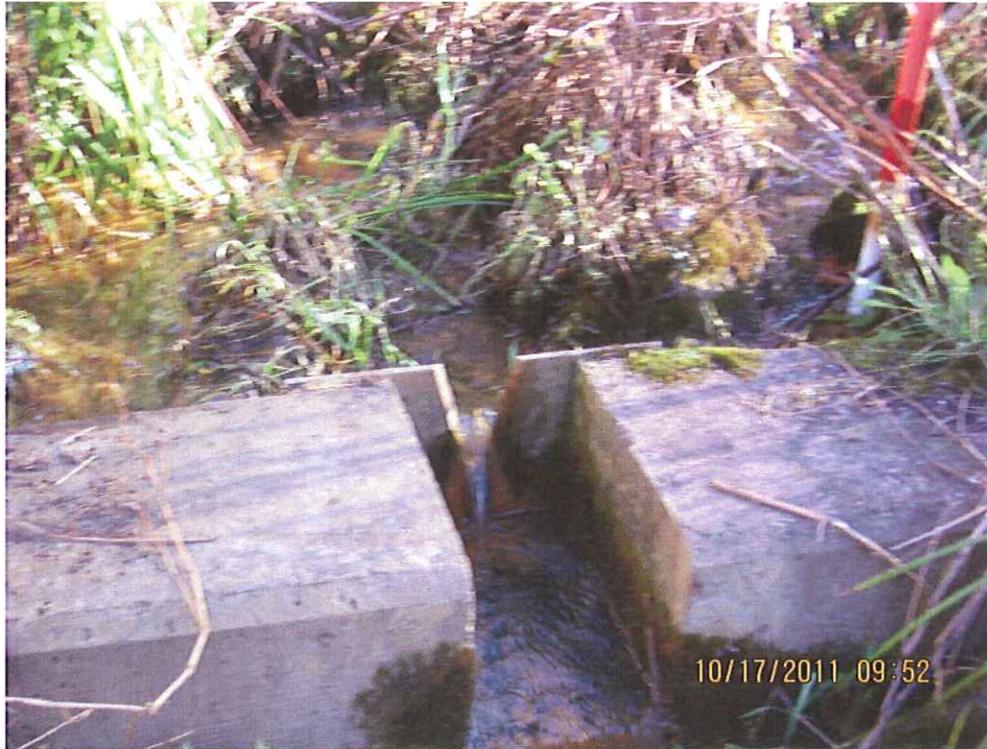
- E. Drains – There is a small weir for measuring flow coming from under and the concrete arches/abutments/sandstone. It looks to be a 30 degree V notch weir. There is no staff gauge associated with weir.
