Response to Great Lakes Legacy Act Request for Projects

**Focused Feasibility Study for Crawford Creek
and Tributary Remediation and Restoration –
Superior, Wisconsin**

**Presentation to GLNPO Technical Review Committee
April 27, 2017**

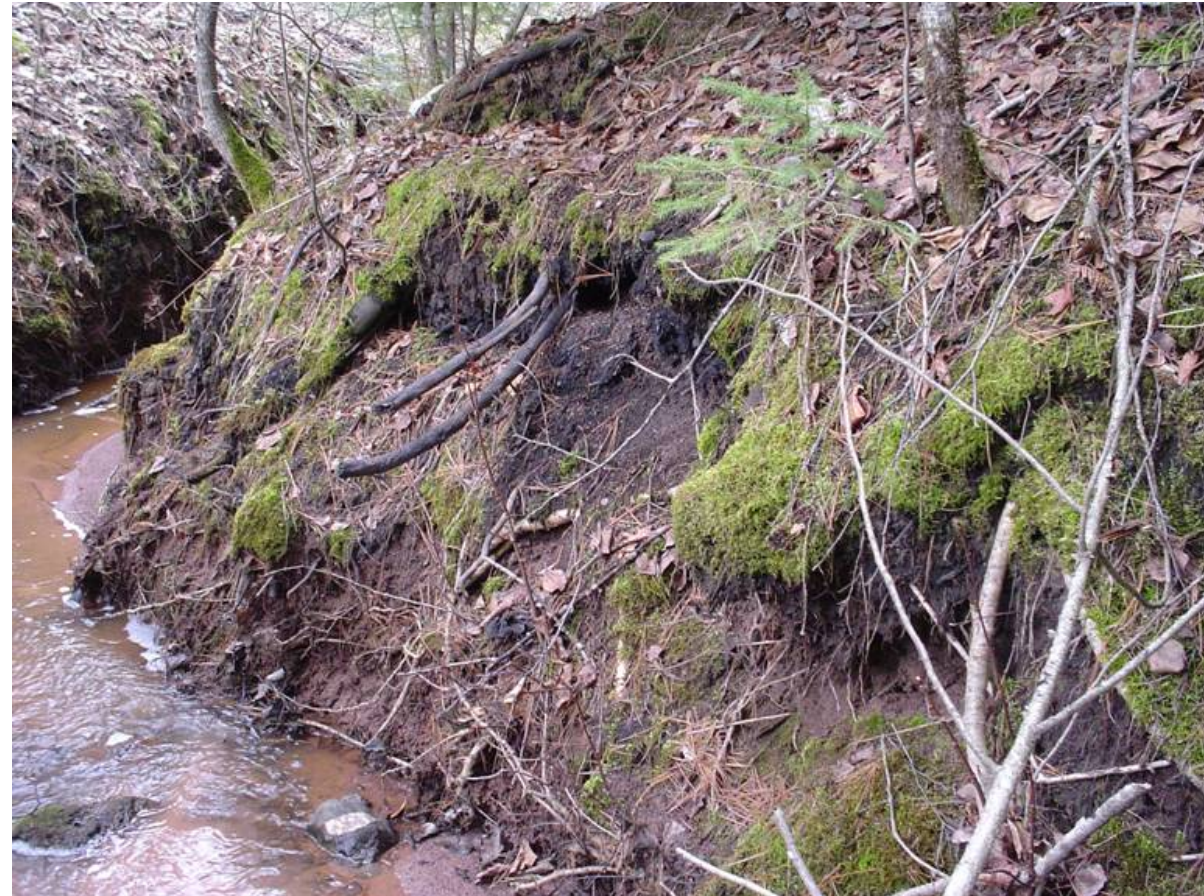
**Deeply incised Tributary channel,
with steep and heavily vegetated
banks**

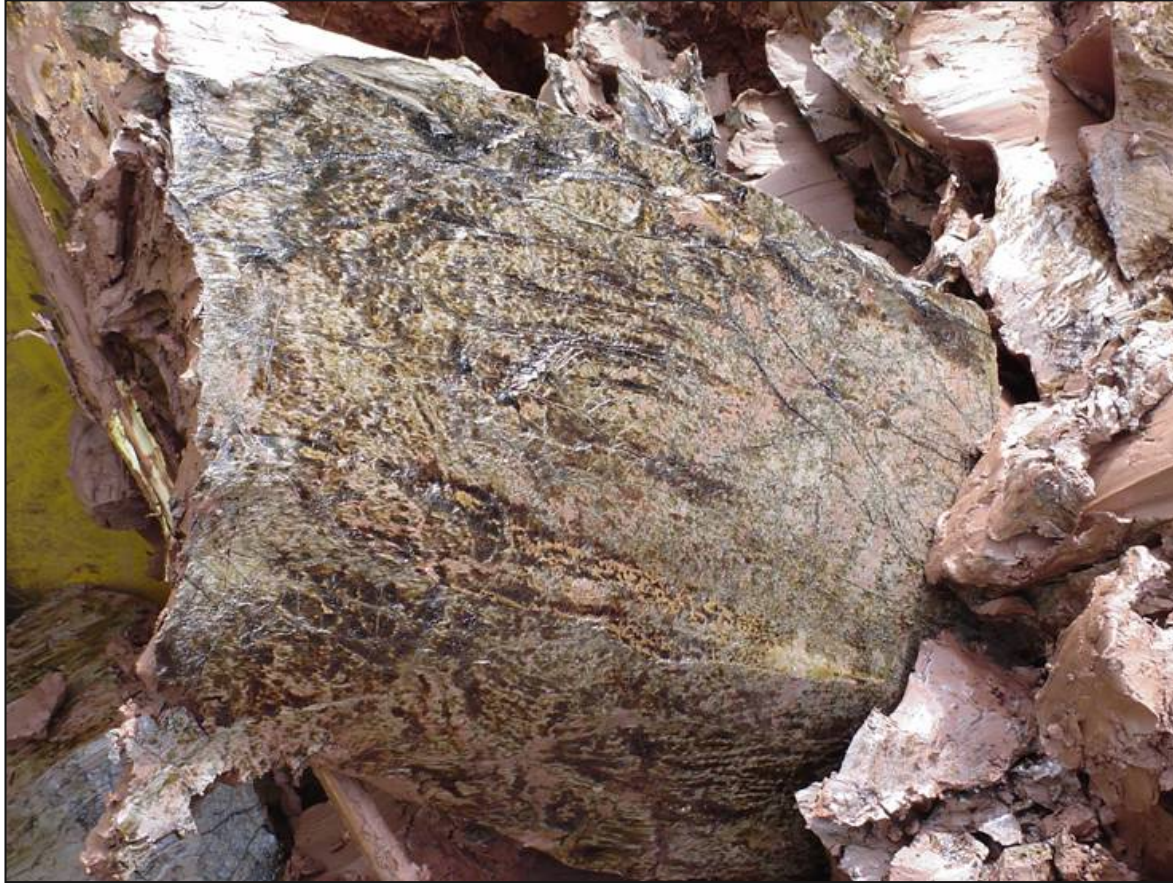
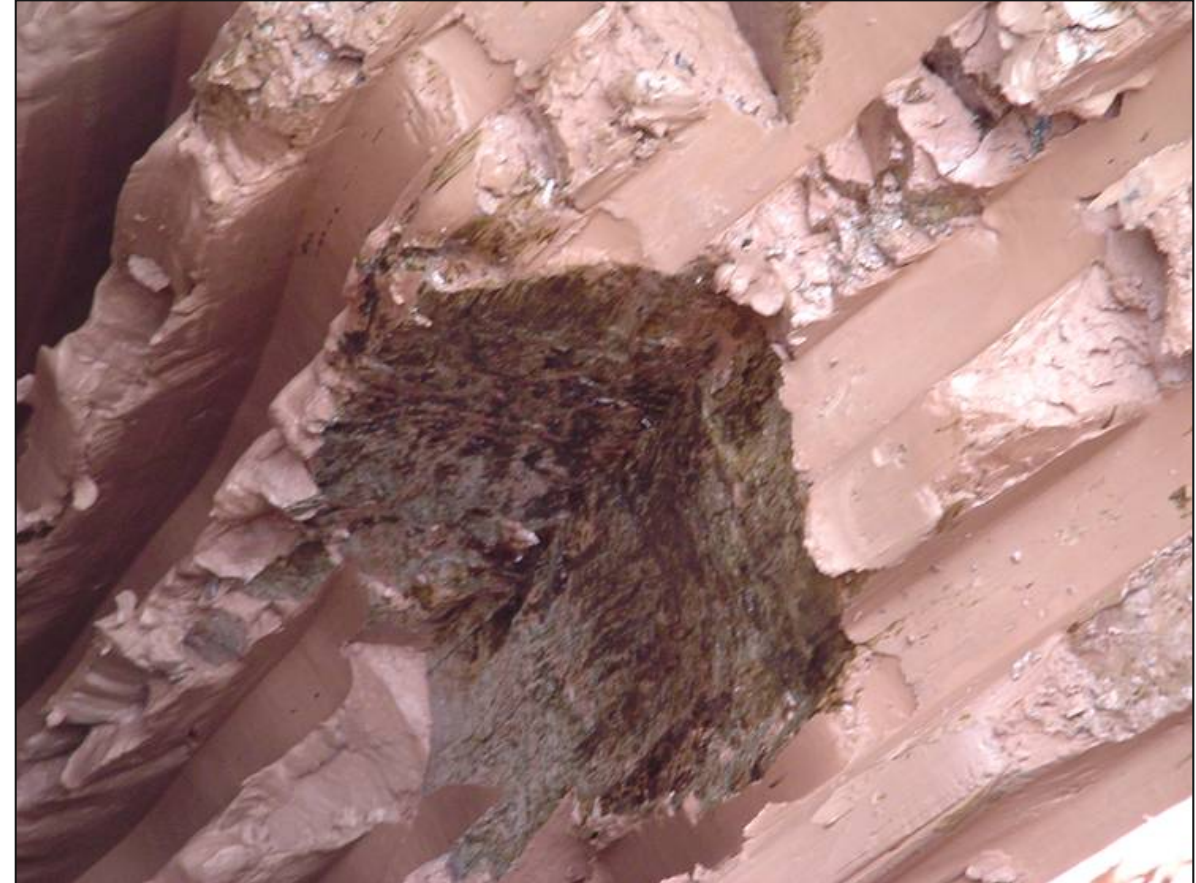
NAPL in clay fractures (cleaved from test pit sidewall)

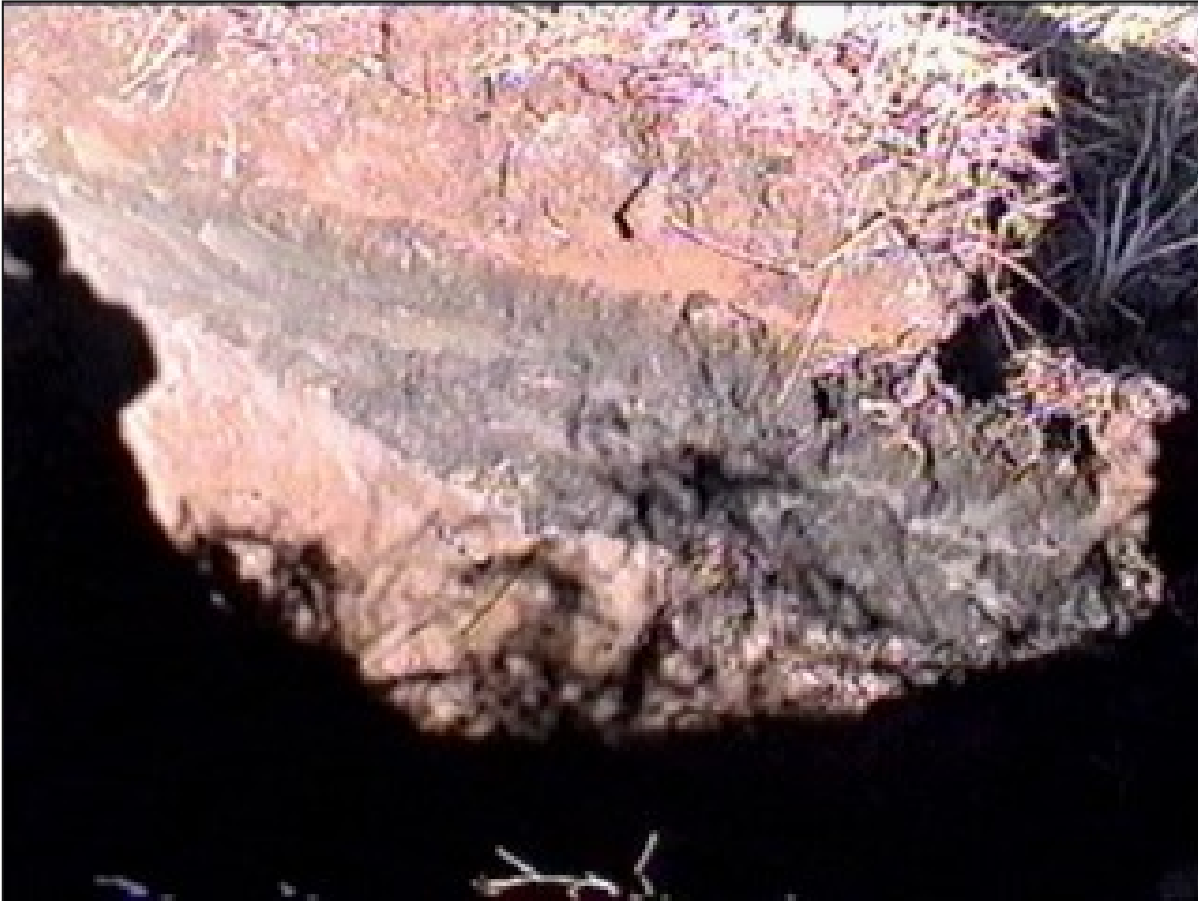
“Black stained layer” in test pit sidewall

- Dry, weathered depositional material (no NAPL)
- Present in Sub-Area B and portions of Sub-Area C
- Generally ~2' in thickness, starting around 2' bgs

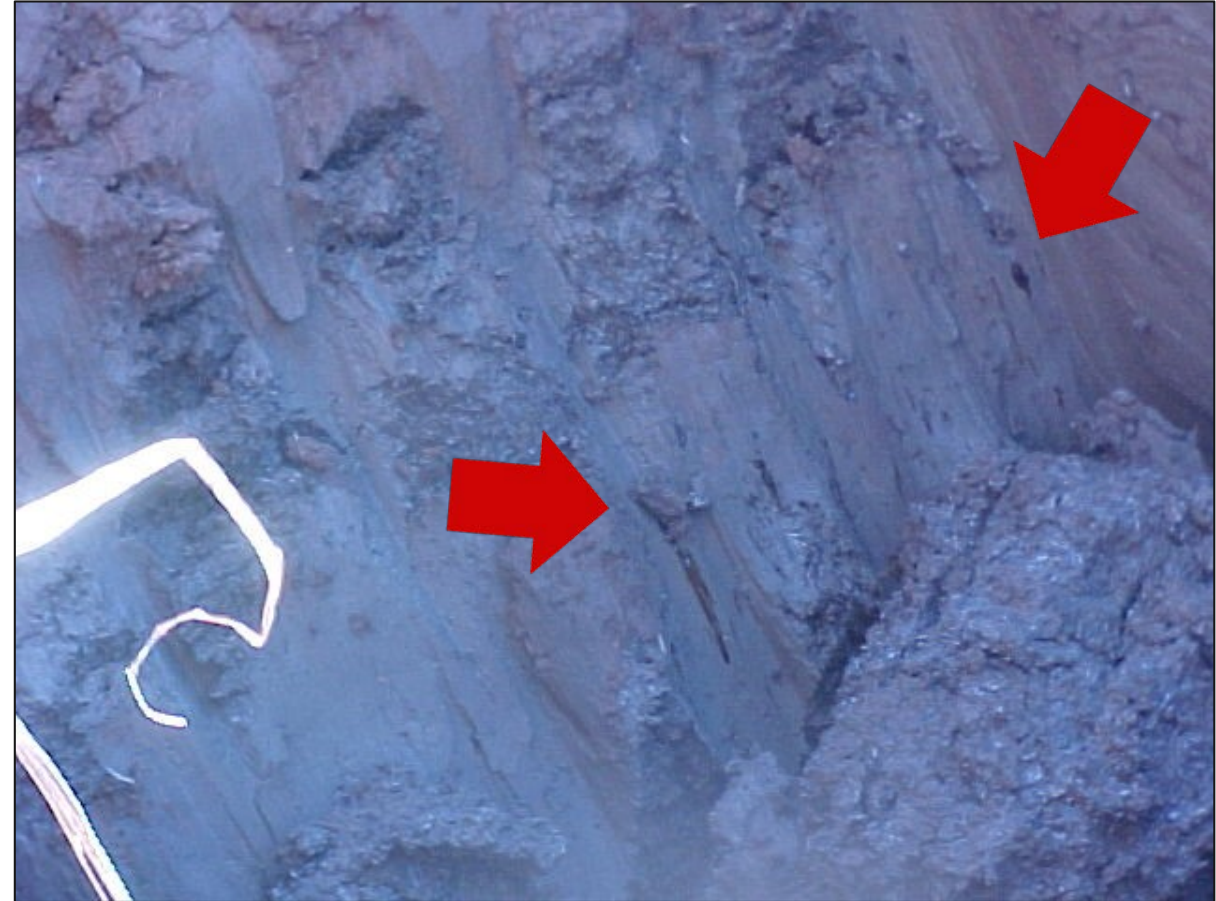
NAPL in clay fractures in test pit sidewall

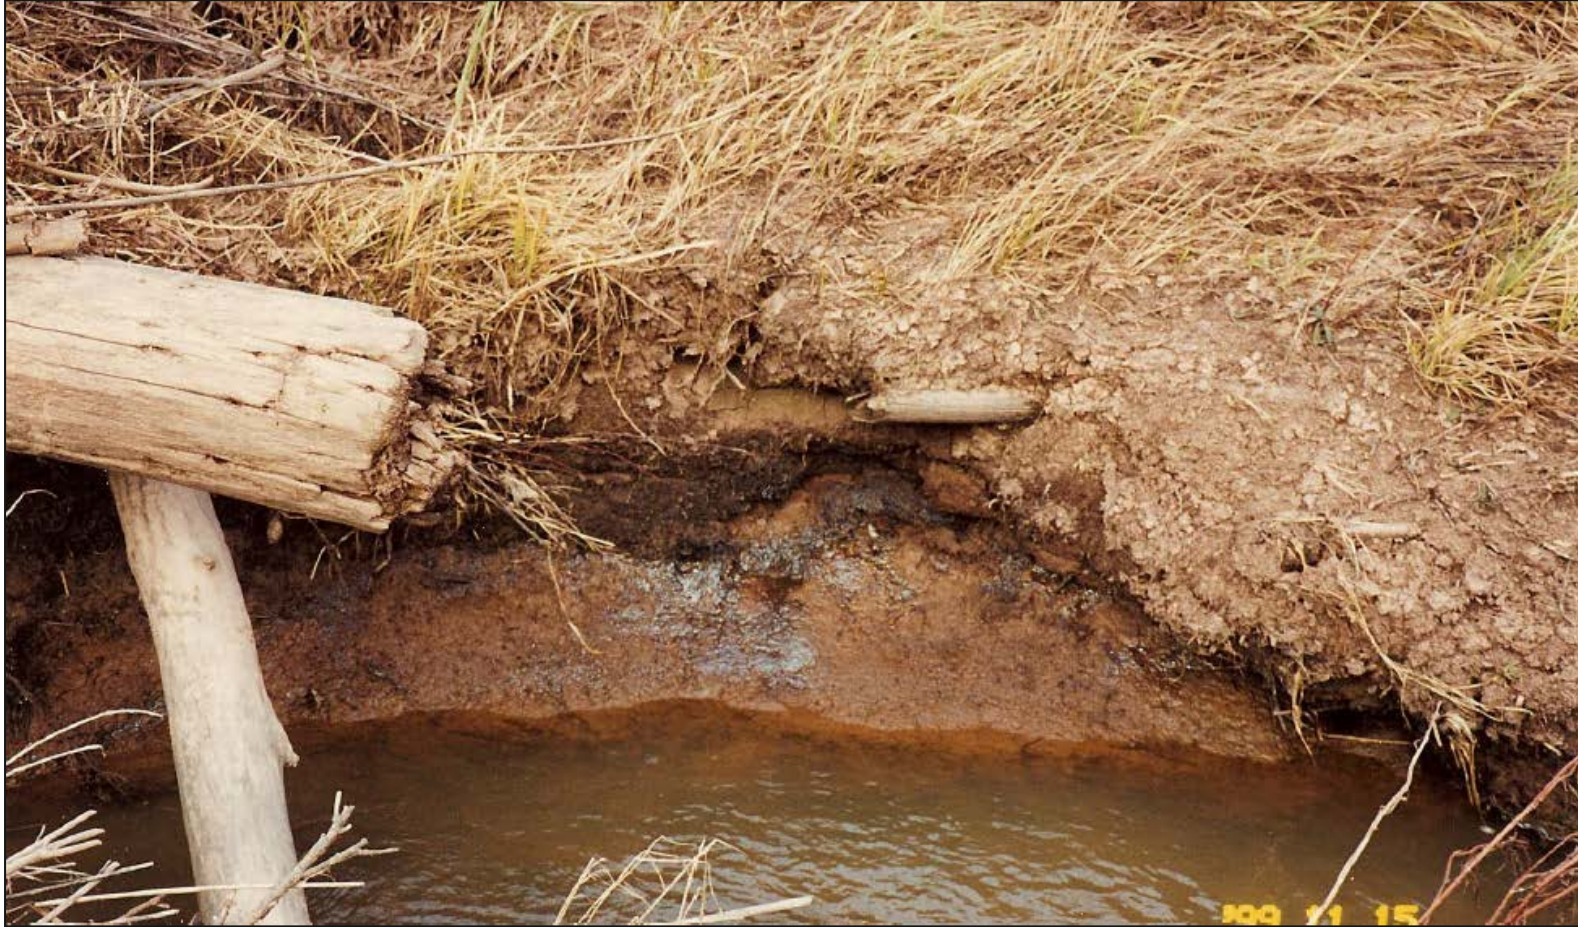
Sheen on Tributary bank
