**RE: Former Koppers Inc. Facility, Superior Wisconsin
WDNR DNR BRRTs No: 0216000484
WDNR Facility ID: 816009810**

Subject: 2018 On-Property Corrective Measures Monitoring & Maintenance Report

Site Inspection - 10/3/18

Former Koppers Inc. Facility – Superior, WI

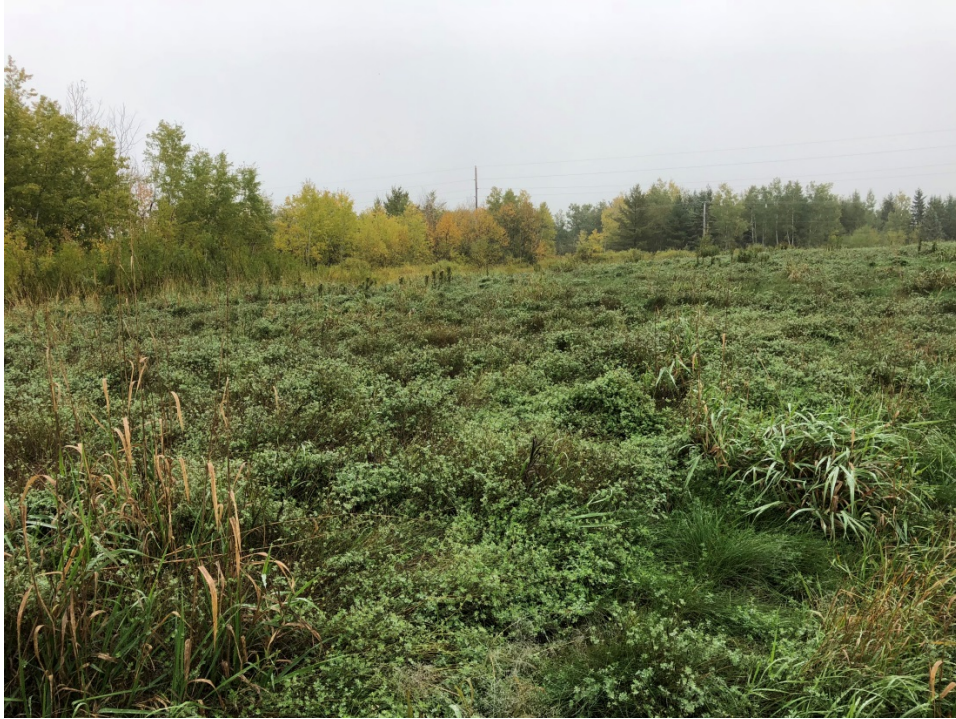
Area A Photo 1, looking Northeast from West side:

(check one)	No	Yes	If yes, provide description and take photos
Excessive erosion	X		
Evidence of excessive settling or ponding	X		
Areas lacking well-established vegetation	X

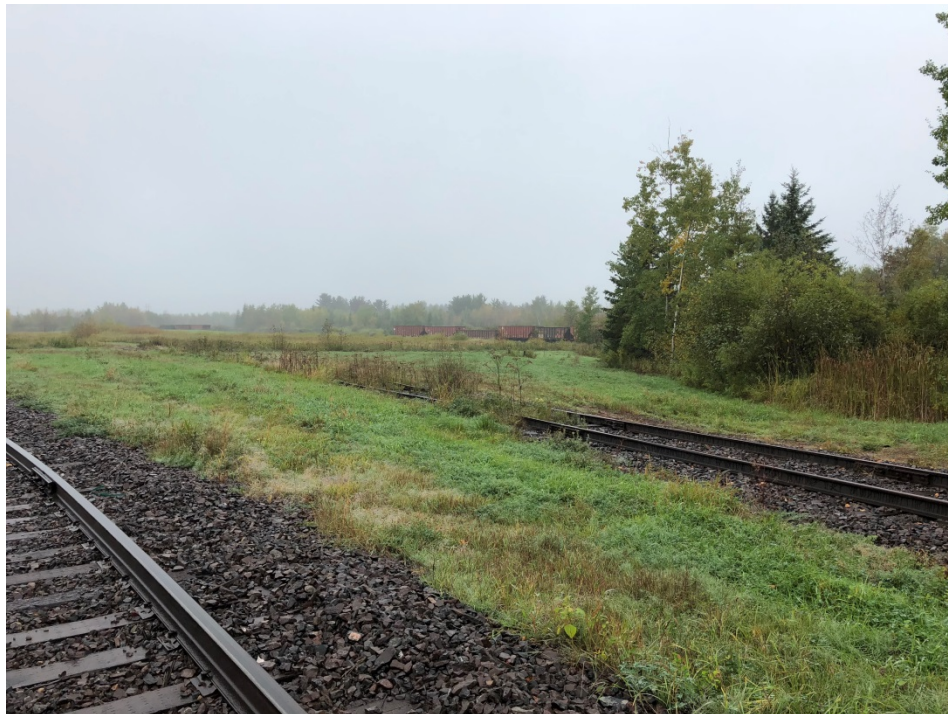
Area B Photo 4, looking South from North West along (ruts in grass along gravel):

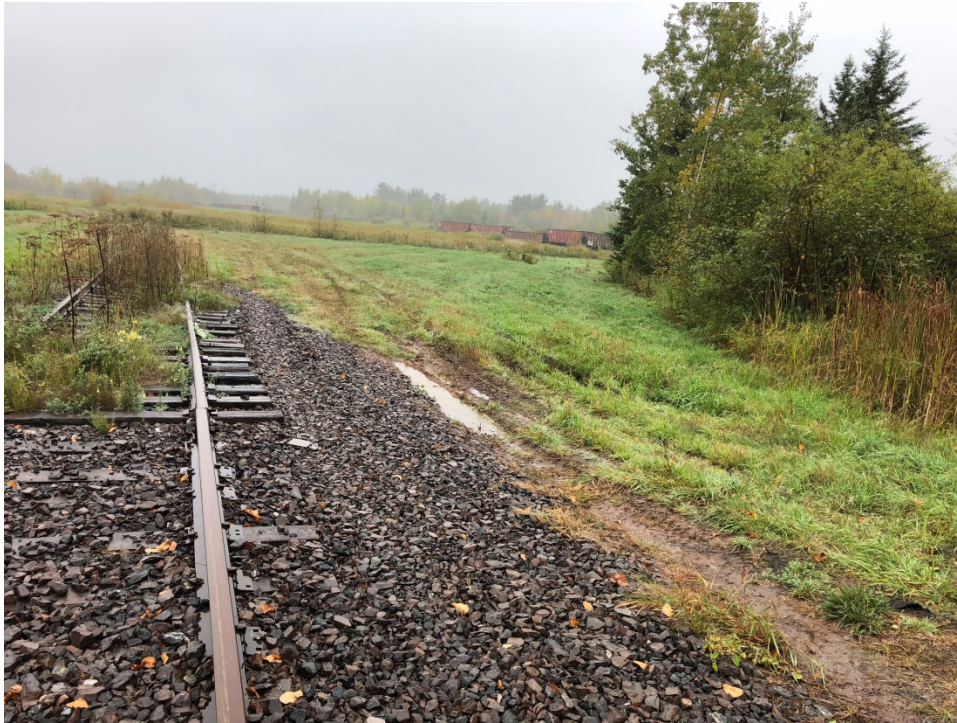
Area B Photo 5, Close up of ruts from photo 4:

(check one)	No	Yes	If yes, provide description and take photos
Excessive erosion	X		
Evidence of excessive settling or ponding		X	<u>ruts on western area, photos 5+6</u>
Areas lacking well-established vegetation	X

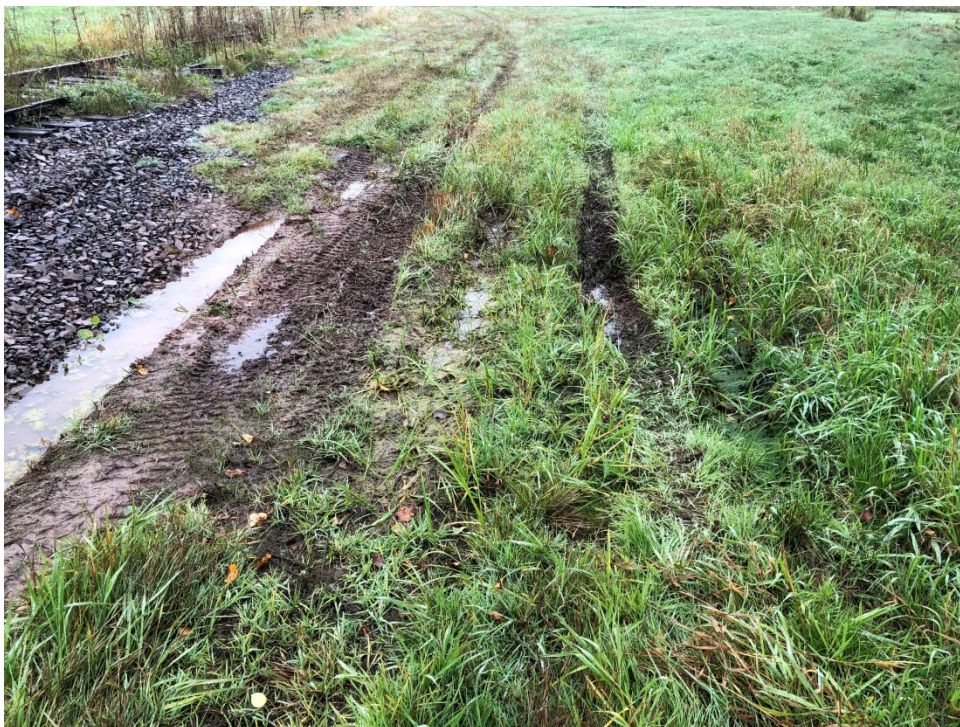
Area B Photo 6, Close up of ruts from photo 4:

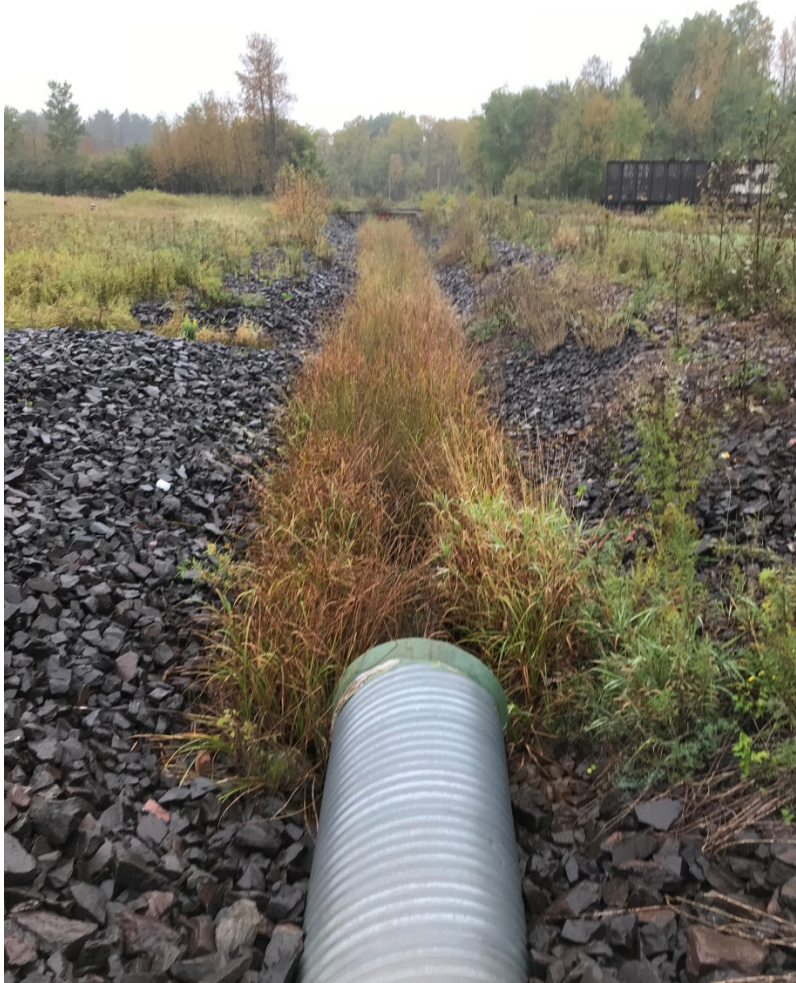
Outfall 001 Drainage Ditch Photo 1, looking West from eastern edge:

(check one)	No	Yes	If yes, provide description and take photos
Excessive erosion	X		
Evidence of excessive settling or ponding	X		
Areas lacking well-established vegetation	X

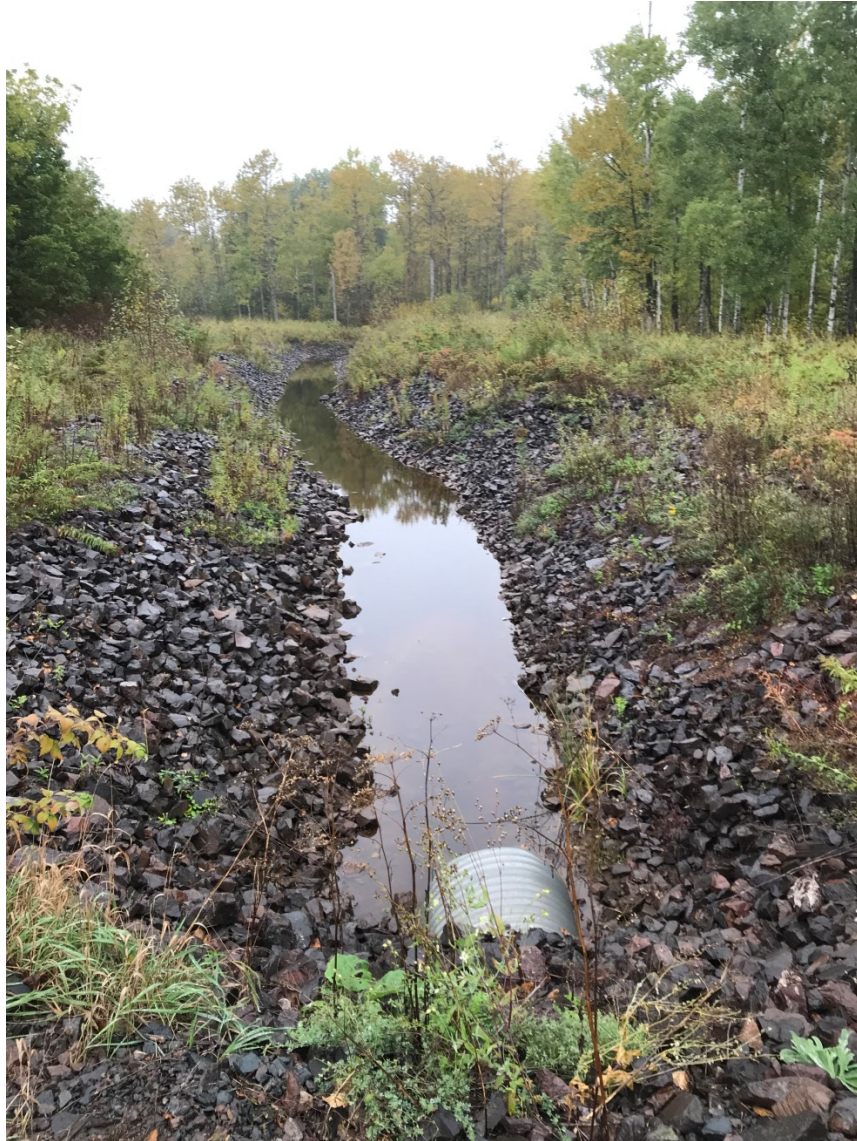
Outfall 001 Drainage Ditch Photo 2, looking west from center:
