**RE: Former Koppers Inc. Facility, Superior Wisconsin
WDNR DNR BRRTs No: 0216000484
WDNR Facility ID: 816009810**

Subject: 2023 On-Property Corrective Measures Monitoring & Maintenance Report

Site Inspection – 10/04/23

Former Koppers Inc. Facility – Superior, WI

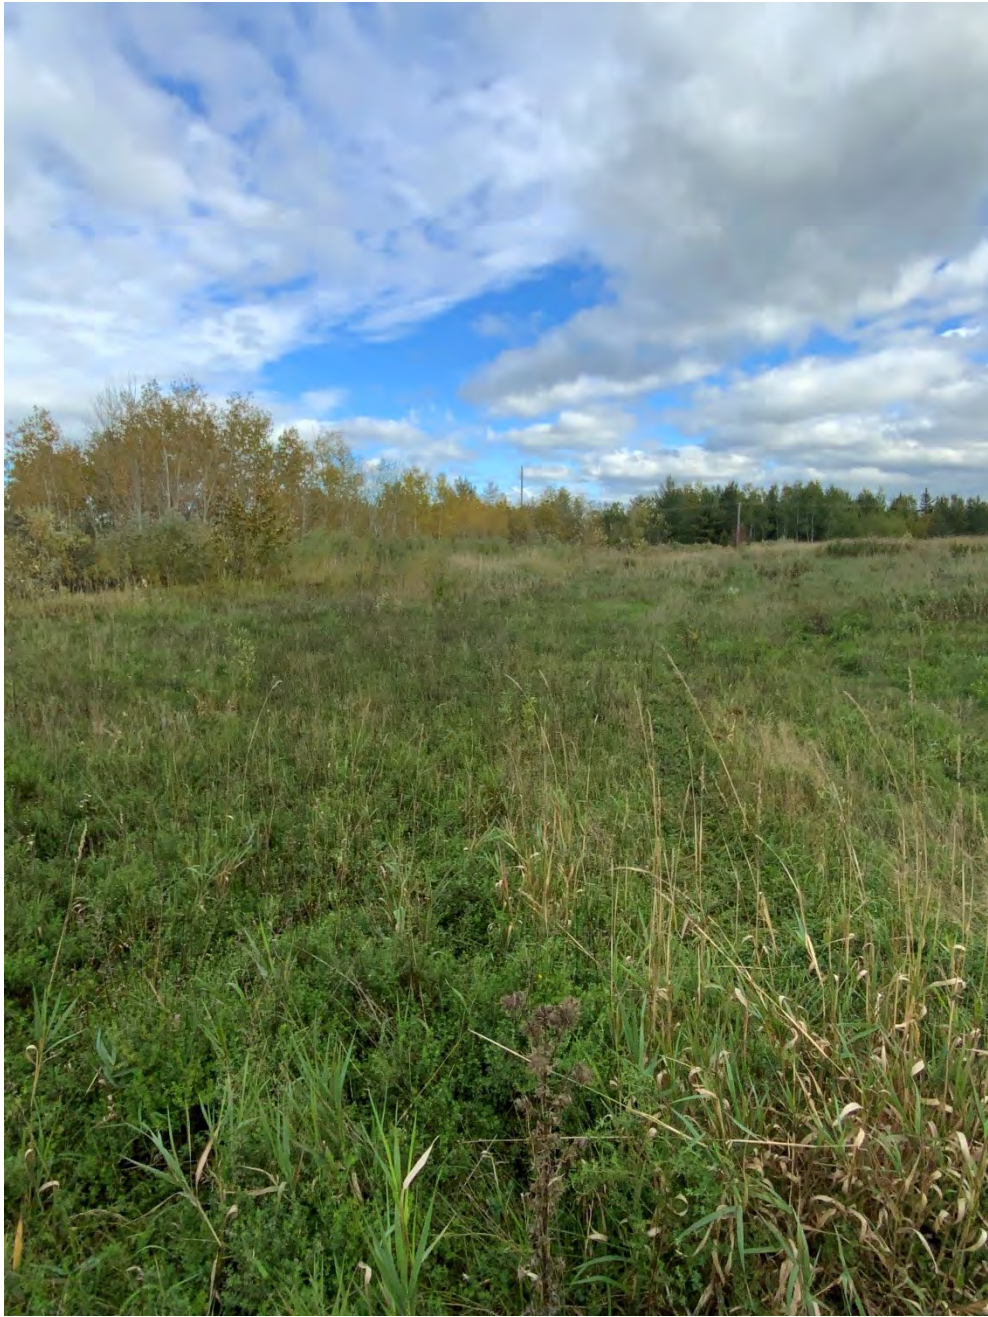
Area A Photo 1, looking Northeast from West side:

<i>(check one)</i>	No	Yes	If yes, provide description and take photos
Excessive erosion	X		
Evidence of excessive settling or ponding	X		
Areas lacking well-established vegetation	X

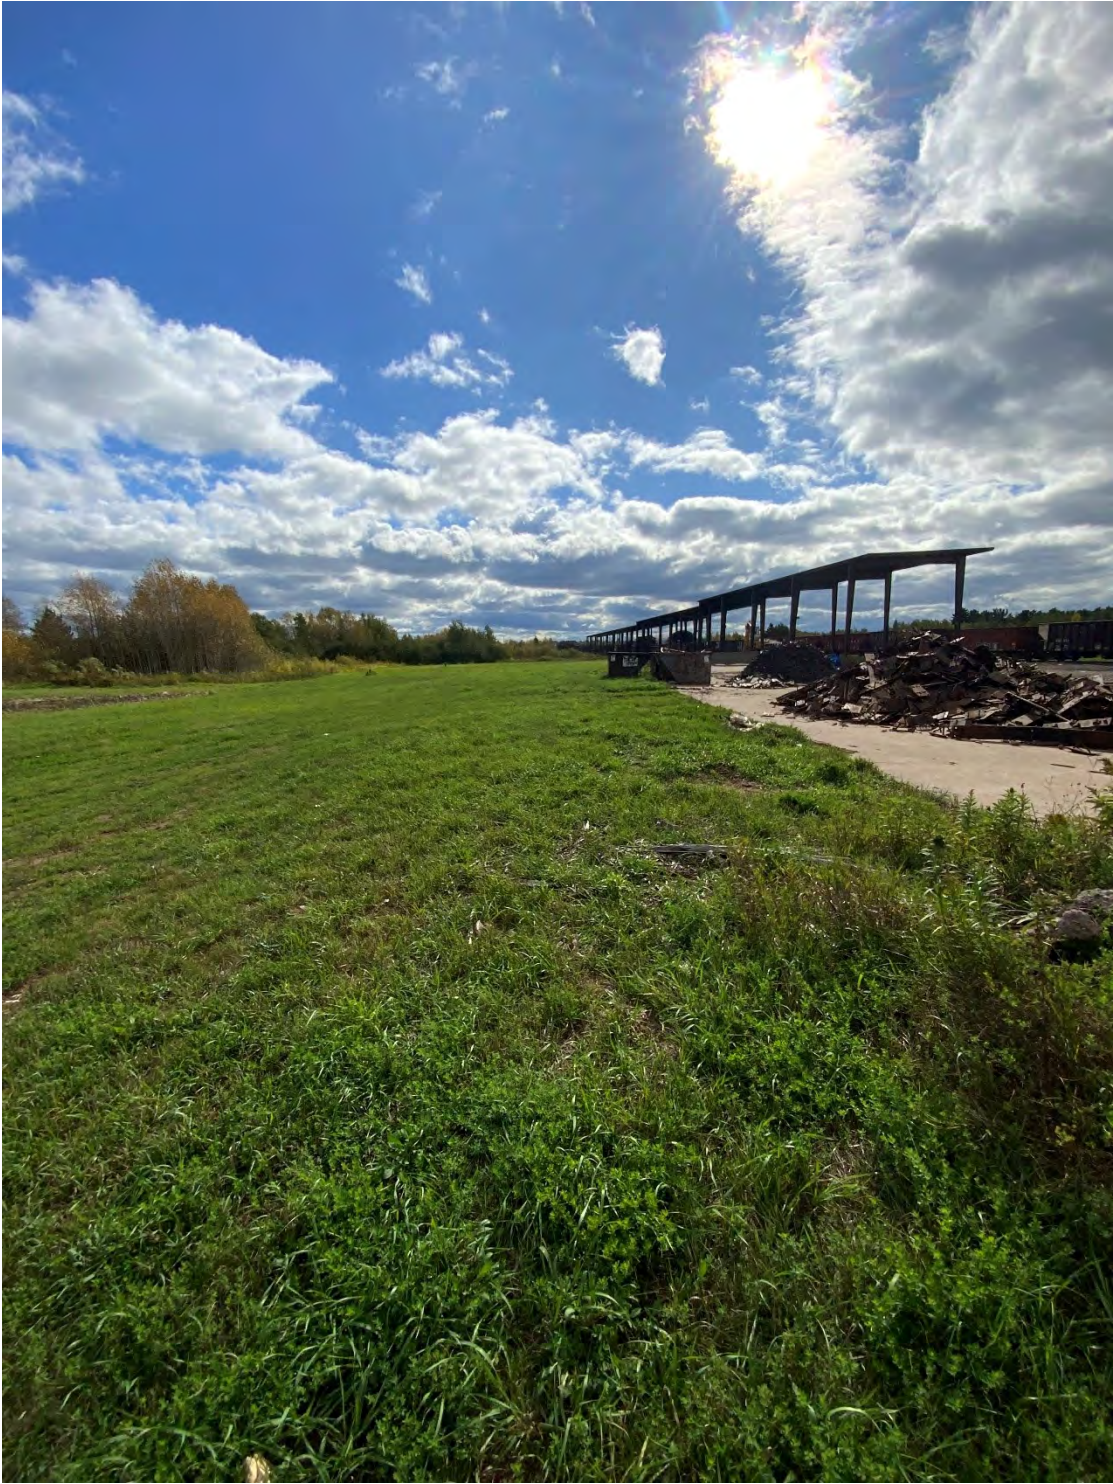
Area B Photo 1, looking South from North East central area:

<i>(check one)</i>	No	Yes	If yes, provide description and take photos
Excessive erosion	X		
Evidence of excessive settling or ponding	X		
Areas lacking well-established vegetation	X

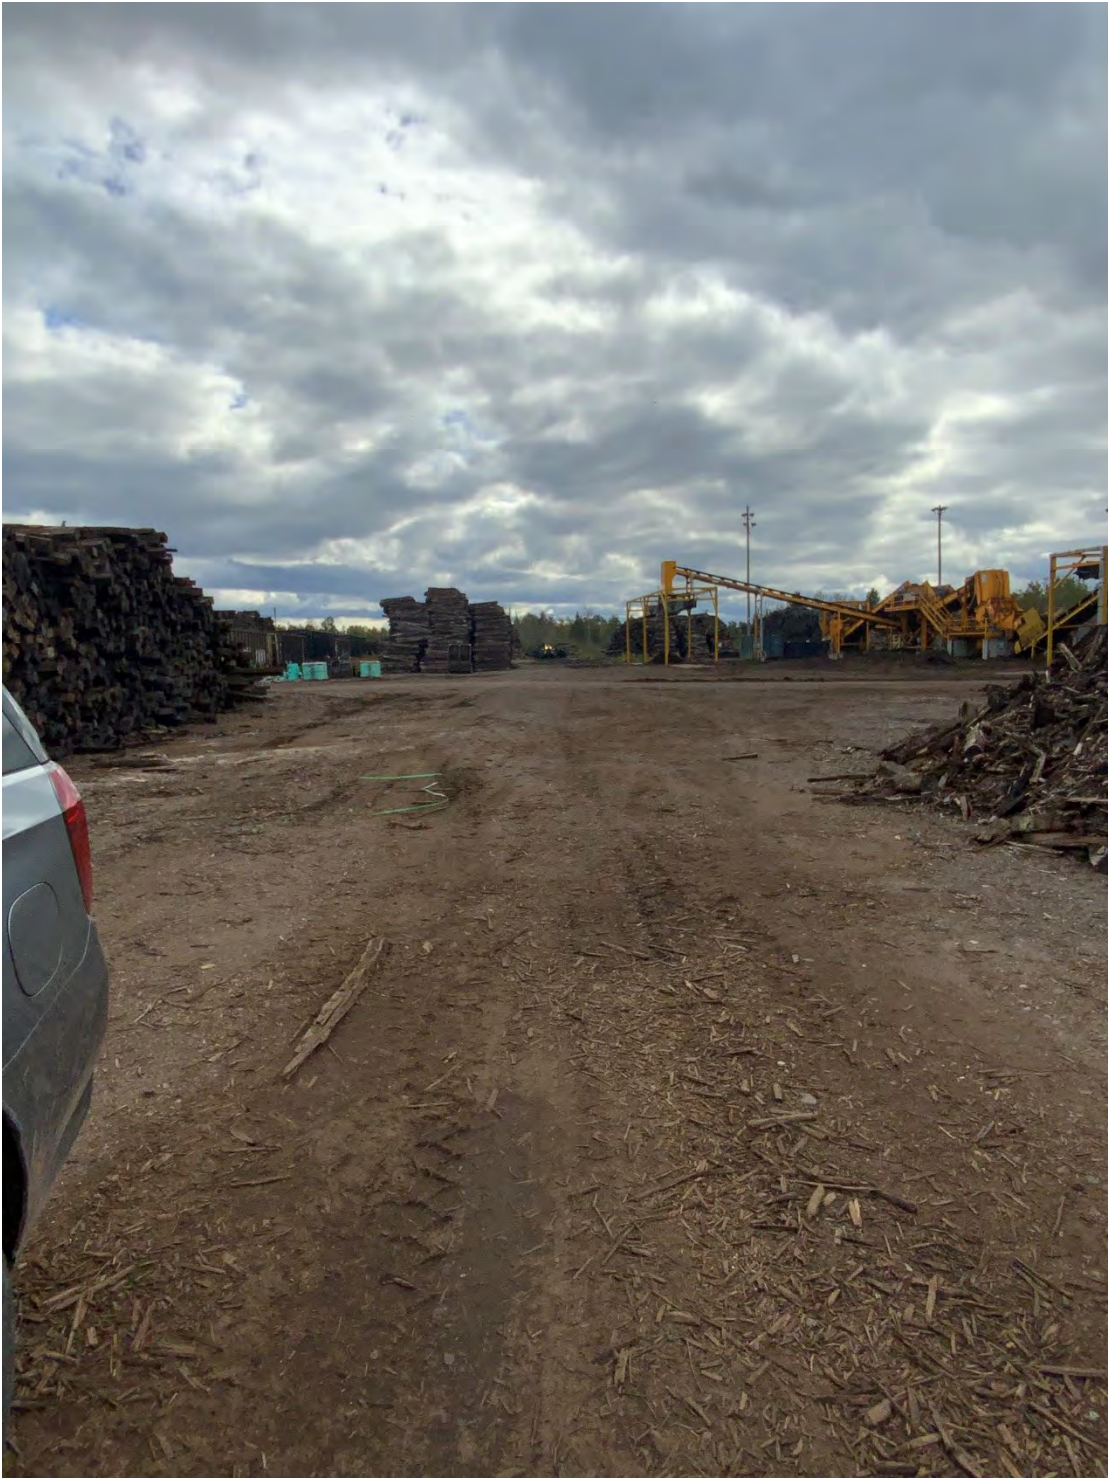
Area F1 Photo 1, Looking South from North end:

(check one)	No	Yes	If yes, provide description and take photos
Excessive erosion	X		
Evidence of excessive settling or ponding	X		
Areas lacking well-established vegetation	X

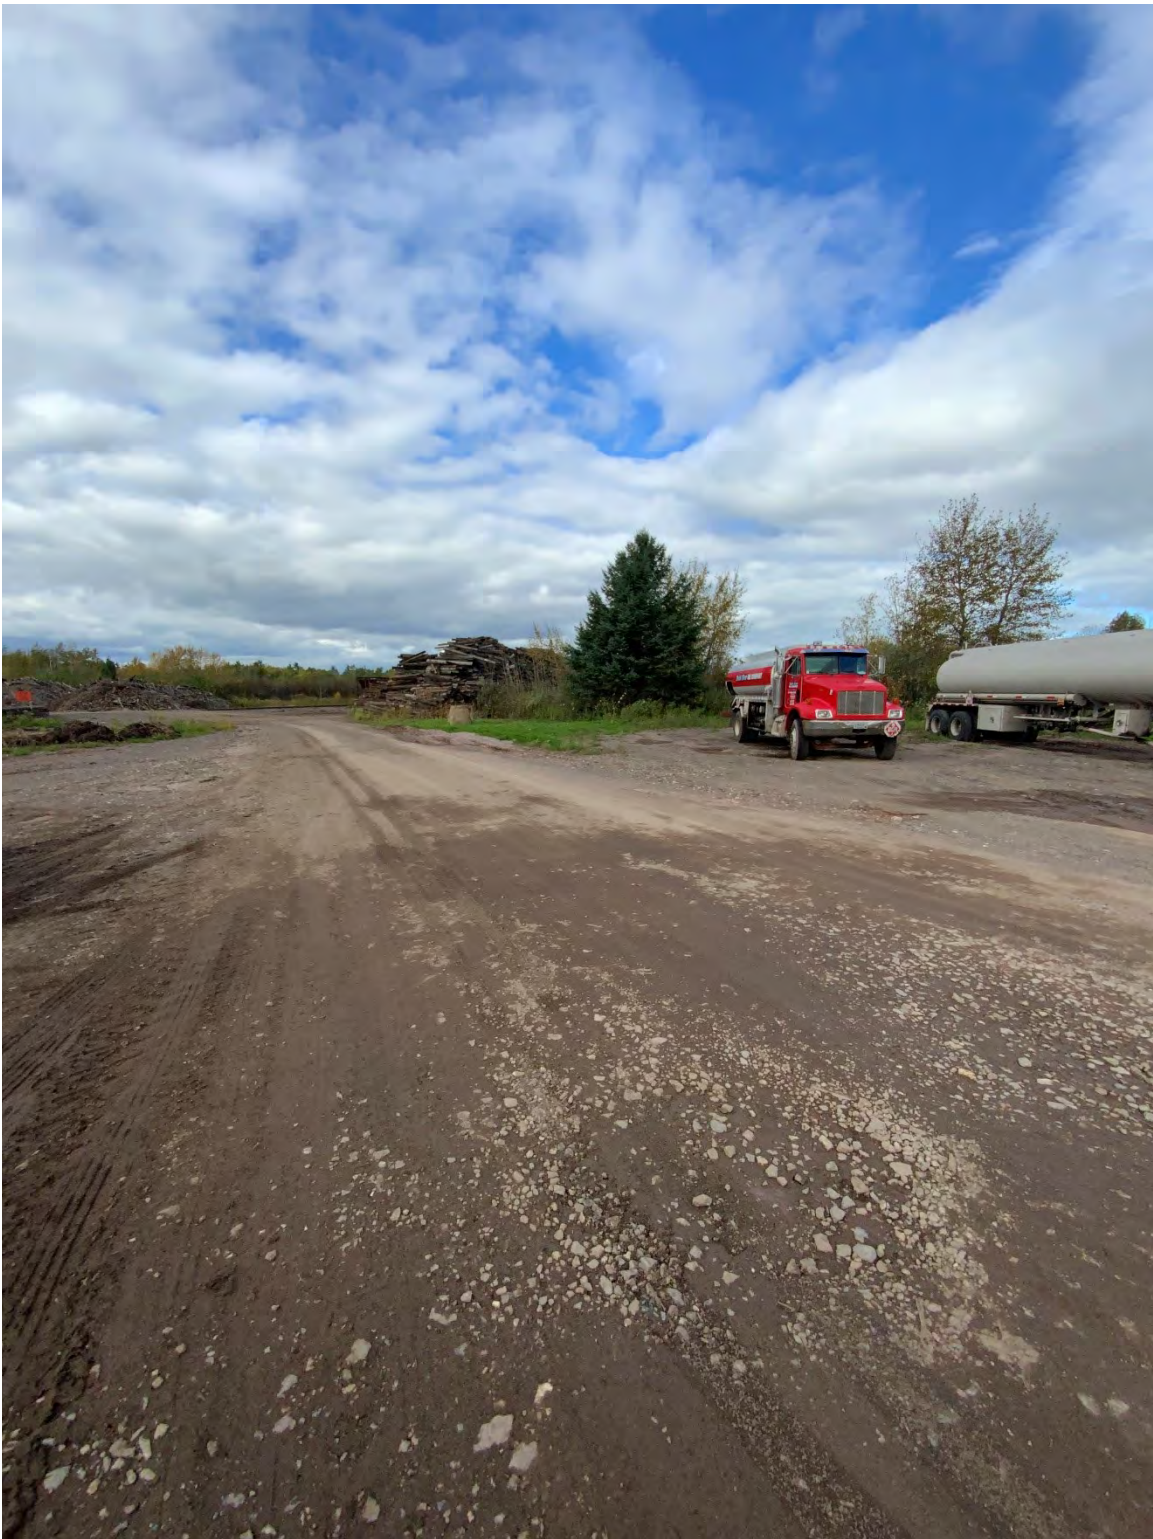
Area F2 Photo 1, Looking Northeast from Southwest:

(check one)	No	Yes	If yes, provide description and take photos
Excessive erosion	X		
Evidence of excessive settling or ponding	X		
Areas lacking well-established vegetation	X

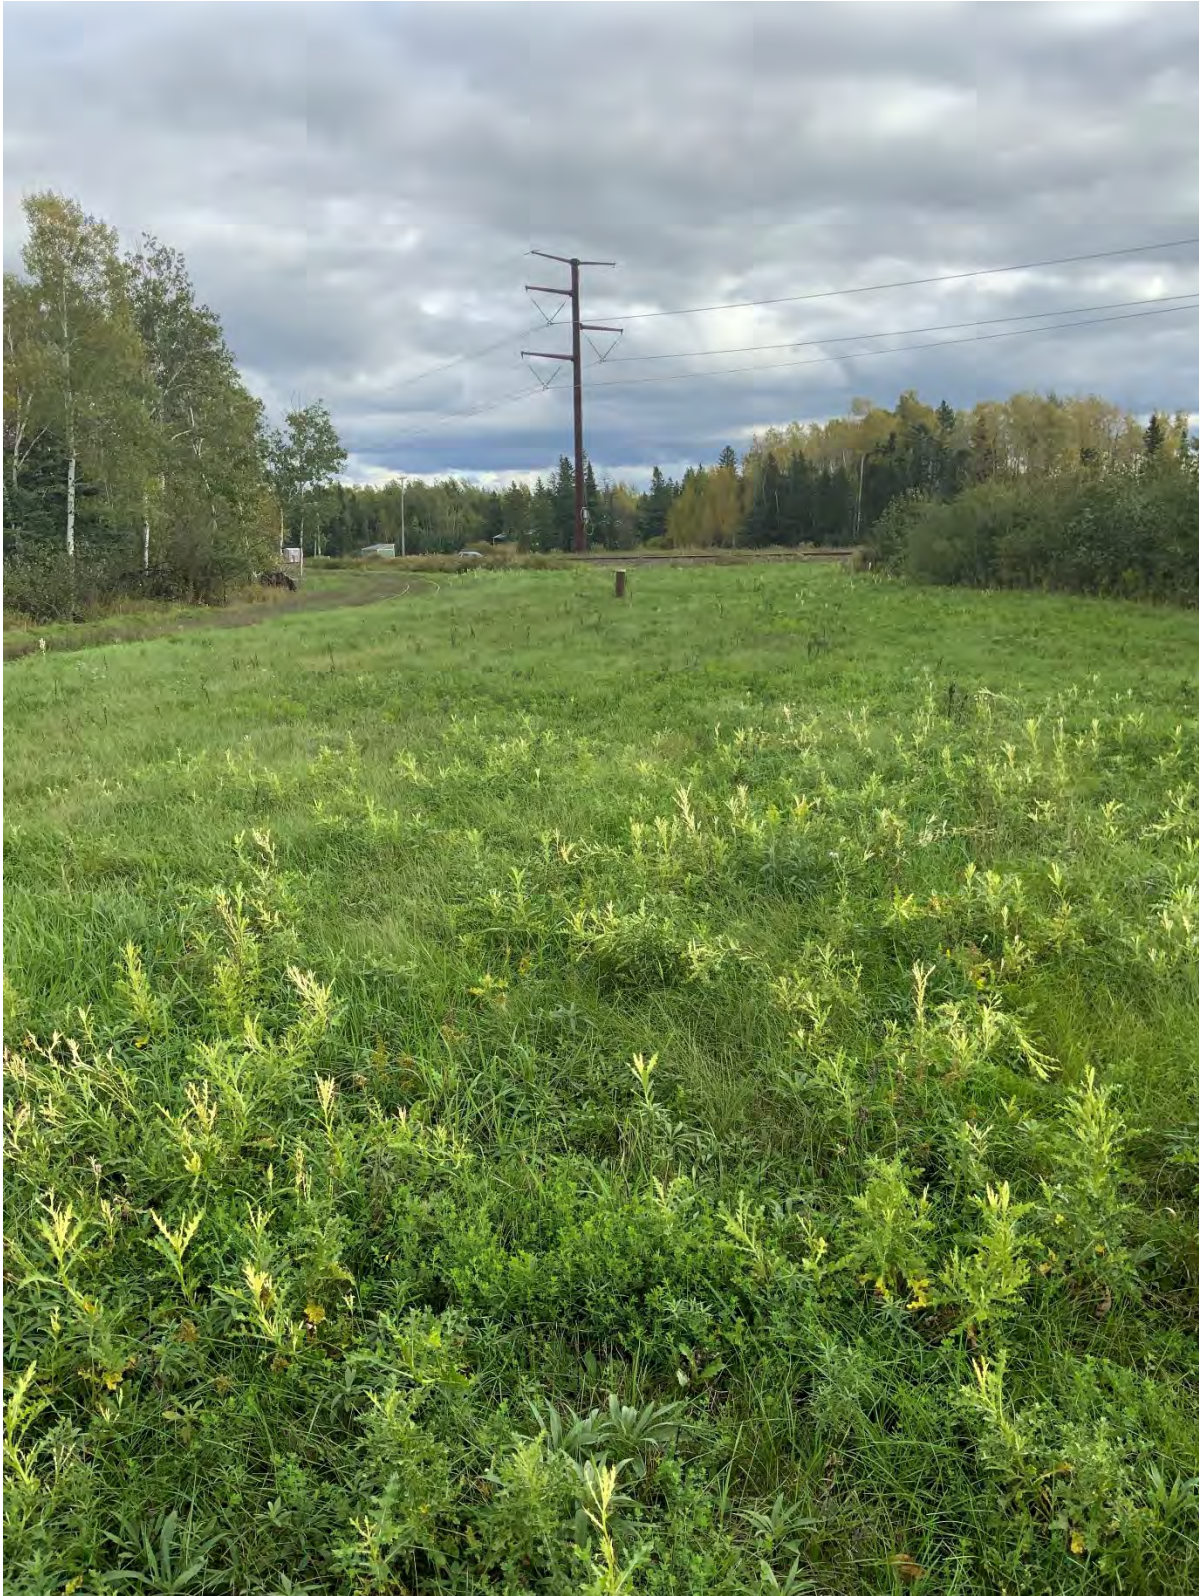
Area G Photo 1, looking Southeast from Northwest corner:

(check one)	No	Yes	If yes, provide description and take photos
Excessive erosion	X		
Evidence of excessive settling or ponding	X		
Areas lacking well-established vegetation	X

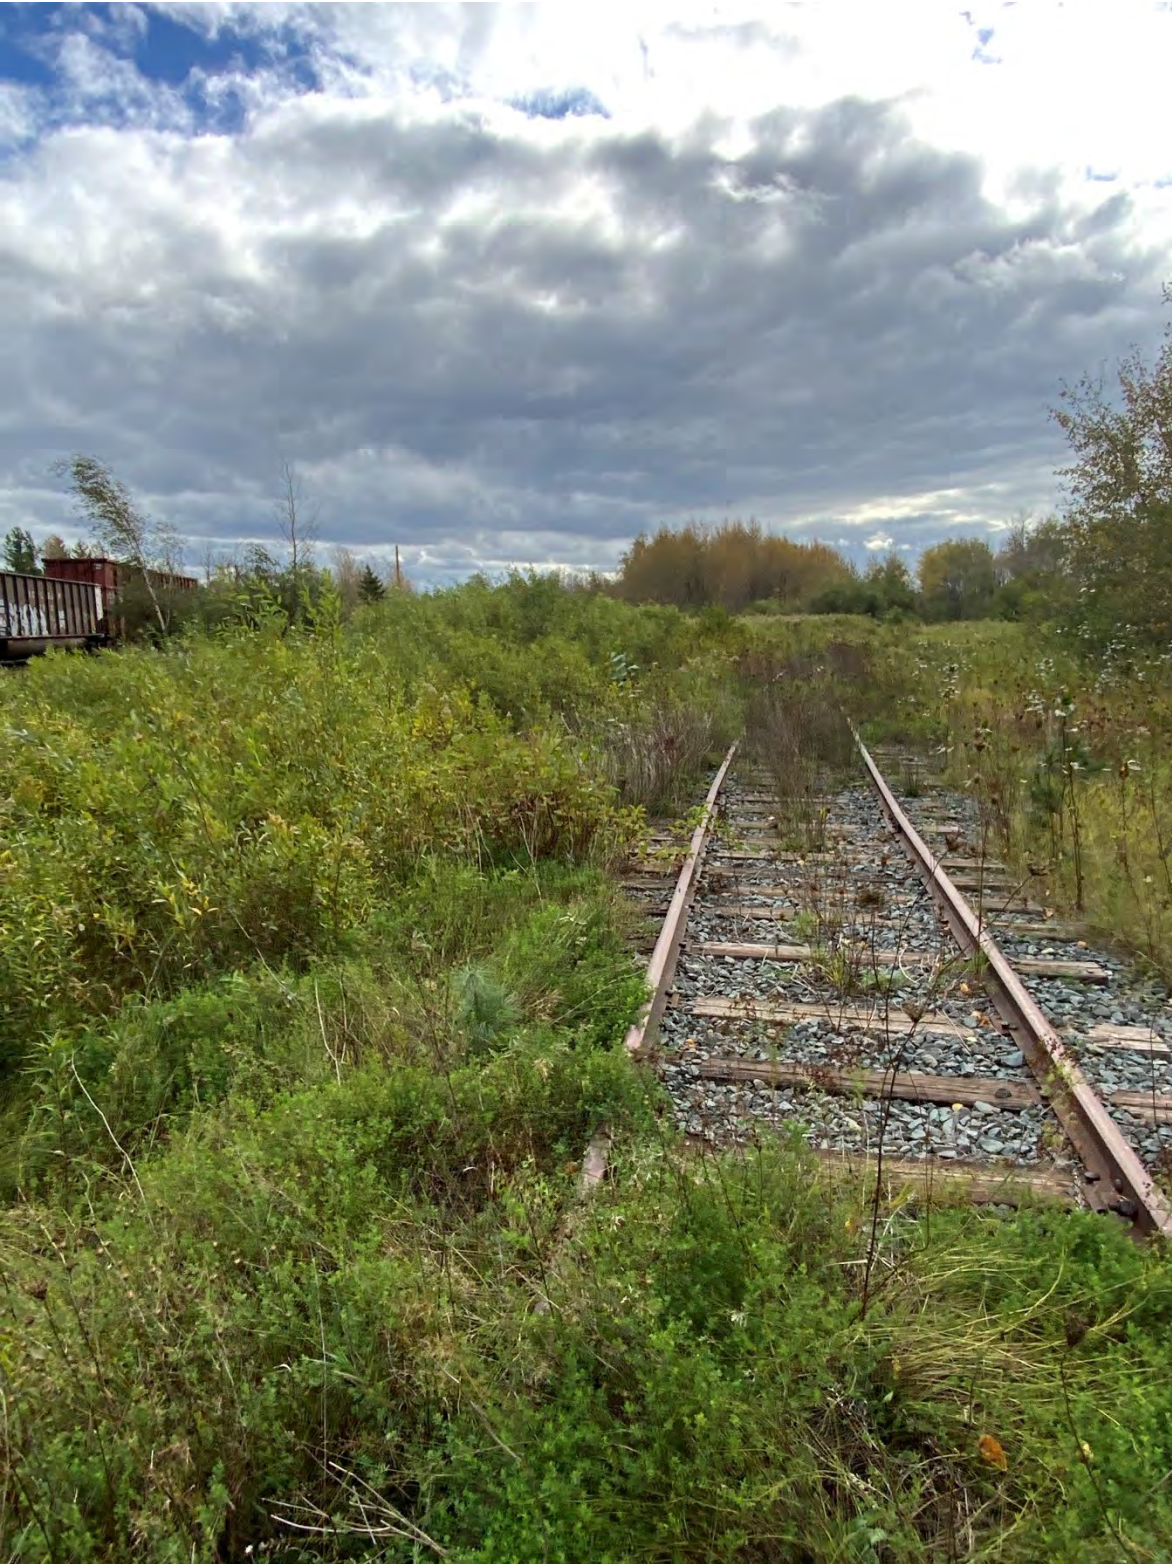
Area H Photo 1, (East side of RR tracks) looking Southwest from Eastern side:

(check one)	No	Yes	If yes, provide description and take photos
Excessive erosion	X		
Evidence of excessive settling or ponding	X		
Areas lacking well-established vegetation	X

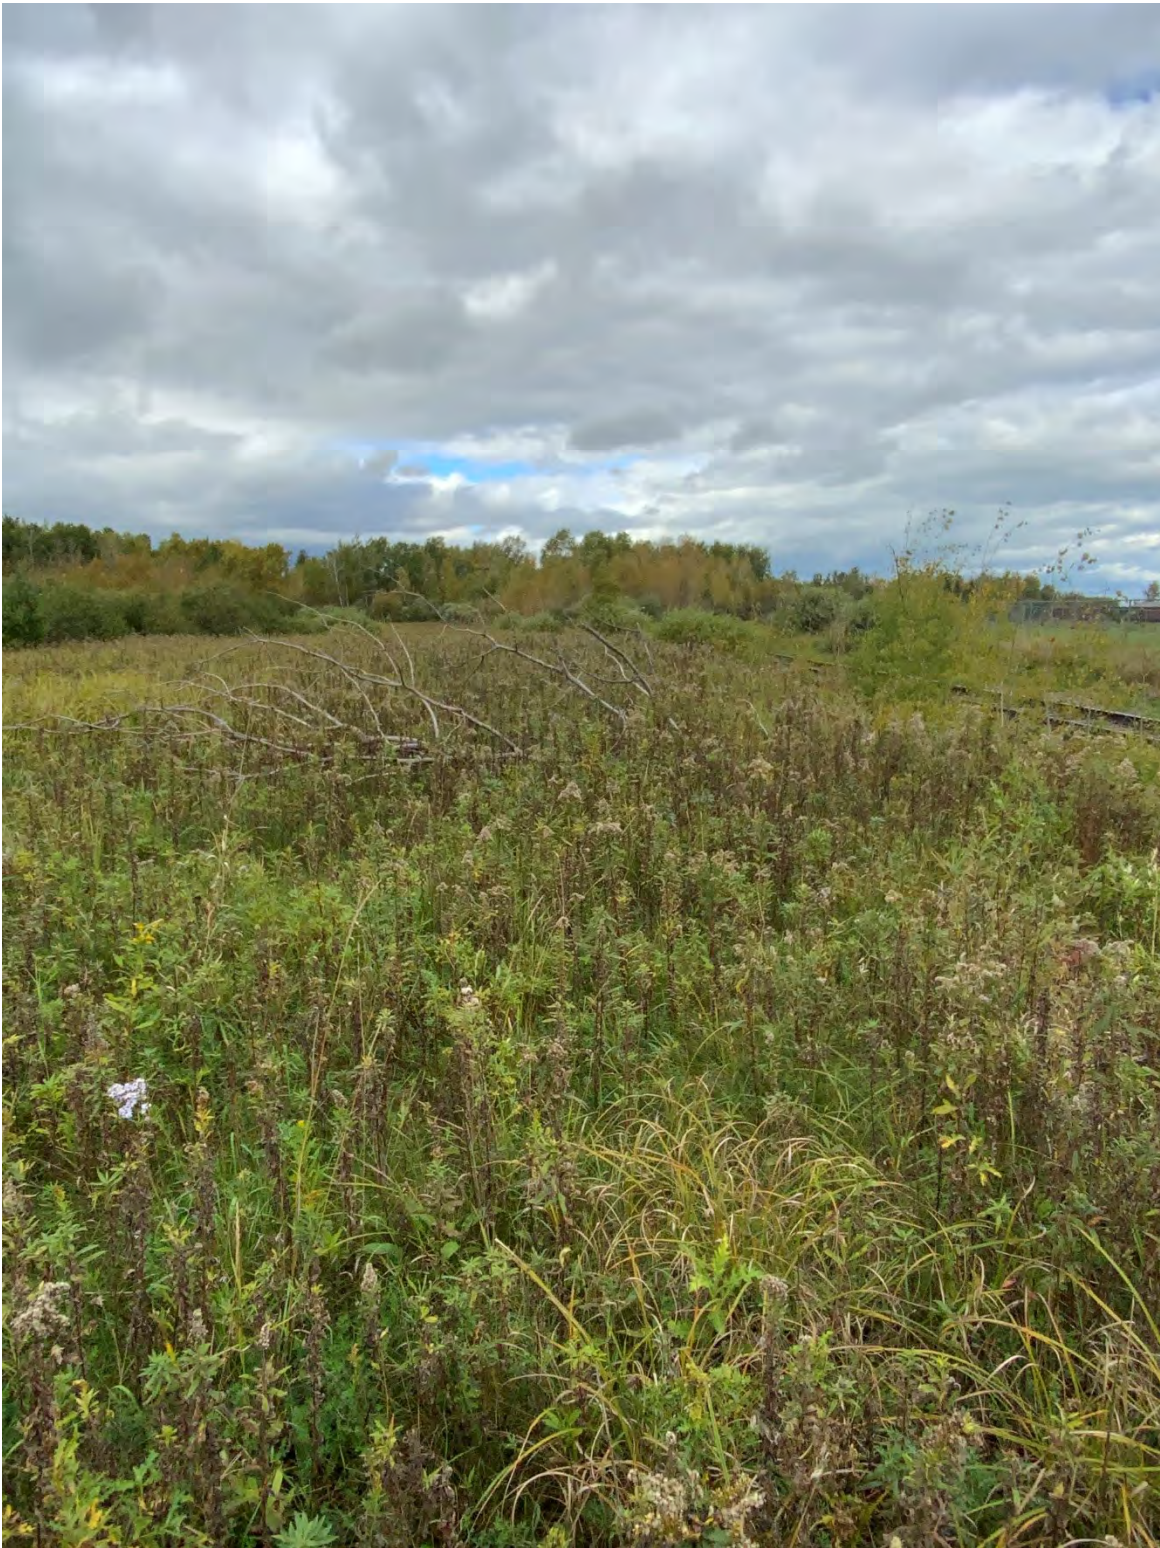
Area S Photo 1, looking North from center of area:

(check one)	No	Yes	If yes, provide description and take photos
Excessive erosion	X		
Evidence of excessive settling or ponding	X		
Areas lacking well-established vegetation	X

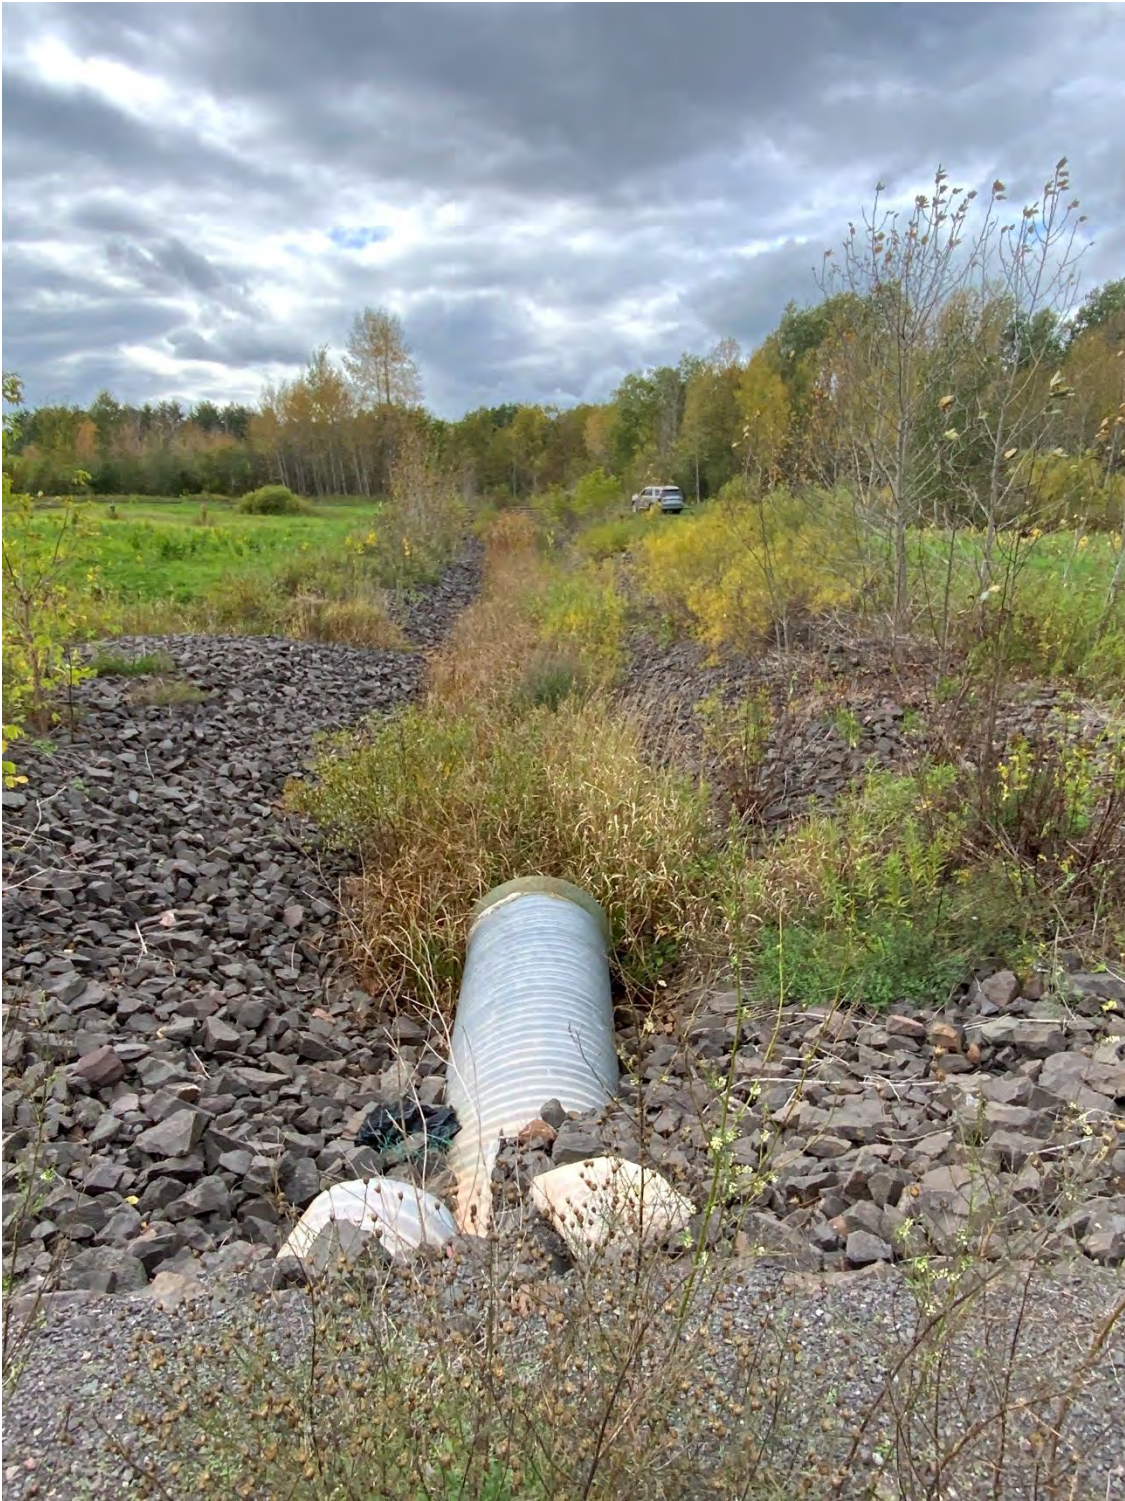
Outfall 001 Drainage Ditch Photo 1, looking West from Eastern edge:

(check one)	No	Yes	If yes, provide description and take photos
Excessive erosion	X		
Evidence of excessive settling or ponding	X		
Areas lacking well-established vegetation	X
