Tyco Fire Protection Products
Stanton Street Parking Lot Area
One Stanton Street
Marinette, Wisconsin
BRRTS # 02-38-559214
Summary of Activities

1.0 Introduction

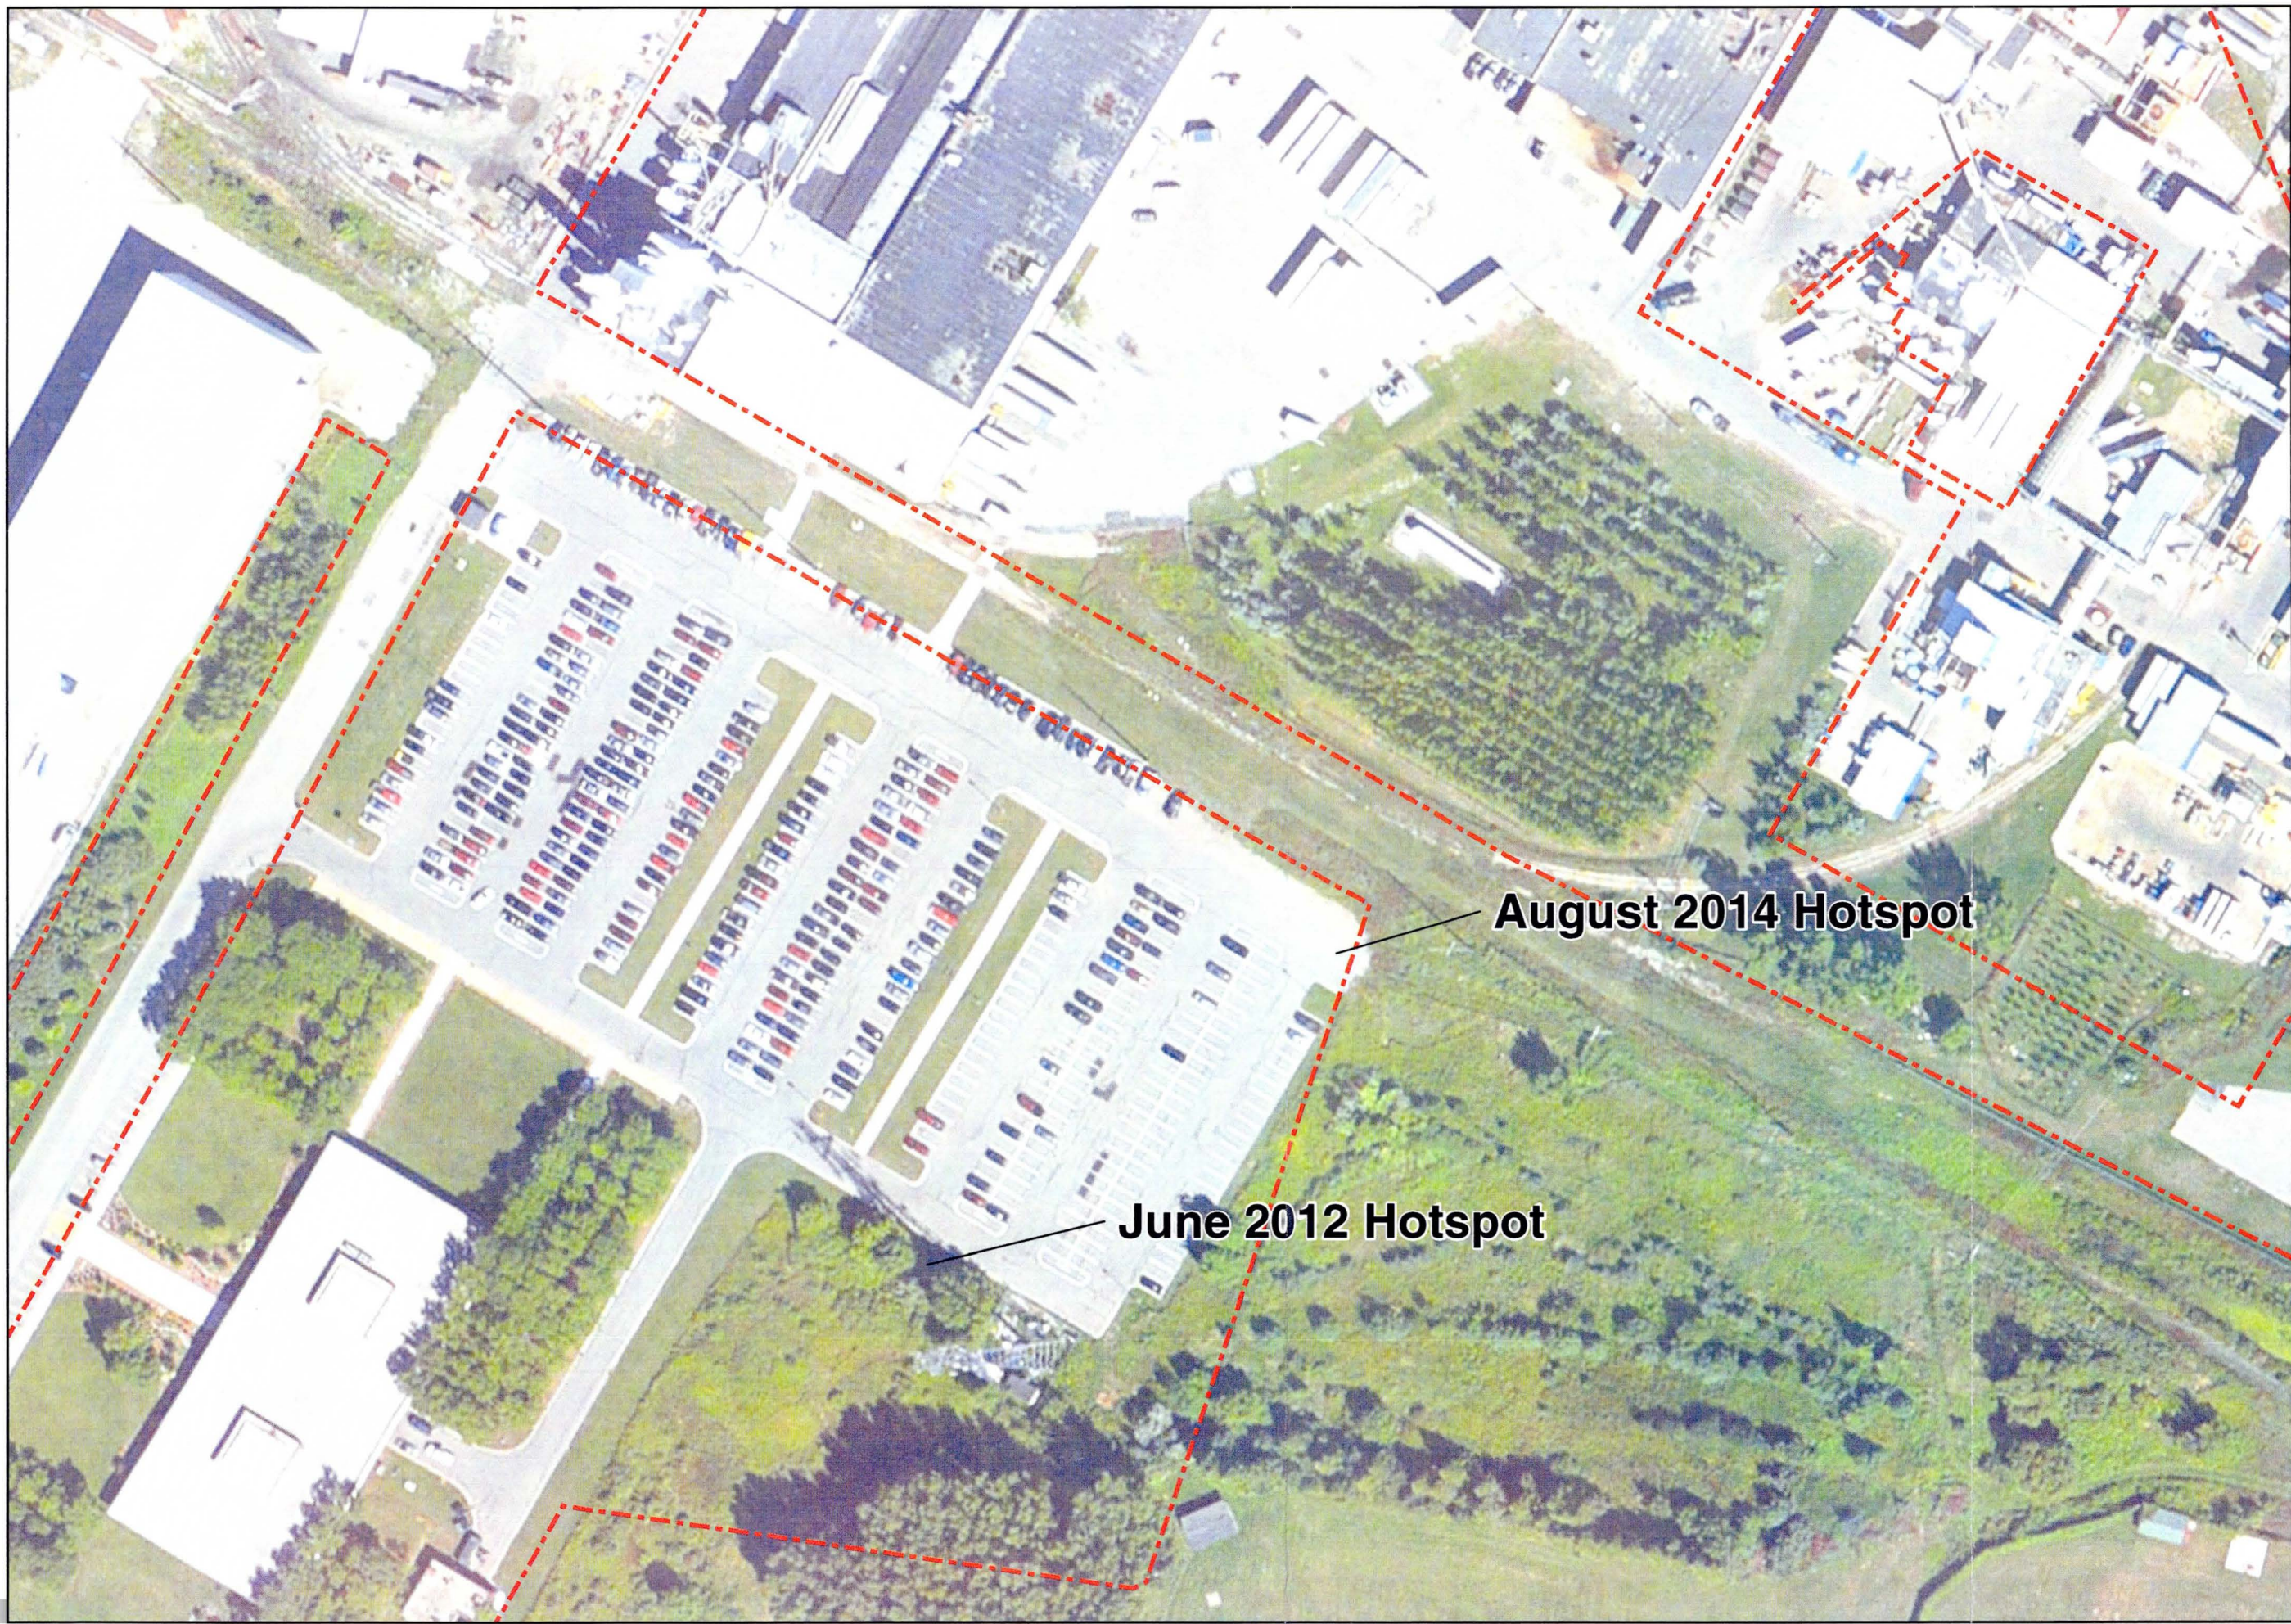
The Tyco Fire Protection Products property has been commercial/industrial since at least 1900. According to Sanborn Maps, in 1901 the area was utilized for lumber transport, including many slips and log runs (water-filled ditches). Based on the reported locations of the log runs and the soil fill observed in soil borings during the site investigation, it is assumed that soil from the property, or dredged material from the turning basin, was used to backfill the log runs. The date the log runs in the parking lot area were filled was not readily available; however, based on aerial photographs it occurred between 1938 and 1954. The trenching, dredging and filling activities are suspected to have occurred over many decades. Historic records, including aerial photographs and Sanborn Maps, show varying configurations of slips and log runs throughout the 1900s. The log runs that were present in 1938, overlain on the current aerial photograph, are shown on Figure 2. No documentation was readily available regarding these assumed cut and fill activities. The Sanborn Maps are provided as Attachment A. A review of Tyco files, Marinette County files and City of Marinette files did not indicate a likely source of the product observed in the utility trench.

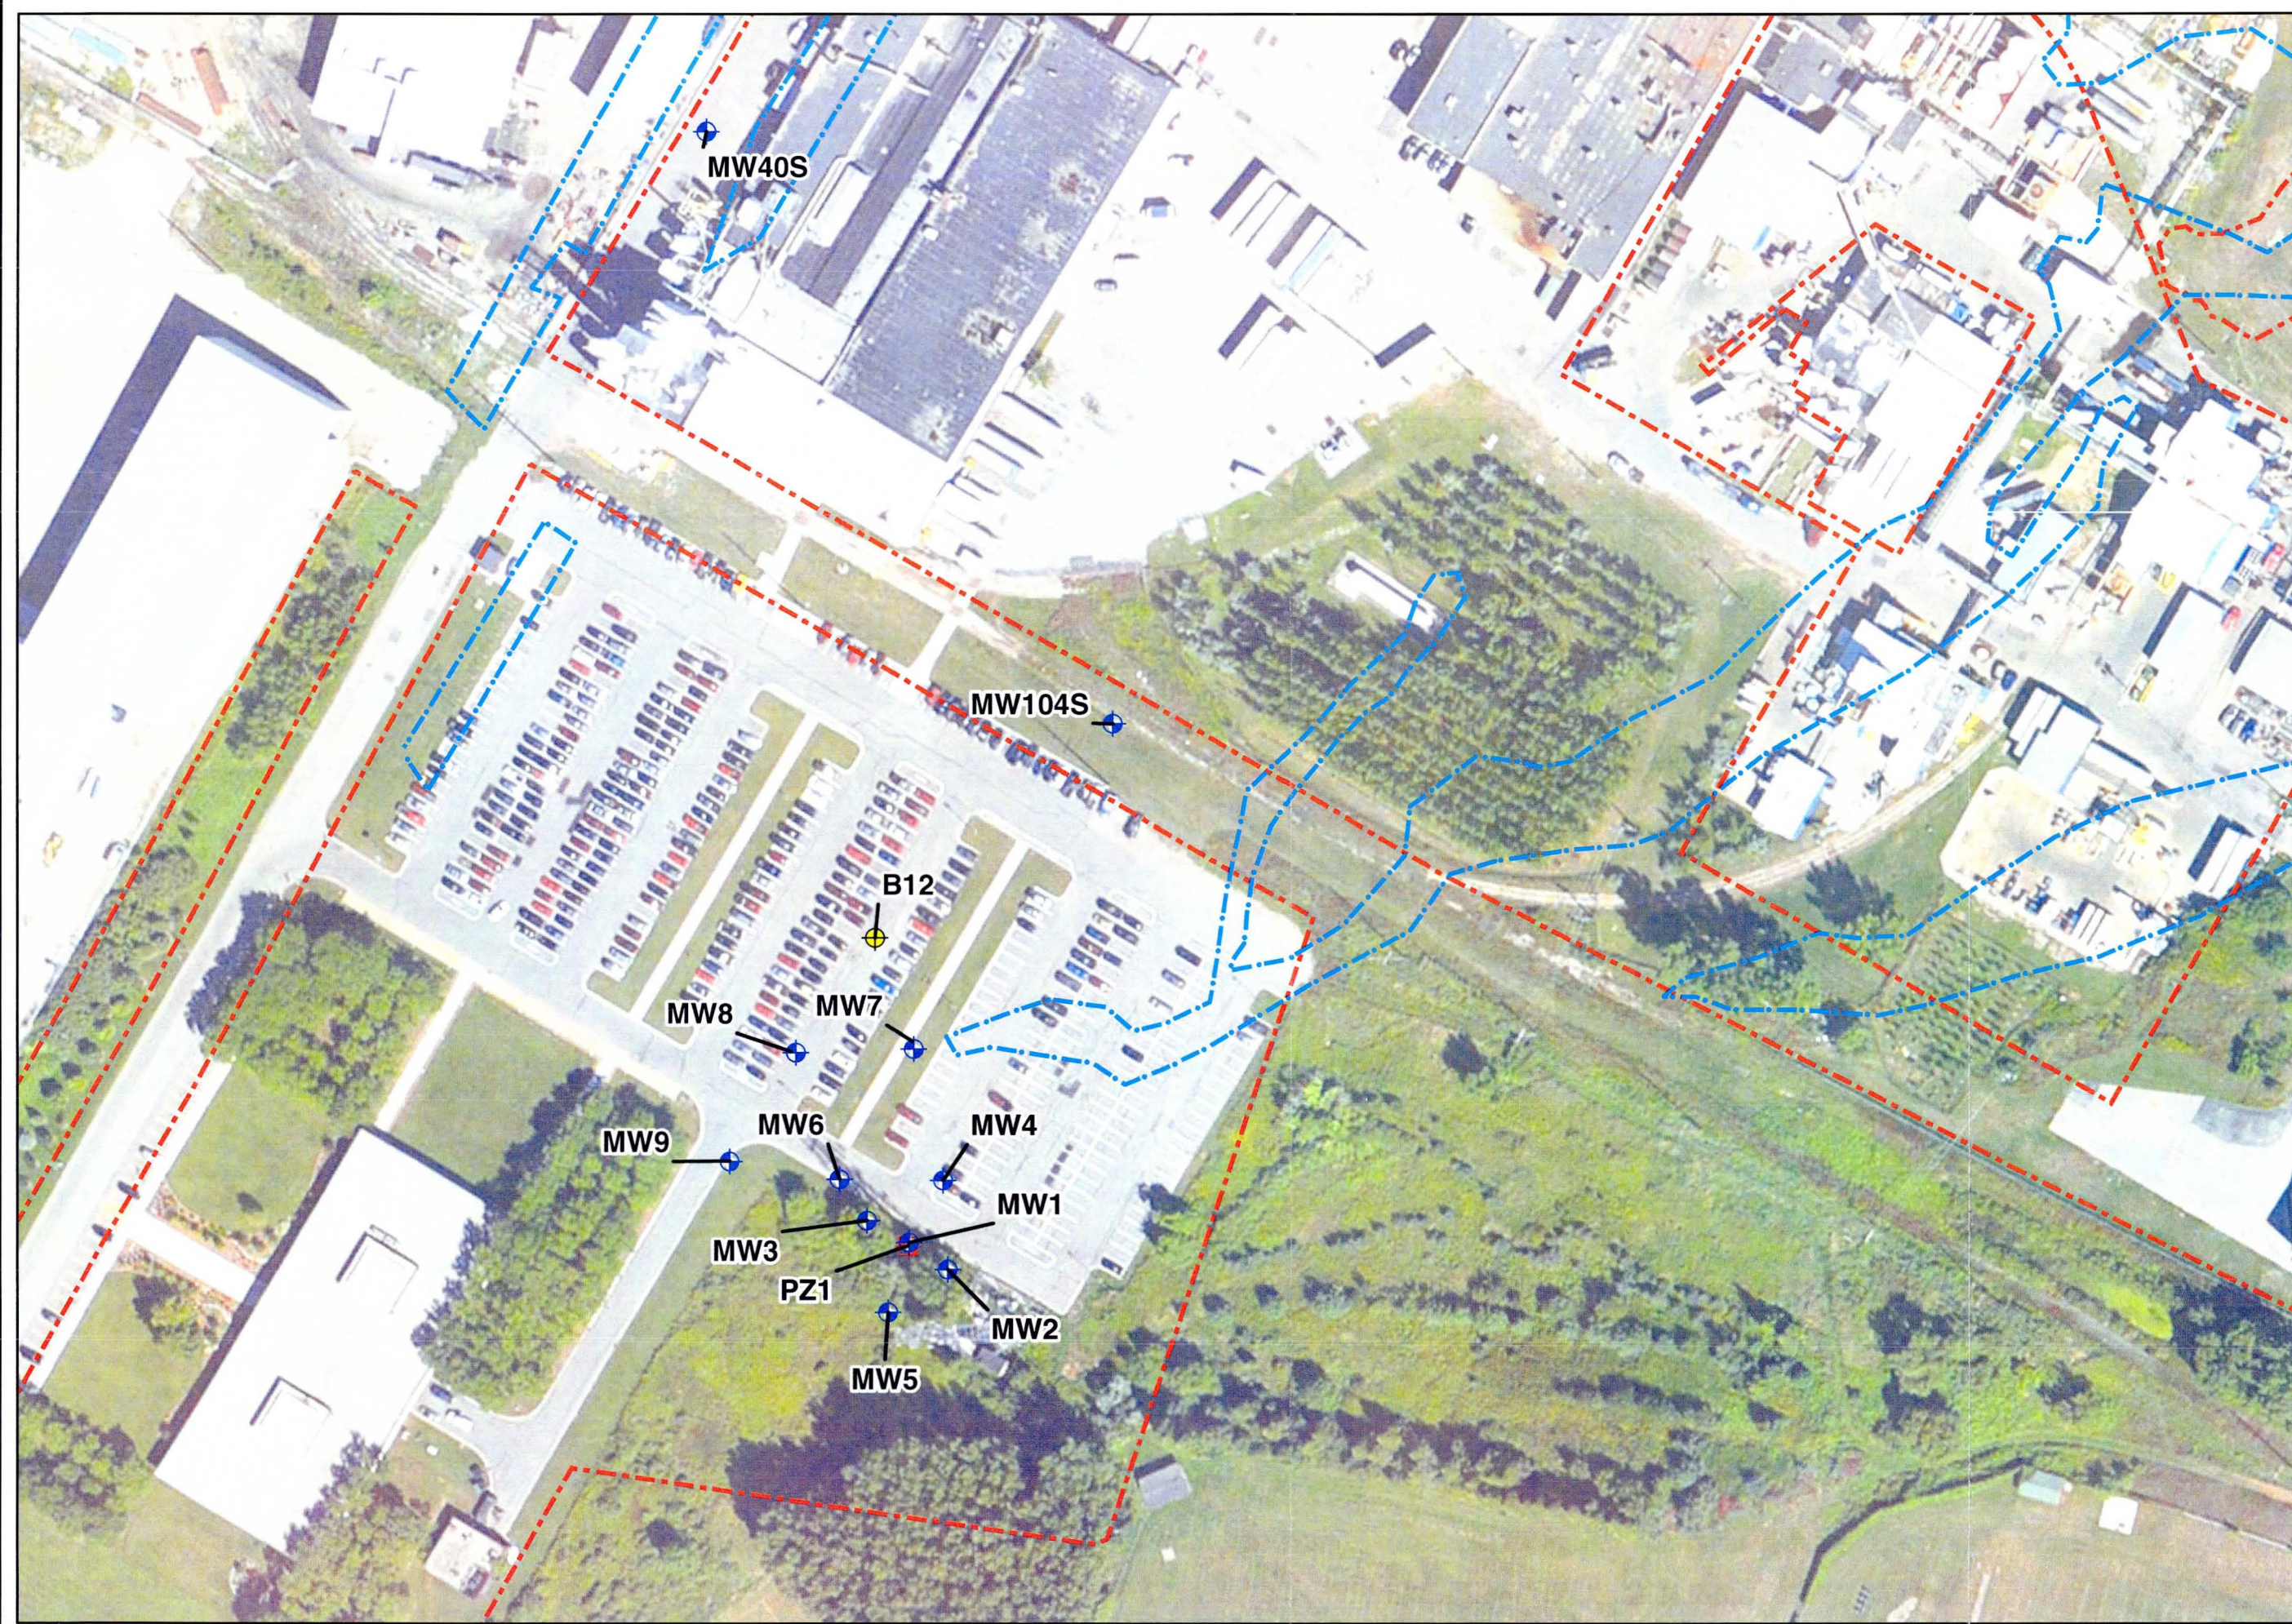
**FIGURE 3
SOIL BORING
LOCATIONS
SOIL REGULATORY
EXCEEDANCES**

detected in the sample collected from all but boring B-2. Ten of the twelve sample locations contained concentrations of volatile organic compounds (VOCs) and/or PAH compounds in the soil exceeding the respective regulatory limits. The contaminated soil is generally present from just below the ground surface to the water table, which is typically less than 5 feet below the ground surface. The surface soil in the borings was logged as fill of varying composition. Depth to apparent native soil was variable, ranging from 2 feet to 16 feet. The soil analytical data and the standards to which they were compared are presented on Table 1. The boring locations and the associated regulatory exceedances are shown on Figure 3.

Parameter	Result	Units
Naphthalene	4300	ug/kg
Benzo(a)anthracene	12300	ug/kg
Benzo(a)pyrene	10200	ug/kg
Benzo(b)fluoranthene	17200	ug/kg
Dibenz(a,h)anthracene	1130	ug/kg
Indeno(1,2,3-cd)pyrene	4520	ug/kg
Phenanthrene	2510	ug/kg

Parameter	Result	Units
2-Methylnaphthalene	1670	ug/kg

Parameter	Result	Units
Benzene	11.6	ug/kg
2-Methylnaphthalene	7960	ug/kg
Phenanthrene	5980	ug/kg

Parameter	Result	Units
1,2,4-Trimethylbenzene	499	ug/kg
Benzo(a)anthracene	4250	ug/kg
Benzo(a)pyrene	4420	ug/kg
Phenanthrene	3740	ug/kg

Parameter	Result	Units
Benzene	21.9	ug/kg
Carbon disulfide	307	ug/kg
1,4-Dichlorobenzene	19.9	ug/kg
1,2,4-Trimethylbenzene	447	ug/kg
1,3,5-Trimethylbenzene	182	ug/kg

Parameter	Result	Units
Naphthalene	1440	ug/kg
Dibenz(a,h)anthracene	347	ug/kg

Parameter	Result	Units
Dibenz(a,h)anthracene	22.9	ug/kg
2-Methylnaphthalene	218	ug/kg

Parameter	Result	Units
Benzo(a)pyrene	1500	ug/kg
Dibenz(a,h)anthracene	170	ug/kg

Parameter	Result	Units
Dibenz(a,h)anthracene	13.2	ug/kg

Parameter	Result	Units
Benzene	6.7	ug/kg
