Subject: MCABI-Tyco Redevelopment Property; BRRTS# 02-38-564236

Stantec is providing a project status update for the MCABI-Tyco Redevelopment Property (BRRTS# 02-38-564236), 1310-1330 Main Street, Marinette, Wisconsin (the Site). This email presents the results of the installation and sampling of an additional temporary groundwater monitoring well for the Site.

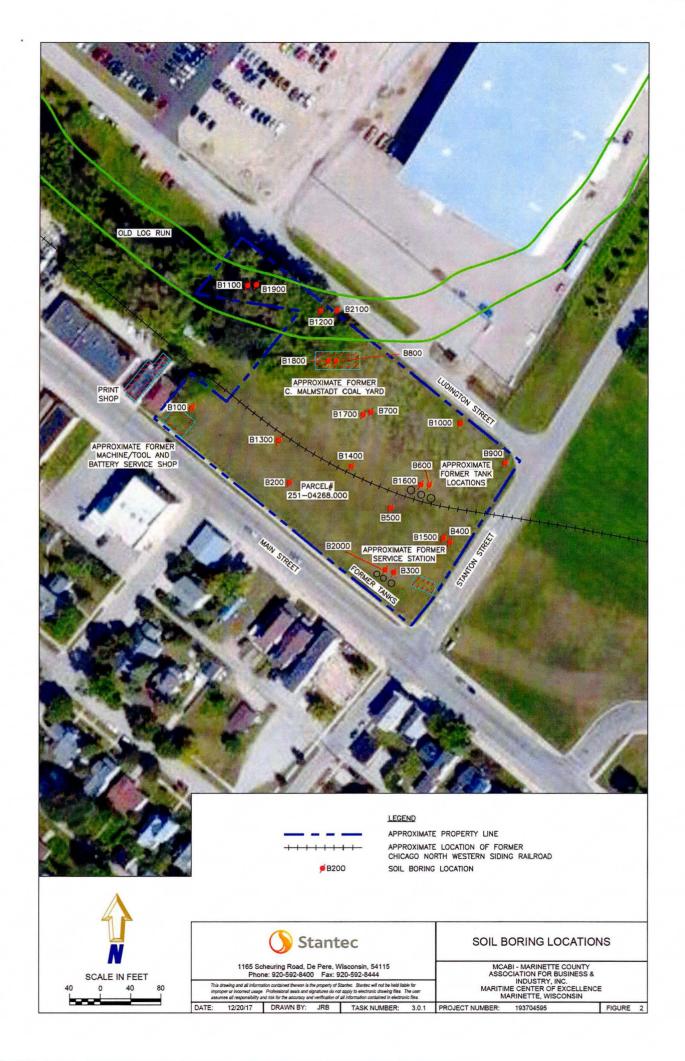
On October 27, 2017 Stantec oversaw the advancement of an additional soil boring (B2100) within the Ludington Street right-of-way. The soil boring was advanced downgradient to existing monitoring well MW1800 located on the MCABI property. Soil samples were collected continuously from the borehole to a depth of 12 feet below grade (fbg) and were subsequently field screened and classified. Unconsolidated material observed consisted of generally sandy topsoil overlying silty sands and intermixing layers of historic fill material/waste (i.e. wood chips, metal, slag, glass, paper, and plastic) from 6 to 8 fbg similar to that found on the MCABI property during Stantec's previous Phase II ESA. Boring B2100 was later converted into temporary monitoring well TW2100. Temporary monitoring well TW2100 was constructed of 1-inch inner diameter, schedule 40 PVC casing utilizing a 10-foot length of factory slotted screen (0.010-inch) to a total depth of approximately 12 fbg. Depth to water was found in the well to be approximately 2.33 feet fbg. Soil boring and monitoring well locations are shown on the attached Figures 2 and 3.
