December 8, 2022

Project Reference #19270

**RE: Additional PCB Investigation, Sediment Sampling, and Sewer Level Monitoring
South Marina Drive Storm Sewer
Milwaukee, Wisconsin
BRRTS No. 02-41-587190 and FID No. 341331430**

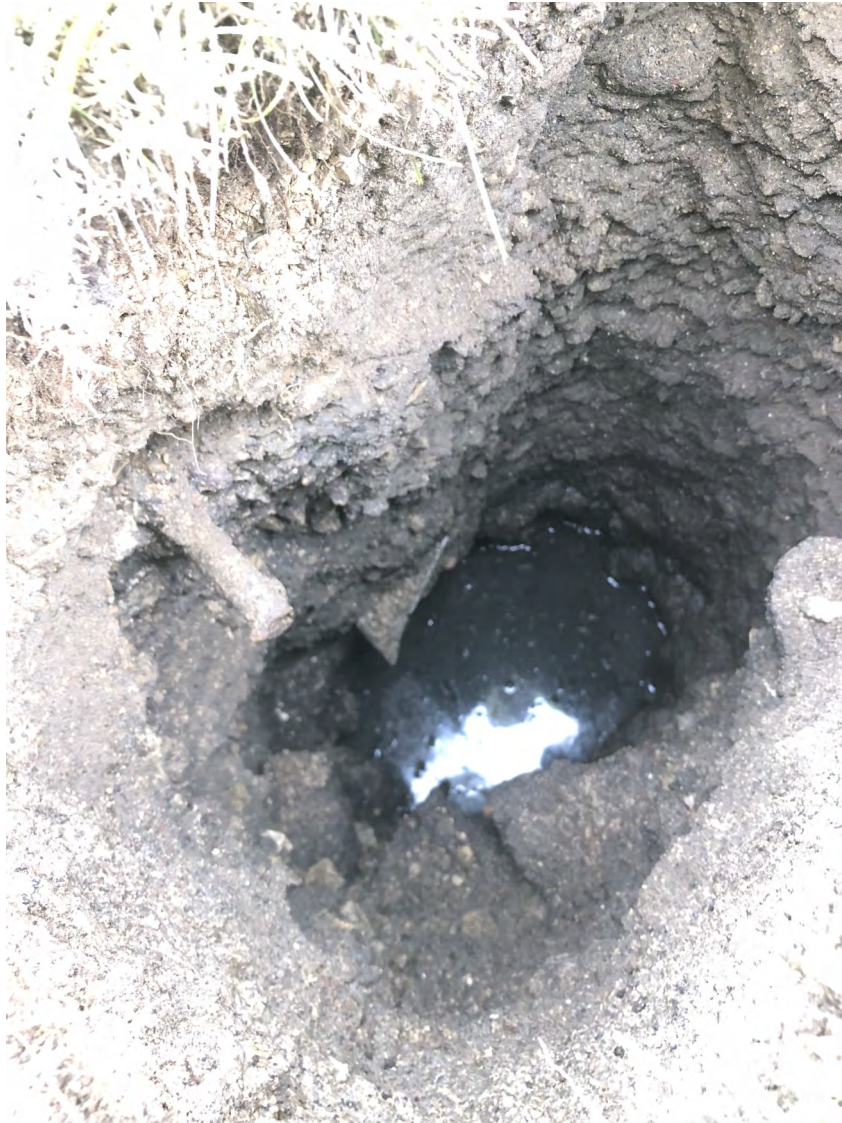
Photo 8: The open HydroVac excavation northeast of manhole MH-2. Water recharged rapidly to cover pipe. View to west; photograph taken on September 20, 2021.

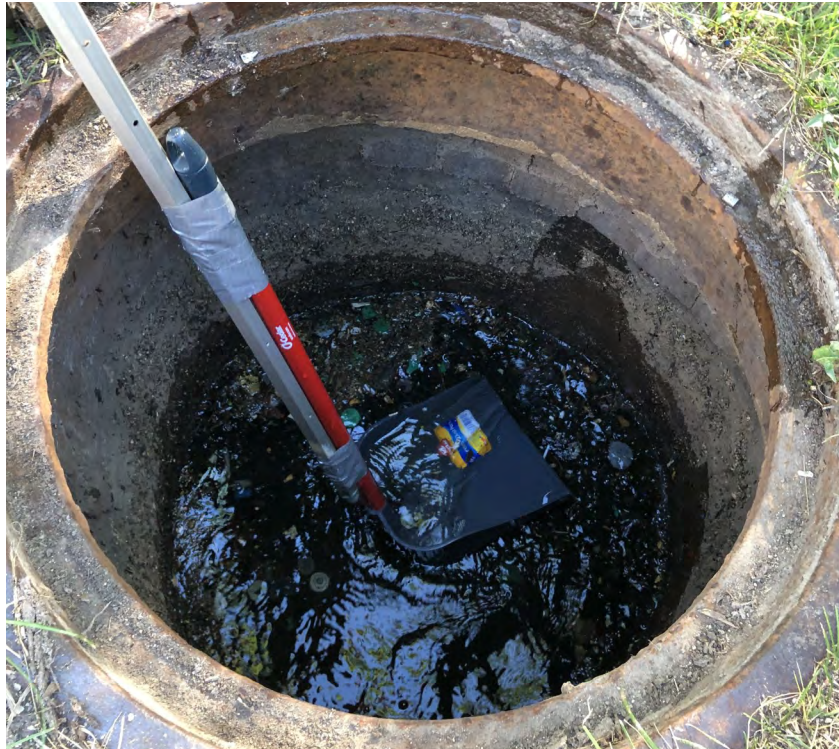
Photo 2: Manhole MH-1 interior with litter, debris, and grass. View to east; photograph taken on September 1, 2021.

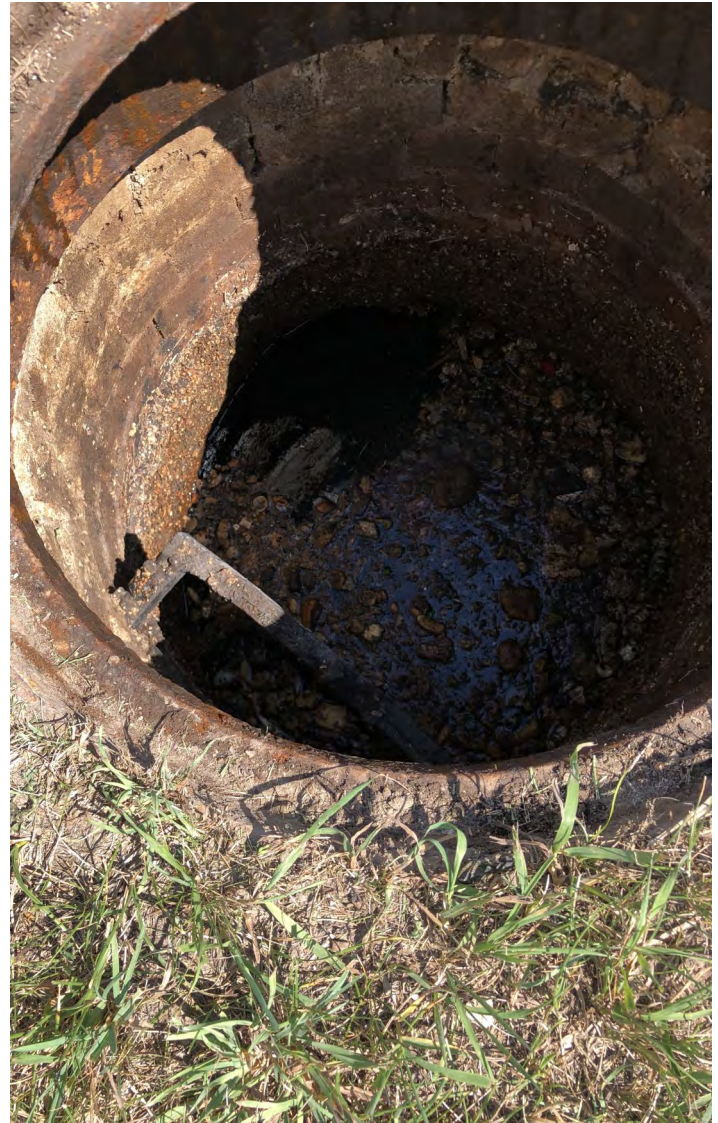
Photo 4: Manhole MH-2 interior with debris. View to north-east; photograph taken on September 1, 2021.

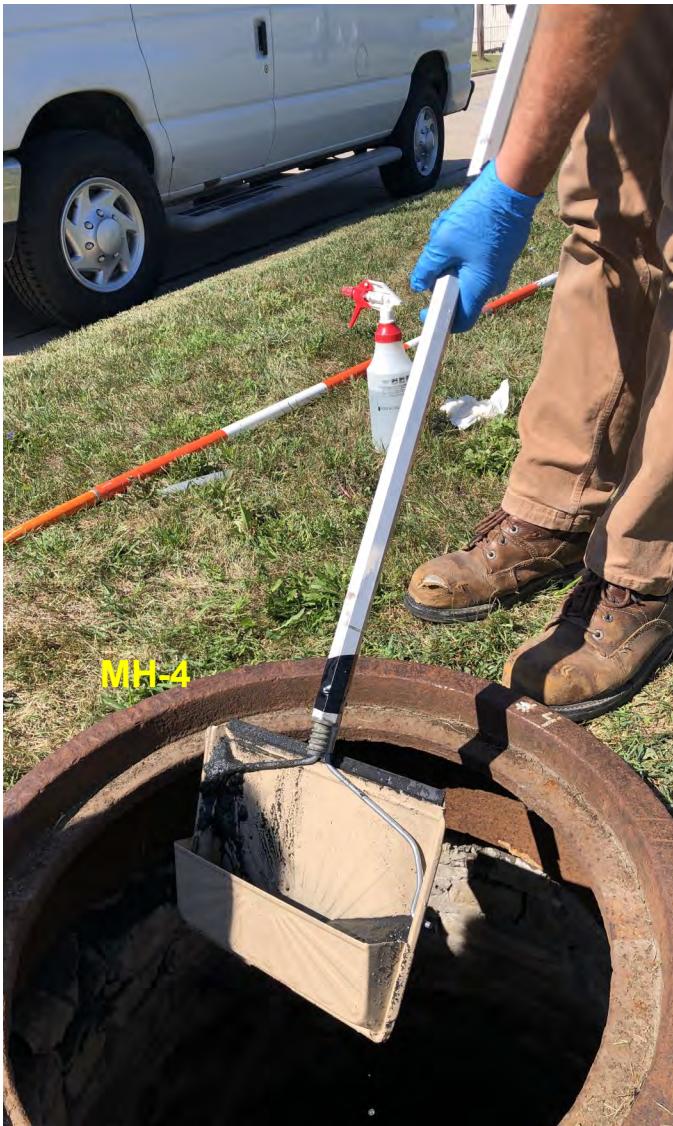
Photo 6: Sediment within manhole MH-4 being sampled with pivoted dustpan. View to northwest; photograph taken on September 1, 2021.

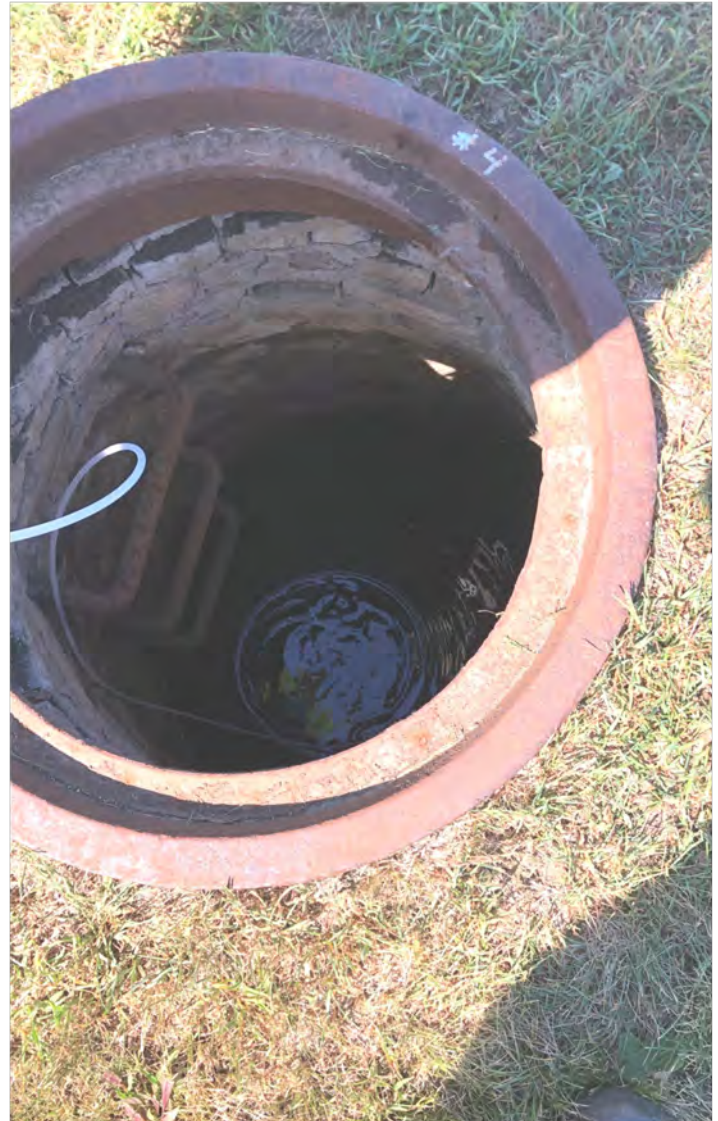
During the September and October 2021 sampling rounds, manholes MH-1 through MH-5 had sediment ranging in thickness between approximately 1 and 4 inches. The sediment sampled was observed to be black fine sands or black silty sands. Oily sheens were observed on the water surface of manholes MH-1 and MH-3. A rotten egg odor was observed at manholes MH-2 and MH-4.

Photo 7: Manhole MH-4 interior with black & turbid water. View to north; photograph taken on September 1, 2021.

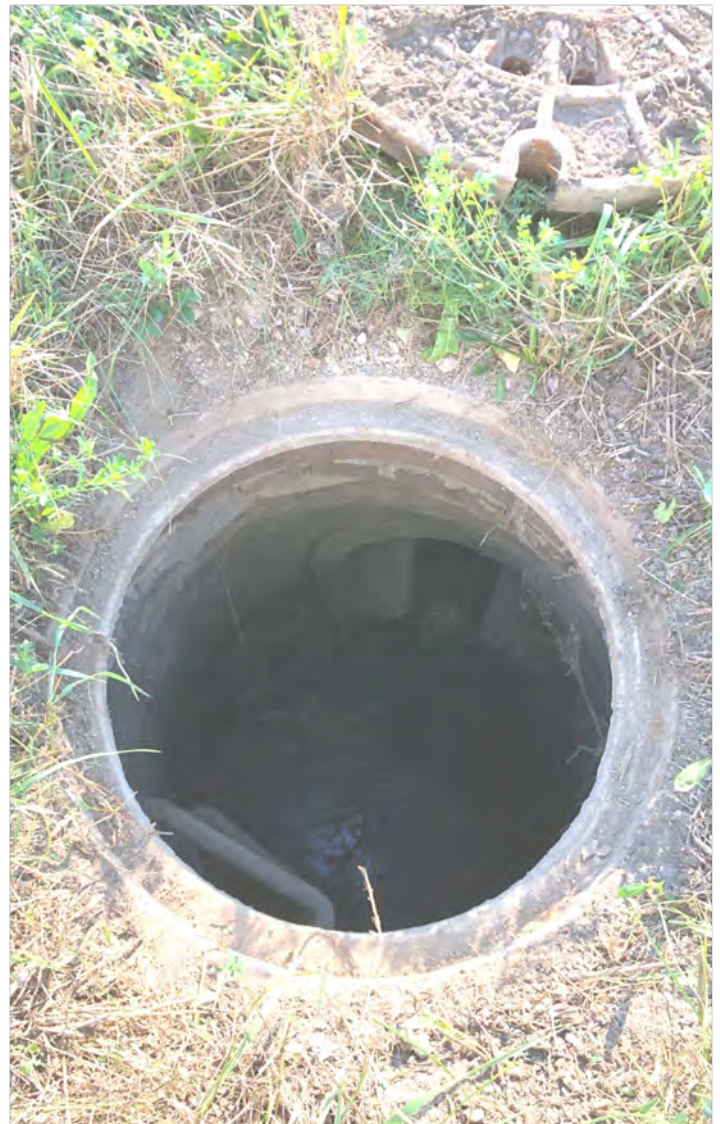
Photo 9: Manhole MH-5 interior with black & turbid water, low water column, and small amounts of sediments on bottom of SE invert. View to east; photograph taken on September 2, 2021.

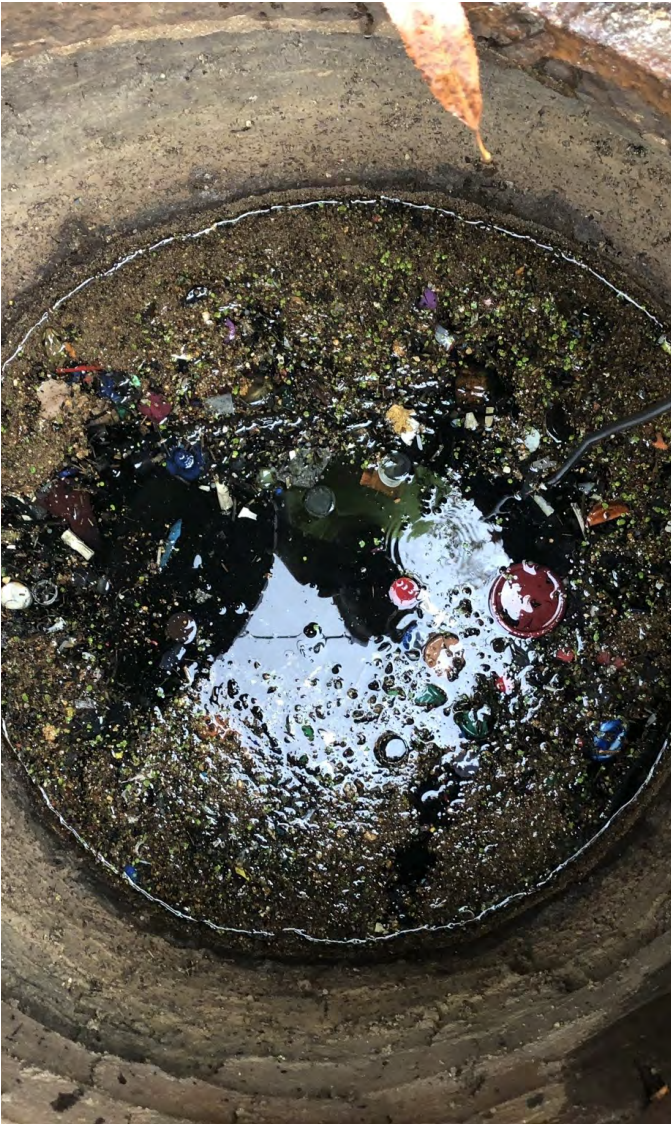
Photo 10: Manhole MH-1 interior with litter, debris, and grass. View to east; photograph taken on October 4, 2021.

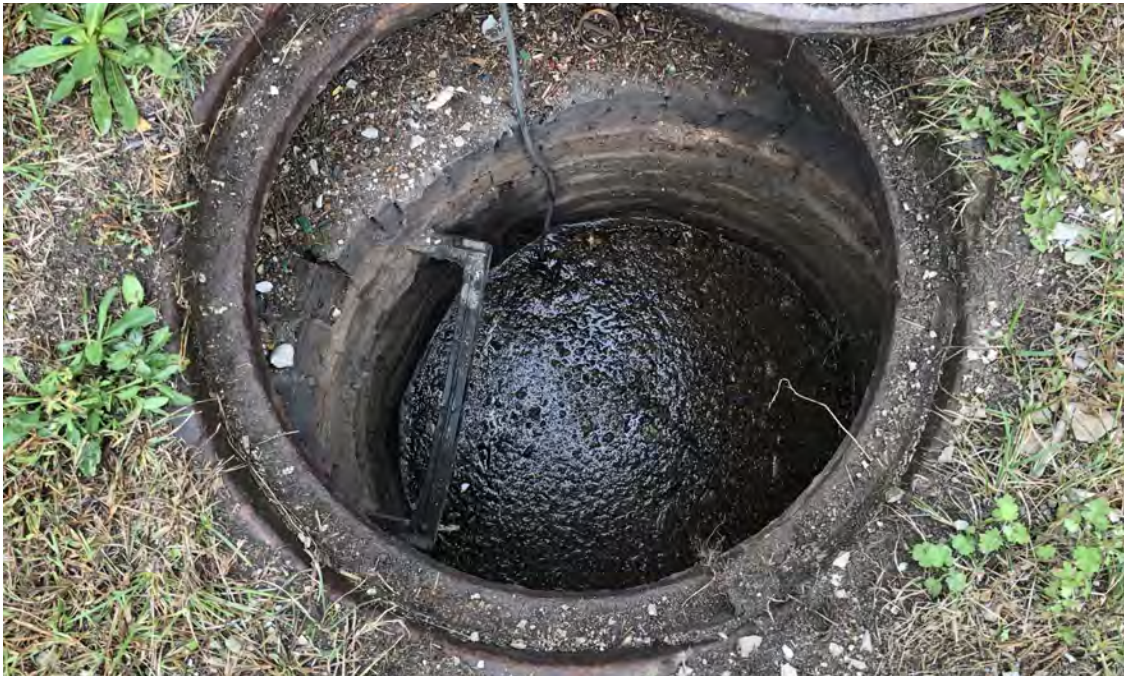
Photo 12: Manhole MH-2 interior with debris. View to north; photograph taken on October 4, 2021.

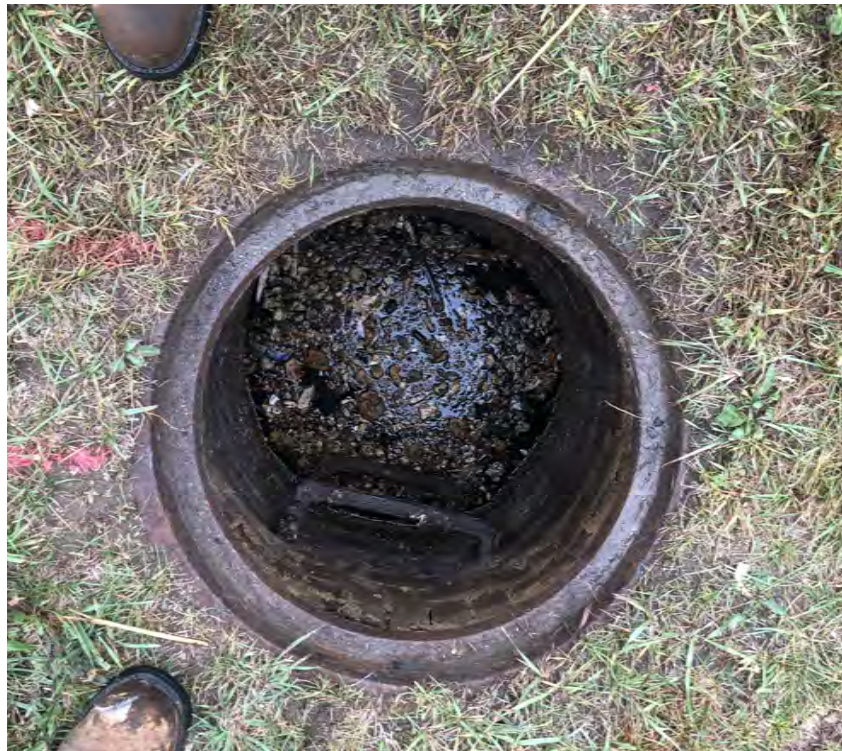
Photo 13: Manhole MH-3 interior with debris. View to east; photograph taken on October 4, 2021.

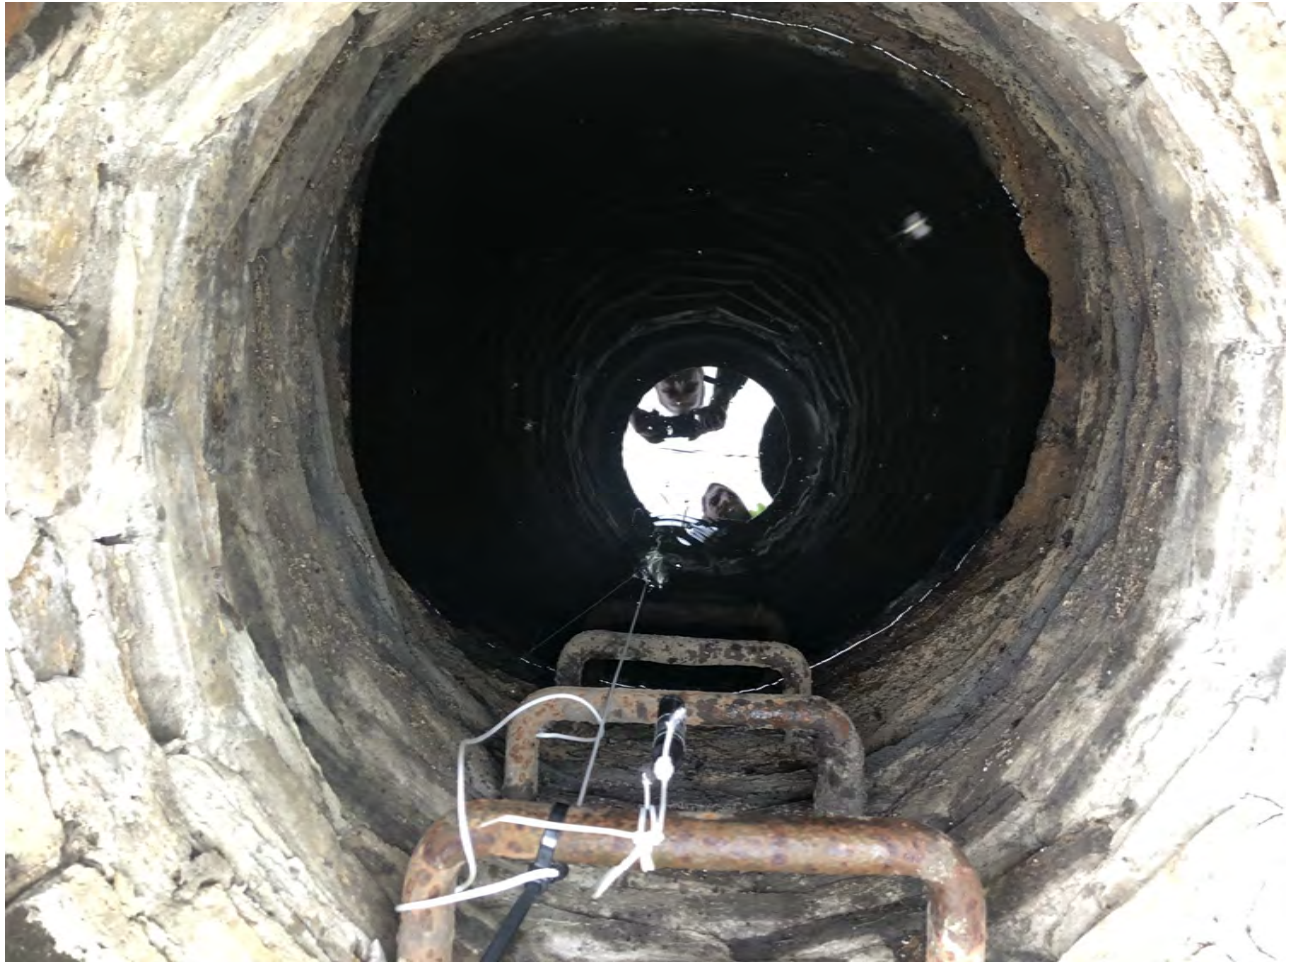
Photo 14: Manhole MH-4 interior with black silty water. Level logger for manhole MH-4 and barometric pressure logger tied to manhole ladder. View to east; photograph taken on October 4, 2021.

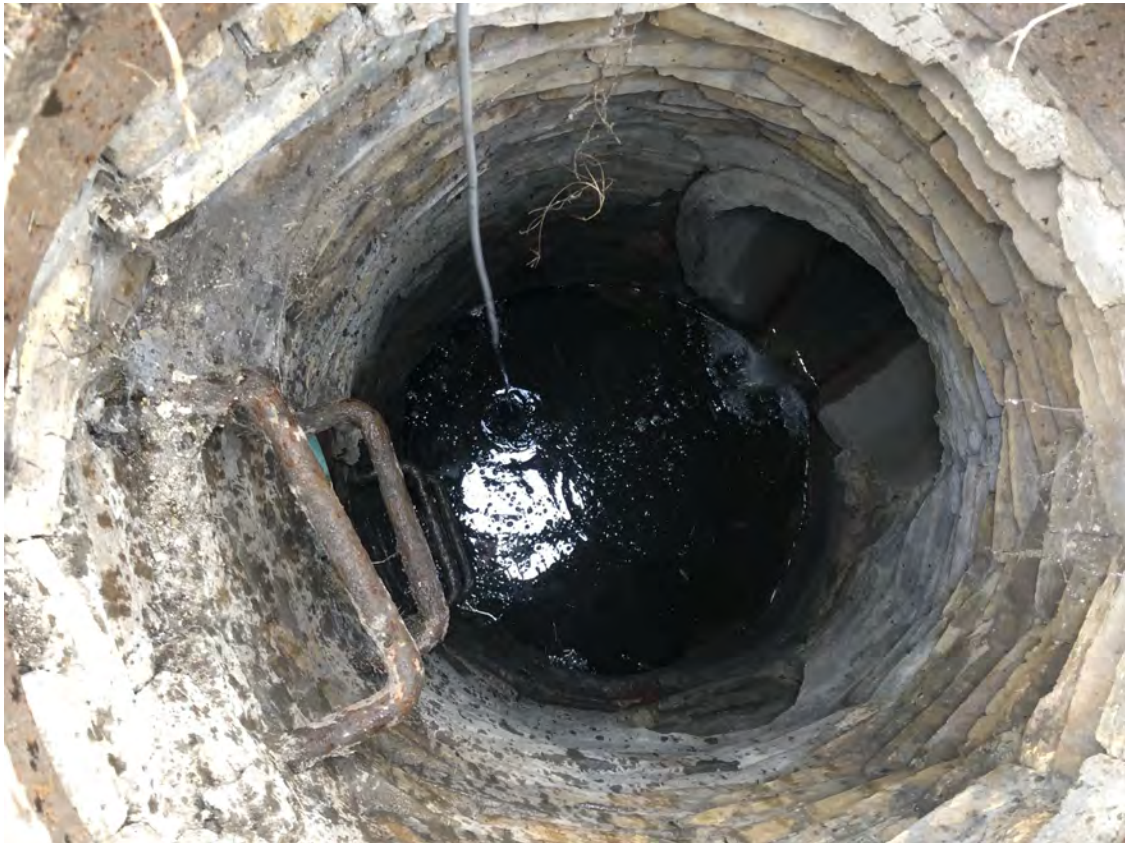
Photo 15: Manhole MH-5 interior with black, silty water. E Invert (on right). View to east; photograph taken on October 4, 2021.

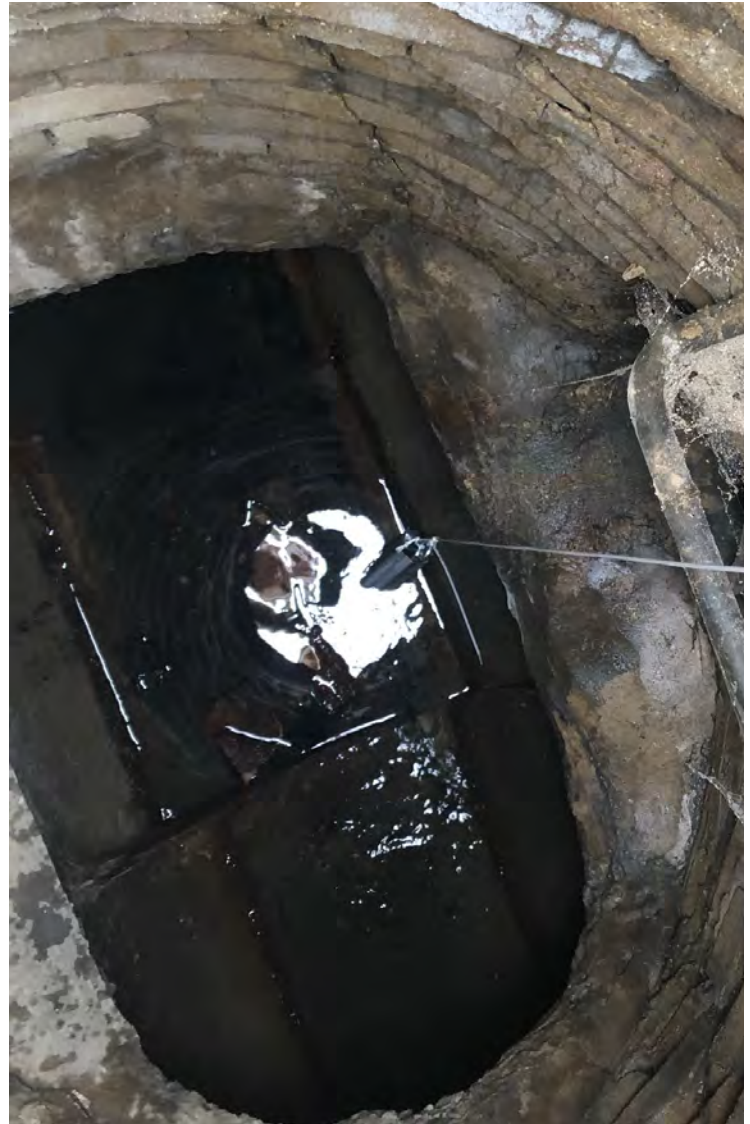
During the October 2021 and November sampling rounds, manholes MH-14 and MH-15 had trace amounts of sediment ($<1/4''$) that were not measurable. The sediment was observed to be a black fine sand.

Photo 17: Manhole MH-14 interior, with trace sediment in the central portion of the pipe. Levellogger MH-14 tied to ladder on south side. View to southeast; photograph taken on October 4, 2021.

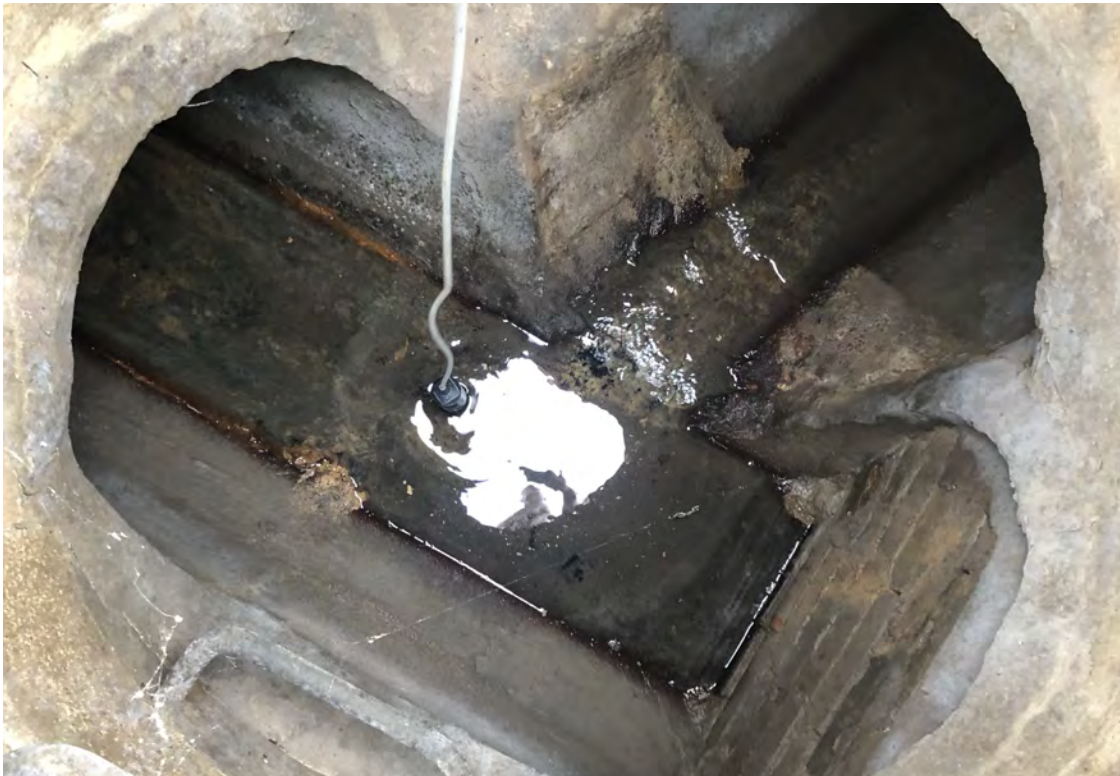
Photo 19: Manhole MH-15 interior with trace sediment and low water column. S invert (left) and W invert (right). View to southwest; photograph taken on October 4, 2021.

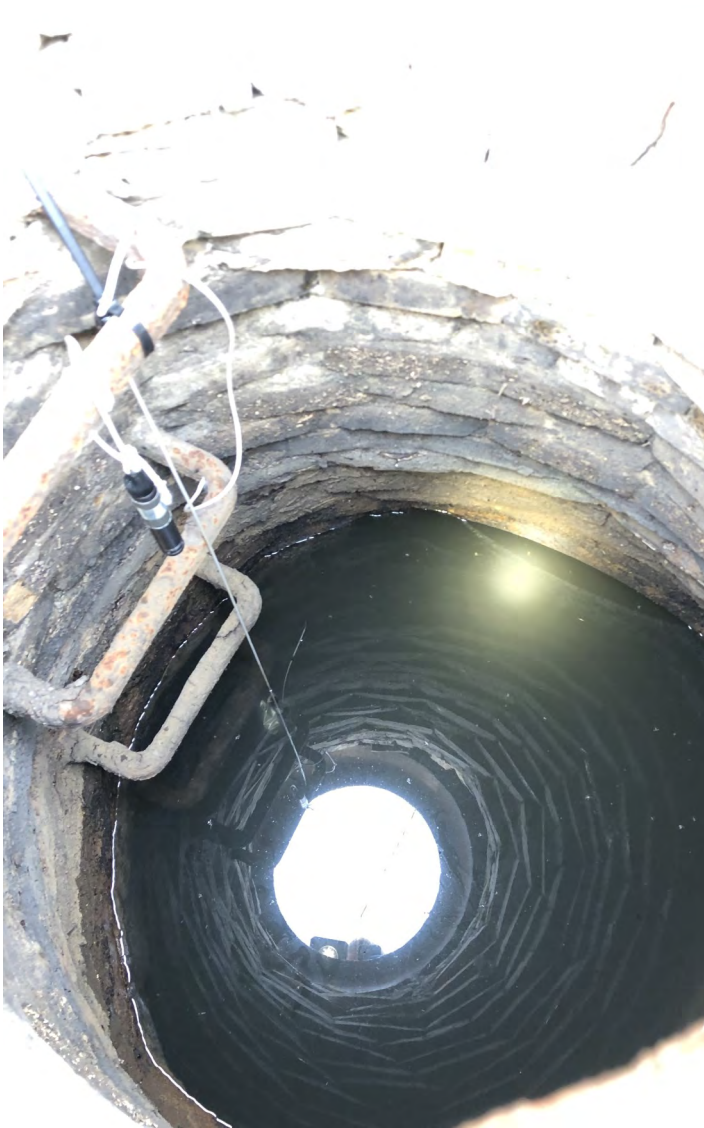
Photo 22: Manhole MH-4 interior with black silty water. View to northwest; photograph taken on October 11, 2021.

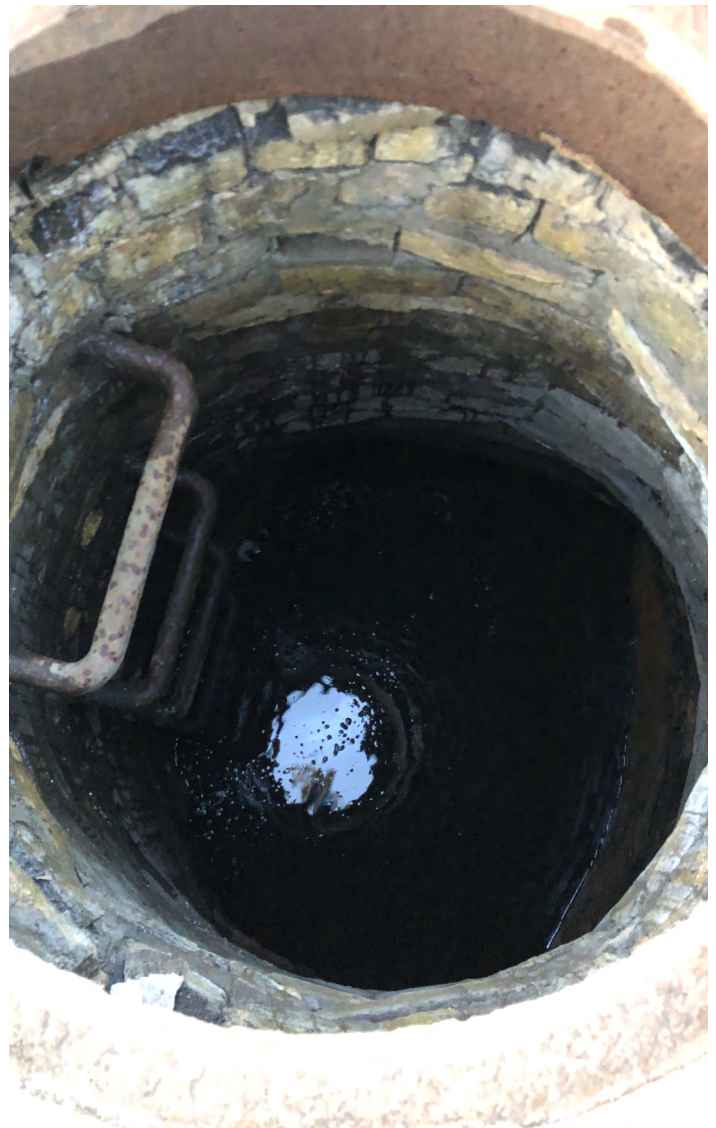
Photo 23: Manhole MH-4 interior with black silty water. View to northwest; photograph taken on February 28, 2022.

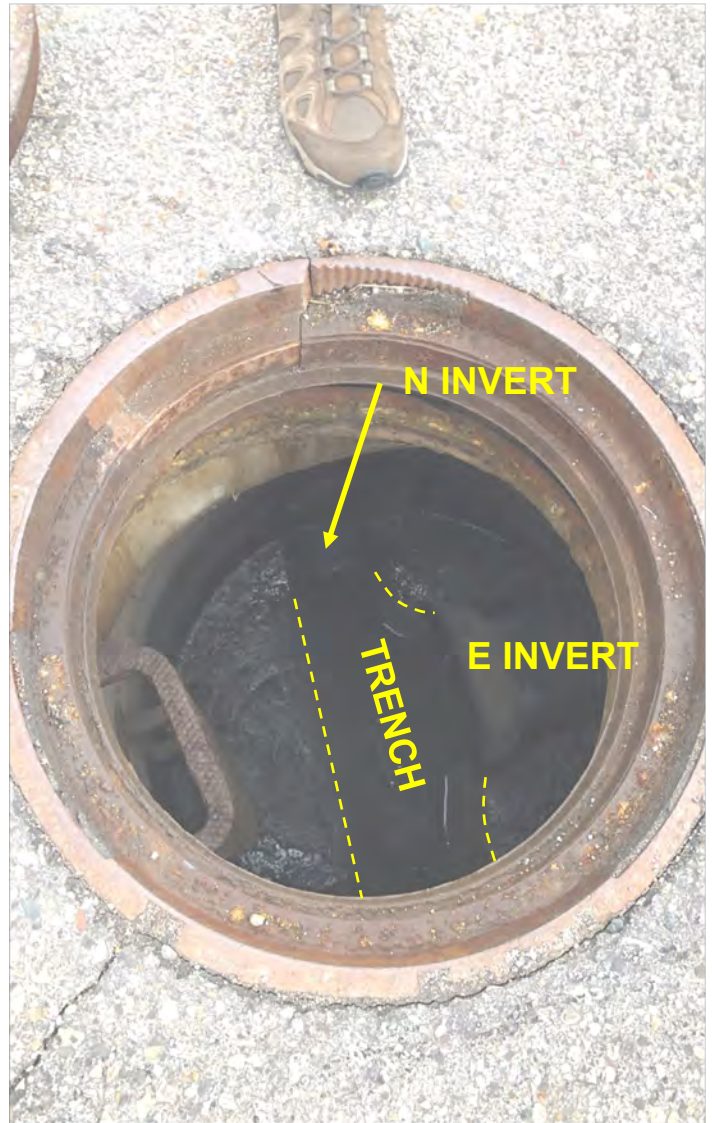
Photo 27: Manhole MH-12 interior with low water level and visible concrete trench & inverts, and trace sediment. View to northwest; photograph taken on April 4, 2022.

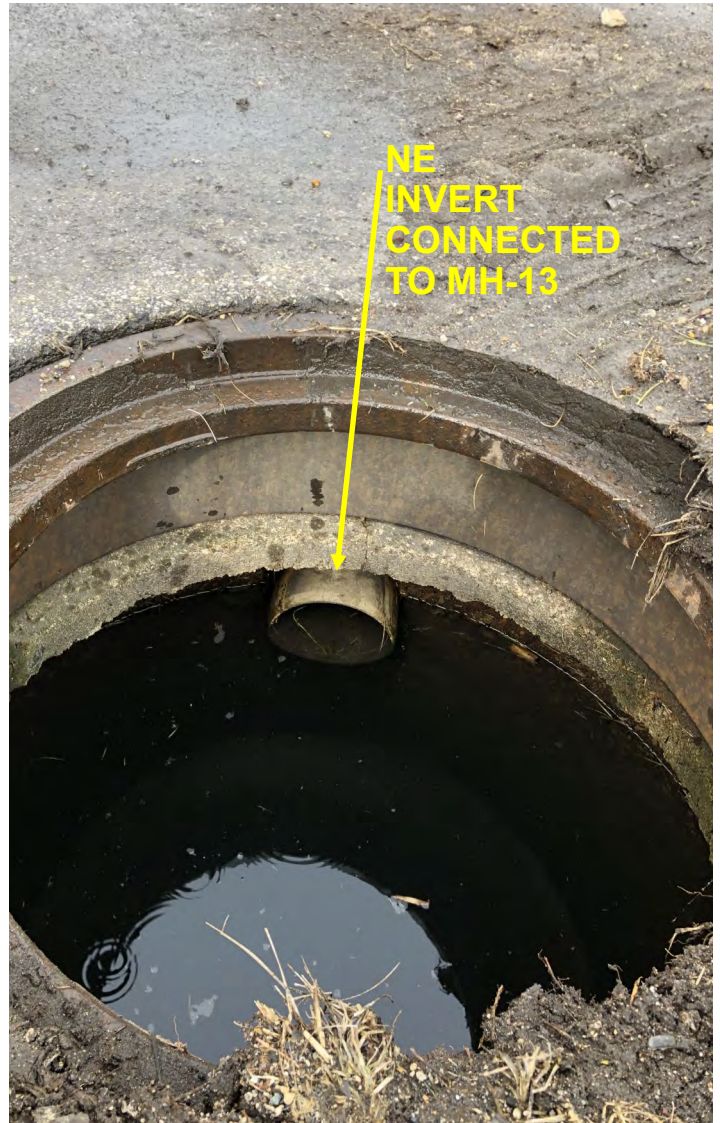
Photo 31: Manhole MH-16 interior with visible NE invert connected to manhole MH-13 and high water level. View to northeast; photograph taken on April 7, 2022.
