Long Lake North Landing

Stormwater Mitigation

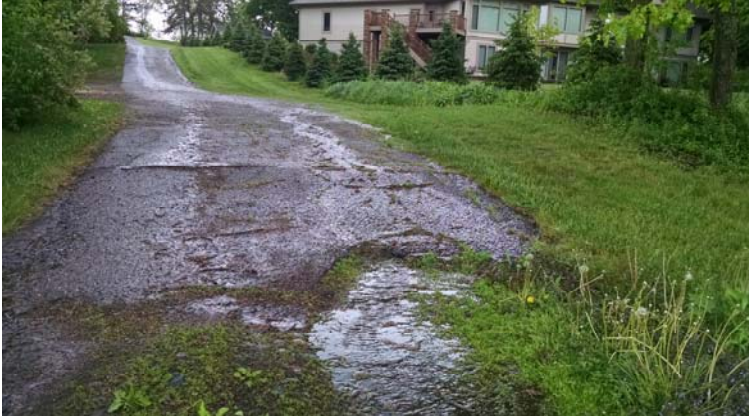
*Runoff flows down entire landing driveway to the lake (5/23/16)
(4,500 ft² of hard surface – need 937.5 ft³ of rock infiltration area to capture a 1” rain.)*

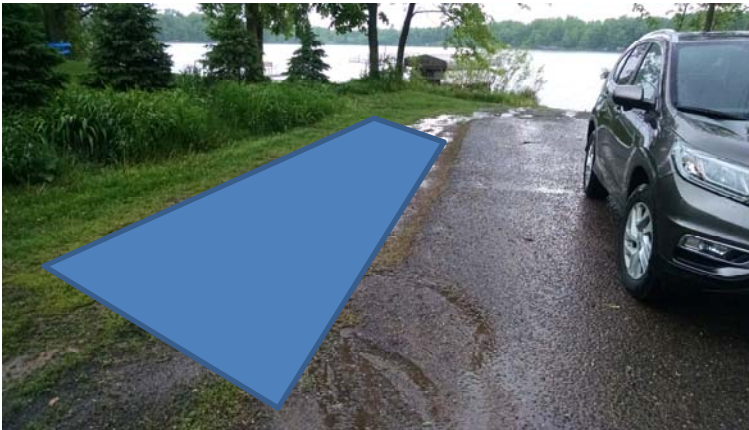
Install rock infiltration area under parking areas. Keep shallow to maintain separation to water table. East side installed in 2016. Top portion has sedimented in. Remove dirty rock and replace with clean.

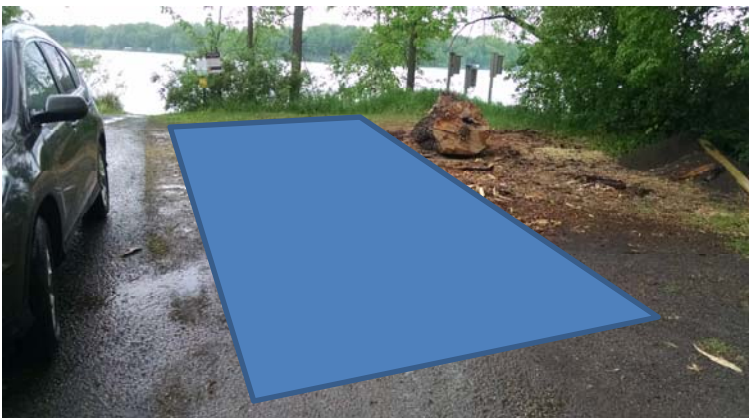
*Rock infiltration – west side
Rock size for both 1 1/2” clean, **level bottom**, rock across entire surface currently dirt.*
