Lake Management Plan for East Alaska Lake WDNR Lake Management Planning Grant, LPL-560

Prepared for
Town of Pierce
Kewaunee County, WI

December 27, 1999
NES Project No.: 13168002

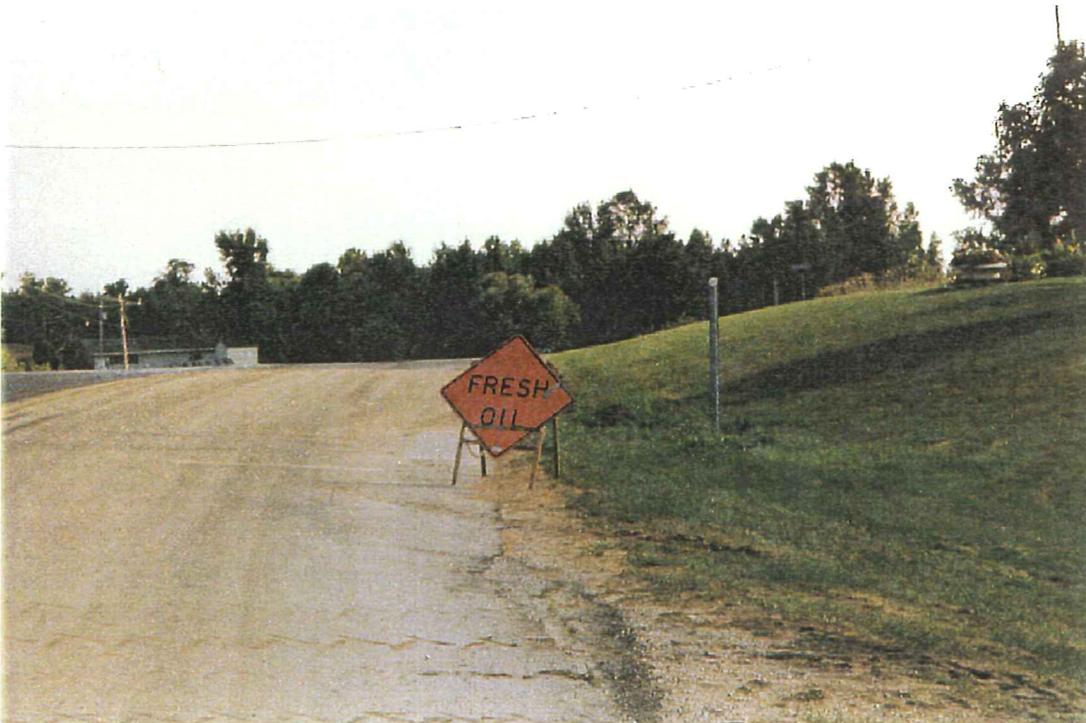
Photographs 3-1 and 3-2 provide an example of the potential problems caused by the stormwater drains discharging into East Alaska Lake. During an August 11, 1999 site visit, fresh oil had been spread along County Trunk Highway D to prepare the surface for a future asphalt application. The oil was spread along the entire reach of County Trunk Highway D along the southwest lake shoreline. According to climatic data from the National Oceanic and Atmospheric Administration, the Green Bay area received 0.12 inches of precipitation on August 12, 1999. Assuming a similar amount of precipitation occurred in the East Alaska Lake area, highway surface runoff resulting from the event likely carried oil from the road directly into the lake.

Photograph 3-1 Fresh Oil Sign Looking South on County Trunk Highway D Near the Intersection of Sixth Road

To prevent issues like that described above, the Town of Pierce could approach the Kewaunee County Highway Department about rerouting the storm drain outlets such that they discharge either outside of the drainage basin or to an area that provides treatment prior to entering the lake. For example, the outlets could possibly be routed to an adjacent wetland or a ditch on the west side of the road.

The Town of Pierce should work with Kewaunee County to examine the feasibility of re-routing the stormwater drains located on County Trunk Highway D such that they no longer directly outlet to East Alaska Lake. Possible alternatives could include discharging stormwater to a nearby wetland area, a ditch on the west side of the road, a constructed infiltration basin, etc.

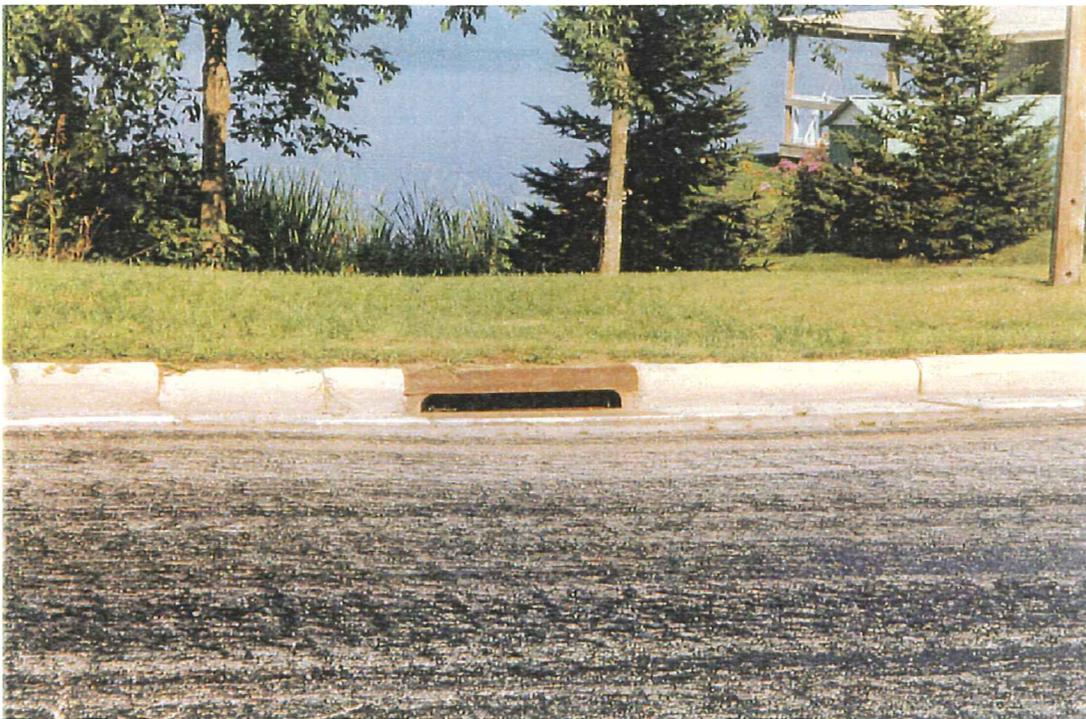
Photograph 3-2 Fresh Oil on County Trunk Highway D and Location of Stormwater Drain which Discharges to East Alaska Lake

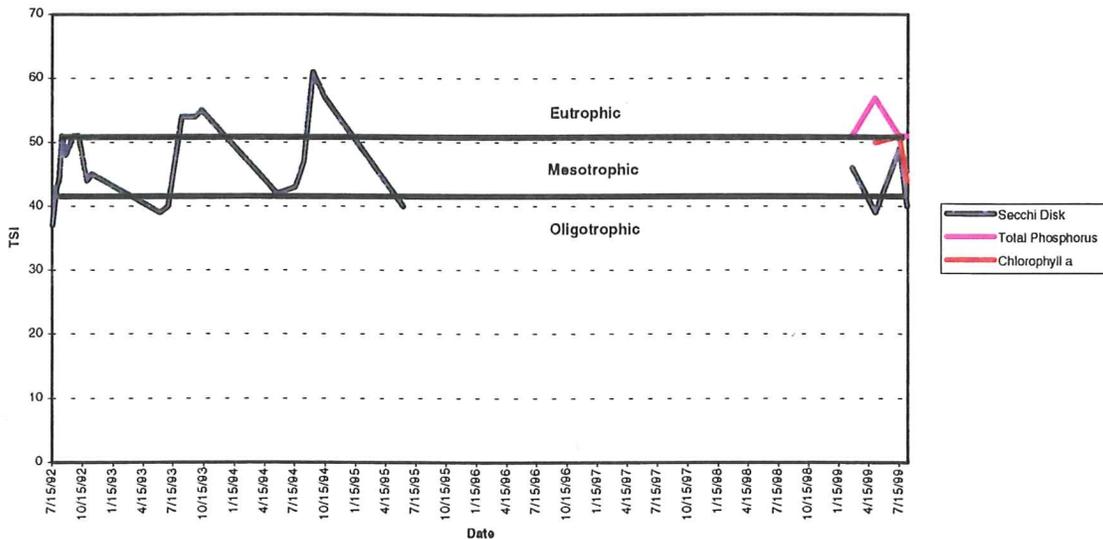
Figure 3-5 Trophic State Index Values for East Alaska Lake

The 1992 through 1995 and 1999 data for East Alaska Lake suggest that the lake fluctuates between mesotrophic and eutrophic conditions. Observations during the study period support the conclusion that the lake suffers from periods of poor water quality. Photographs 3-3 and 3-4 show the lake in June of 1999. Photograph 3-3 provides a view of the dense filamentous algal growth observed on the lake, and Photograph 3-4 demonstrates the apparent high concentration of suspended algae in the water column as evidenced by a noticeable “green” tinge to the water.

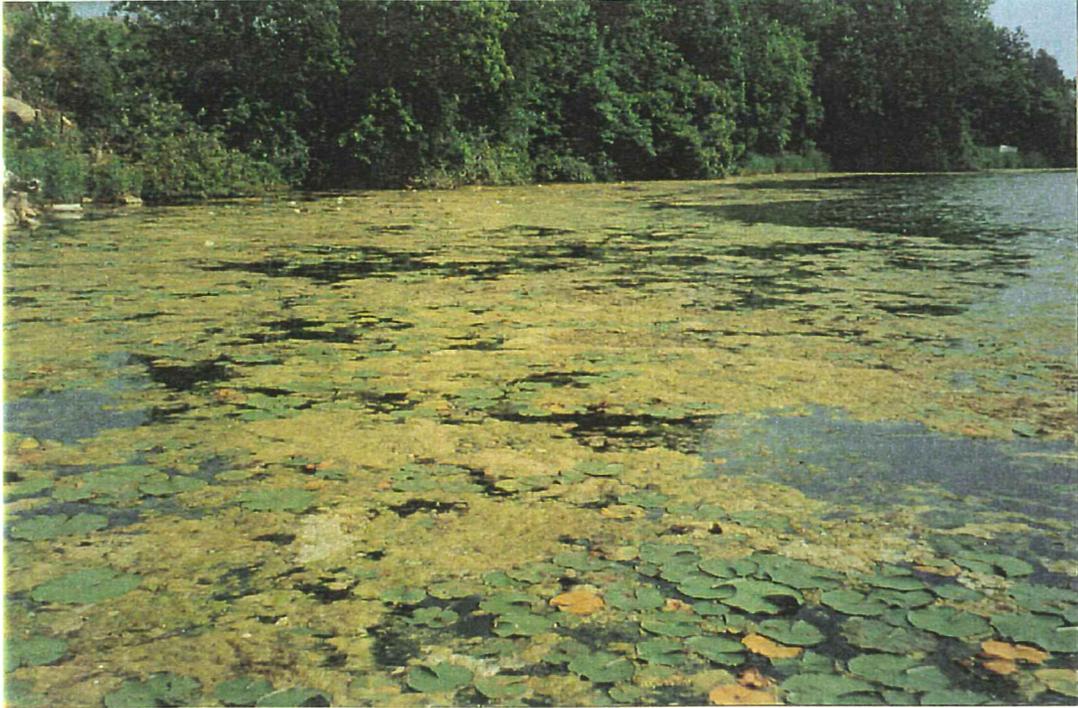
Photograph 3-3 **Filamentous Algal Growth on East Alaska Lake,
June 1999**

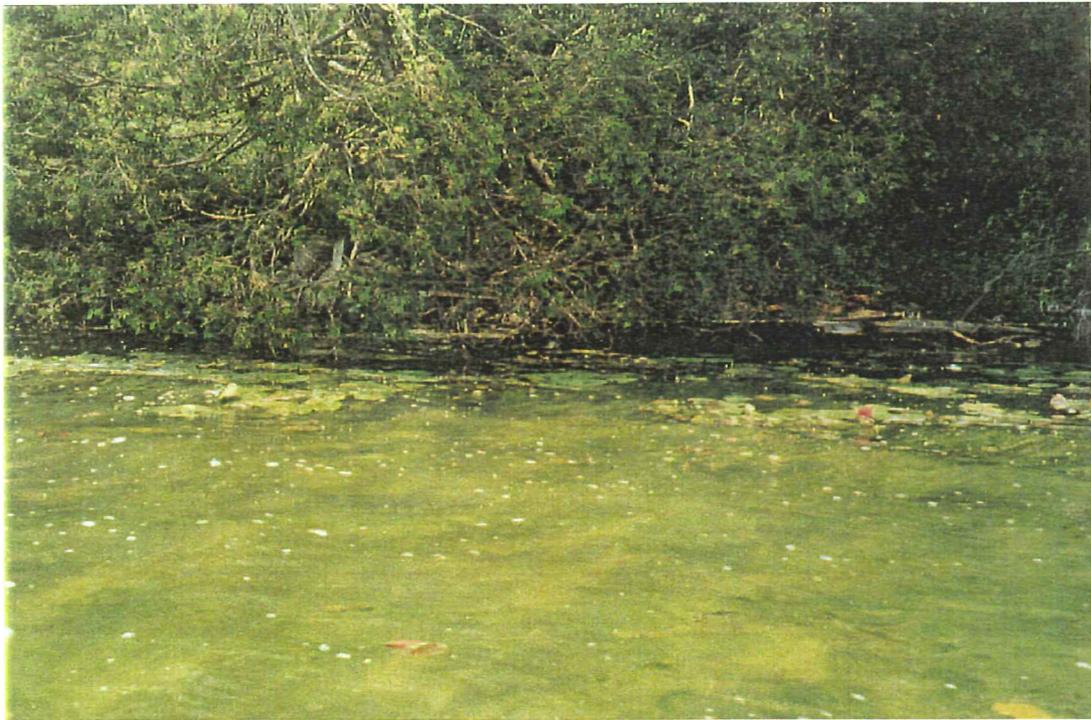
Photograph 3-4 **East Alaska Lake Water Column, June 1999**

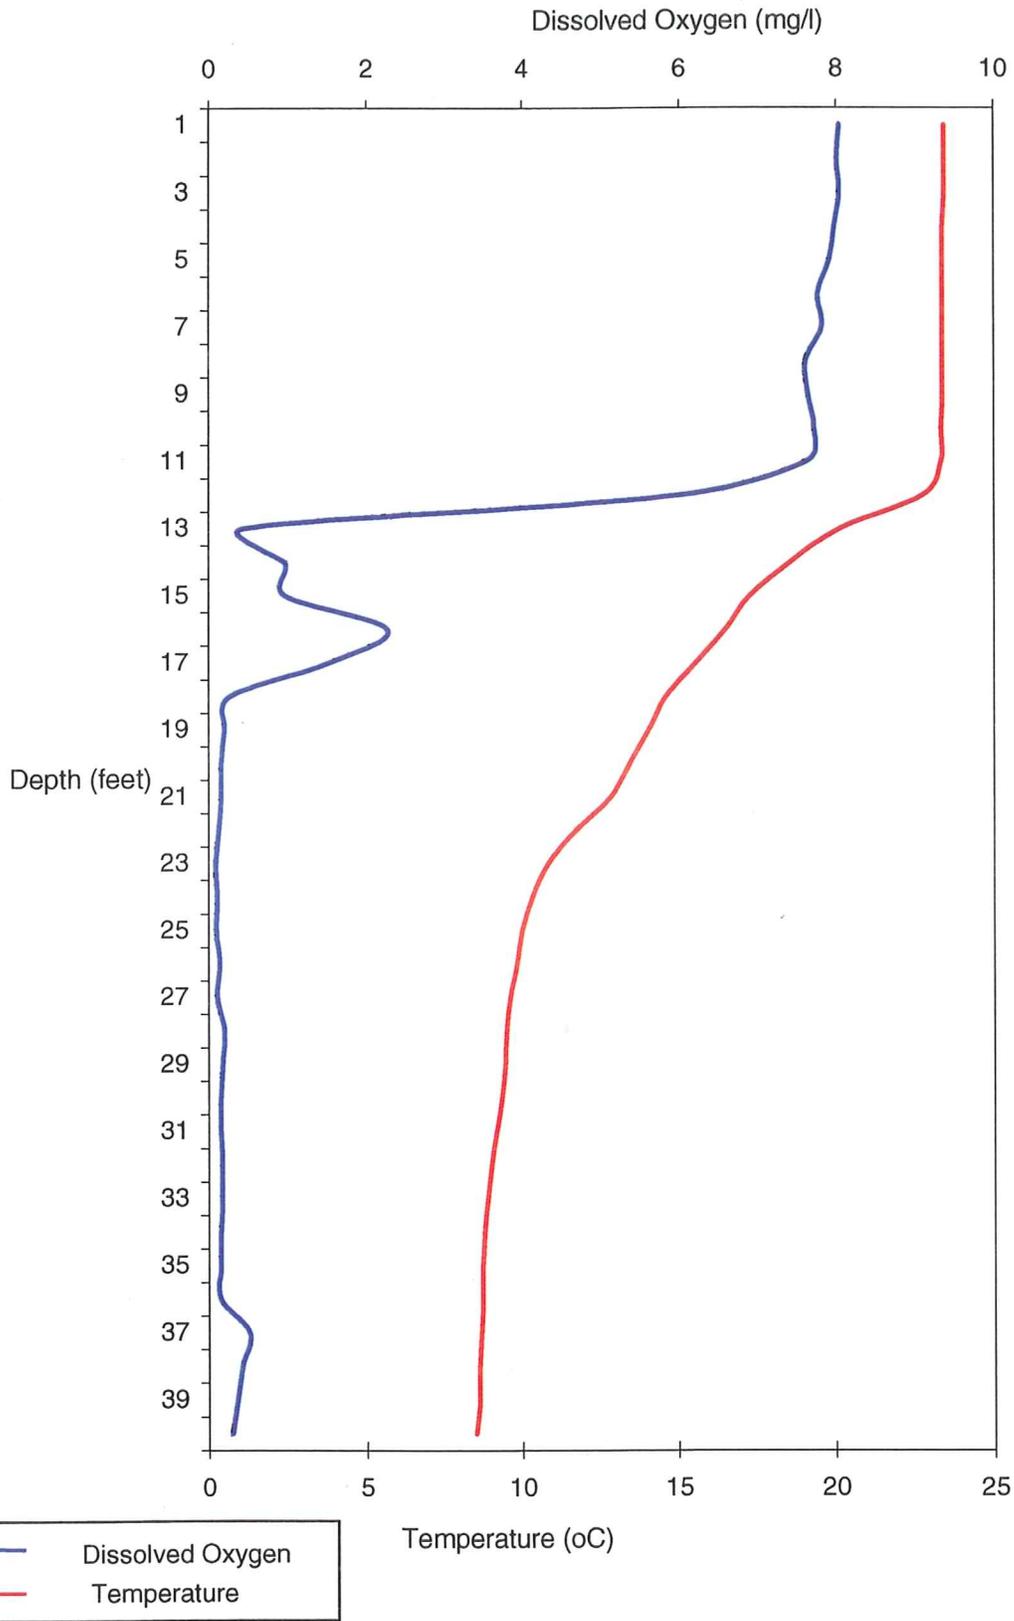
Figures 3-6 through 3-9 provide the dissolved oxygen and temperature profiles for the study period. In general, the profiles suggest that East Alaska Lake exhibits a clinograde oxygen profile. Clinograde profiles are indicative of lakes which are eutrophic and experience rapid depletion of oxygen in the hypolimnion (i.e., bottom waters) during stratified periods due to oxidative processes such as animal and plant respiration and bacterial decomposition of organic matter. The creation of anaerobic conditions in the hypolimnion during stratified periods excludes a portion of the lake from habitation by most animals and many plants. For example, in July the habitable portion of the water column extended to about 13 feet, and the remaining 27 feet of water were basically inhabitable due to low dissolved oxygen levels (Figure 3-8).

Figure 3-8. Dissolved Oxygen/Temperature Profiles for July 15, 1999

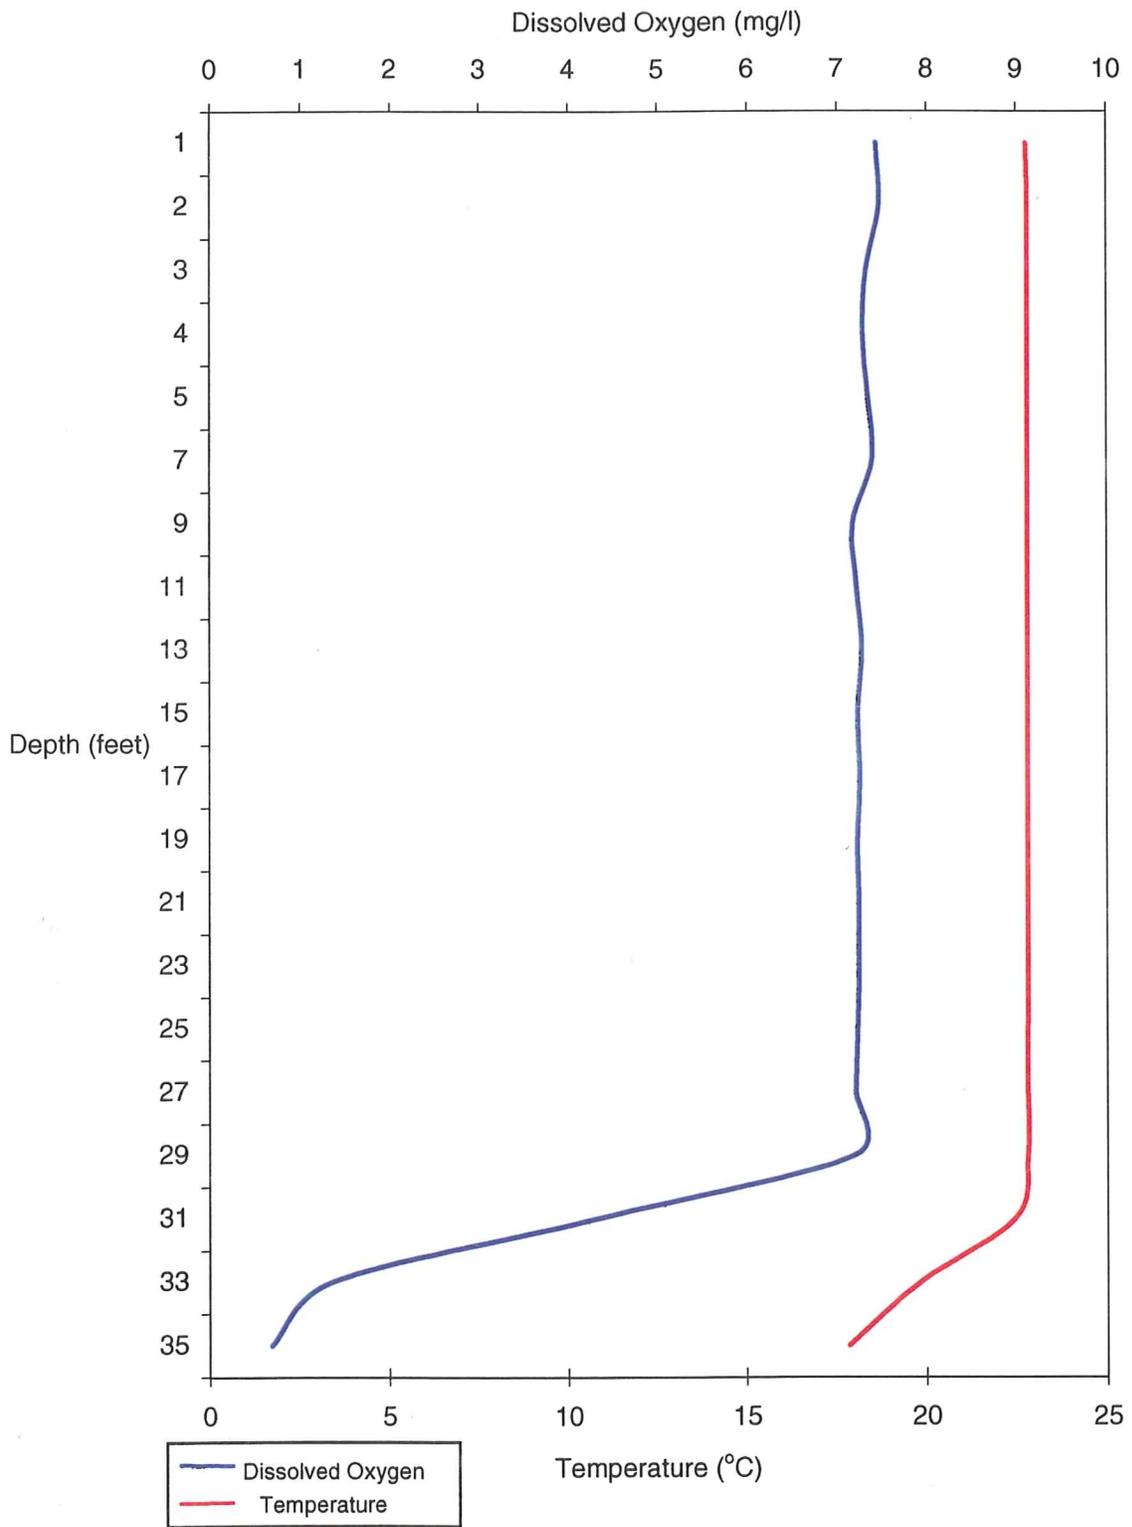
The August dissolved oxygen profile (Figure 3-9) demonstrates the processes that occur as a lake progresses toward turnover. Turnover is a phenomenon in which the lake circulates completely creating a uniform water column that is unstratified. Turnover occurs in the spring and fall and is driven by temperature changes and wind energy. The process of turnover mixes the oxygen-rich surface waters and nutrient laden bottom waters. This process is one of the methods by which nutrients released from the sediments are circulated through the water column. The August dissolved oxygen profile in Figure 3-9 exhibits a deepening of the epilimnion (i.e., surface waters). The epilimnion deepens during fall through progressively deeper circulation of oxygen-rich water. When circulation is complete, the water column will be uniformly saturated with oxygen in accordance with the maximum oxygen solubility as dictated by the lake's temperature. The recorded August profile is indicative of the terminal stages of fall turnover.

Figure 3-9. Dissolved Oxygen/Temperature Profiles for August 9, 1999
