**Re: Oconto Falls Upper, Project No. 2523, N.E.W. Hydro, Inc.
Submittal of Purple Loosestrife/Eurasian Watermilfoil Inventory for Year 2006**

**Oconto Falls Upper Project Purple Loosestrife & Eurasian Watermilfoil Inventory
August 19, August 23, & August 24, 2006
FERC Project #2523 Article 407**

Project: Oconto Falls Upper #2523
 Date: 8/19/06 & 8/23/06
 Crew: RAL & CTM

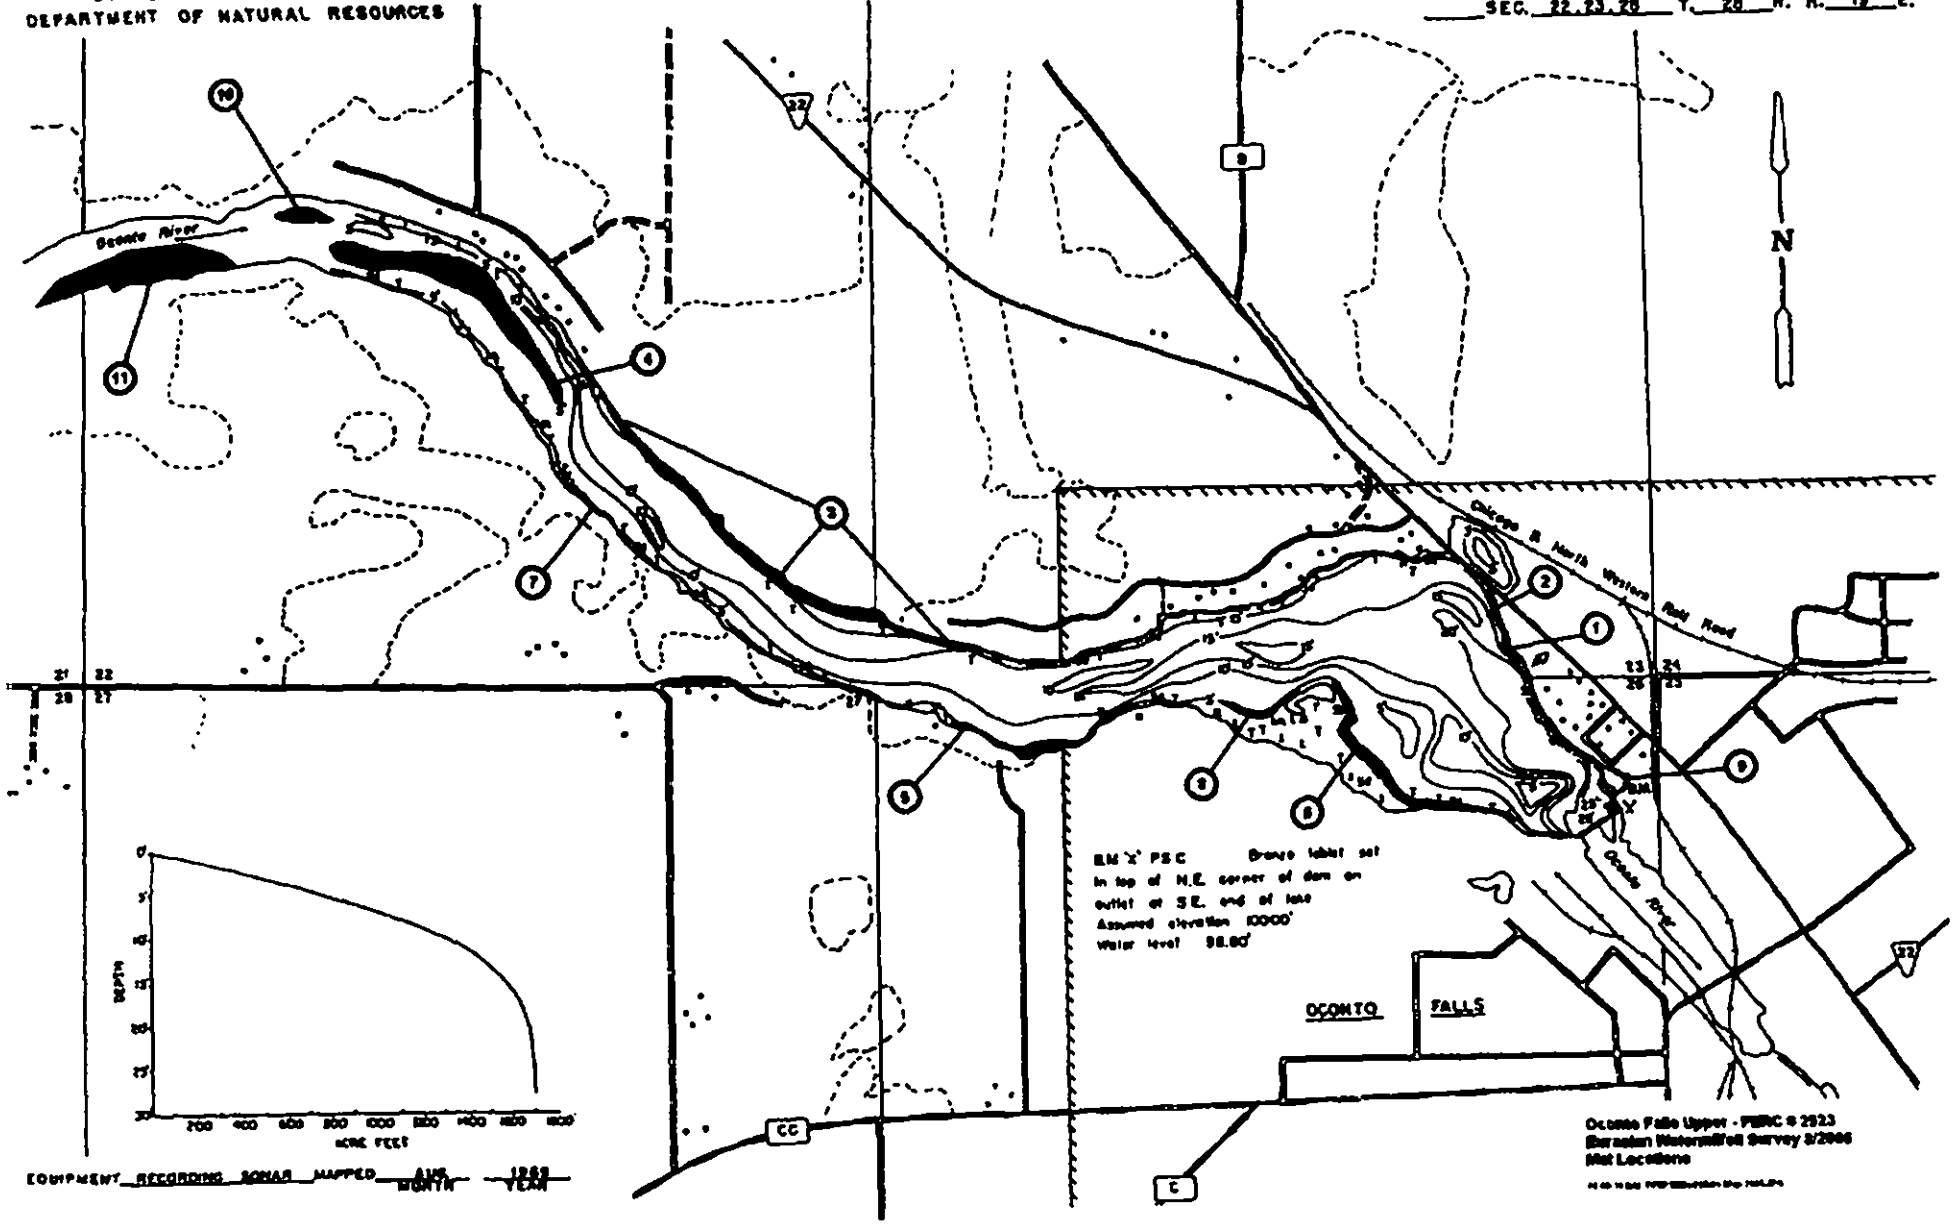
LAKE SURVEY MAP

The headwaters were surveyed by boat. Five occurrences of purple loosestrife plants were observed in this area and are noted on the lake map and survey comments at the end of this report. One of these occurrences appears to be on project owned land and is so noted.

Eleven mats containing Eurasian watermilfoil were identified within the project boundary of which mat #1, #2, #3, and #4 were first identified in the 2000, mat #5 was first identified in 2001, mat #6 and #7 were first identified in 2003, mat #8 was first identified in 2005, and mat #9, #10, and #11 were identified in 2006. All eleven mats were discovered using the visual search method. All of these mats were interspersed with other types of plants and all of the mats had Eurasian watermilfoil densities as noted in the survey comments at the end of this report. Mats #1 through #10 are located in the *main basin* while mat #11 is located in the *headwaters*.
