Rock Lake Shorelands and Shallows Survey

In 2015, the Jefferson County Land and Water Conservation Department (LWCD) obtained a Department of Natural Resources (DNR) lake planning grant in order to assess the current conditions in the shoreland and near-shore shallow areas of Rock Lake. The survey will serve as a baseline so that future changes (improvements or declines) in conditions can be measured.

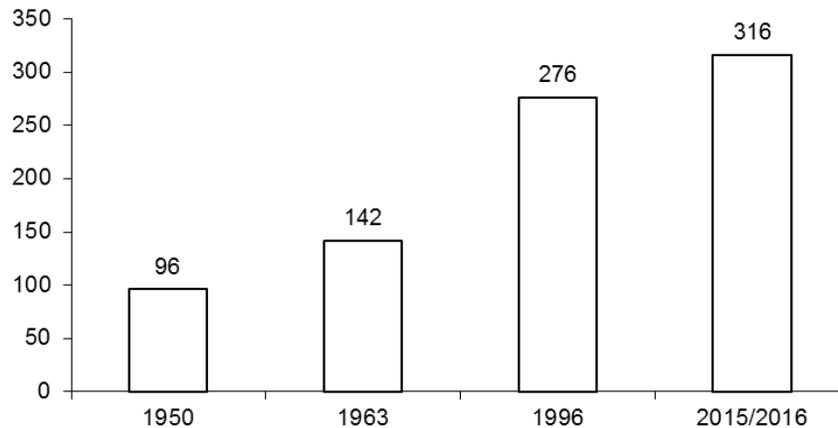
Number of Piers on Rock Lake (not including Marsh Lake, millpond, or Elm Point channel)

Throughout the years, there have been surveys of piers on Rock Lake. This number is important because it gives an indication of the development of the near-shore water area. The information is contained in the chart below. The 1950 and 1963 data was generated by the Department of Natural Resources (DNR) via mid-summer aerial photos. The DNR also did a pier survey by boat in 1996. These 3 surveys didn’t include piers in the millpond, Marsh Lake, or the channel located along Elm Point Road. The number of piers displayed in the chart for 2015/2016 includes the piers counted on Rock Lake (not the Marsh, millpond, or Elm Point channel). The number of piers documented in 2015 and 2016 in the Elm Point channel was 3 and in the millpond was 13. Properties that don’t have piers in the Elm Point channel still have boats that are parked along their frontage. In 2015/2016, the total number of piers on Rock Lake, the millpond, and the Elm Point channel was 332.
