An Assessment
of
German Valley Creek

WBIC = 909200

Dane County, WI

A proposal for delisting from the state's 303(d) list of impaired waters

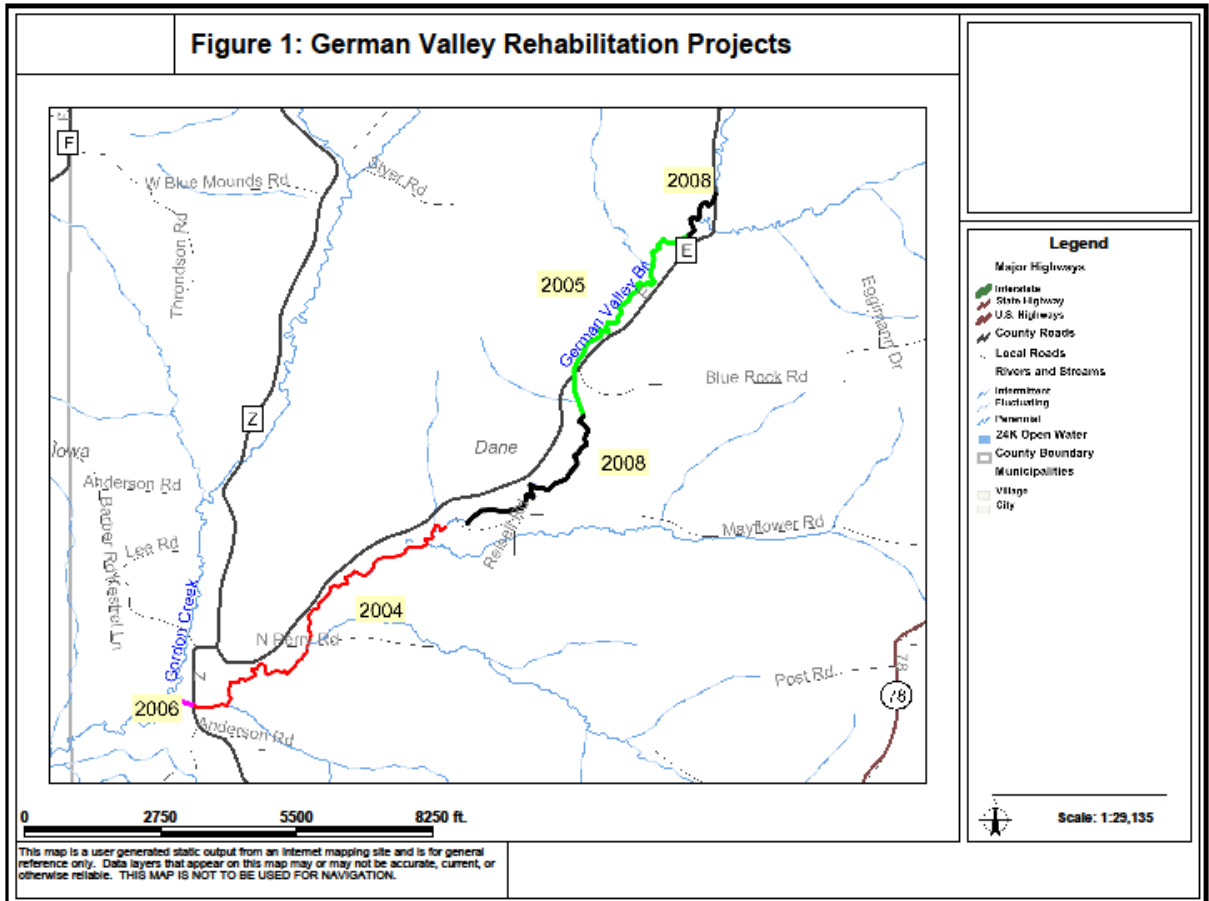
Landowners along German Valley Creek expressed their support for improving the stream and the fishery. In 2003, the Dane County Land and Water Conservation Department (LWCD) received the first of four Targeted Runoff Management (TRM) grants from the state to improve a 1.5 mile long section of stream from CTH Z to Mayflower Road (Figure 1). Cost share money was received from a county conservation

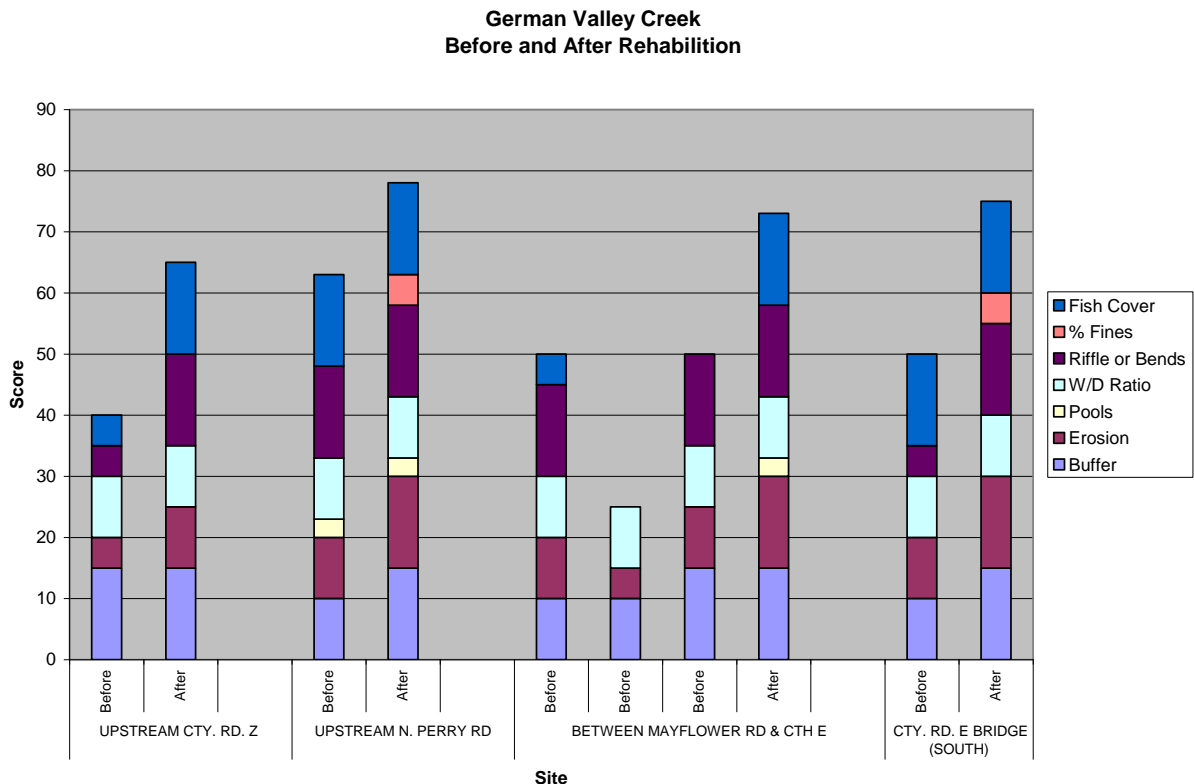
Figure 2: Habitat Surveys on German Valley Creek Before and After Rehabilitation

The improved habitat is immediately noticeable in the improved metrics that make up the habitat scores (Figure 2). The mean buffer width was already good and was one of the reasons managers felt the chances of success with the project were reasonably good. Banks were stabilized and erosion reduced as evidenced by the improved erosion scores. This was an important aspect in meeting the goals of the project. While the score for the width to depth ratios was unchanged, the actual ratio decreased from an average of 9.3 to 4.3, indicating a narrower, deeper channel which is generally more favorable to fish habitation. The score for percent fines did not increase appreciably; however, the percentage of fines decreased from an average of 84.6% before the projects to 54.2% after. The placing of rock and log weirs as well as LUNKER structures led to improved fish habitat. Overall habitat scores improved from “fair” and “good” to “good” and “excellent”.
