SITE-SPECIFIC SAMPLING AND ANALYSIS PLAN SUPPLEMENTAL SITE INVESTIGATION

Former Chilton Plating and Adjacent Parcels; Chilton, Wisconsin

WDNR BRRTS ID: 02-08-000040 (Open)

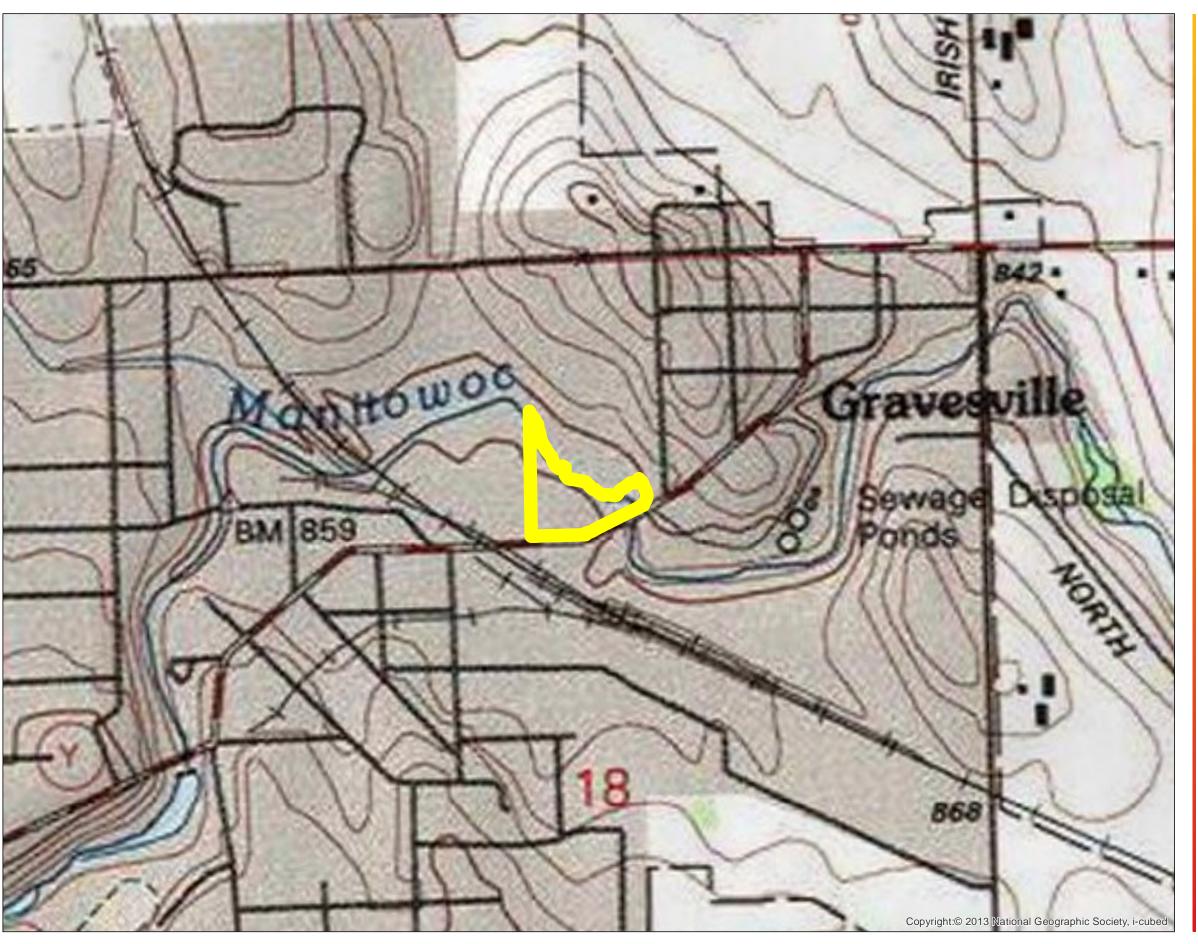
Site Investigation Project Area and Regional Topography

This Site-Specific Sampling and Analysis Plan (SSSAP) has been prepared on behalf of Calumet County (hereinafter referred to as the "County") by Stantec Consulting Services Inc. (Stantec) for field sampling and associated laboratory analyses to be performed as part of a supplemental Site Investigation (SI) at the former Chilton Plating and adjoining parcels (herein referred to as the "Property" or "Site") located in the Chilton, Wisconsin. The locations of the Property relative to regional topography are illustrated on **Figure 1**.

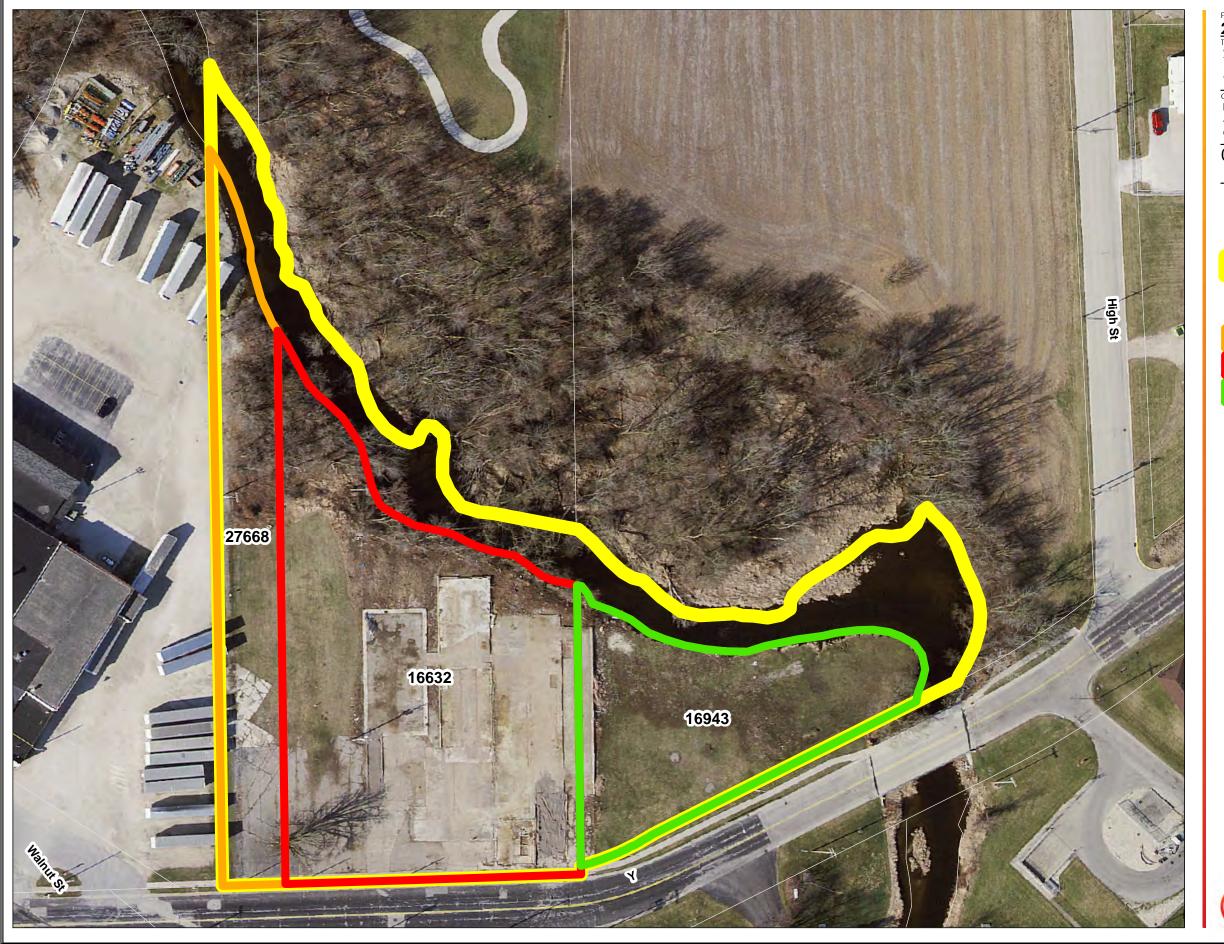
2
Title
Site Investigation Project Area and Target Parcels

The Property (outlined in yellow) consist of three contiguous vacant parcels of land and the adjoining reach of the Manitowoc River, totaling 4.20 acres of land (**Figure 2**).

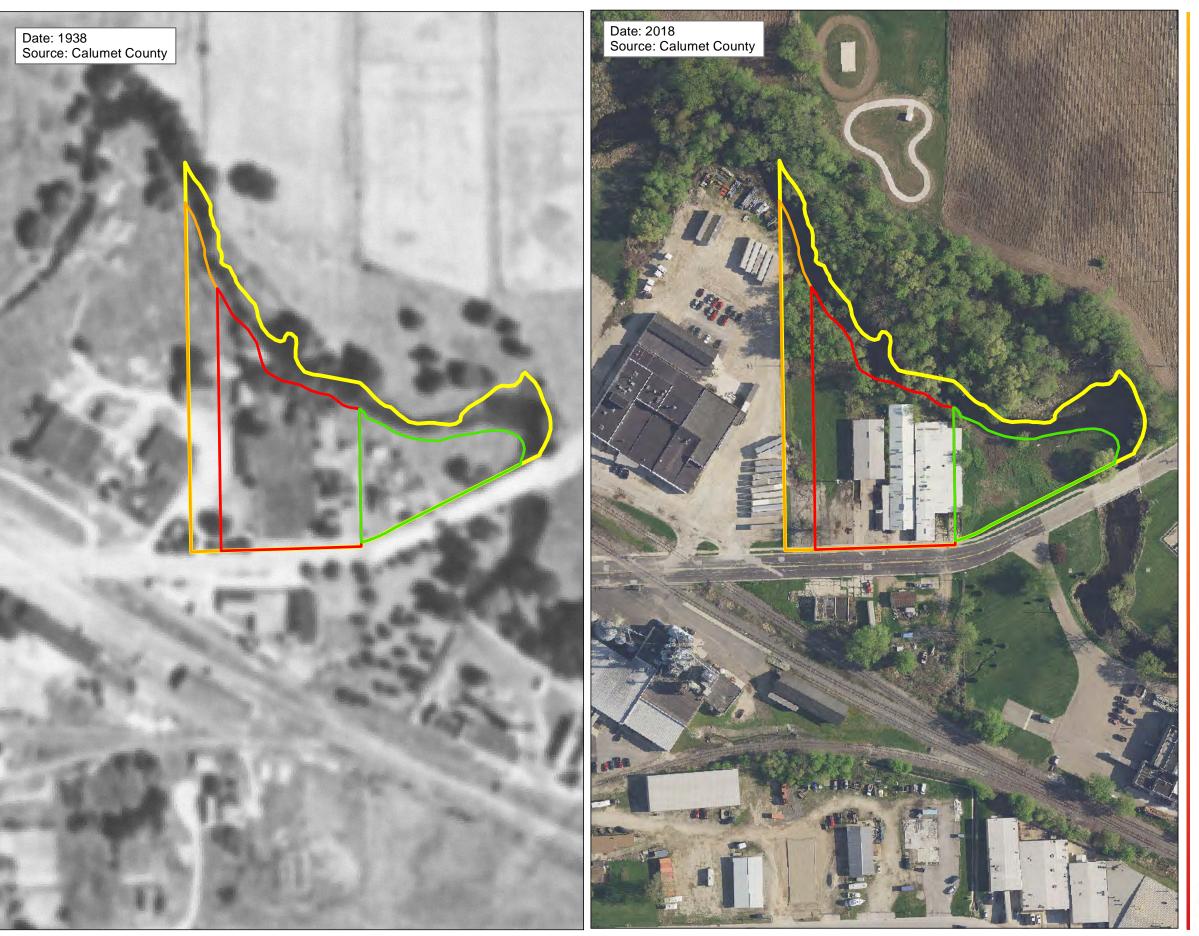
Figure No. 3
Title

Site Investigation Project Area and Historic Orthophotographs

Parcel 1. The operational history of Parcel 1 was not directly addressed in the Sigma (2014) Phase I Environmental Site Assessment (ESA). Although specific prior operations remain largely unknown, a large driveway apparently associated with the west-adjacent property was constructed across Parcel 1 by 1938 (**Figure 3**). The 2018 aerial photograph shows Parcel 1 as a vacant lot, with the southern quarter of the parcel being paved and the northern three quarters as apparently well vegetated (**Figure 3**).

Parcel 2. A Phase I ESA prepared by The Sigma Group (Sigma, 2014) notes the Chilton Plating Company (Chilton Plating) constructed a 26,000 square foot, one-story building on Parcel 2 in 1960 and operated at the Site from 1960 through 2008. Sigma's summary of prior use is general agreement with features apparent on orthophotographs taken in 1938 and 2018 (**Figure 3**). Of supplemental note, by 1938, the east half of Parcel 2 appears to be paved and occupied by several structures potentially associated with operations on the east-adjacent parcel (**Figure 3**).

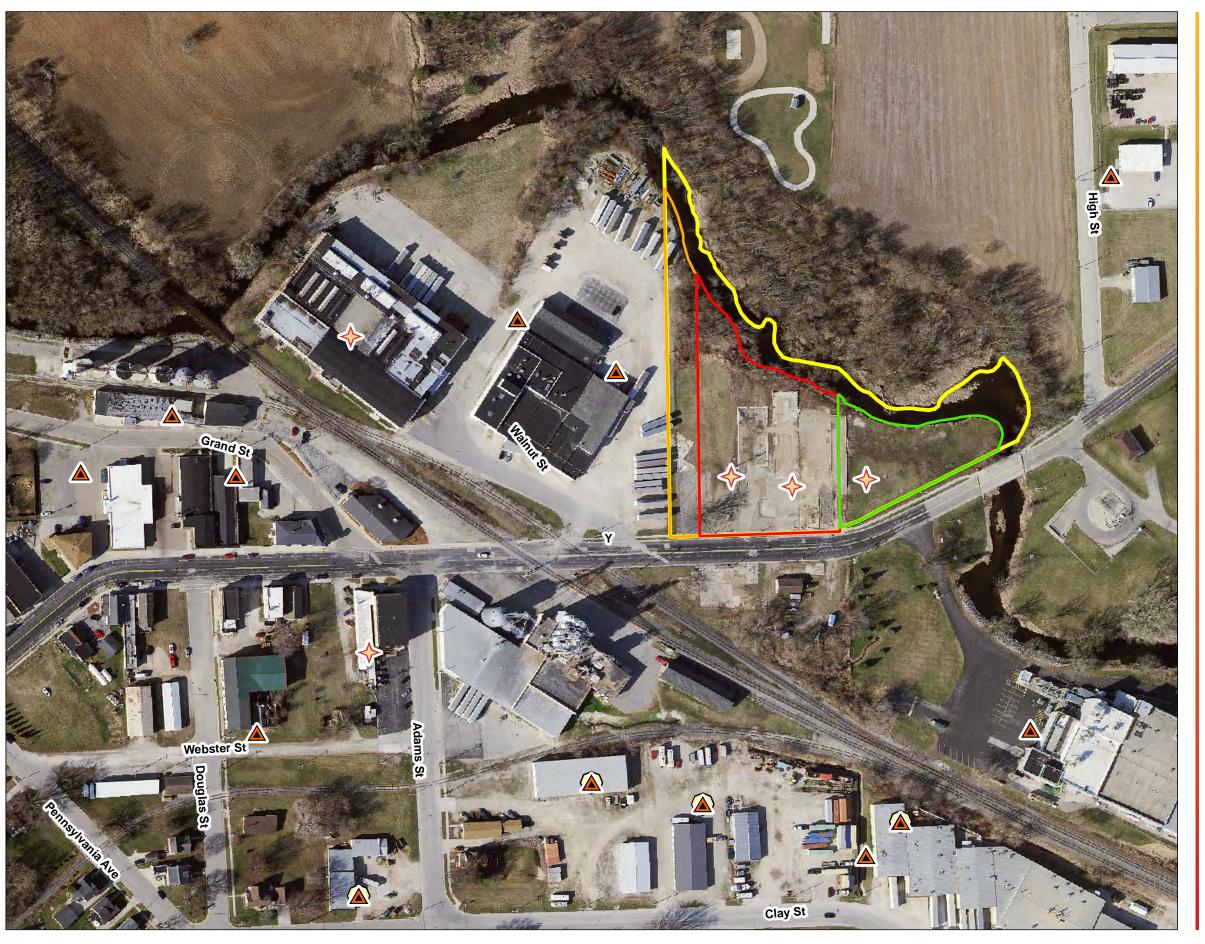
Site Investigation Project Area and Brownfield Database Records

A map of ERP cases on the Site is shown on **Figure 4**. A summary of contamination at the Site is described below:

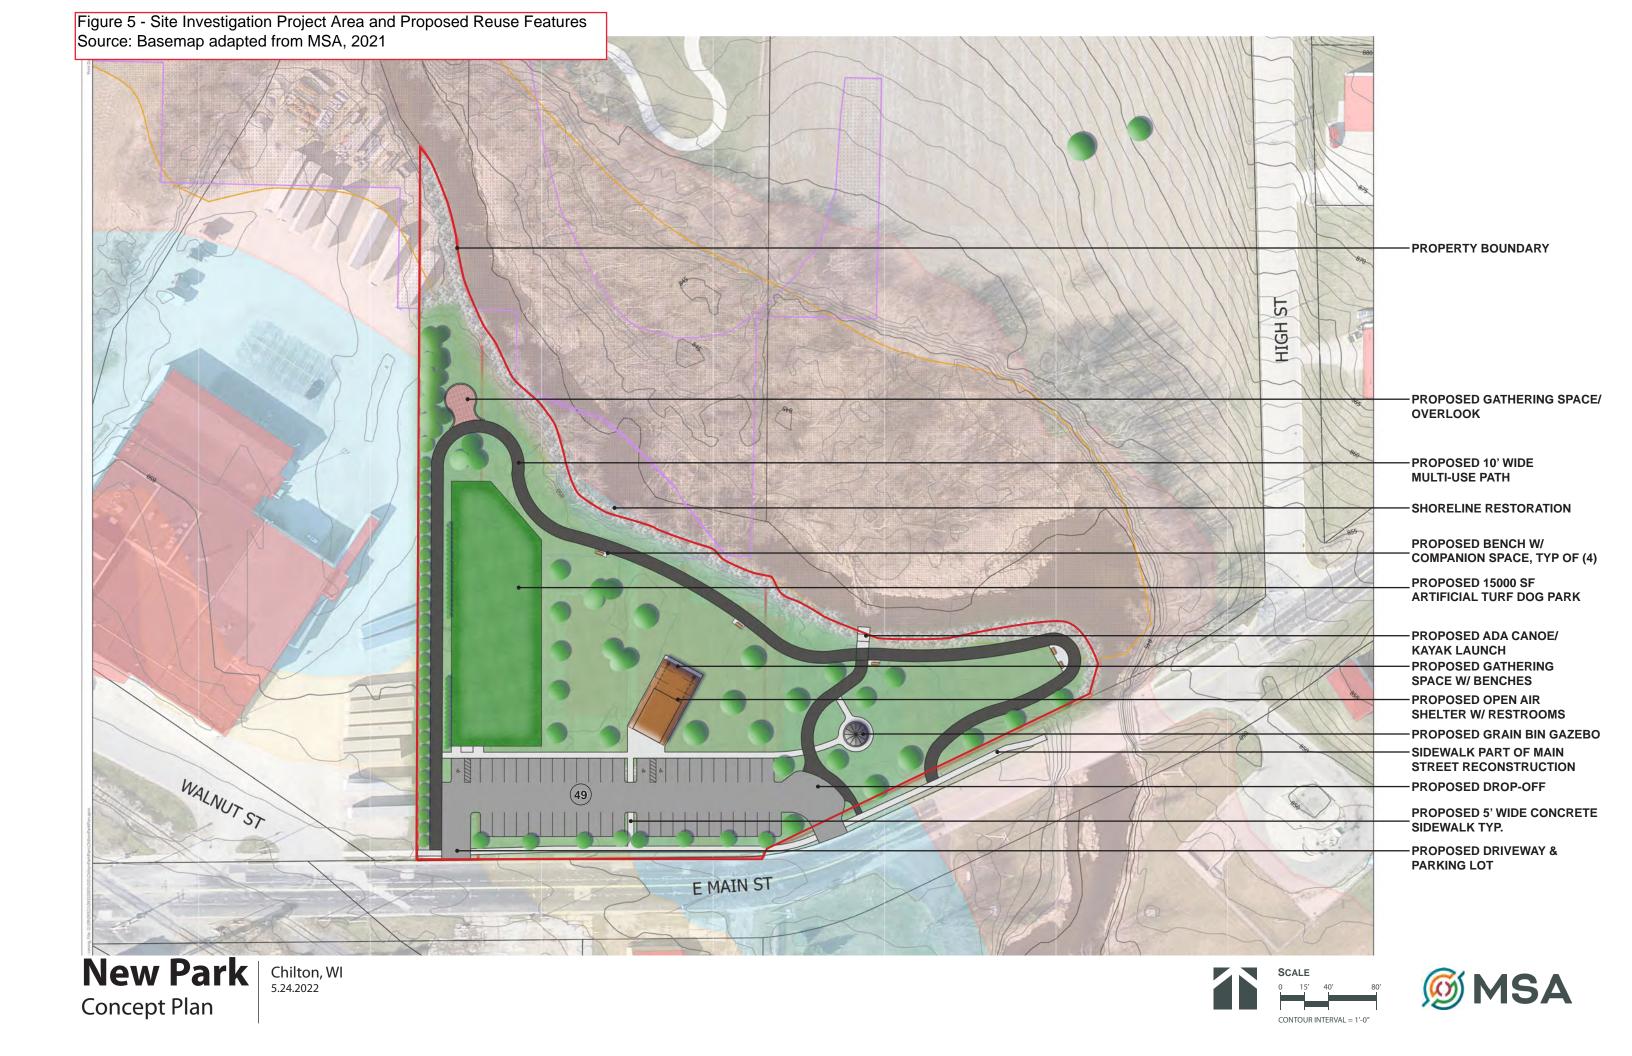
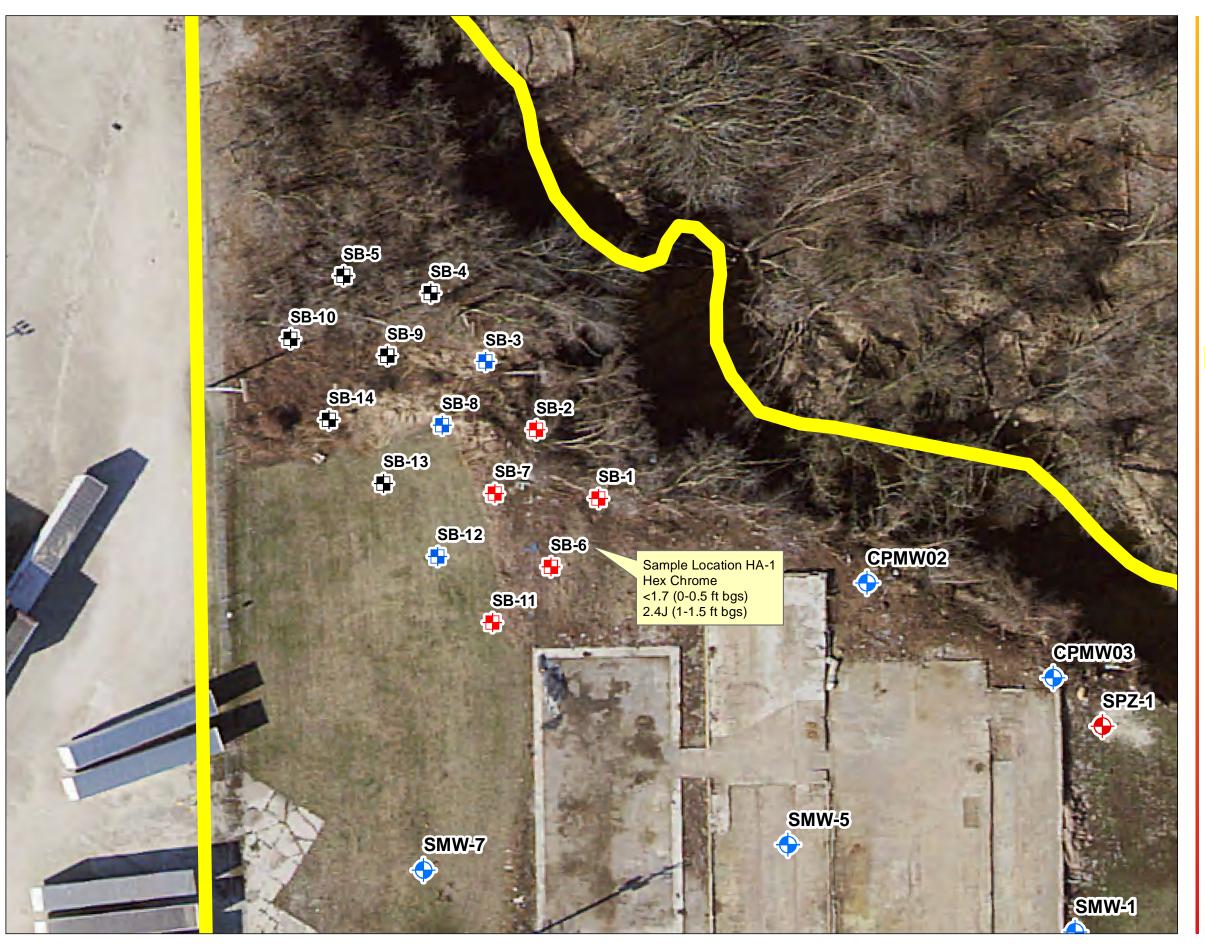
Site Investigation Project Area and Proposed Soil Borings

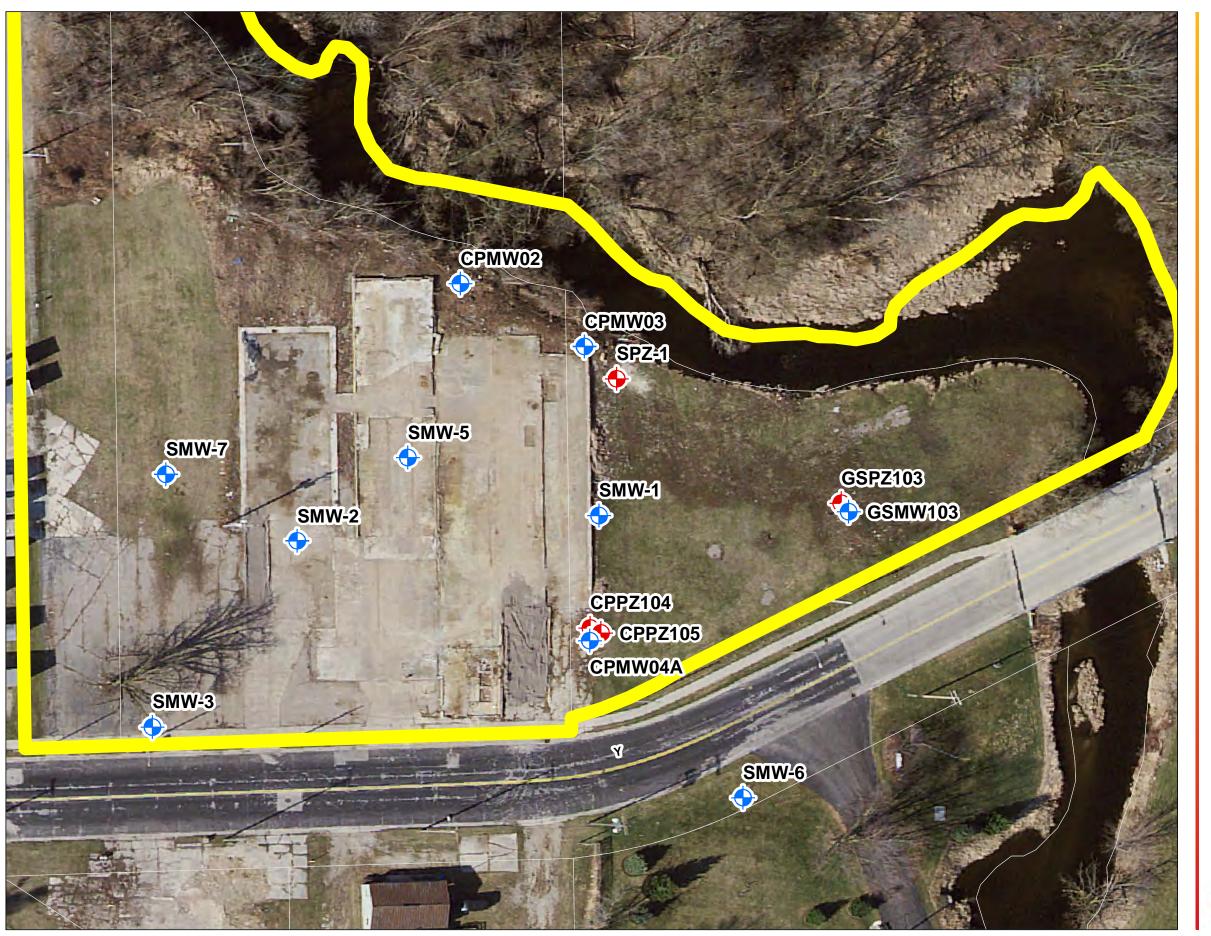
Site Investigation Project Area and Monitoring Wells

As illustrated on **Figure 7**, the groundwater assessment will include the sampling of all 14 existing monitoring wells and piezometers for multiple hazardous substances and emerging contaminants summarized on **Table 2**.
