**SUBJECT:** Final Case Closure  
Ambrosius Property, 1620 Grant Street, Village of Ashwaubenon, Wisconsin  
DNR BRRTS Activity # 02-05-551631

**B.1.b. Detailed Site Map**

**Ambrosius Property – 1620 Grant Street – Ashwaubenon, Wisconsin  
WDNR BRRS# 02-05-551631**

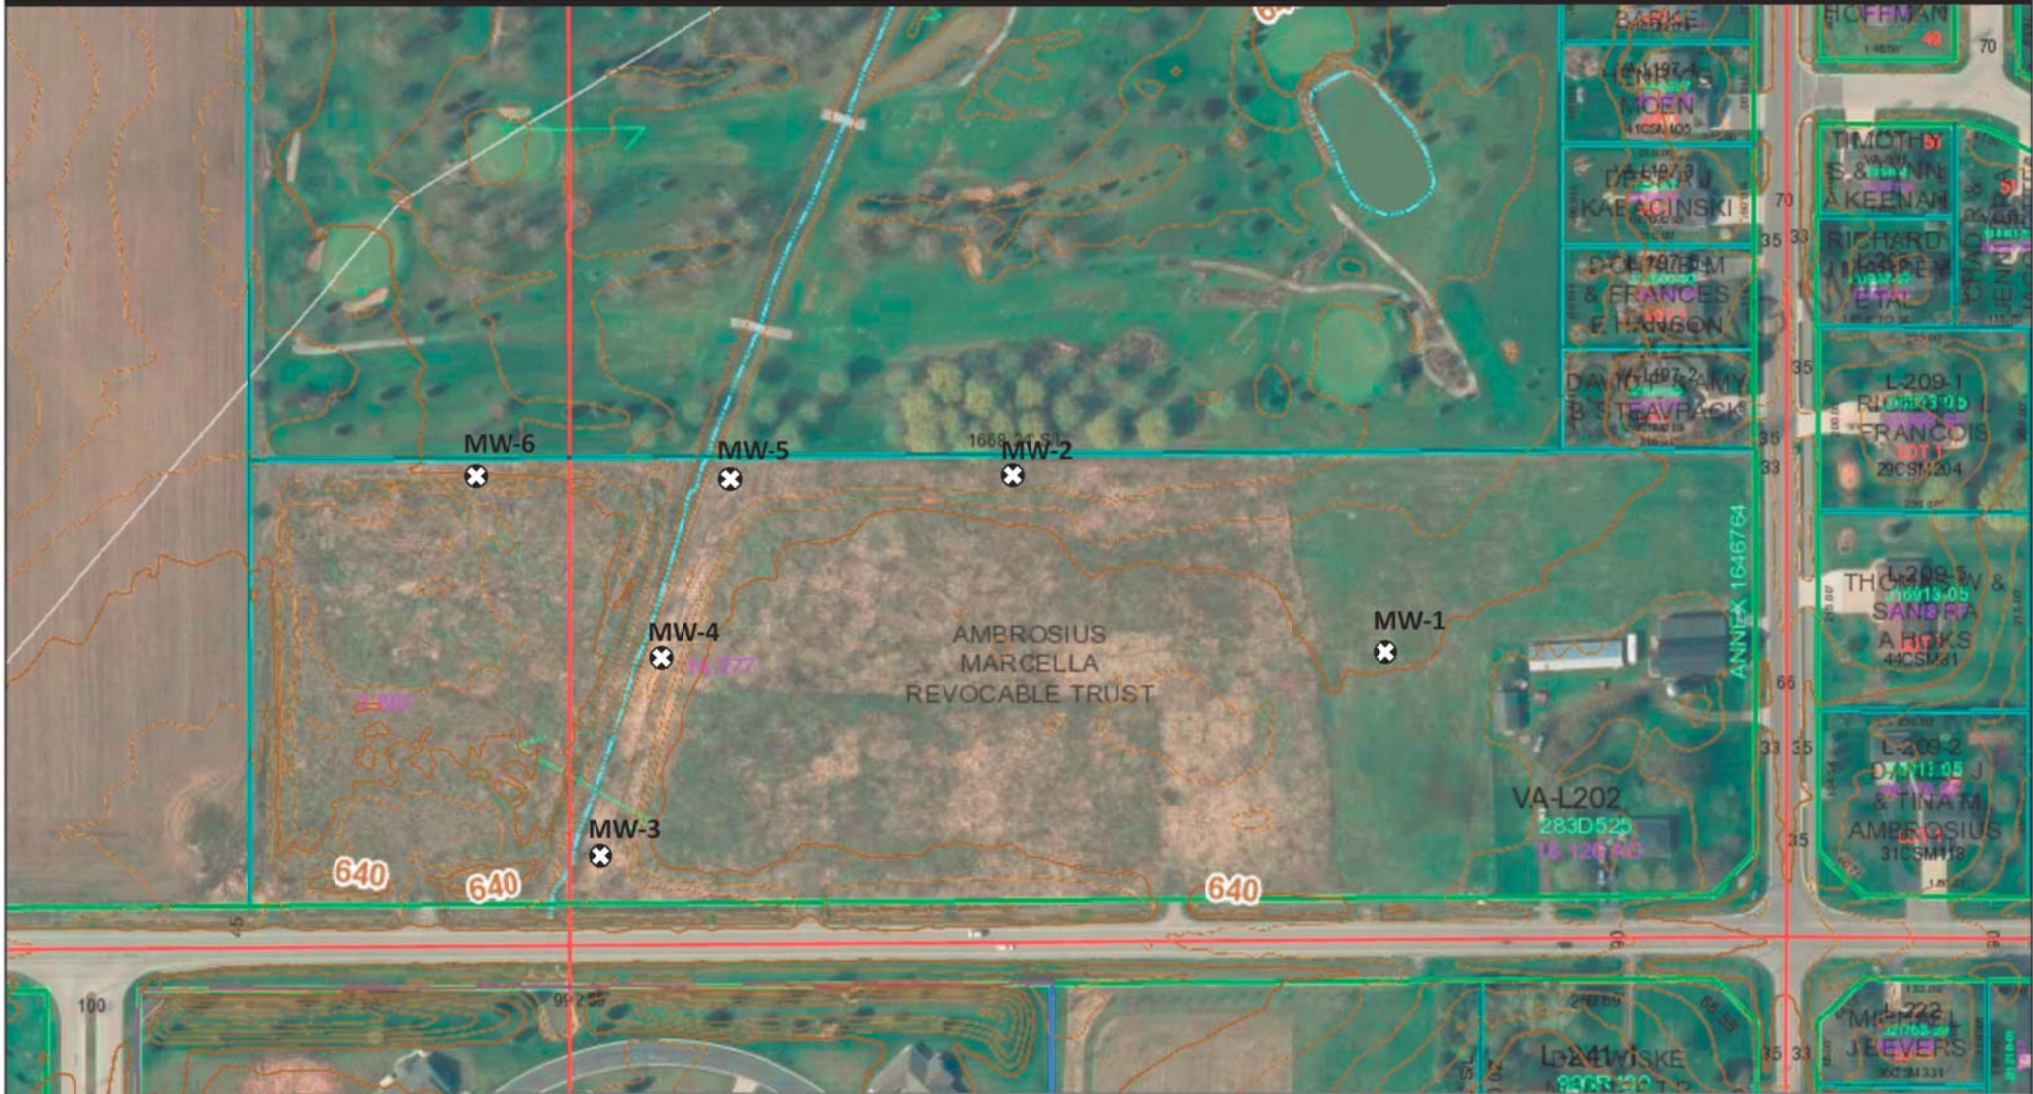
⊗ = Monitoring Well Location

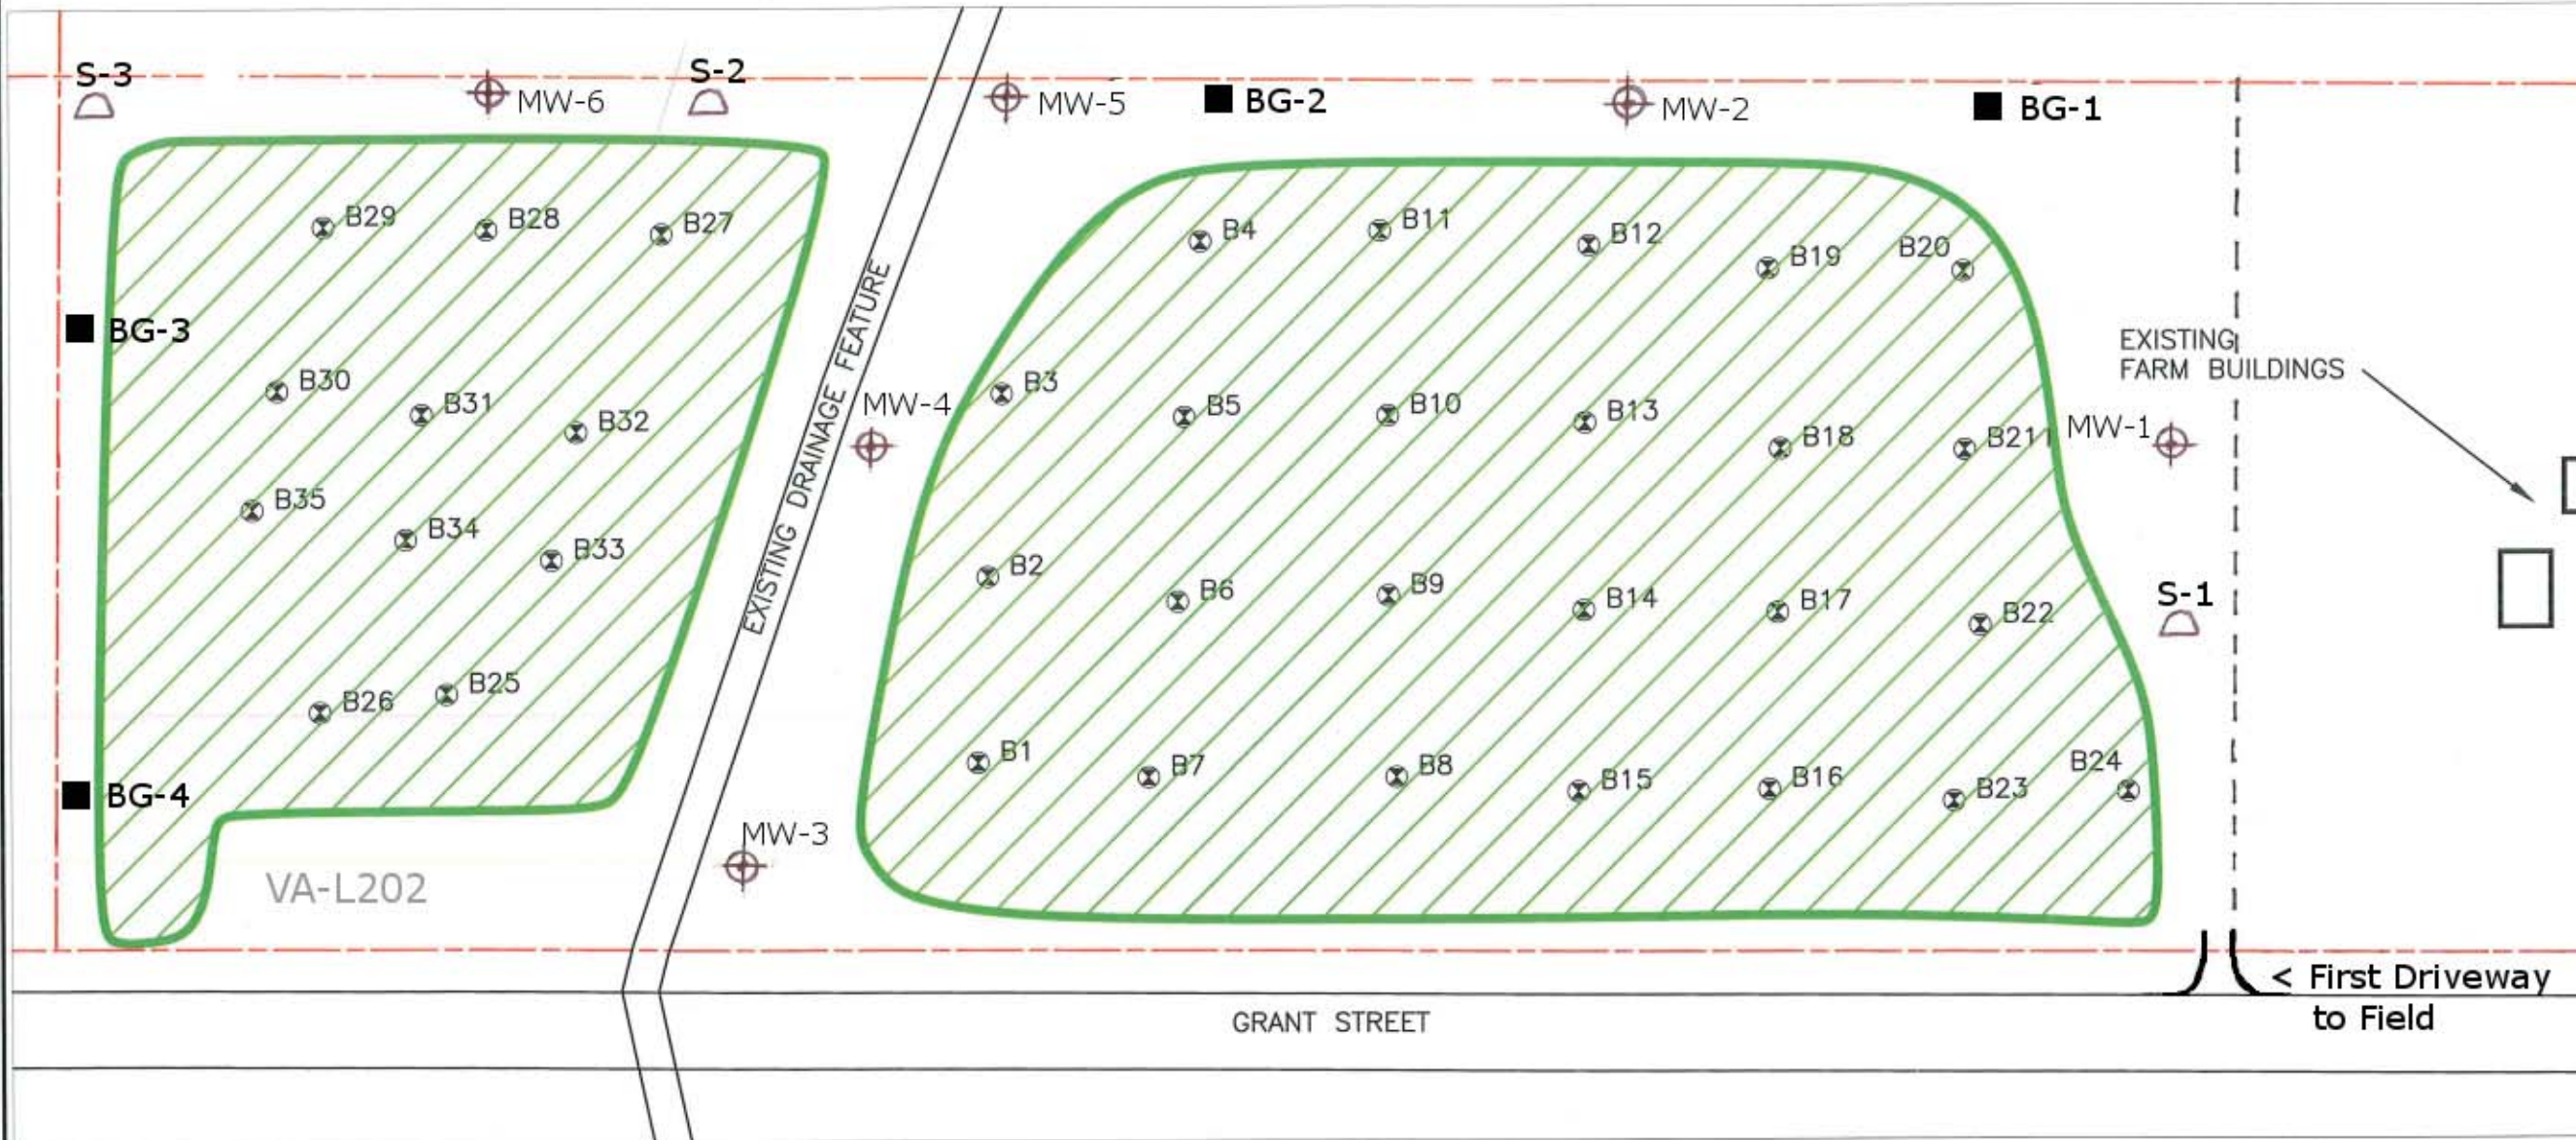
**\*ALL MONITORING WELLS WILL BE ABANDONED UPON CONDITIONAL CLOSURE\***
