Final Case Closure

Ashwaubenon Boardwalk, 2491 South Broadway (aka 465 and 480 Pilgrim Way),

DNR BRRTS Activity #: 02-05-551641

### Case Closure - GIS Registry Form 4400-202 (R 3/15) Page 1 of 14

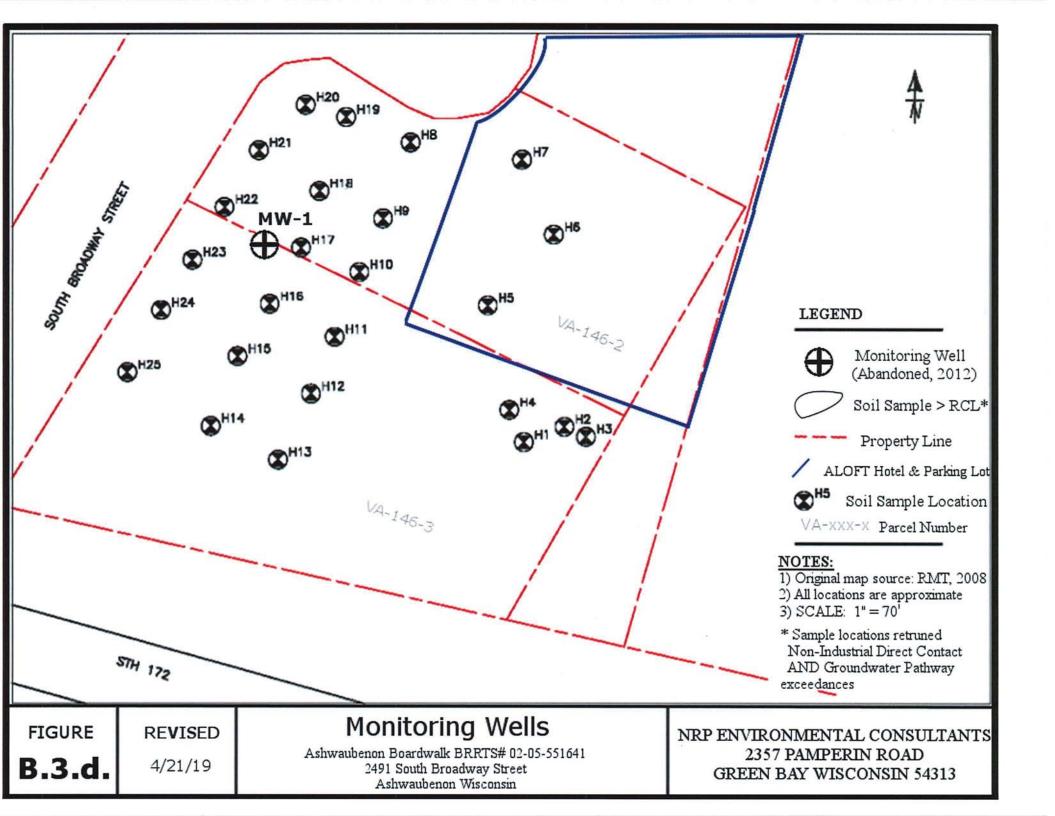
Attachment: Figure B.3.d; Monitoring Wells; April 21, 2019

The site is identified by the historic parcel boundaries of parcels VA-146-2 and VA-146-3 as identified on the attached map (Figure B.3.d; Monitoring Wells; April 21, 2019). Subsequent to the completion of the site investigation, the above parcels were merged into a larger parcel identified via parcels VA-1373, VA-1374 and VA-1374-1. This closure only covers the known contamination contained within the historic parcels VA-146-2 and VA-146-3.

Historically, the site appears to have been agricultural and residential land use prior to being utilized for commercial and/or manufacturing purposes from 1992-2000. Any site buildings were razed circa 2004. There are no other known historical uses of the site. Contamination was discovered in 2008 and believed to have been caused by contaminated fill material removed from a contaminated industrial property known as GDC American Blvd (BRRTS # 02-05-551627) in West De Pere and deposited on the Ashwaubenon Boardwalk property in 2006 as general fill material in an effort to raise the grade and potentially facilitate site redevelopment. General fill material was brought in from other unknown properties as well. The main soil contaminants were Polycyclic Aromatic Hydrocarbons (PAHs). Soil sampling over time exhibited declining PAH concentrations to generally below the applicable soil standards. The attached map (Figure B.3.d; Monitoring Wells; April 21, 2019) shows the site parcel boundaries and soil and groundwater sampling locations.

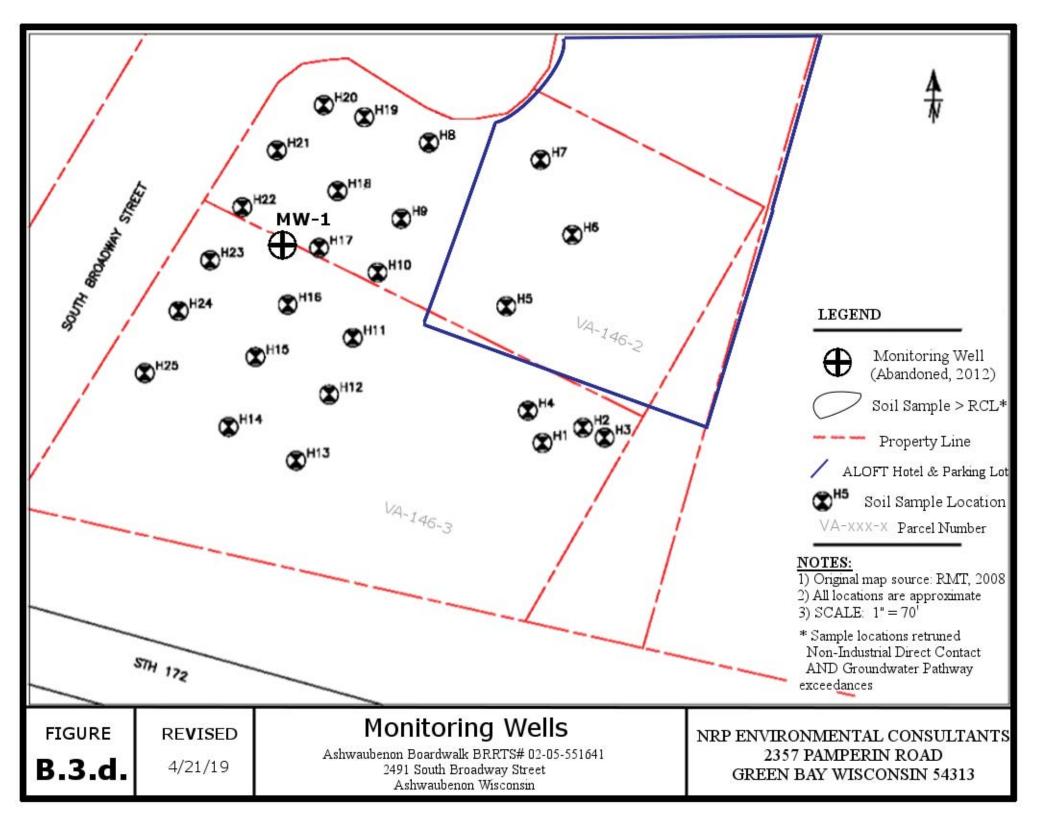
No Data. Only one groundwater monitoring well was installed at the site.

Groundwater would flow toward the Fox River.

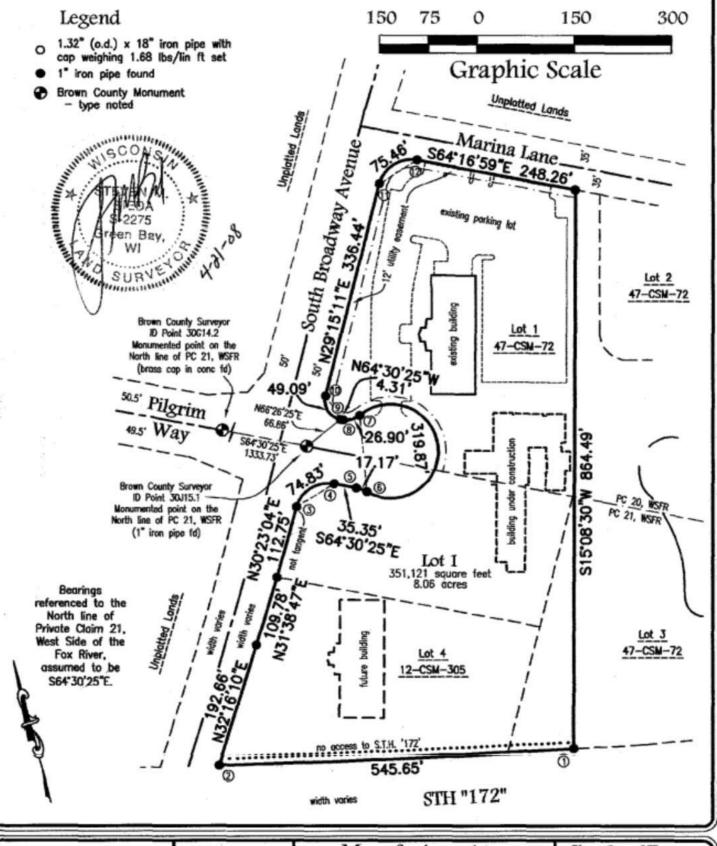
Certified Survey Map

A combination and depiction of the land boundaries recorded as Lot 1, Volume 47, Certified Survey Maps, page 72, Map Number 6970, Document Number 2087153, Brown County Records and Document Number 2196328, Brown County Records except Lot 2, Volume 12, Certified Survey Maps, page 305, Map Number 2619, Document Number 1012385, Brown County Records, being all of Lot 1, Volume 47, Certified Survey Maps, page 72, Map Number 6970, Brown County Records, said Lot being in part of Private Claim 20, West Side of the Fox River; all of Lot 4, Volume 12, Certified Survey Maps, page 305, Map Number 2619, Brown County Records, said Lot being in part of Private Claim 21, West Side of the Fox River; and also part of said Private Claim 21, all being in the Village of Ashwaubenon, Brown County, Wisconsin into a single parcel and description, more fully described on sheet 2:

Scale: 1"=150'
