Soil Vapor Extraction Shut Down & Monitoring Well Network Modification Work Plan

BRRTS #02-13-578015 & #02-13-558625

August 2018

*Prepared For
Madison Kipp Corporation
Madison, Wisconsin*

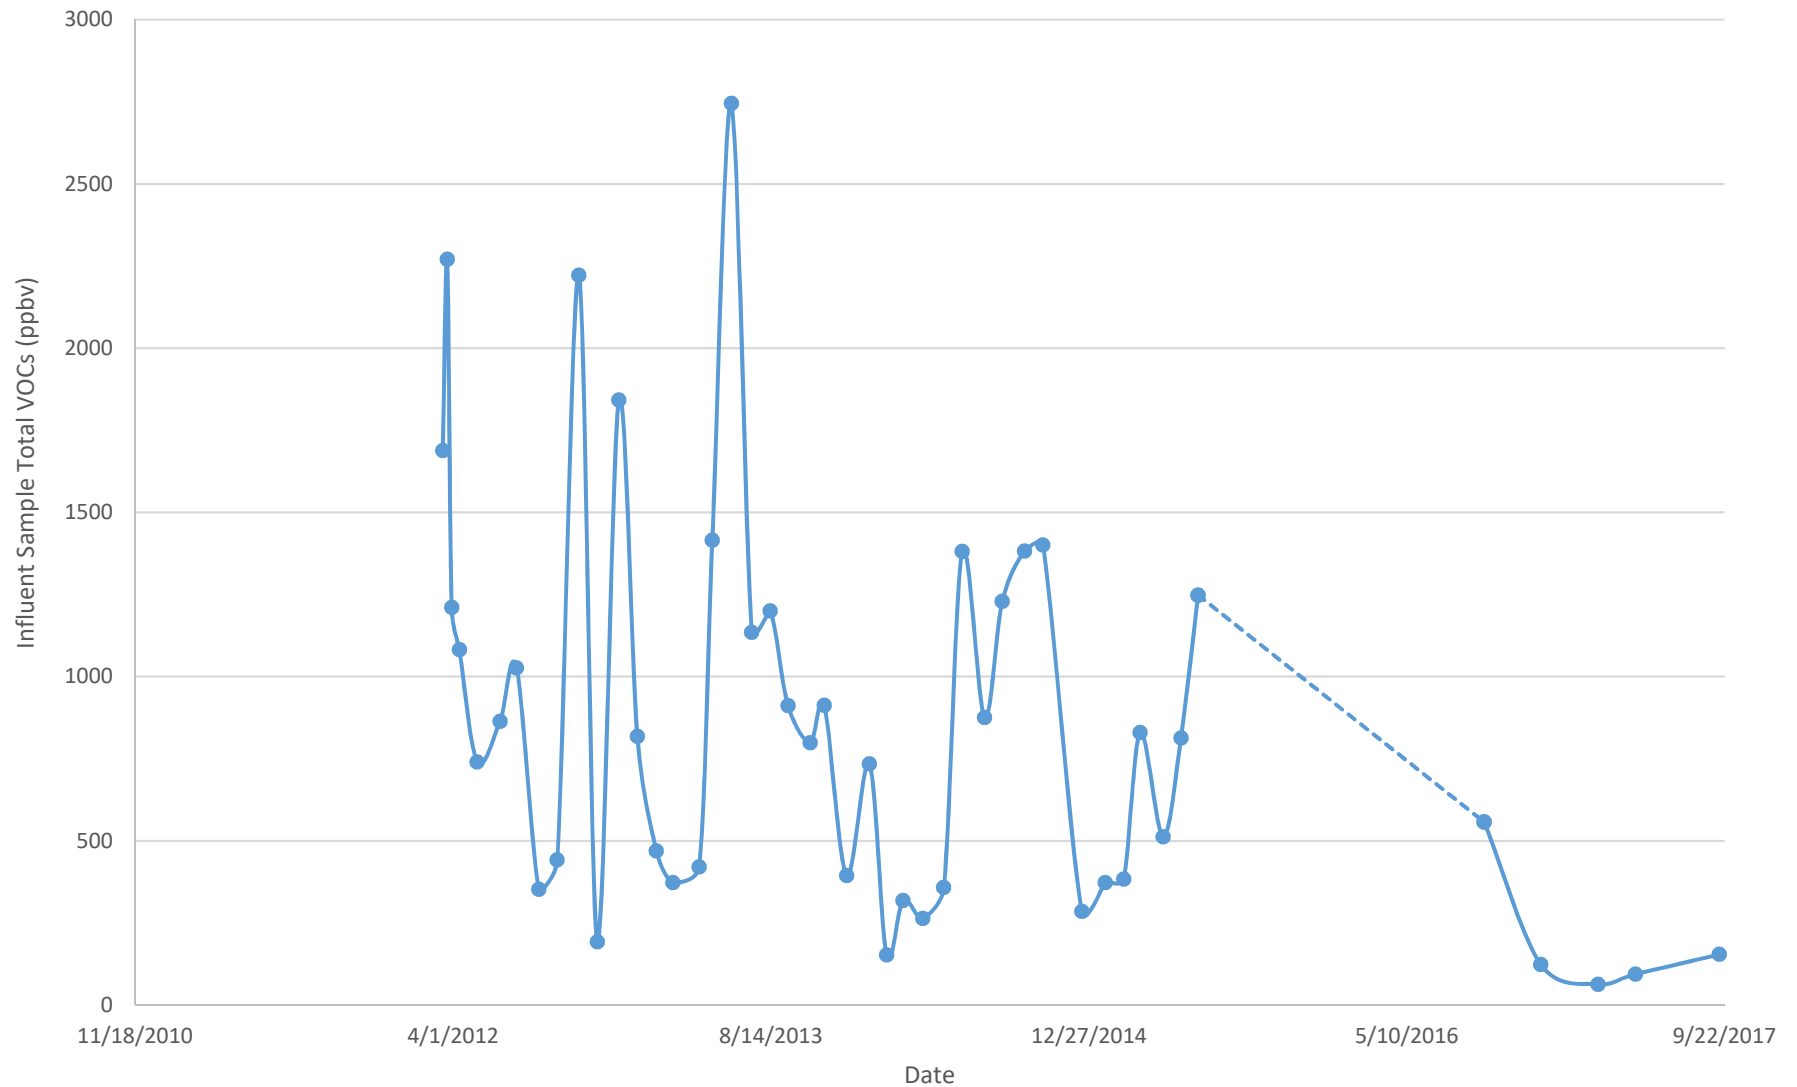
SVE System Influent Total VOC Results

From 2012 through 2014, there were occasional times when the influent had low total VOC concentrations, but these were always followed by increases in total VOC concentrations. Since data collection began again in 2016, influent concentrations have remained at historic lows.

Starting in September 2016, calculated VOC mass removal rates have ranged between 0.0002 to 0.002 pounds per hour, which is significantly lower than the anticipated removal rate 0.37 pounds per hour (estimated based on the pilot test operations) (Arcadis, 2012). Removal rates are calculated using average SVE system flow rates and total VOC concentrations.

1. Total VOC concentrations were calculated based on analytes reported above and below the method reporting limit. For detected analytes, the reported concentrations were used. For all other analytes detected below the method reporting limit, half of the reporting limit was used.
