ADDENDUM OF  
FEBRUARY 2021 PHASE I ENVIRONMENTAL SITE ASSESSMENT  
DAIRYLAND POWER COOPERATIVE  
ROCKGEN ENERGY CENTER

Final  
March 26, 2021  
Project No. 13014.014

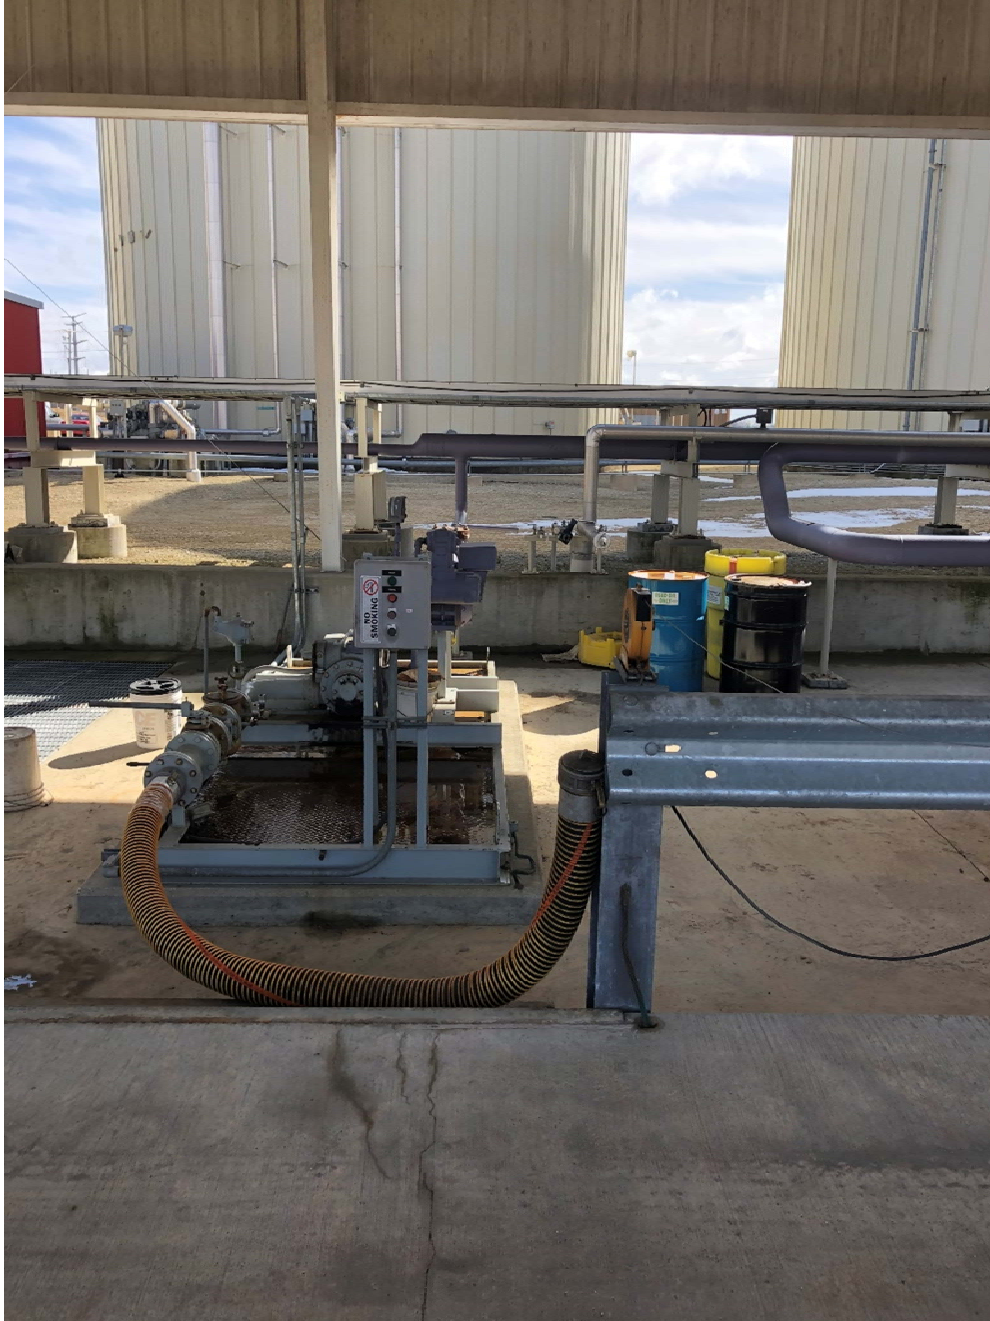
Photo 1

Photo facing east of machinery with oil spill within secondary containment on concrete pad and concrete foundation under canopy area.

- Several pieces of equipment throughout the RockGen Energy Center facility contained small oil spills within secondary containment and/or internally. Due to the lack of visual evidence of a release to the environment in the surrounding areas of these secondary containment structures and the corrective action plans prescribed in the RockGen SPCC Plan regarding such spills, S&L considers these spills to be *de minimus* conditions. Example photographs of these spills are provided in Appendix B.

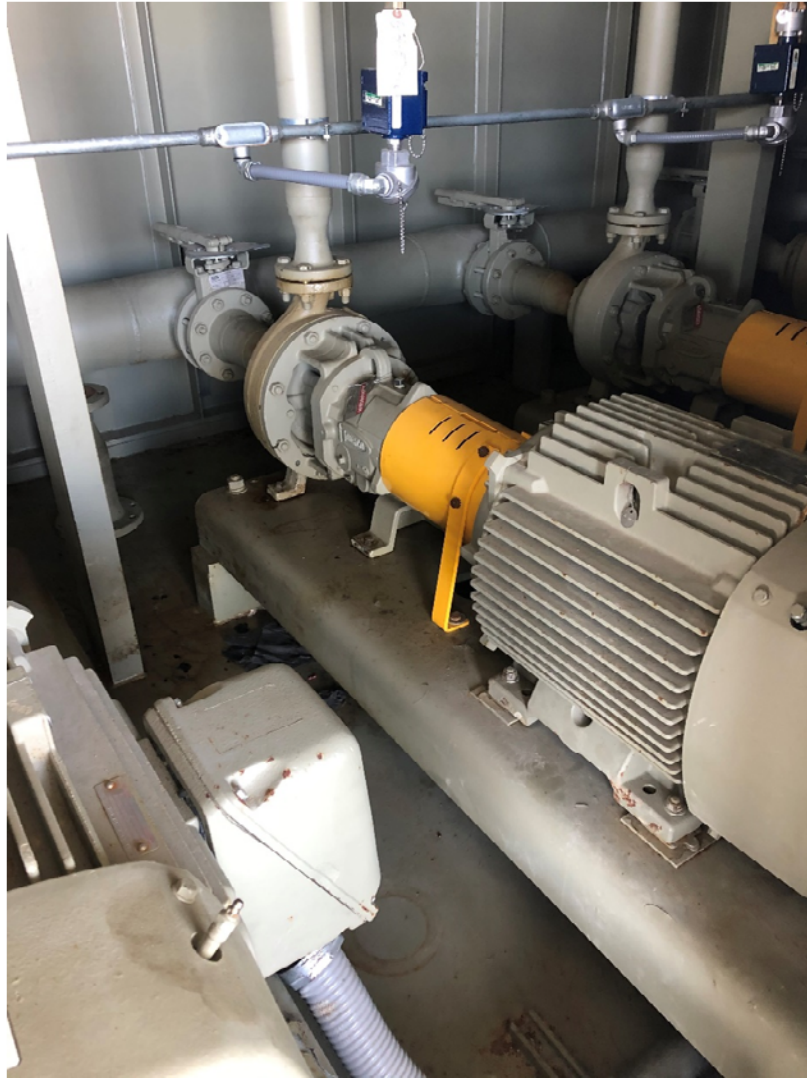
Photo 2

Photo facing east of machinery with oil spill within enclosed in a structure on concrete foundation under canopy area.

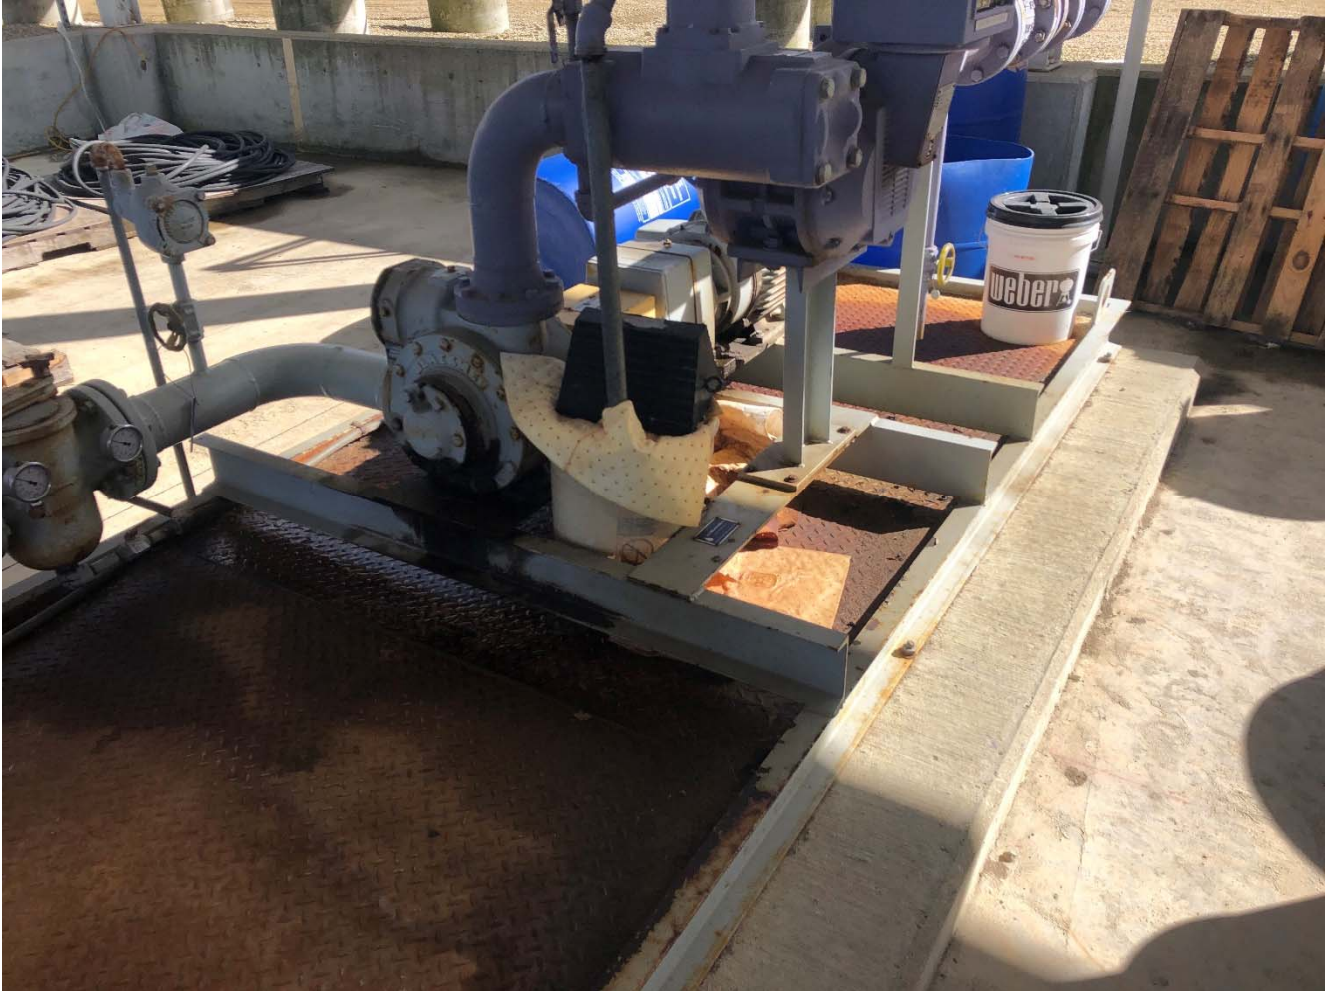
Photo 3

Photo facing east of machinery with oil and other substance spill within secondary containment on concrete pad and concrete foundation under canopy area.

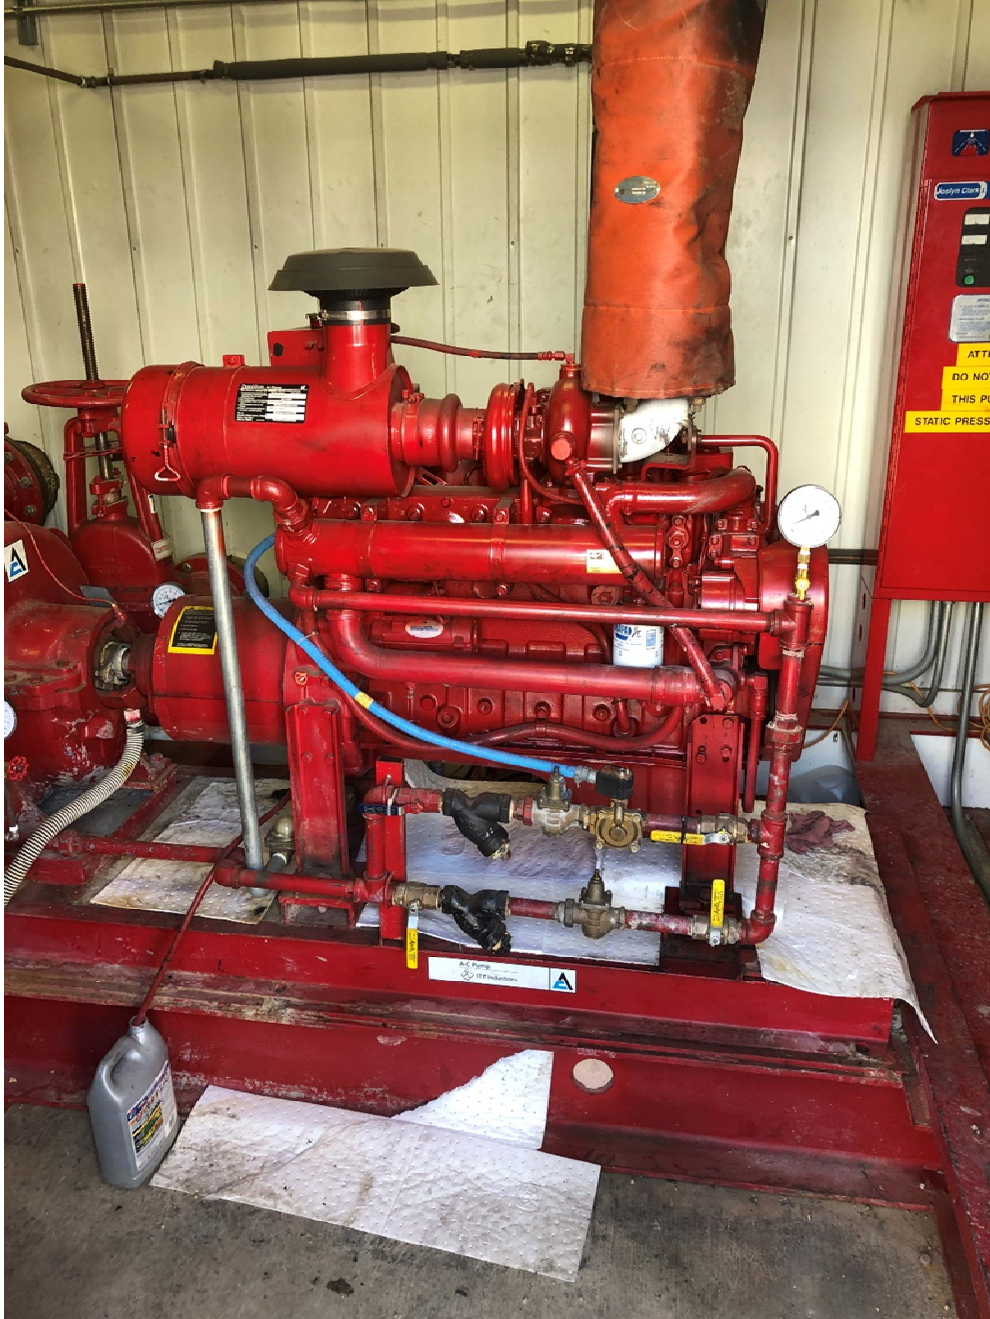
Photo 4

Photo facing east of machinery with oil spill in secondary containment on concrete foundation in the main fire pump house located west of the ASTs

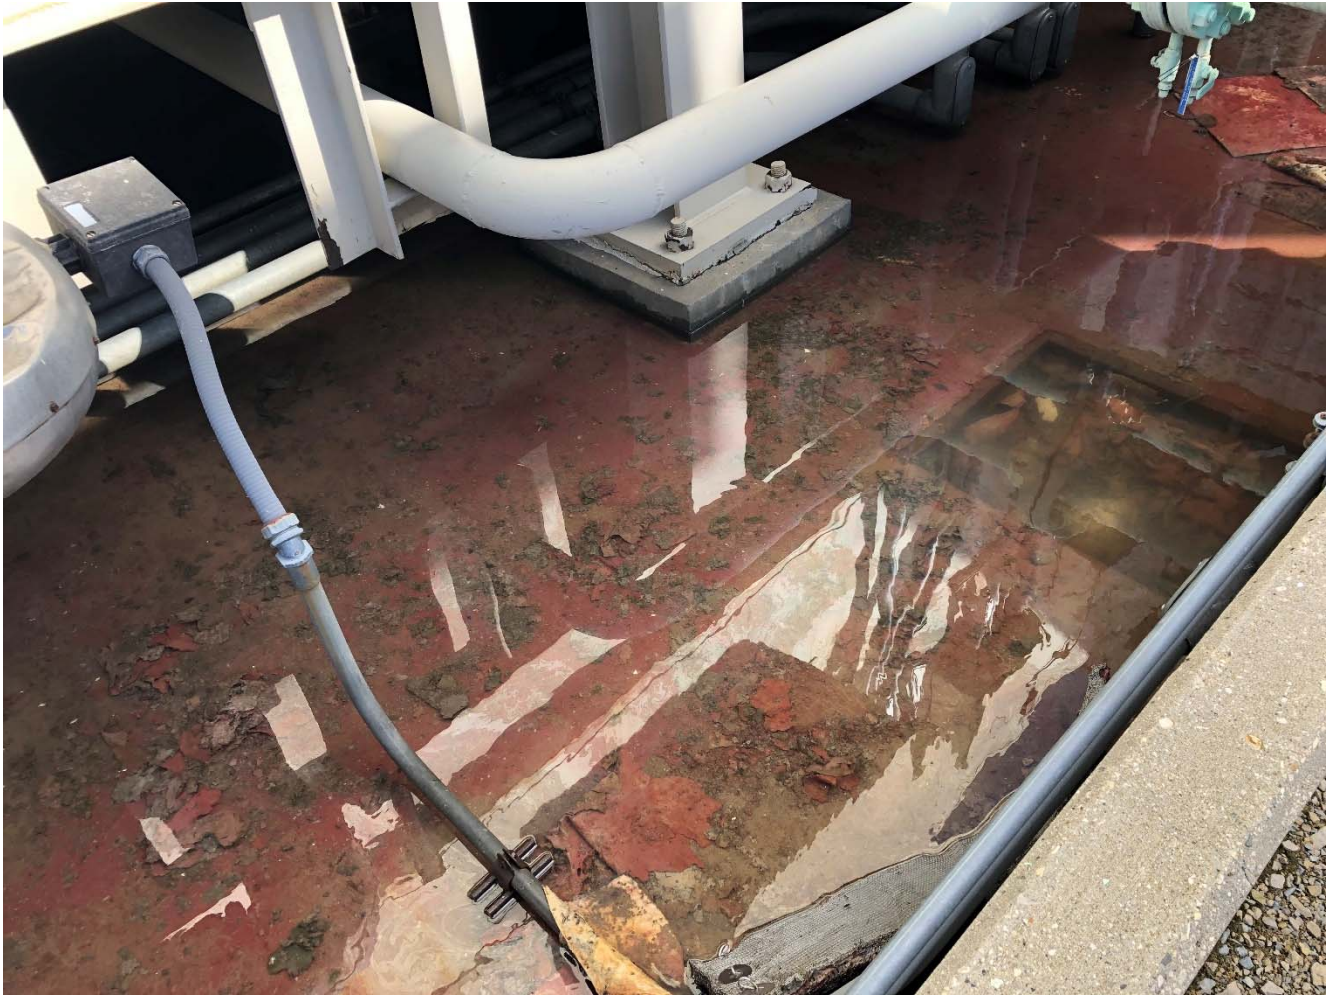
Photo 5

Photo facing east of oil sheen on stormwater collected in secondary containment of in the CT Unit 3 Accessory Module.

- An oil spill was identified based on visual observation of a sheen on stormwater collected in the Combustion Turbine (CT) Unit 3 Accessory Module secondary containment. Mr. Robert Smith, who has been associated with the Site for five years as an Operator Technician III for RockGen Energy Center, indicated that the release would be collected via absorbent pads and/or sucked out by a vacuum truck for proper disposal off-site. S&L considers the identification of oil sheen within secondary containment as a *de minimus* condition due to the release collection plan described by Mr. Smith, lack of visual evidence of a release to the environment in the surrounding area, and the corrective action plans prescribed in the RockGen SPCC Plan regarding such a release.

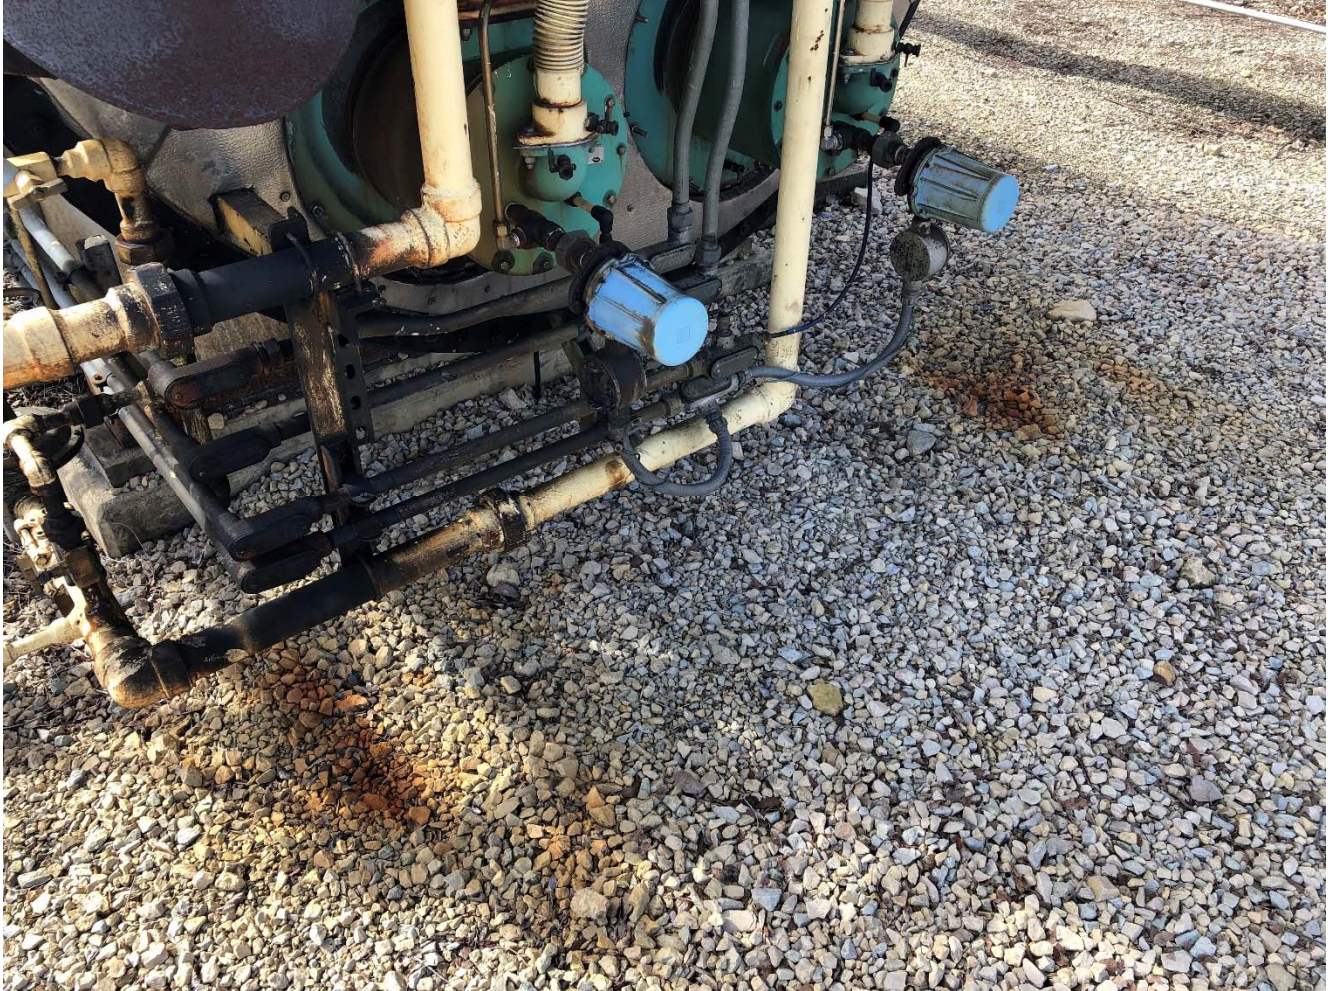
Photo 6

- S&L identified black- and copper-colored residue on the graveled area under the fuel gas intake and conditioning area equipment. Mr. Smith identified the residue as “carbon and rust residue,” which is not considered a release to the environment; however, the residue obstructs the view of the ground if a release were to occur and therefore is considered a *de minimus* condition.

Photo facing west of the "carbon and rust residue" on gravel under the fuel gas intake and conditioning equipment.

No stained soils or pavement areas indicative of a release or spill were identified; however, S&L identified black- and copper-colored residue on the graveled area under the fuel gas intake and conditioning area equipment. Mr. Smith identified the residue as “carbon and rust residue”. This residue is discussed further in Section 7.

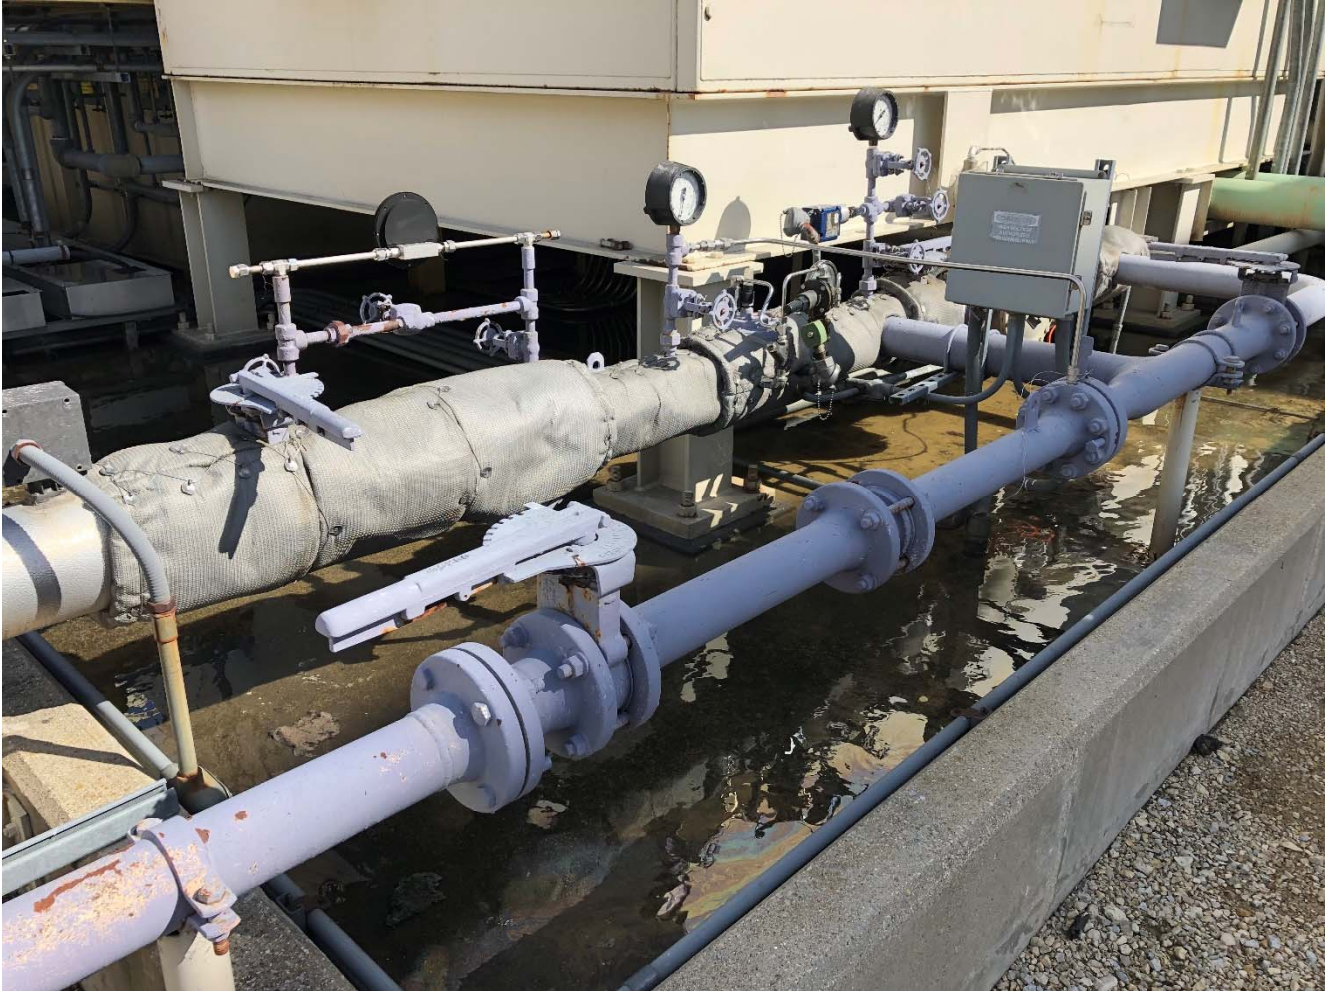
Photo 7

Photo facing east of oil sheen on stormwater collected in secondary containment of in the CT Unit 1 Accessory Module.

Since the February 2021 Phase I ESA, no changes in hazardous substance and petroleum product use and storage were identified during the March 2021 site visit; however, several pieces of equipment throughout the RockGen Energy Center facility contained small oil spills within secondary containment and/or on interior concrete. In addition, an oil spill was observed as a sheen on stormwater collected in the secondary containment of the Combustion Turbine (CT) Units 3 and 1 Accessory Modules. An oil spill was also observed as a sheen on

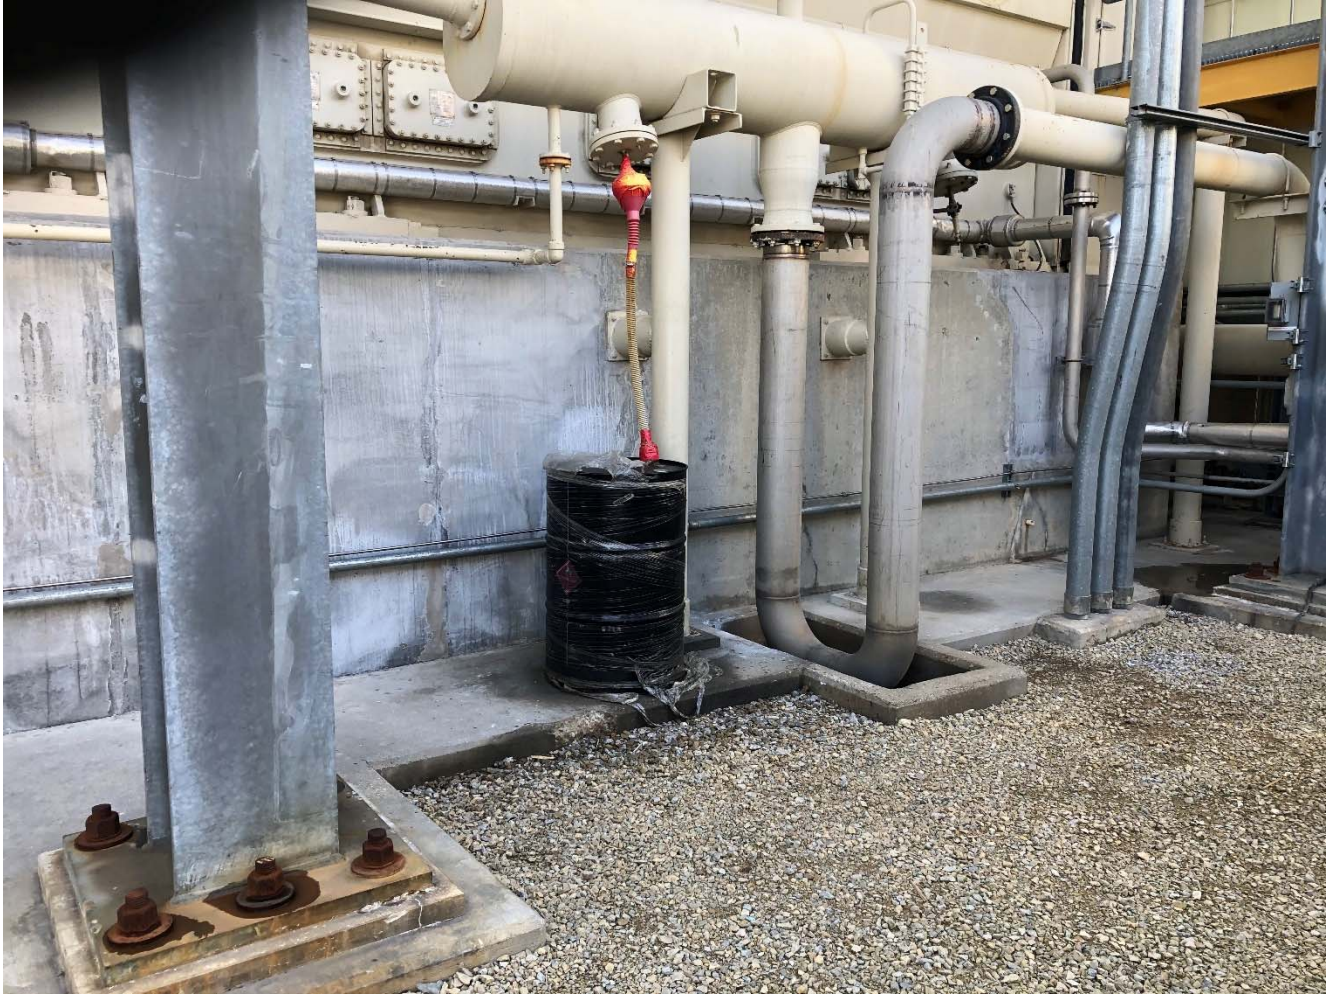
Photo 8

- On the northwestern side of CT Unit 1, S&L visually observed a 55-gallon drum located on concrete and connected to CT Unit 1 equipment via plastic tubing and tape. Mr. Smith explained that the 55-gallon drum was collecting lube oil from a leak in the CT Unit equipment and that the use of the drum for this purpose was only temporary until the leak was addressed. S&L considers the use of the 55-gallon drum as a collection container for the lube oil leak without secondary containment a *de minimus* condition due to the lack of visual evidence of a release to the environment in the surrounding area. S&L recommends a secondary containment skid around the 55-gallon drum until a permanent solution to the leak can be developed and implemented. A permanent solution to the leak should be developed and implemented as soon as possible to prevent a potential release to the environment.

Photo facing east of a 55-gal drum located on concrete and connected to CT Unit 1 equipment via plastic tubing and tape.

- On the northwestern side of CT Unit 1, S&L identified a 55-gallon drum located on concrete and connected to CT Unit 1 equipment via plastic tubing and tape. Mr. Smith explained that the 55-gallon drum was collecting a lube oil from a leak in the CT Unit equipment and that the use of the drum for this purpose was only temporary until the leak was addressed. This 55-gallon drum is discussed further in Section 7.

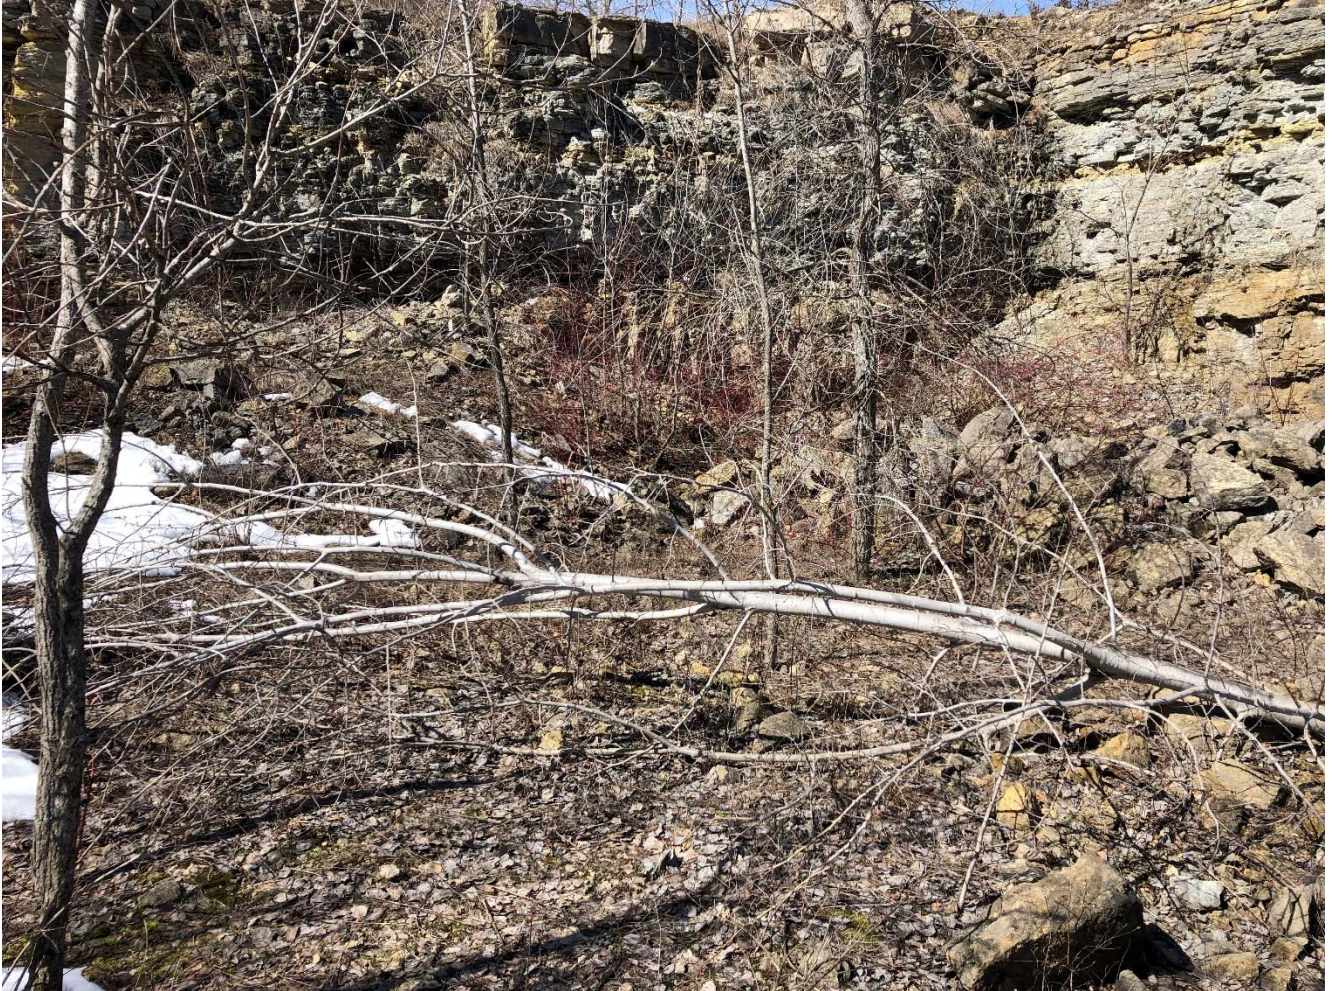
Photo 9

Example photo facing south of minimal snow cover and rubble in abandoned quarry.

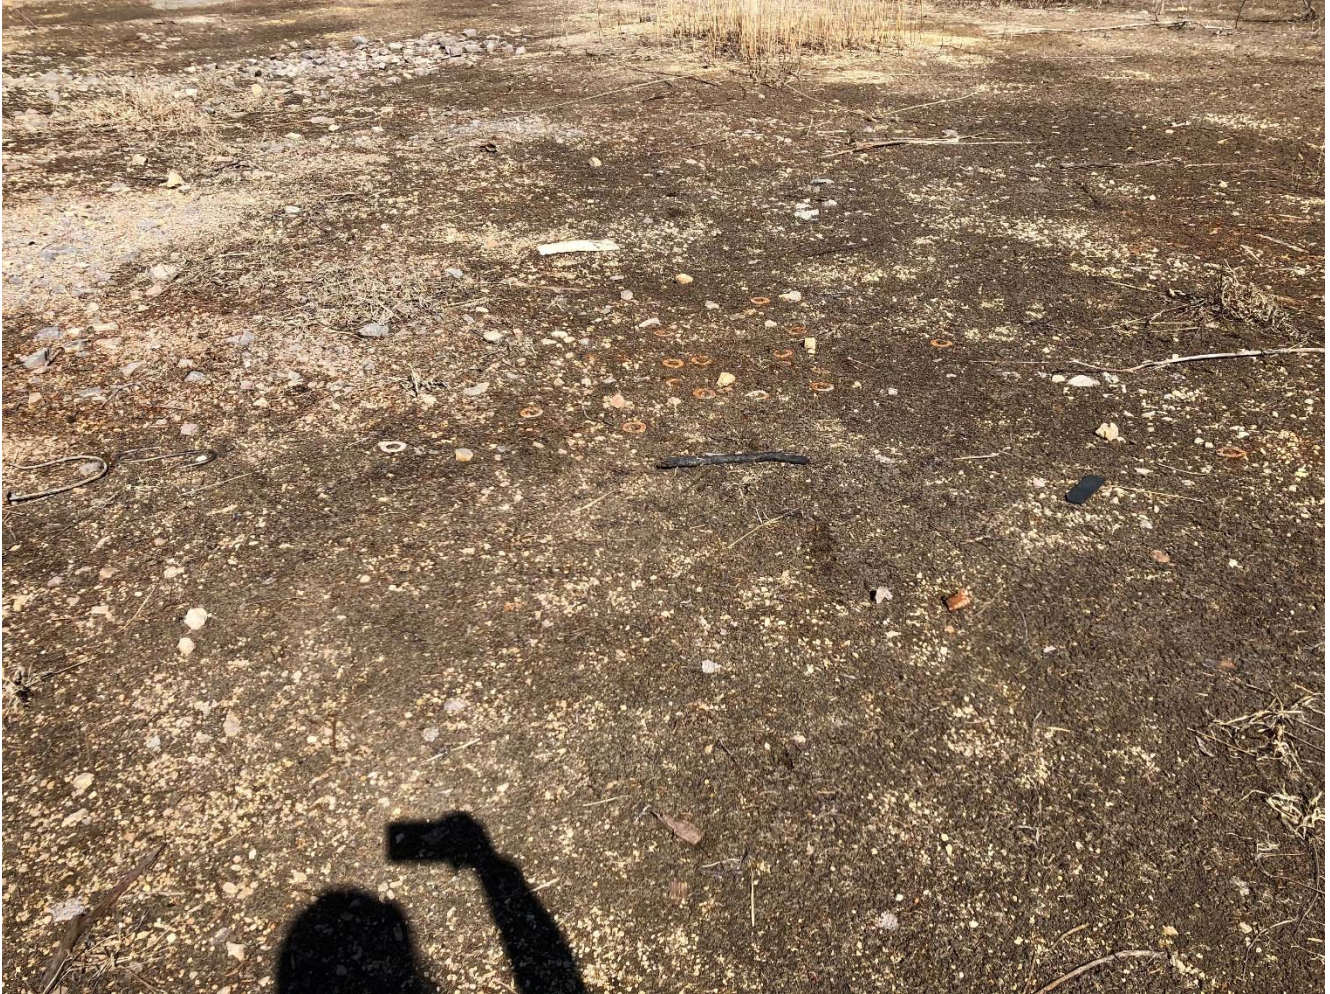
Photo 10  
Example photo of debris in abandoned quarry.

- Two prior Phase I ESA Reports (detailed in Section 4.4 of the February 2021 Phase I ESA) observed evidence of buried building materials (reportedly from the Koshkonong Creek Dam from Rockdale, Wisconsin) placed in the quarry under an agreement with Wisconsin DNR; however, no record of this agreement was provided with either report. Facility Personnel interviewed in preparation of the February 2021 Phase I ESA also asserted that Wisconsin DNR sanctioned the disposal of materials from the Wisconsin DNR Koshkonong Creek Dam project in the abandoned quarry. Facility Personnel stated that they would provide documentation regarding the agreement with Wisconsin DNR; however, this documentation has not yet been provided. A records request with Wisconsin DNR was also outstanding as of the time of finalization of the February 2021 Phase I ESA and has now been fulfilled without any documentation regarding sanctioned disposal of the building materials. The nature of materials observed in the vicinity of the abandoned quarry at the time of the March 2021 site reconnaissance appeared to be household items (e.g., bikes and building materials), while materials in the abandoned quarry appeared to be metal parts and rubble. A third prior Phase I ESA report (detailed in Section 4.4 in the February 2021 Phase I ESA) stated that 55-gallon drums and a fuel oil AST were associated with quarry operations. In addition, the original contents of an unmarked 55-gallon drum observed in the abandoned structure located adjacent (south) of the abandoned quarry are unknown (discussed above). During the March 2021 site visit, S&L identified an unidentifiable concrete block, remnant foundation, and discolored vegetation of unknown cause in this area. Overall, S&L considers the unconfirmed source and nature of the materials/debris stored/disposed-of in and around the quarry, the remanent foundation, and the cause of the discolored vegetation to represent a data gap with potential to impact the Site.

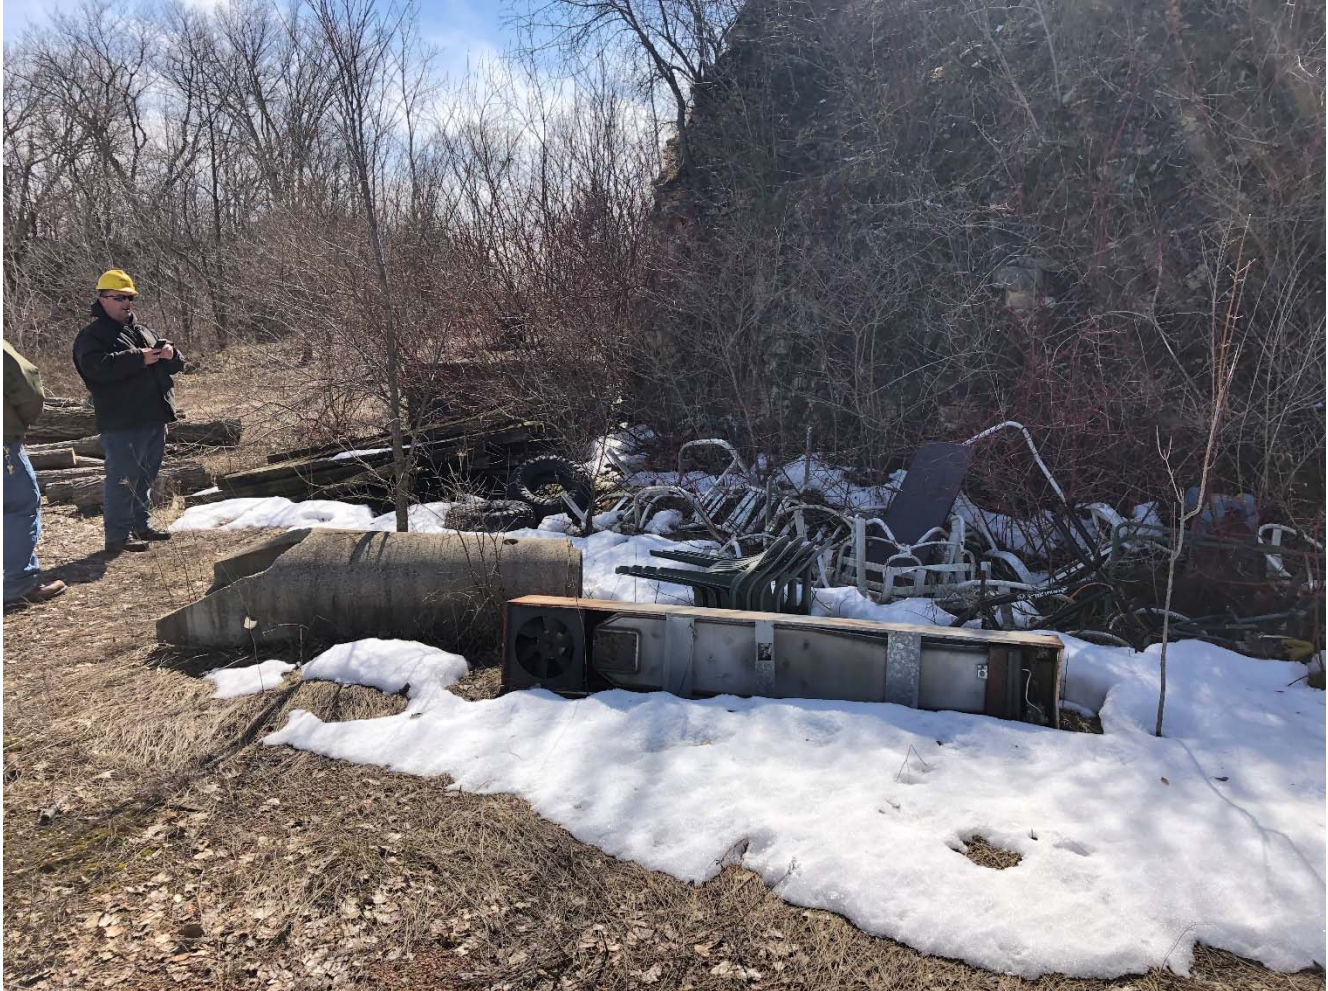
Photo 11

Photo facing south of the miscellaneous debris, including the unidentified concrete block in the background, near the abandoned quarry.

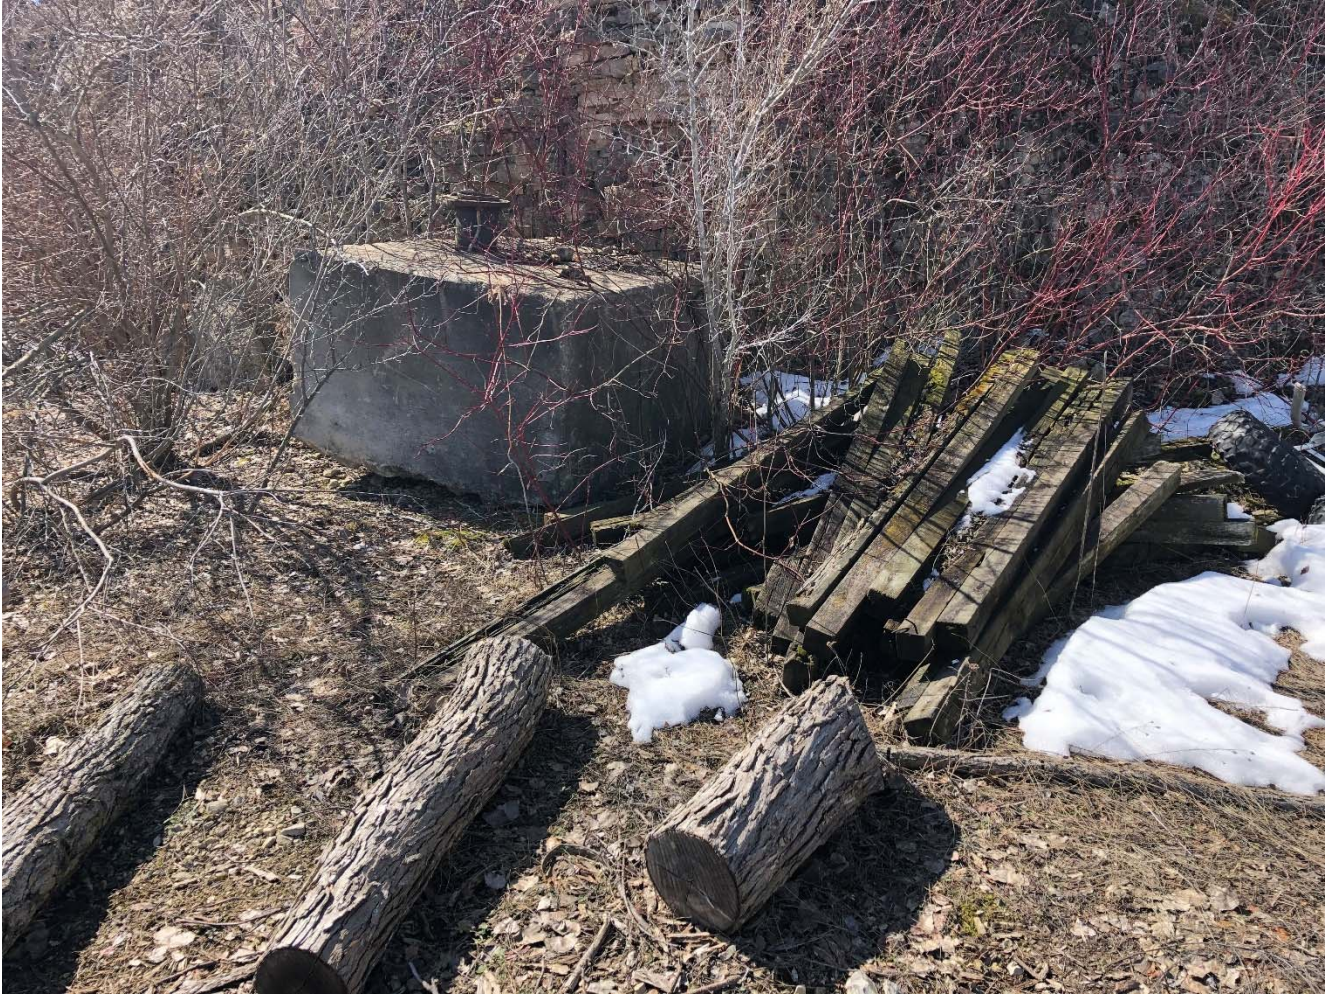
Photo 12

Photo facing southwest of the unidentified concrete block and miscellaneous debris near the abandoned quarry.

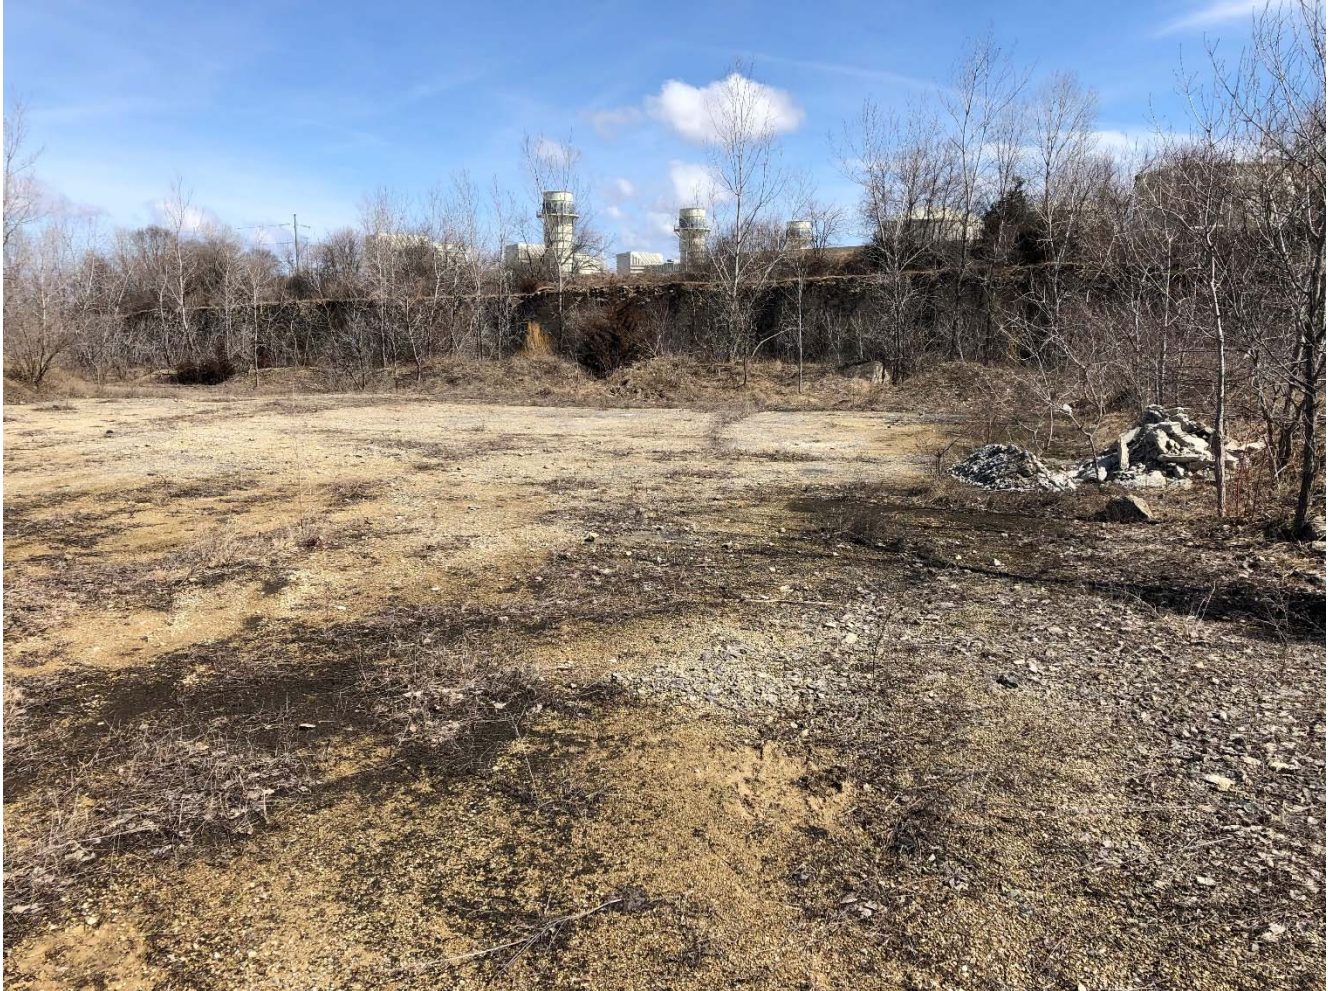
Photo 13

Photo facing east of cleared, remnant foundation in foreground near abandoned quarry.

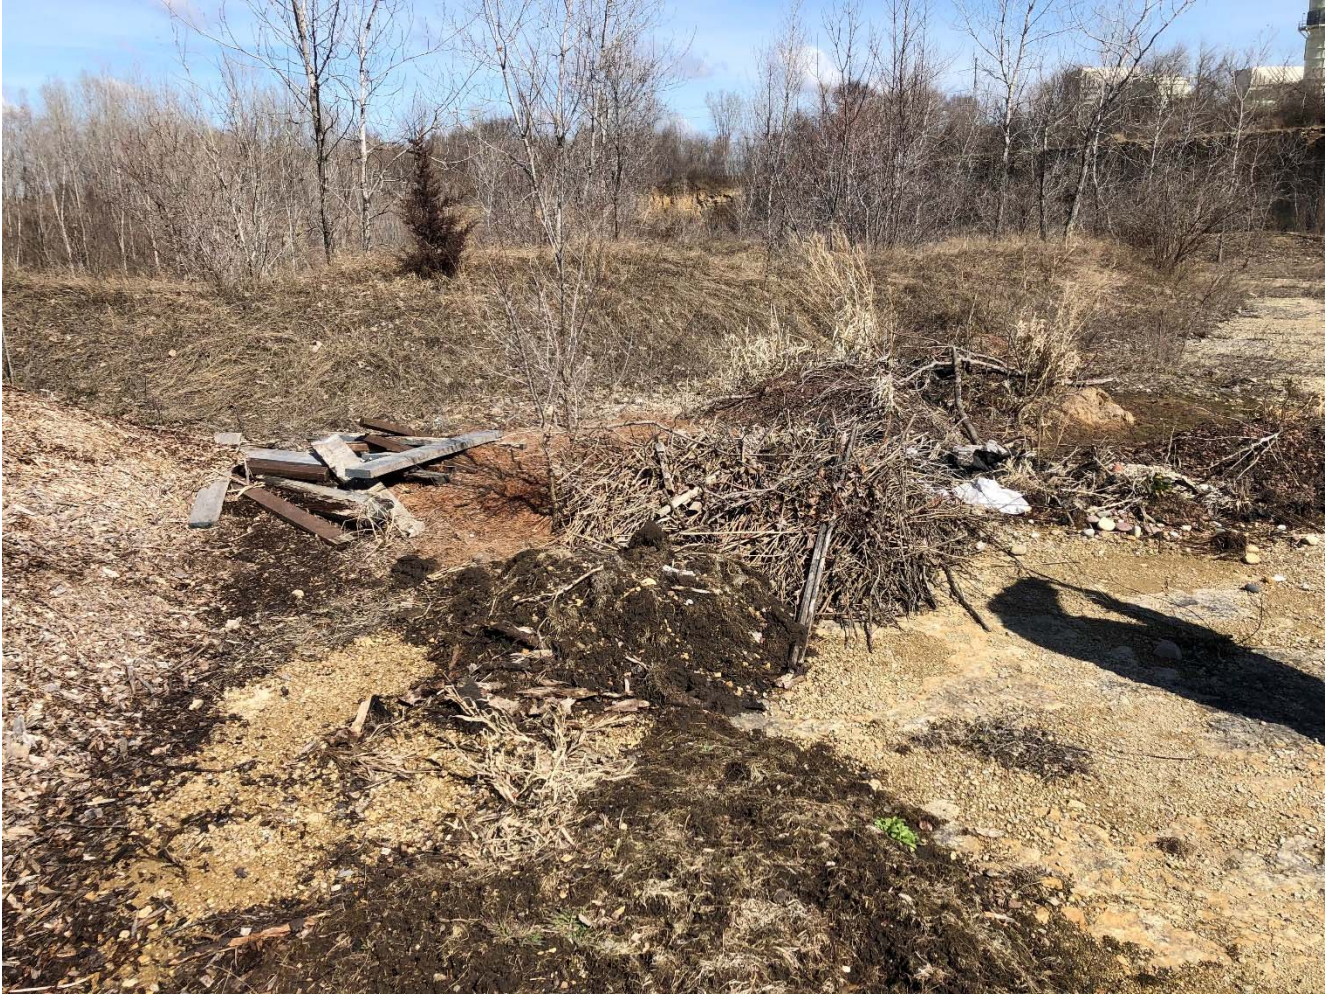
Photo 14

During the March 2021 site visit, S&L identified discolored, red/orange vegetation of unknown cause near an area southwest adjacent of the abandoned quarry; this discolored vegetation is discussed further in Section 1.6.

Photo facing north of potentially discolored vegetation near abandoned quarry.

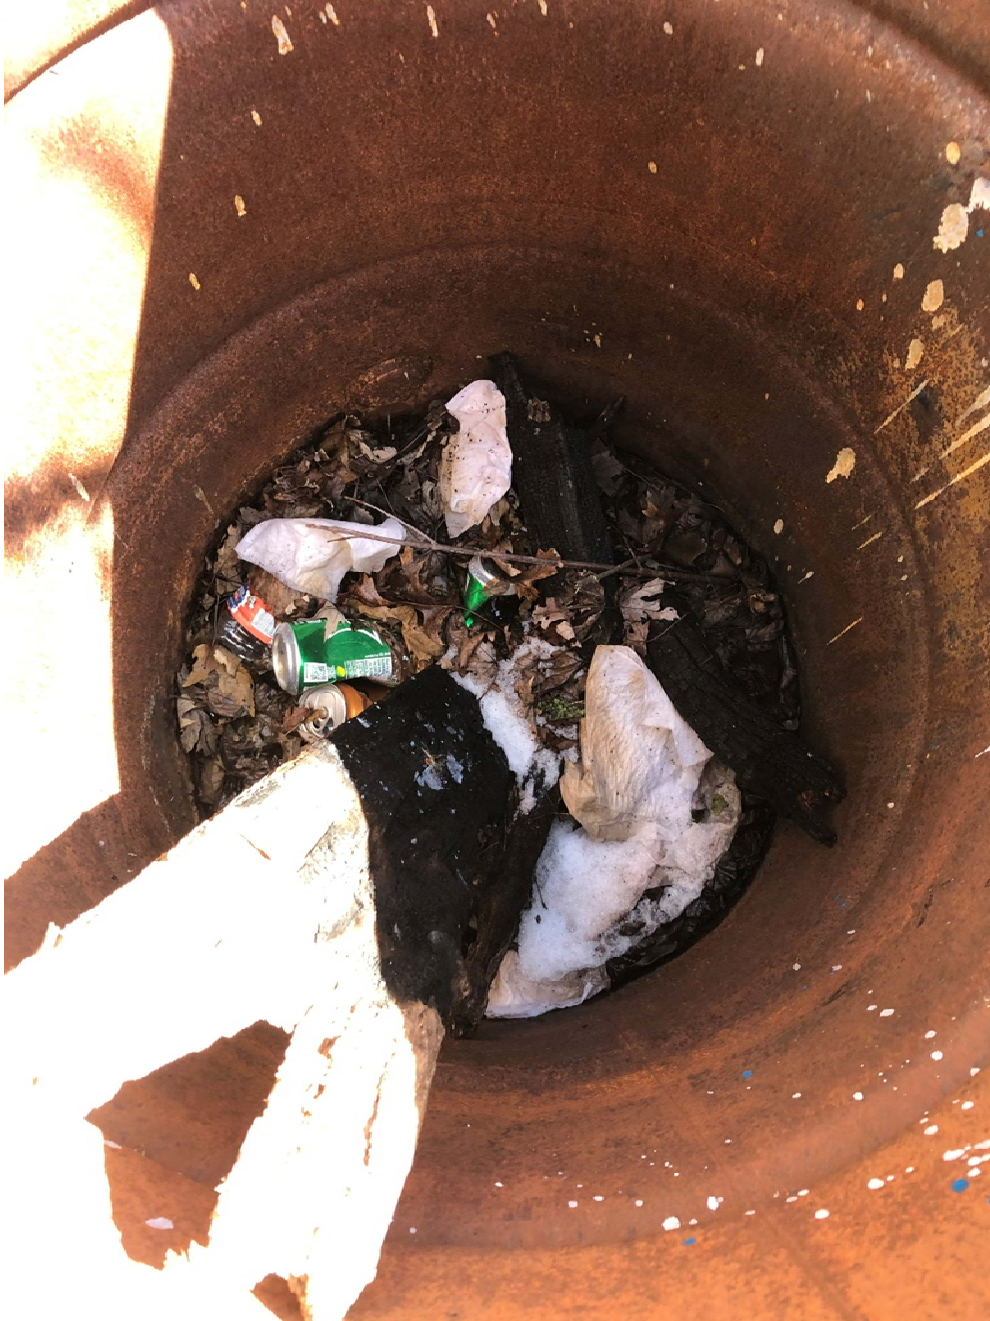
Photo 15

An abandoned structure was observed south of the abandoned quarry, just south of the RockGen Energy Center's main entrance. The structure contained various debris and a 55-gallon drum. The debris appears to be associated with unauthorized usage of the structure by unknown person(s) (e.g., as an unauthorized shelter and/or gathering place for unknown person(s)).

Debris inside 55-gal drum in abandoned structure south of abandoned quarry.
