ADDENDUM OF  
FEBRUARY 2021 PHASE I ENVIRONMENTAL SITE ASSESSMENT  
DAIRYLAND POWER COOPERATIVE  
ROCKGEN ENERGY CENTER

Final  
March 26, 2021  
Project No. 13014.014

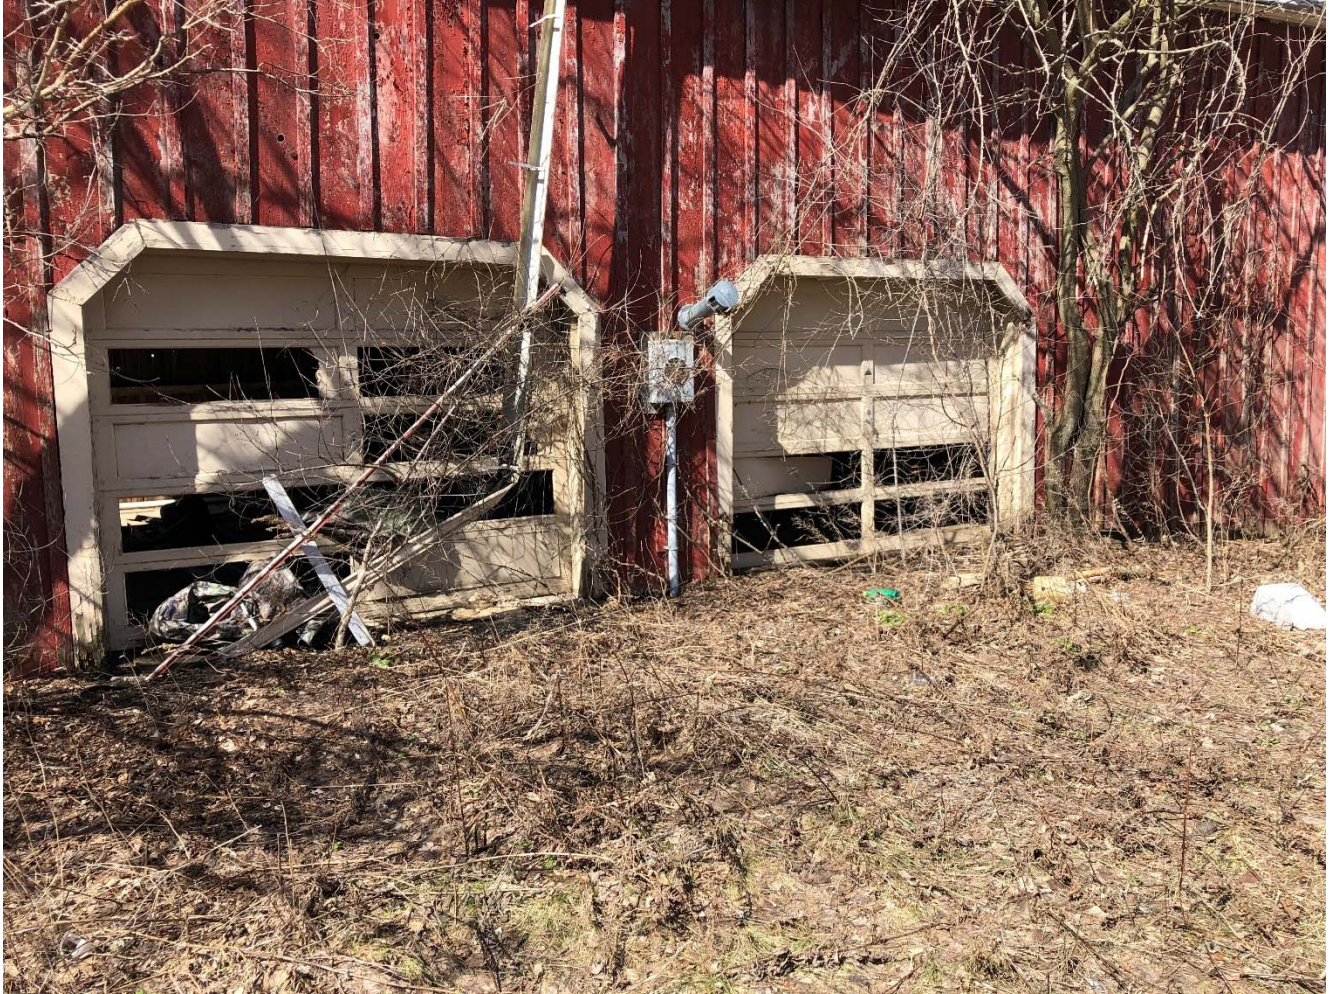
Photo 16

- Within the farmstead structures and the area around the abandoned farmstead in the east-central portion of the Site contained scattered debris, including tires, metal parts, paint cans, a 55-gallon drum and handheld plastic substance containers. All debris materials were not completely discernable due to the minimal snow at the time of the March 2021 site reconnaissance. Facility Personnel were unaware of the debris but had no specific knowledge of the nature of the debris beyond that discernable by visual inspection. The visual identification of improper disposal of handheld plastic chemical containers, the lack of information regarding these materials, and their improper disposal is considered a data gap that could pose potential impact to the Site.

Example photo facing west of debris, including handheld plastic containers, around abandoned farmstead barn structure.

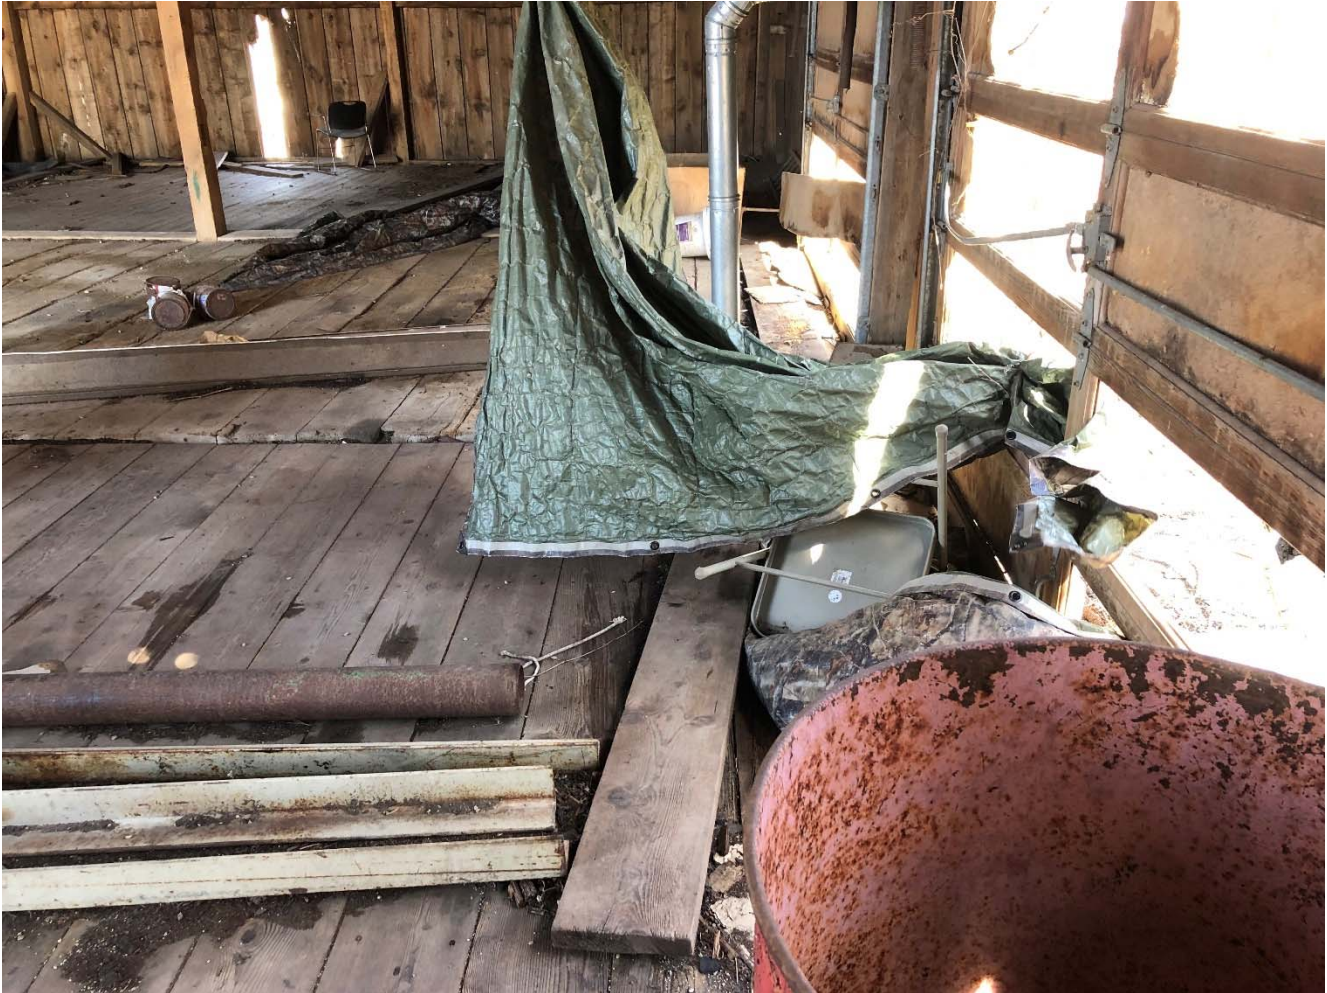
Photo 17

- S&L's representative visually inspected the area surrounding the former farmstead but did not enter the two structures in this area due to safety concerns; however, portions of the interior were able to be observed from the exterior. S&L's representative visually observed debris and other material stored within the structures, including metal equipment and parts, remnant pieces of furniture, and a handheld plastic container, but could not specifically determine the nature of the debris. Due to observation of debris stored within these structure, and the nature of debris identified in a previous Phase I ESA Report (i.e., paint cans and a 25-gallon drum), S&L considers the lack of information about the source and natures of all debris stored within these structures and their improper disposal to be a data gap that could pose potential impact the Site.

Example photo of paint cans and plastic containers (left and center background), red 55-gal drum (right foreground), a miscellaneous debris in abandoned farmstead barn structure.

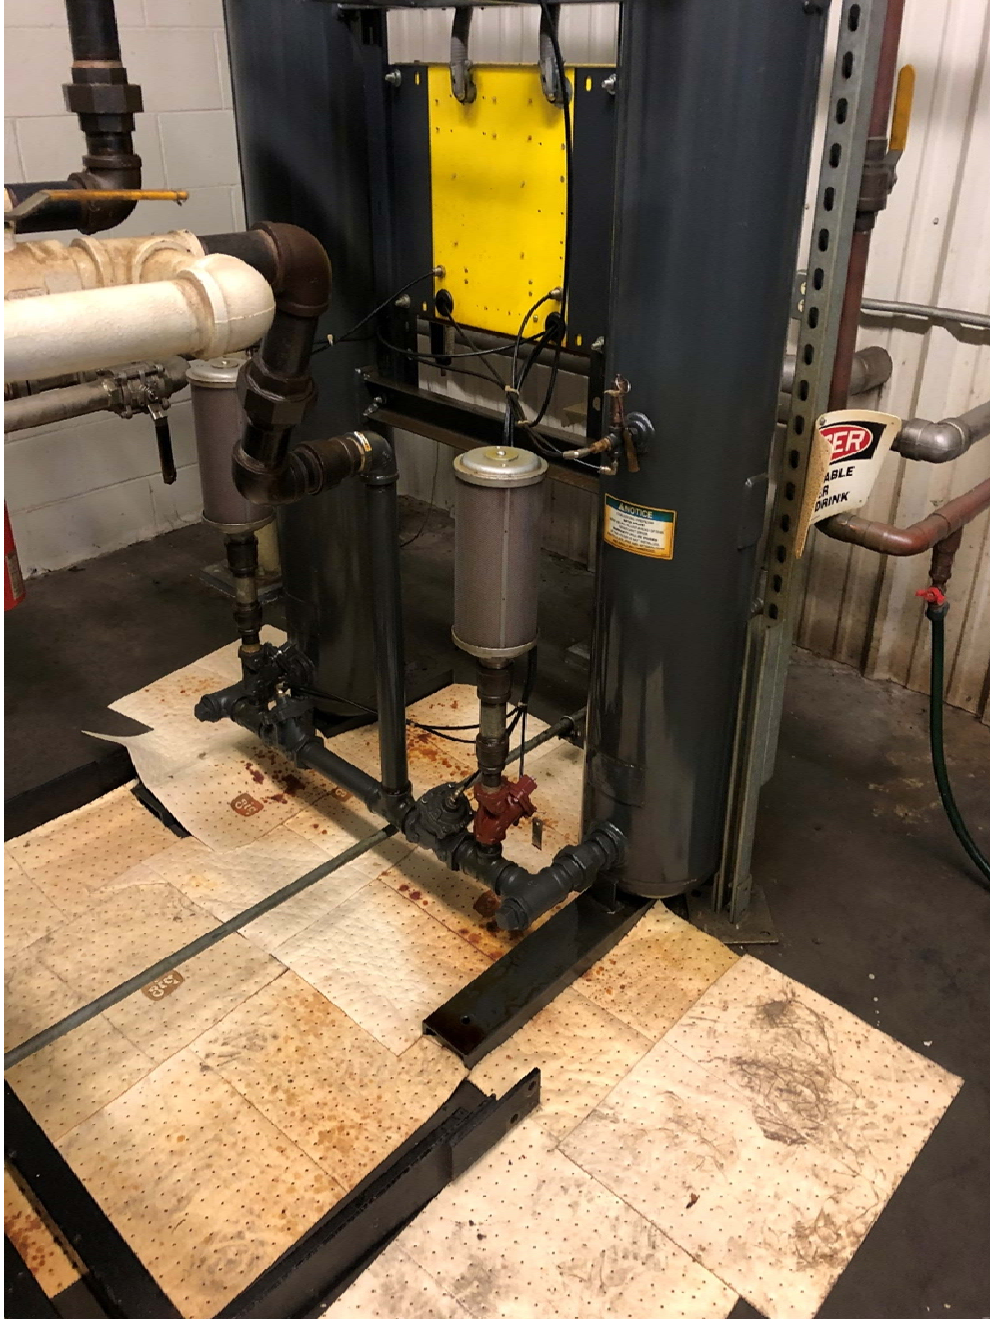
Photo 18

- A red/orange stain on a concrete foundation located in the industrial air compressor room was observed; however, a photo of the stain was not obtained. Due to the lack of visual evidence of a release to the environment and the corrective action plans prescribed in the RockGen SPCC Plan regarding such spills, S&L considers this spill to be *de minimus* condition.

Photo of spill on concrete foundation in air compressor room.

A red/orange stain on concrete foundation was identified in the industrial air compressor room; however, a photo of the stain was not obtained. This spill is discussed further in Section 7.

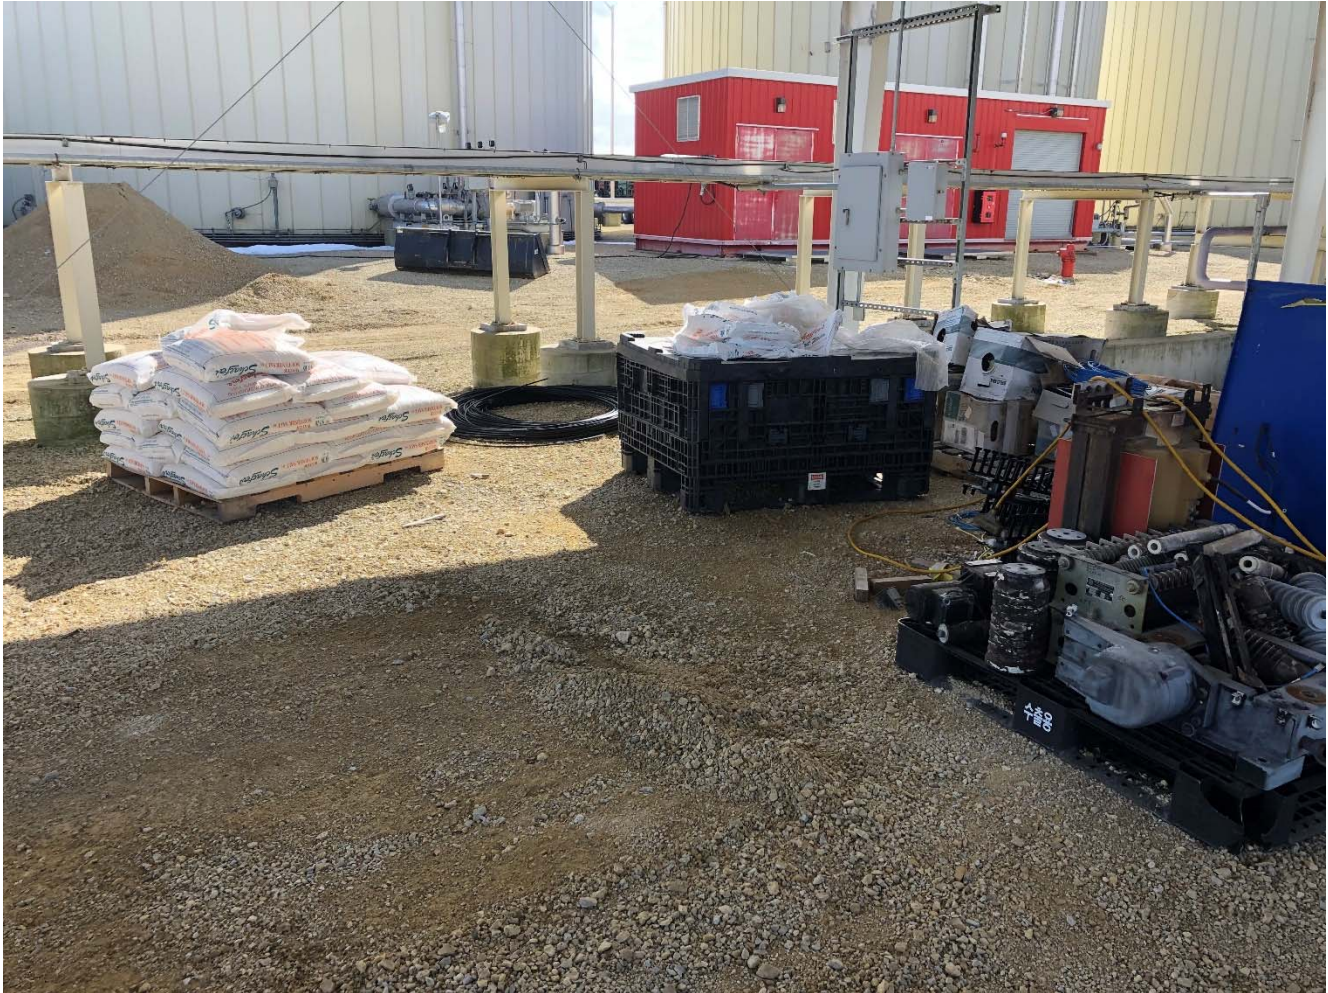
Photo 19

- S&L visually observed the storage of used parts on a plastic skid on gravel under the canopy area. Due to the lack of visual evidence of a release to the environment, S&L considers this activity to be a *de minimus* condition.
- S&L identified an office trailer with a walled generator with corrosion located on a plastic skid on gravel west of the canopy area. Due to the lack of visual evidence of a release to the environment, S&L considers this observation to be a *de minimus* condition.

Spare metal parts stored on a plastic skid on gravel under the canopy area on the right.

Visual observations of the canopy area were made via walking. The canopy area consists of enclosed structures as well as unenclosed areas. S&L identified storage of used parts on a plastic skid on gravel under the canopy area, which is discussed further in Section 7. Other observations are discussed below. West of the canopy area also includes an office trailer with a walled generator with corrosion located on a plastic skid on gravel; the generator is discussed further in Section 7.
