WETLAND AND WATERBODY DELINEATION REPORT

Fire Technology Center Marinette County, Wisconsin

October 2019

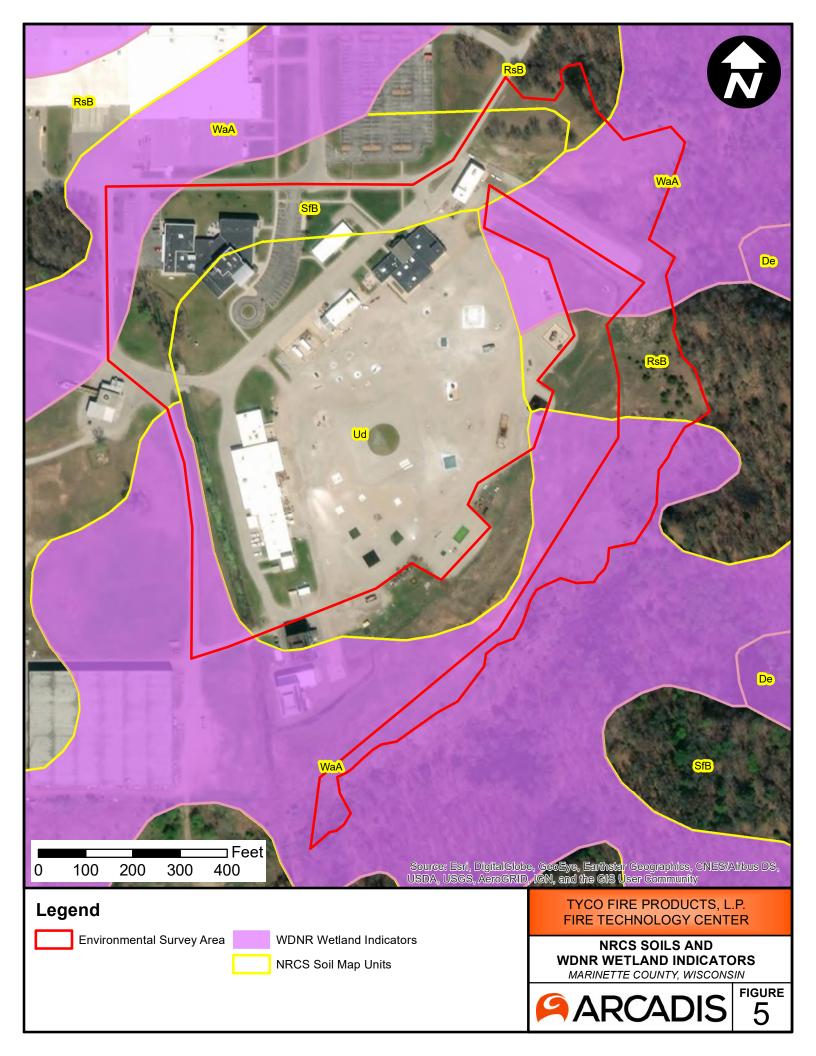
Generally, soil units identified as hydric contain soils that indicate through their color and structure texture that they have experienced dominantly reducing (i.e.; oxygen poor) conditions, which are a result of inundation and/or saturation by water. The location and extent of the soil units and wetland indicators identified within the ESA are depicted in **Figure 5**.

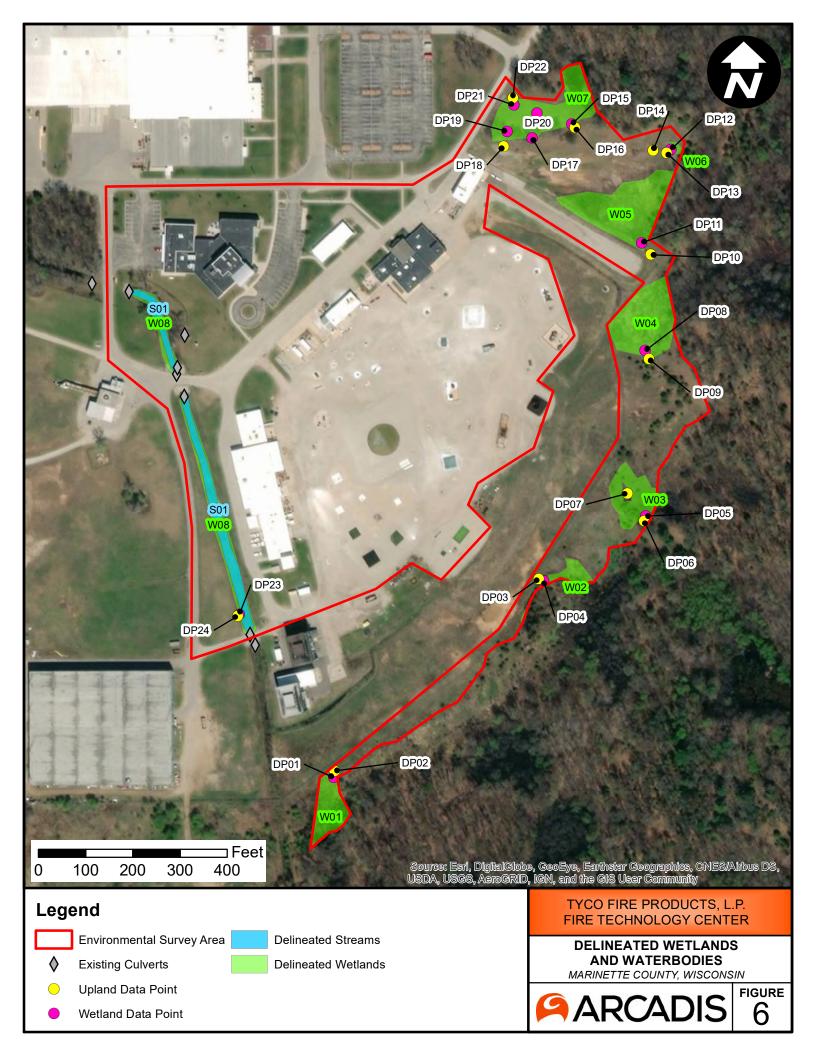
As shown in **Figure 6**, a total of eight wetlands (W01 through W08) were identified as part of the delineation for a total of 2.17 acres. All wetlands appear to be hydrologically connected to surface water systems in the vicinity of the ESA and may be considered jurisdictional by the USACE and WDNR. It should be noted that the USACE and WDNR make the final determination of wetland hydrologic

As shown in **Figure 6**, one intermittent unnamed tributary to the Little River (S01) was identified within the ESA for a total of approximately 741 linear feet. S01 flows generally north to south within the ESA. Due to the assumed hydrologic connection between this stream and Lake Michigan, a TNW, it may be considered jurisdictional by the USACE and WDNR. It should be noted that the USACE and WDNR make the final determination of significant nexus with a TNW. Stream characteristics are summarized in **Table 3**.

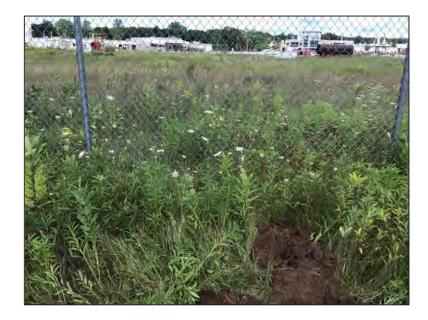
Photo: 03

Upland data point DP03 near the boundary of W02.

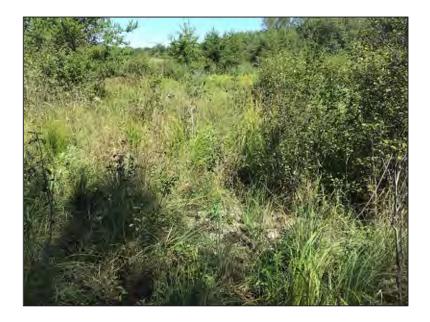
Photo: 05

Description:Wetland data point DP05 in W03.

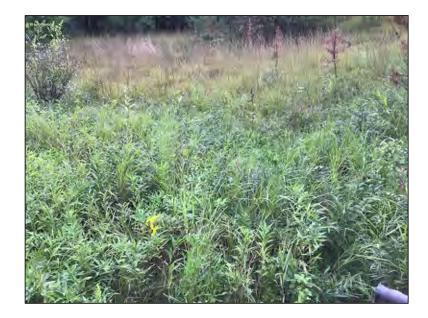
Photo: 09

Upland data point DP09 near the boundary of W04.

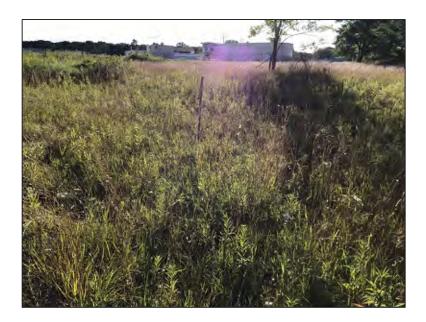
Photo: 13

Upland data point DP13 near the boundary of W06.

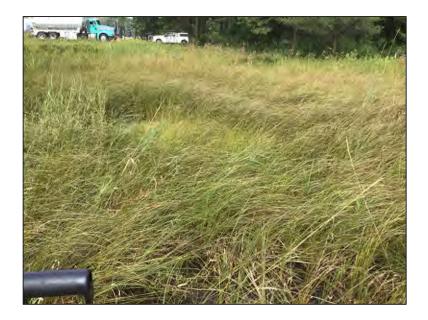
Photo: 15

Description:Wetland data point DP15 in W07.

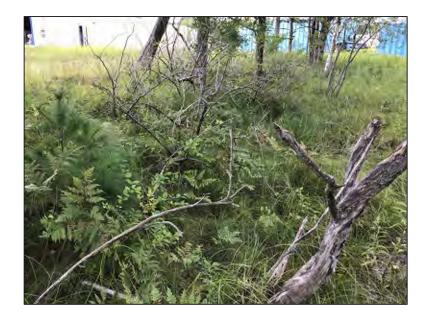
Photo: 17

Wetland data point DP17 in W07.

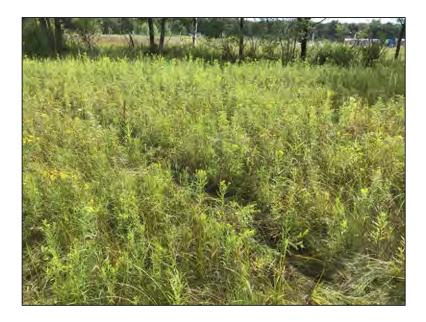
Photo: 21

Description:Wetland data point DP21 in W07.
