Technical Assistance, Environmental Liability Clarification or Post-Closure Modification Request

MARINETTE, WISCONSIN **CONCEPTUAL SITE MODEL**

TYCO FIRE TECHOLOGY CENTER
MARINETTE, WISCONSIN
CONCEPTUAL SITE MODEL

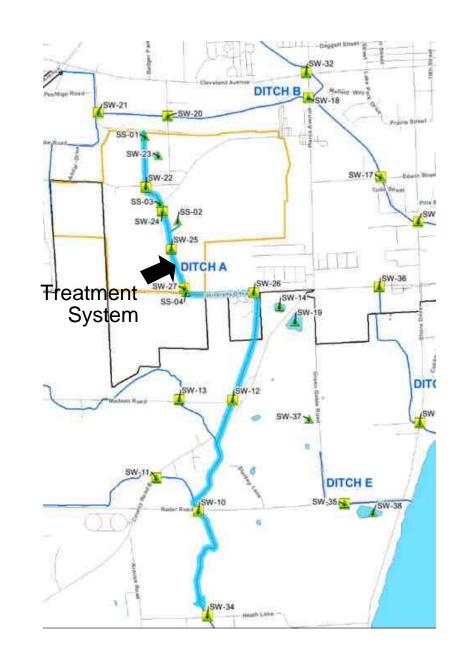
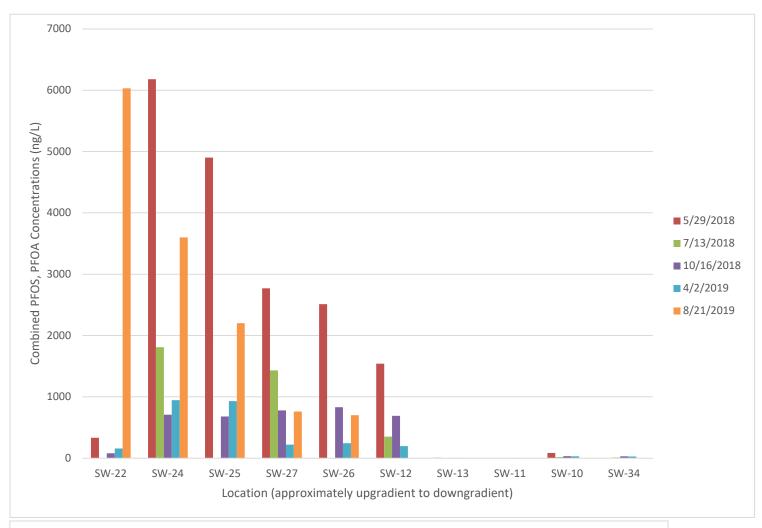
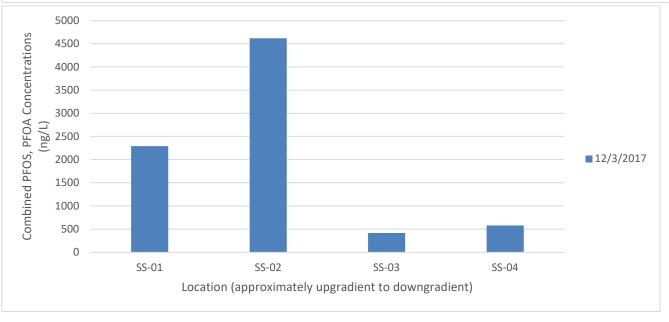
18

comparison of combined PFOA and PFOS concentrations at locations on Site and locations that continue downgradient shows a linear decreasing trend (**Figure 18**). The average combined concentration of PFOA and PFOS observed at the on-site locations (SW-22, SW-24, SW-25, SW-27) was 1,967 ng/L whereas the combined concentrations observed at downgradient locations (SW-10, SW-11, SW-13, SW-34) was 21.5 ng/L during the 2018 sampling events, prior to the installation and operation of the Ditch A treatment system. Two intermittent locations after the ditch first flows off- site (SW-12 and SW-26) averaged a combined concentration of 1,184 ng/L across during the 2018 sampling events. Seasonal variability can be observed throughout the sample locations and is greatest at locations where higher concentrations were detected. Although there is variation in detections across samples at each location, the general trend is of higher upgradient concentrations and linear decreasing detections as the flow moves south from the OTA.

PFOS + PFOA in Surface Water (2017 - 2019)

Since the site investigation began, a water treatment system has been installed in Ditch A, north of the southern boundary of the FTC and SW-27. The Ditch A treatment system began operation in January 2019. Since then, a decrease in average detections was observed at the three downgradient sample locations, SW-27, SW-26, and SW-12, in respective order of north to south. The average detections of combined PFOA and PFOS observed at SW-27 were 1,660 ng/L in the three sampling events prior to the operation of the treatment system and 490 ng/L after operations began. Average combined concentrations changes observed at SW-26 decreased from 1,660 ng/L to 490 ng/L at SW-26 and at SW-12 decreased from 860 ng/L to 196 ng/L at SW-12.

Average detections of combined PFOA and PFOS concentrations at the three upgradient on-site locations have remained relatively stable since the installation of the Ditch A treatment system. The average detections of combined PFOA and PFOS concentrations observed at the three upgradient on-site locations (SW-22, SW-24, SW-25) were observed average combined PFOA and PFOS concentrations slightly above 2,000 ng/L prior to the installation and averaged 2,311 ng/L after operation began. The minimum detection observed was 78.9 ng/L at SW-22 and the maximum detection observed was 6,180 ng/L at SW-24.

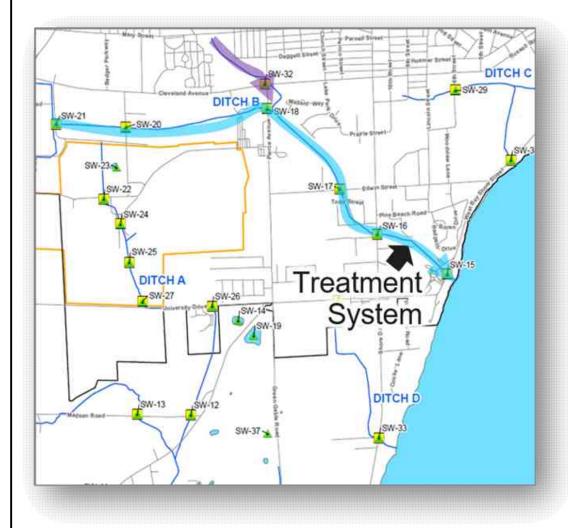
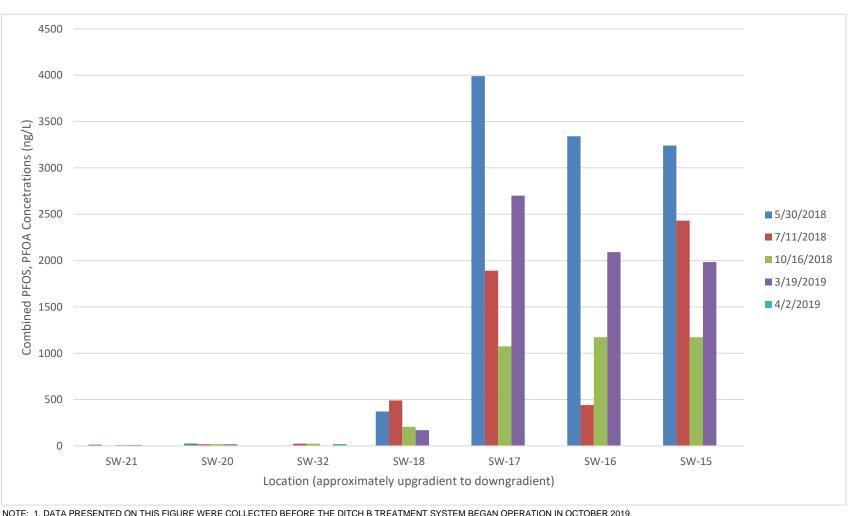
PFOS + PFOA in Surface Water (2018 - 2019)

NOTE: 1. DATA PRESENTED ON THIS FIGURE WERE COLLECTED BEFORE THE DITCH B TREATMENT SYSTEM BEGAN OPERATION IN OCTOBER 2019.

Seven locations along the length of Ditch B were sampled over five seasonal events. Surface water samples located upgradient of the Site-related impacts contained minimal seasonal variations and concentrations (SW-20, SW-21, and SW-32), averaging combined concentrations of 18.2 ng/L (**Figure 19**). At the confluence of Ditch B with a northern tributary and slightly northeast of the OTA (SW-18), combined detections of PFOA and PFOS increased to an average of 309 ng/L. Downgradient of this location, increases in concentrations and seasonal variations are were observed. These downgradient locations along Ditch B (SW-15, SW-16, SW-17) are due east of the OTA. The average PFOA and PFOS combined concentrations observed seasonally across the three locations were 3,523 ng/L during the spring event, 1,587 ng/L during the summer event, 1,139 ng/L during the fall event, and 2,258 ng/L during the winter snowmelt event . Samples were collected prior to the installation and operation of a water treatment system installed in Ditch B, southeast and downgradient of SW-16. The treatment system began operation in October 2019.
