# **AN EVALUATION OF BEACH NOURISHMENT ON THE LAKE SUPERIOR SHORE**

**Technical Bulletin No. 157  
Department of Natural Resources  
Madison, Wisconsin**

**1985**

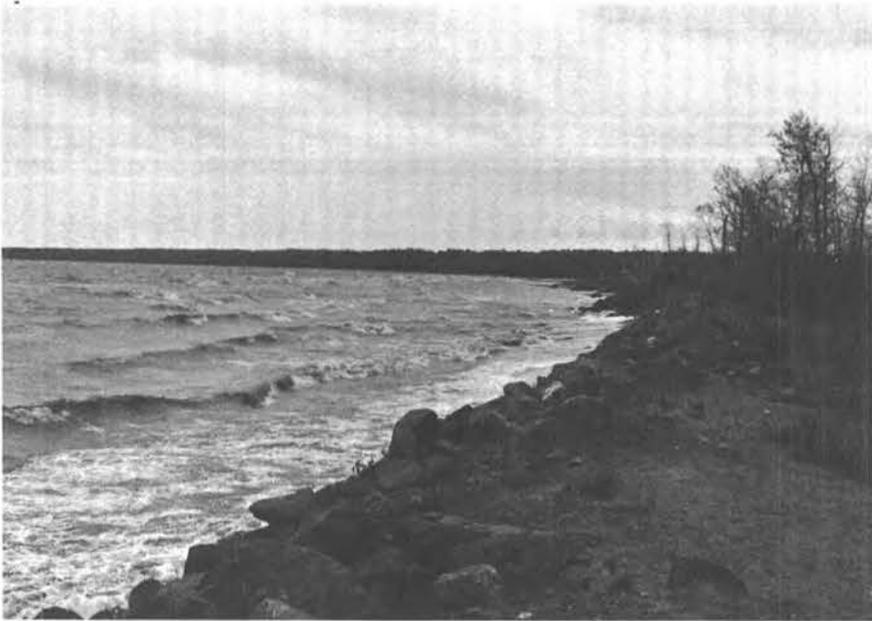
View of riprap along shoreline. Groins can be seen in distance.

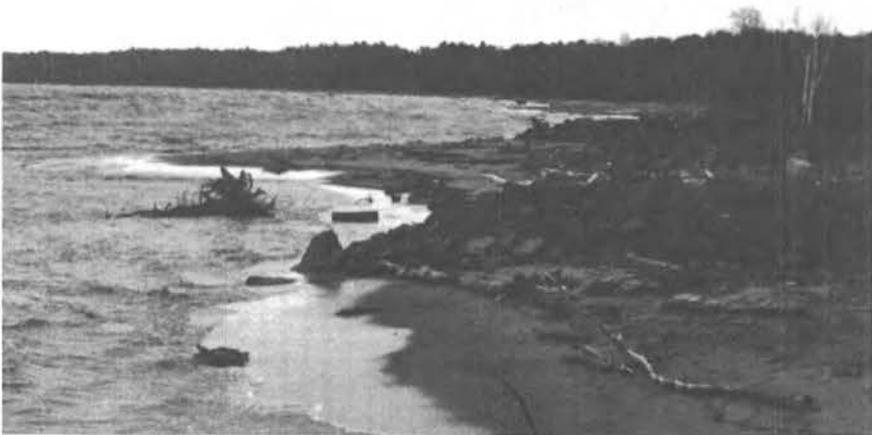
Typical groin. Note placement perpendicular to shoreline.

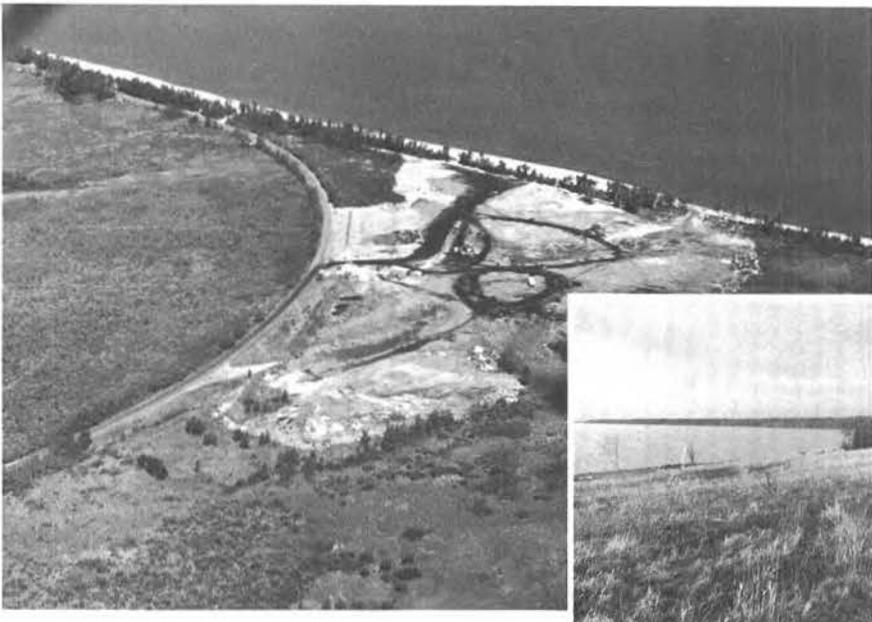
Aerial view of the landfill on Wisconsin Point during its operation by the City of Superior in the 1960s. Inset: A view of the shoreline from the restored landfill area (note lack of trees).

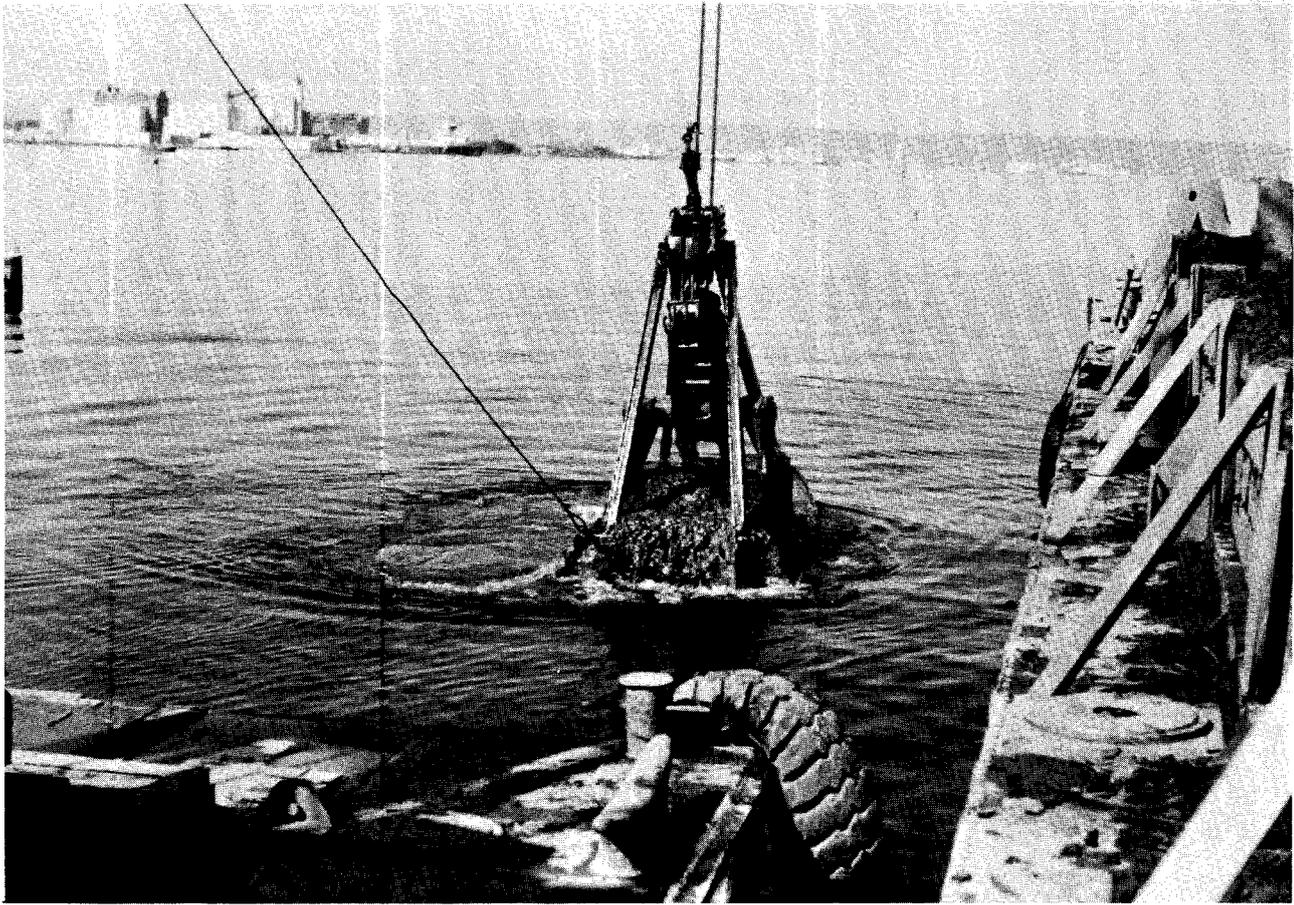
Clam shell dredge removing Nemadji sediments at dredging sites ...

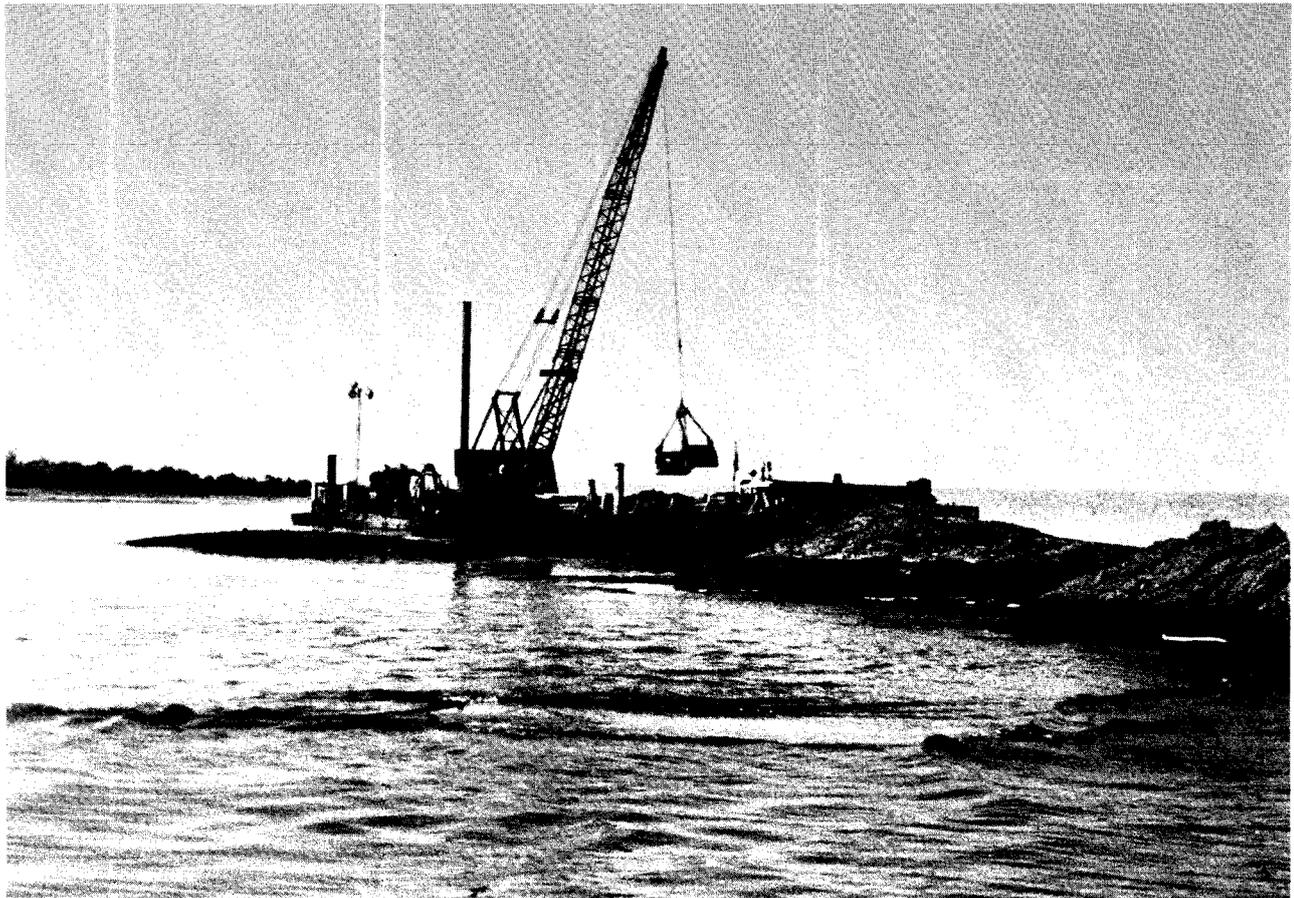
... and unloading them at the nourishment site off Wisconsin Point.

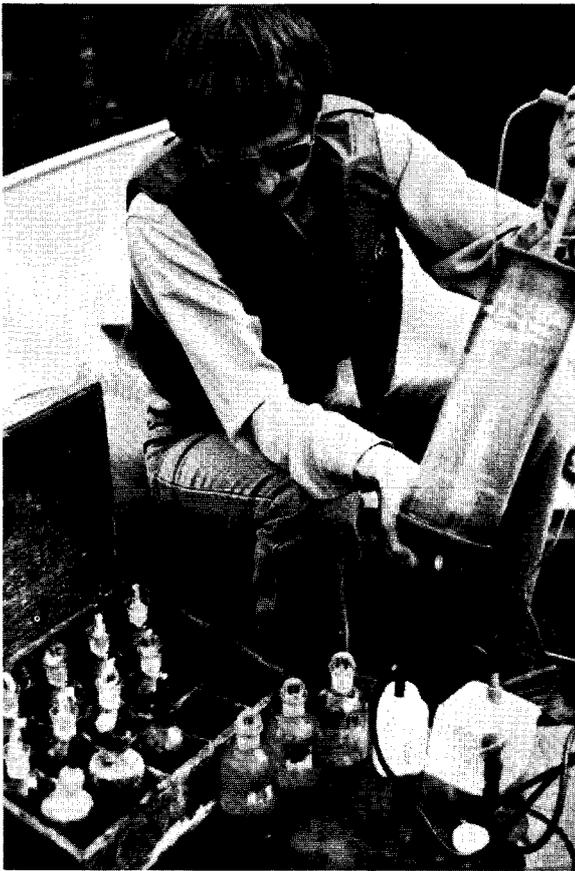
Near shore water quality measurements were made along 5 transects before, during, and after the nourishment operation.

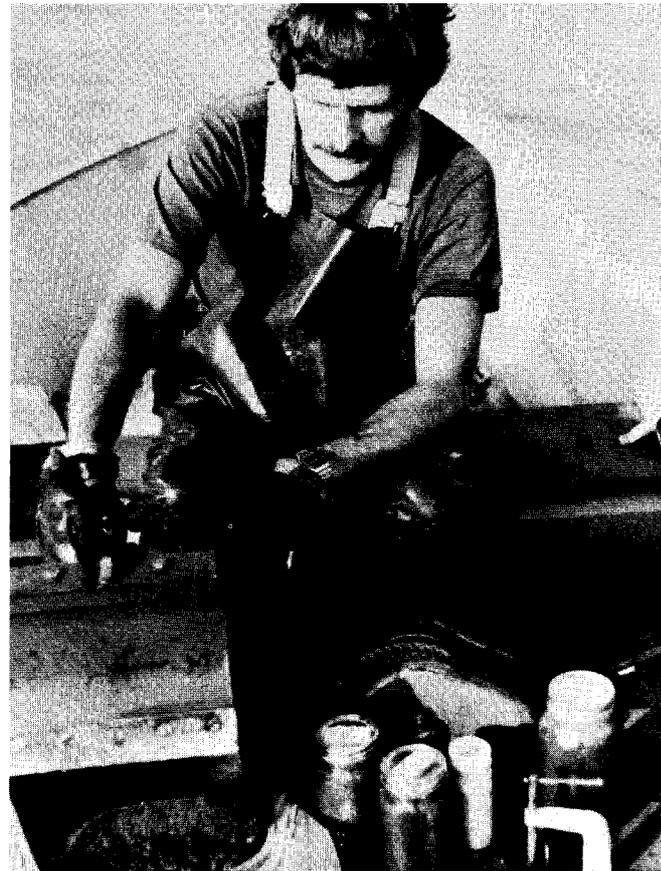
Benthic invertebrates and bottom material samples were collected with a ponar dredge.

Bottom samples were collected exclusively with a ponar dredge. The material for physical and chemical analysis was prepared on-site according to procedures specified by the laboratories performing the analyses. In order to determine sample variability, four separate benthic samples were taken at the same location on several occasions. At the laboratory, benthic organisms were concentrated with a 30-mesh sieve, sorted, and preserved in 70% ethanol for identification and counting. Chironomidae and Amphipoda were identified to genus and species, respectively, and the remainder to the lowest possible taxonomic classification.

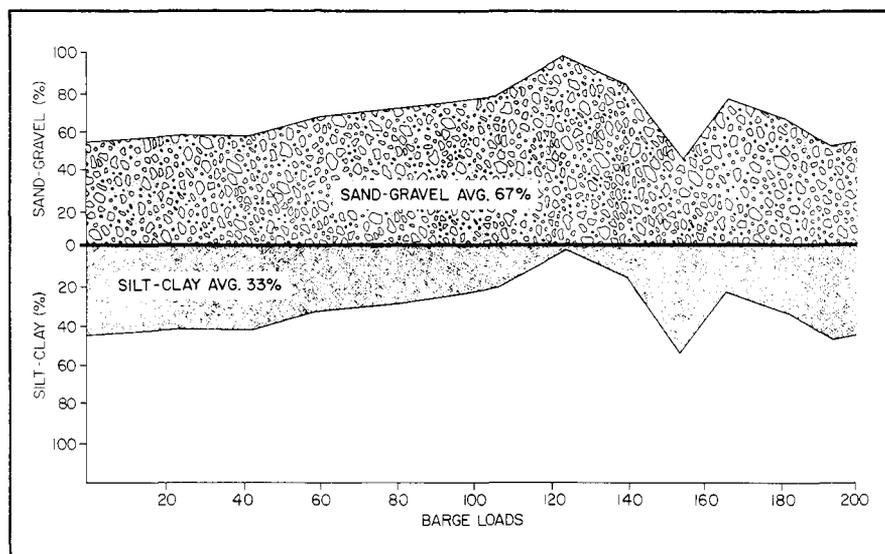
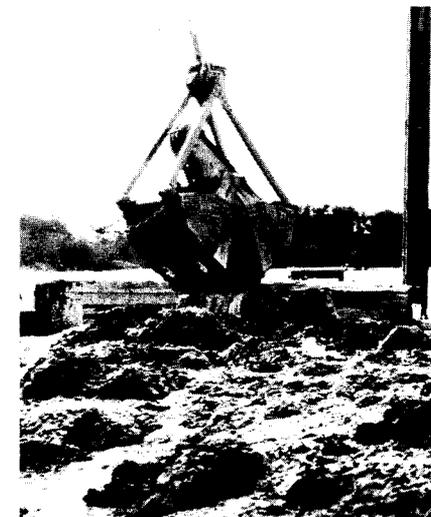
Some of the dredged material was too fine-grained for a beach nourishment project. This barge load was mostly clay and silt.

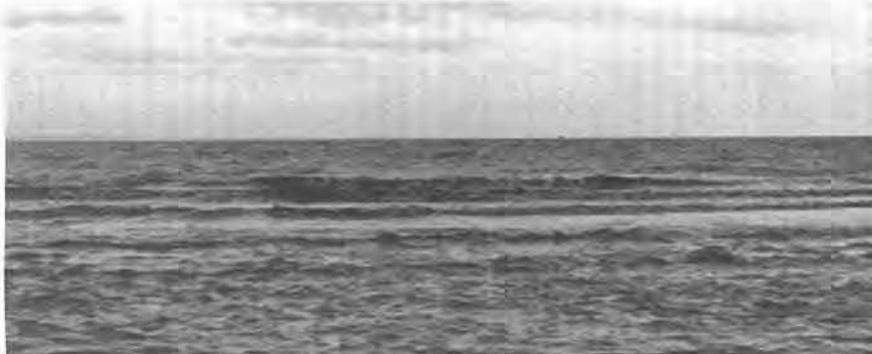
The dredged material placed in front of the old landfill caused waves to break further offshore, expending erosion energy that otherwise would have been brought to bear on the shoreline.

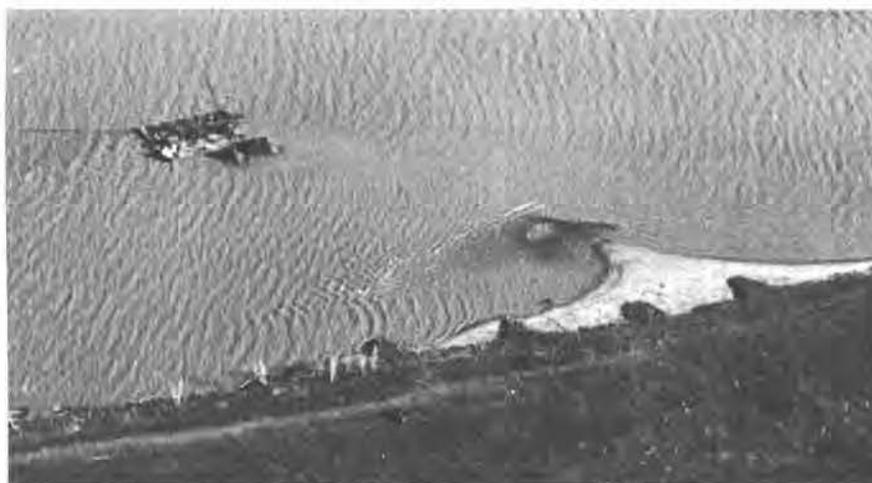
Littoral drift accumulated in front of the groins following the deposition of sediments.

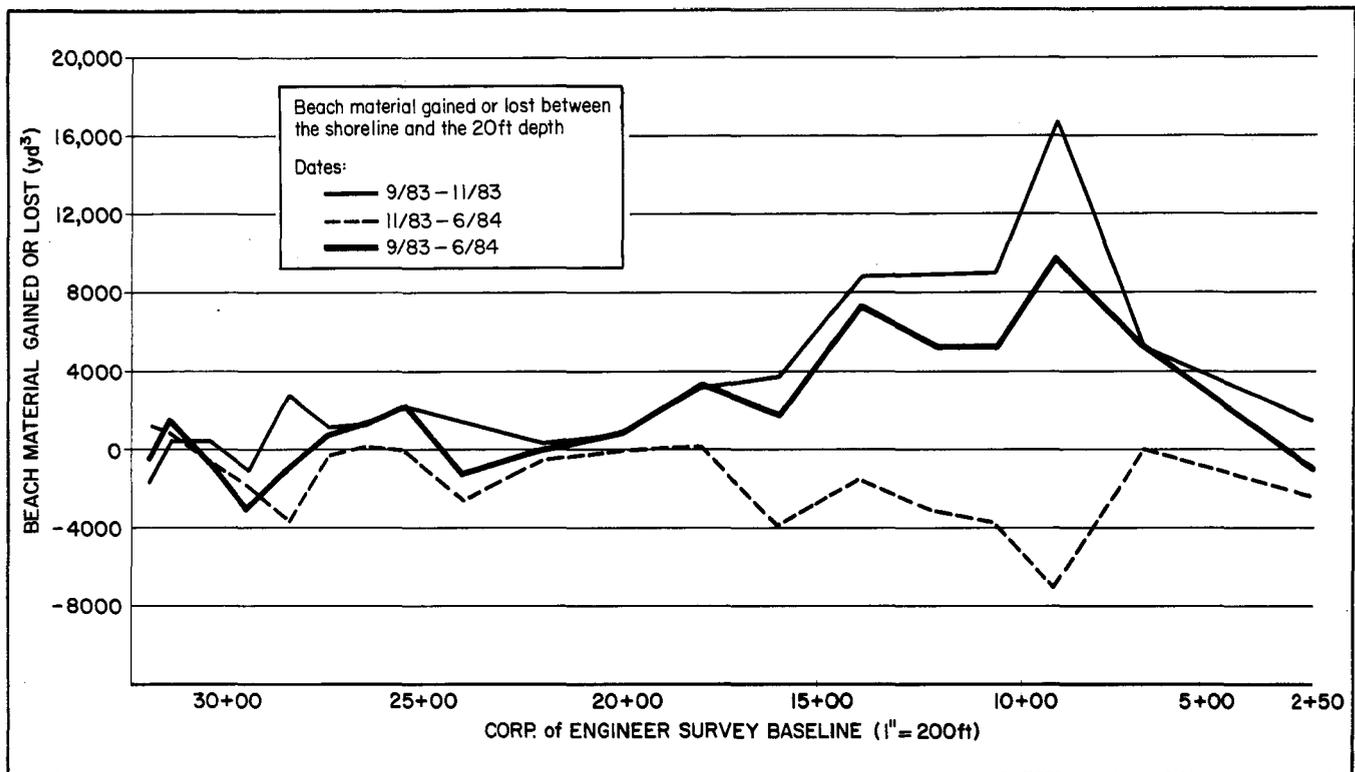
FIGURE 5. Beach material gained or lost between the shoreline and the 20 ft depth.

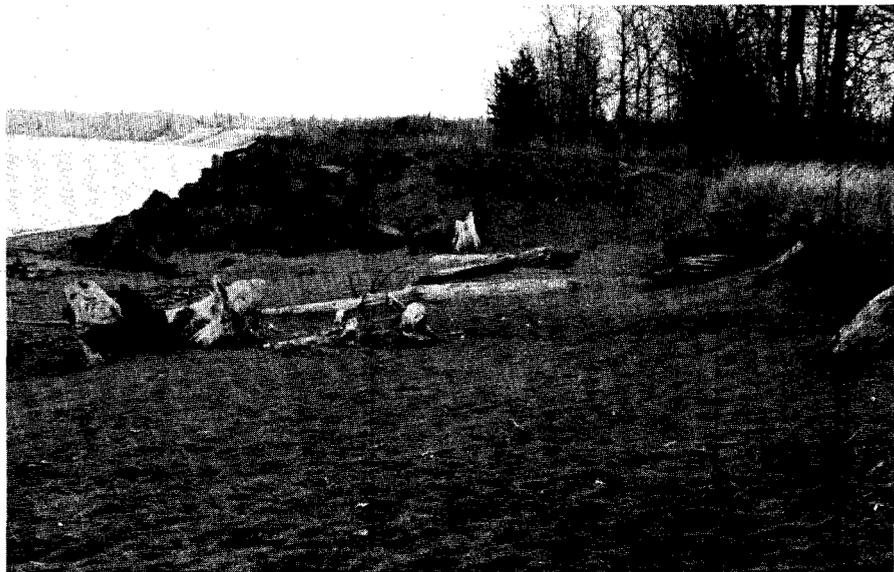
Beach berm erosion at the downdrift end of the riprap (May 1985).

Severe bank erosion took place west of the riprap shoreline at Pts. 9 and 10 (Fig. 8) after completion of the project. The November storm and the dredged material breakwater appeared to have caused the erosion to occur. A survey in May 1984 showed an estimated loss of about 1,400 yds<sup>3</sup> of bank material due to the erosion the previous fall. At Pt. 8, approximately 1,000 ft west of the end of the riprap, little bank erosion occurred.

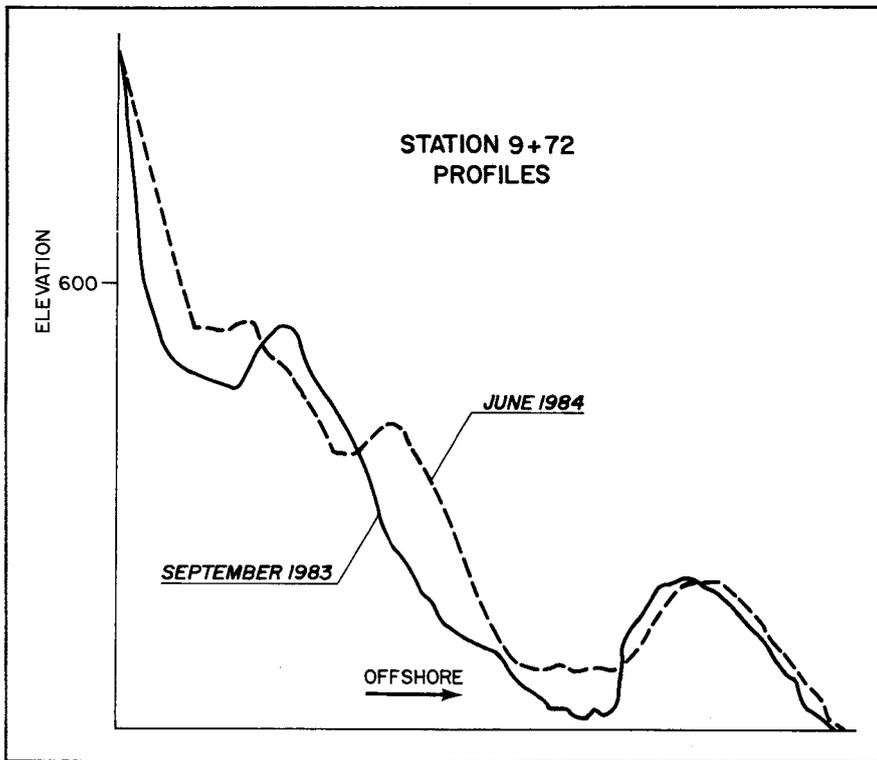
FIGURE 7. Near shore profile (below water surface) at station 9+72.

Pre- and post-operation surveys were conducted and depth sounding data converted to a bathymetric map (Fig. 6) and near shore profile (Fig. 7). The map shows 5-ft contours for comparison of bathymetry before and after the operation. Near shore profiles are cross sections of the study area. They extend from the shoreline out into the water to the 20-ft contour. The profiles were used for calculating the volume of sediment movement.

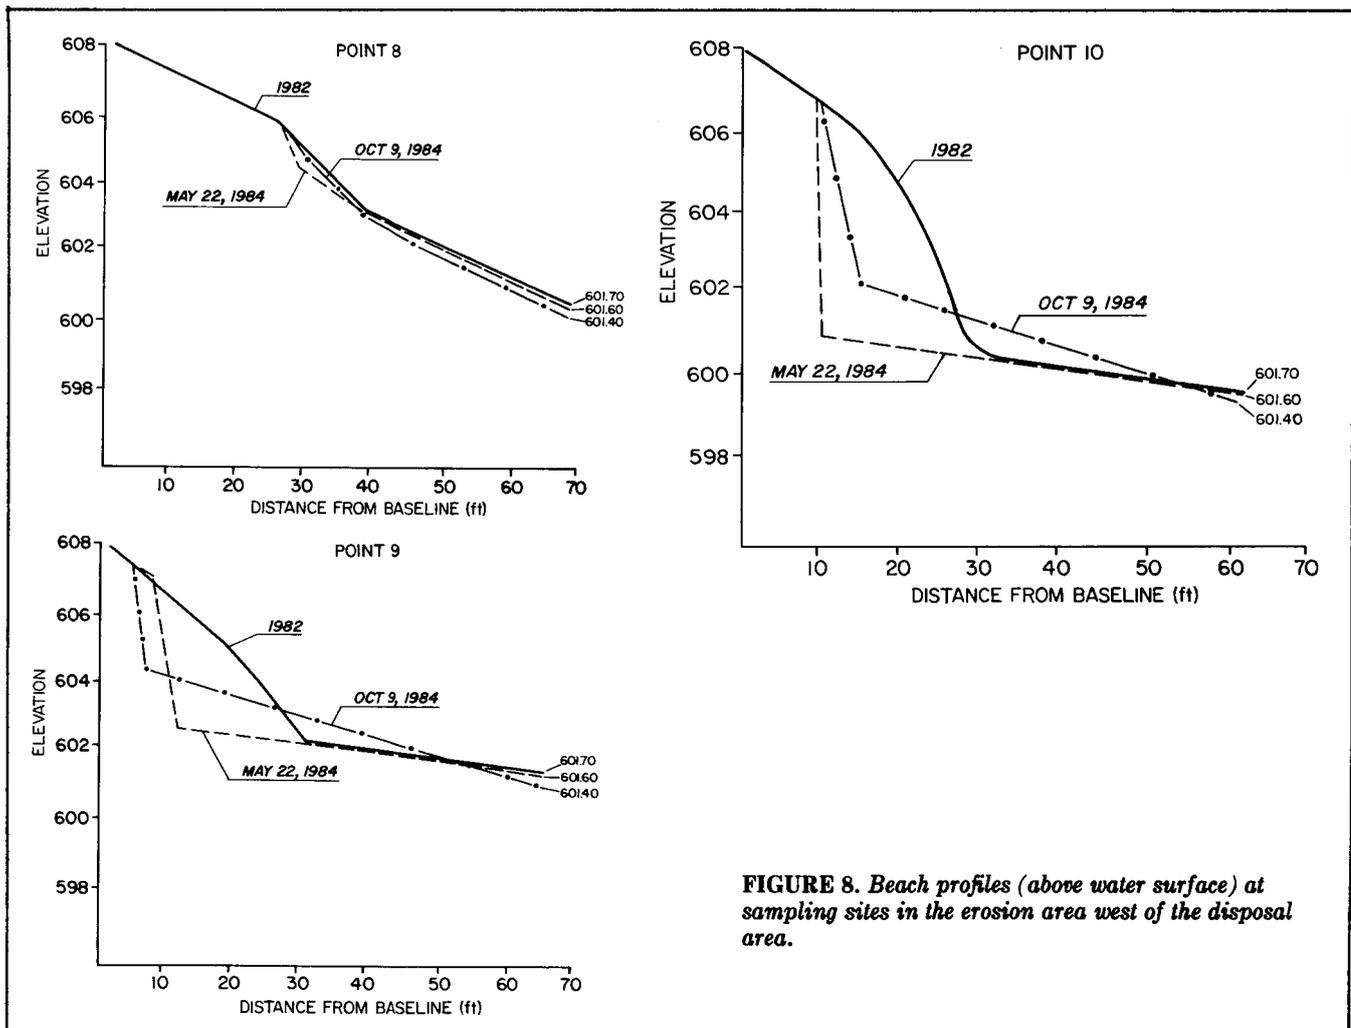
FIGURE 8. Beach profiles (above water surface) at sampling sites in the erosion area west of the disposal area.

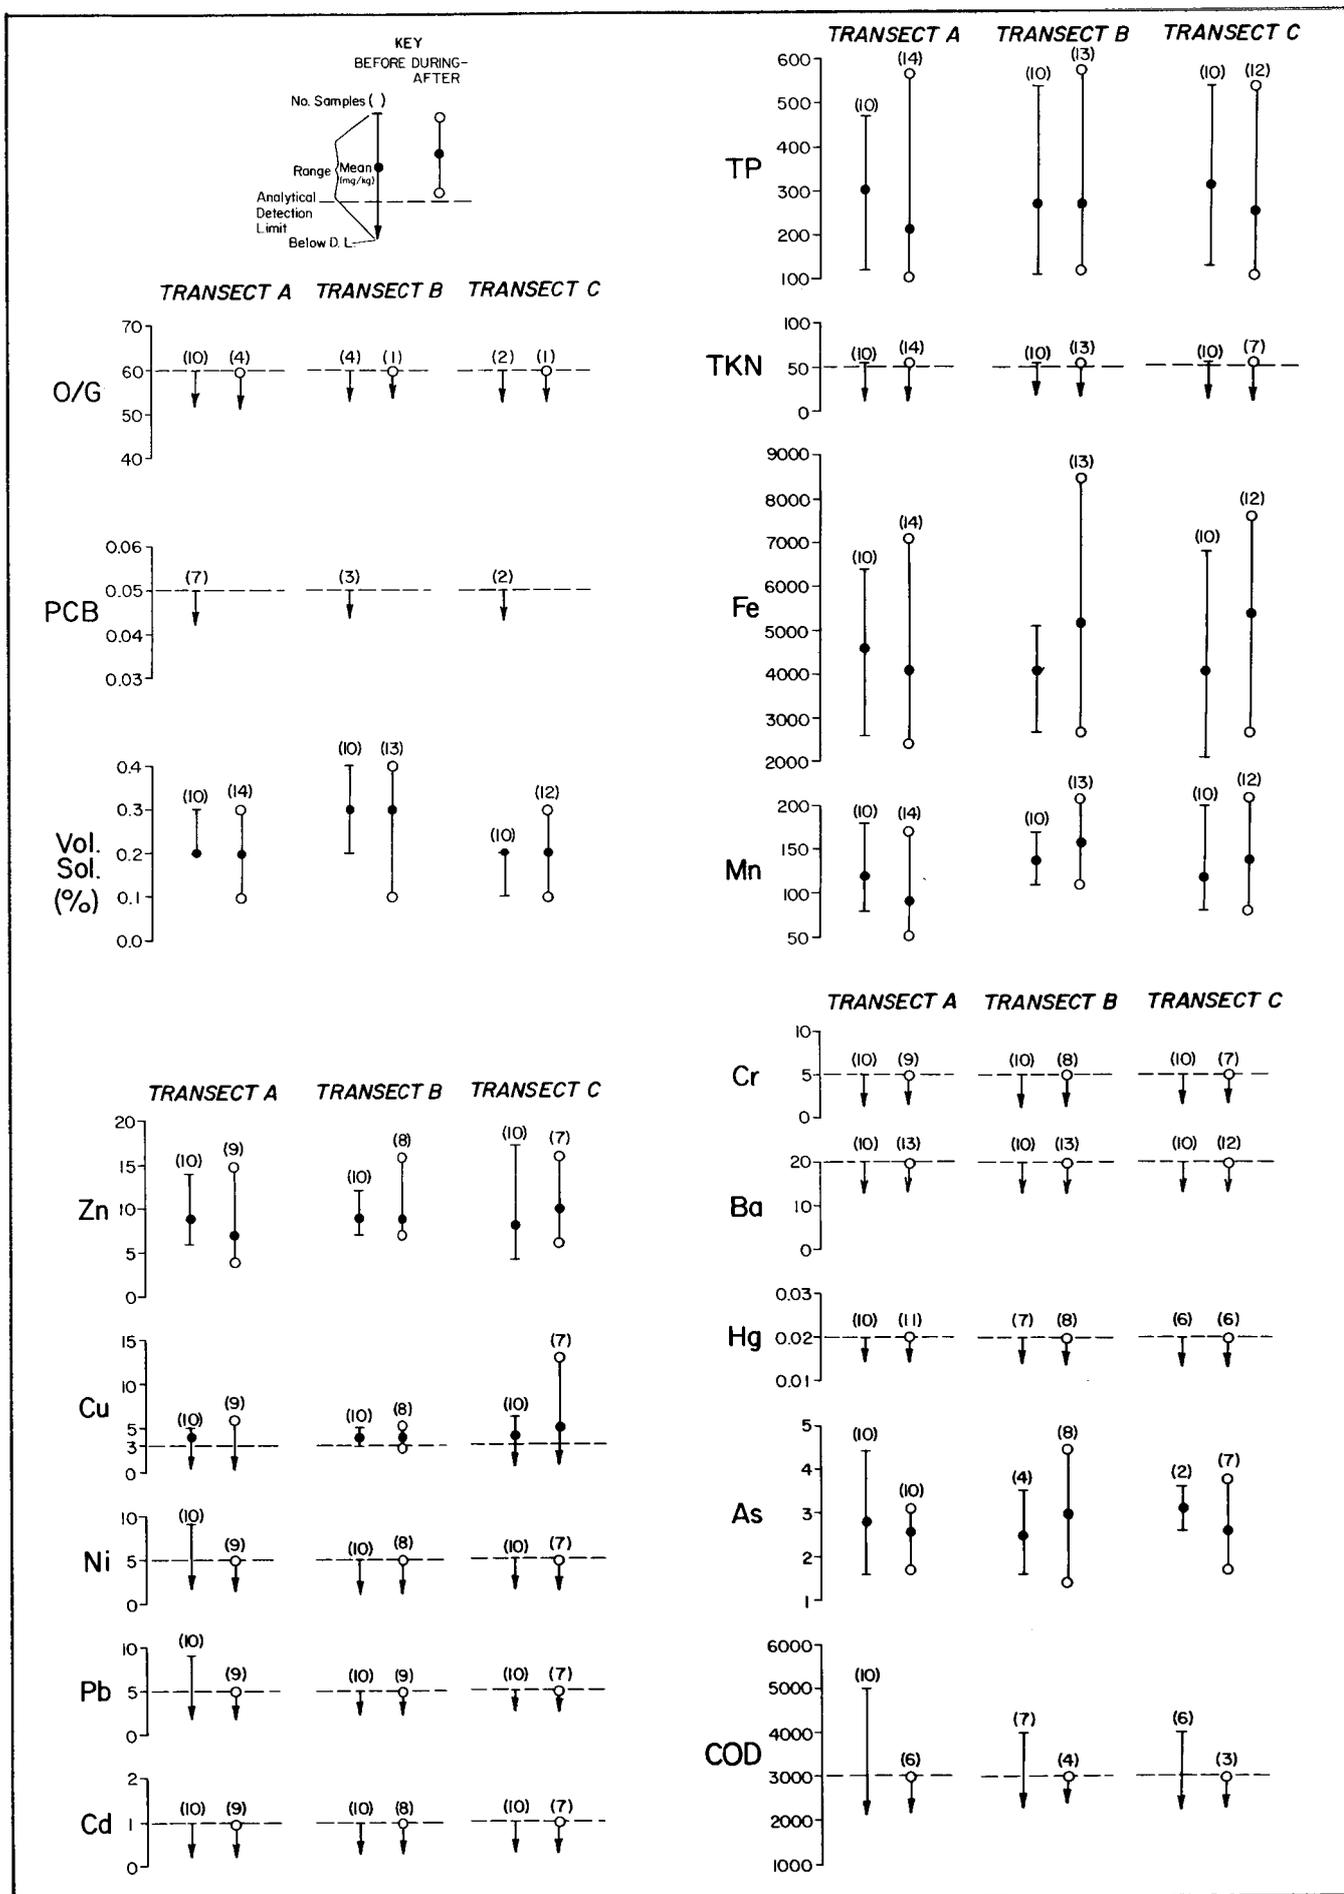
FIGURE 10. Chemical analysis of beach sediments. (All values in mg/kg dry weight, except Vol. Sol. (%)).

Chemical analyses of beach materials (Fig. 10) showed no changes in chemical composition as a result of the project. Levels of all measured constituents were the same before, during, and after treatment. Although a relatively small amount of dredged material used in the nourishment operation was found to contain mercury, no mercury was detected in any beach samples collected during or after the project. Other

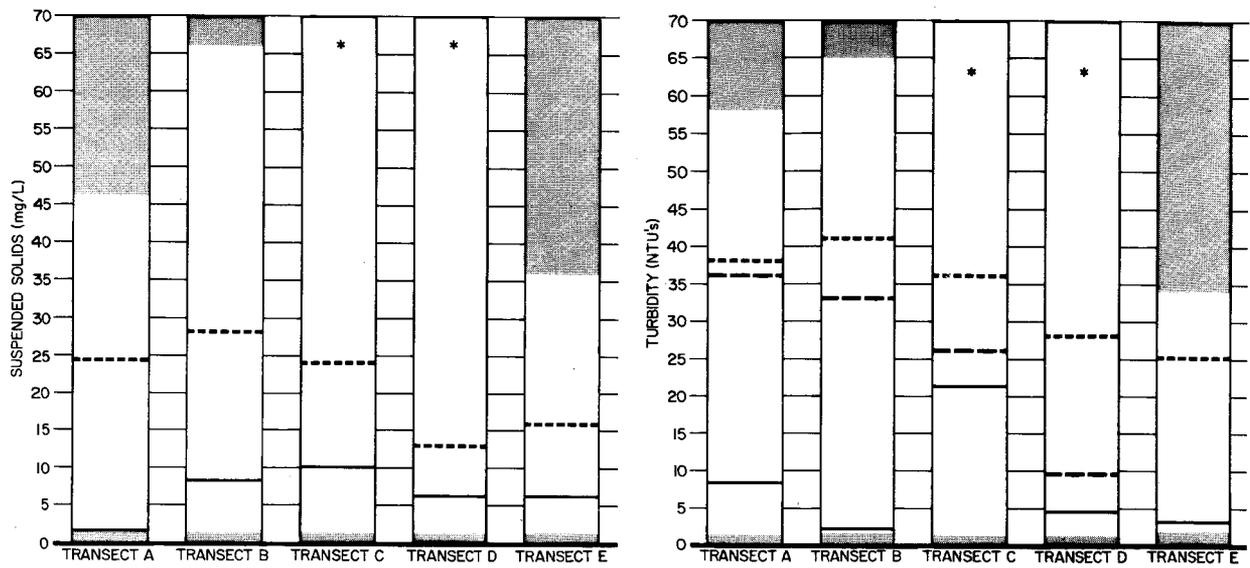
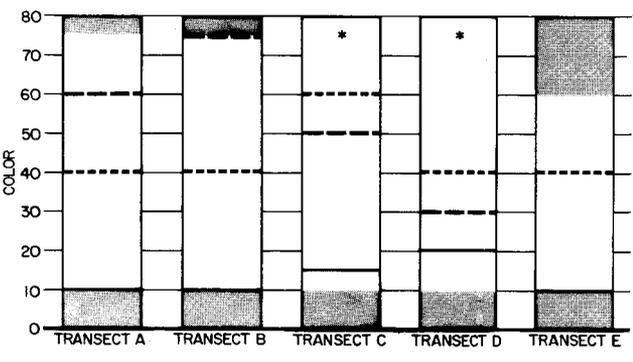
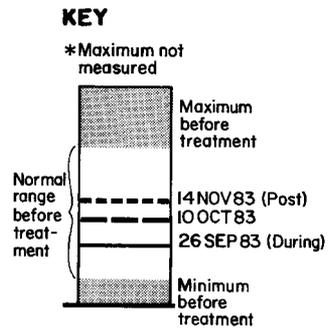
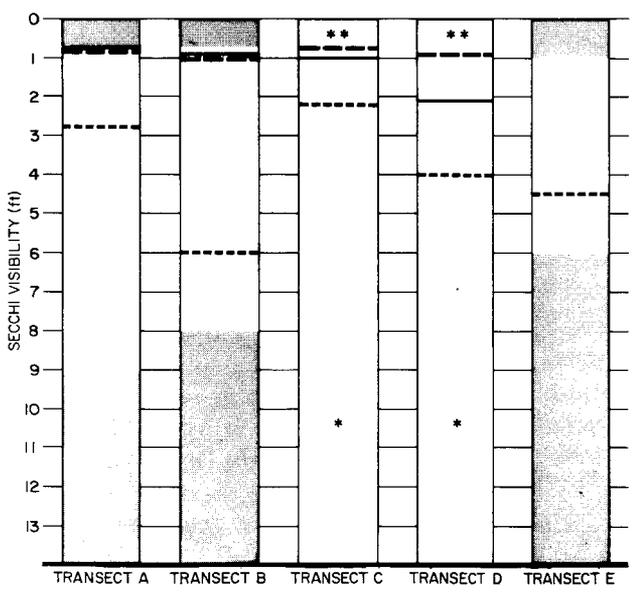
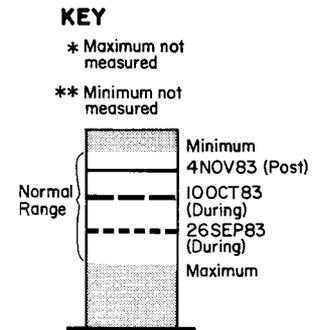
18 **FIGURE 11. Water clarity indicators before, during, and after the nourishment operation.**

As a basis for determining impacts of the demonstration project on water quality, naturally occurring water quality conditions off Wisconsin Point were documented before the project began. In general, water quality in the near shore zone did not vary much during the year prior to treatment (Table 4), except for water clarity, which showed considerable variation (Fig. 11). The before-treatment ranges in

values for turbidity, suspended solids, color, and Secchi disc reading demonstrate the great differences in water clarity that occurred within the project area. Dramatic and often rapid changes in water clarity are a well recognized natural phenomenon along the Lake Superior shoreline. Weather conditions are the determining factor. During periods of calm or offshore winds, the water is usually very clear, but during storms or periods of strong onshore wind, bluff erosion and resuspension of bottom sediments causes the turbidity and "red clay" color characteristic of the Lake Superior shoreline.

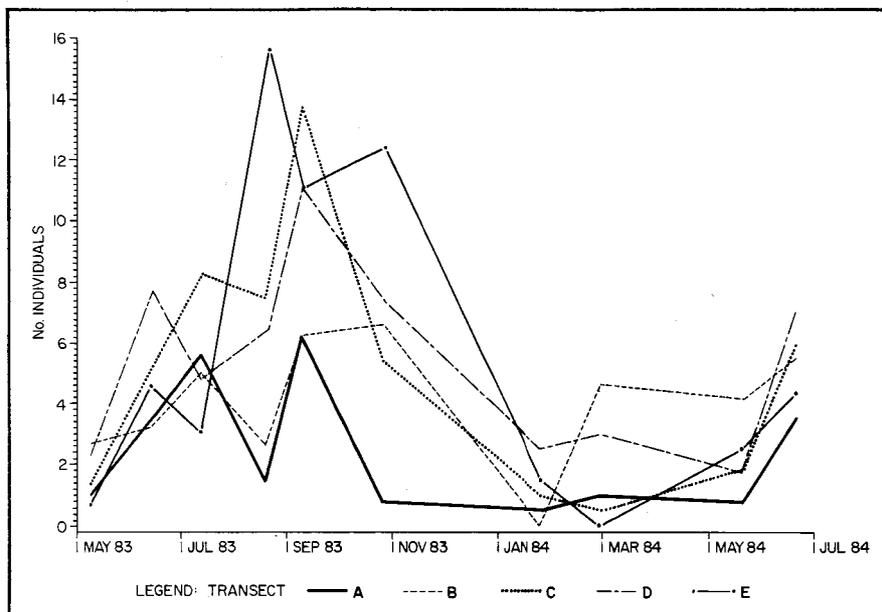
FIGURE 12. Average number of organisms at each transect by date.

Sparse populations of benthic organisms characteristic of oligotrophic lakes are generally found in the western end of the Lake Superior basin in locations where pollution from cities and industries have not been an influence (Winter 1971). Sampling prior to the nourishment operation along the transects off Wisconsin Point, which for the most part appears to be isolated from direct impact of the Duluth-Superior ports, reaffirmed that few organisms were inhabiting the near shore zone (Fig. 12).

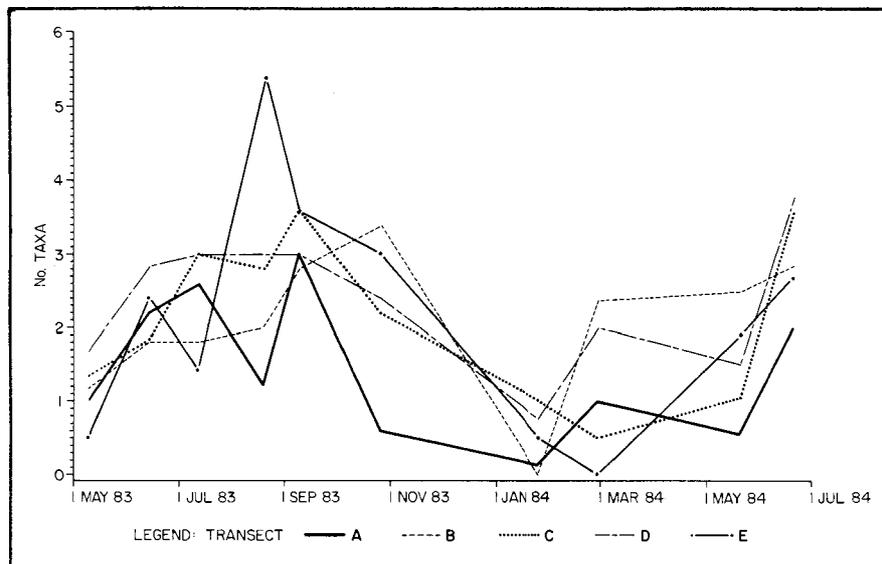
FIGURE 13. Average number of taxa at each transect by date (Chironomid families separately identified).

In addition to being naturally sparse, benthic populations on high-energy Great Lakes beaches are known to change dramatically with seasons of the year. Our Wisconsin Point sampling showed a reduction in the number of invertebrates and number of taxa found in the near shore zone during winter and early spring (Figs. 13, 14).

Because Wisconsin Point benthic populations are naturally sparse and subject to dynamic changes, major or permanent impacts due to the nourishment project were not documented. Figures 13 and 14 do suggest there were lower numbers, fewer taxa, and less diversity (Shannon Index) along Transect A, in the treatment zone, than along control transects in October 1983 when nourishment operations were nearing completion. However, it appears that by summer 1984, there was no important difference between benthic communities inside and outside the nourished area. The taxa found pre- and post-treatment are shown in Table 6 (Append.).

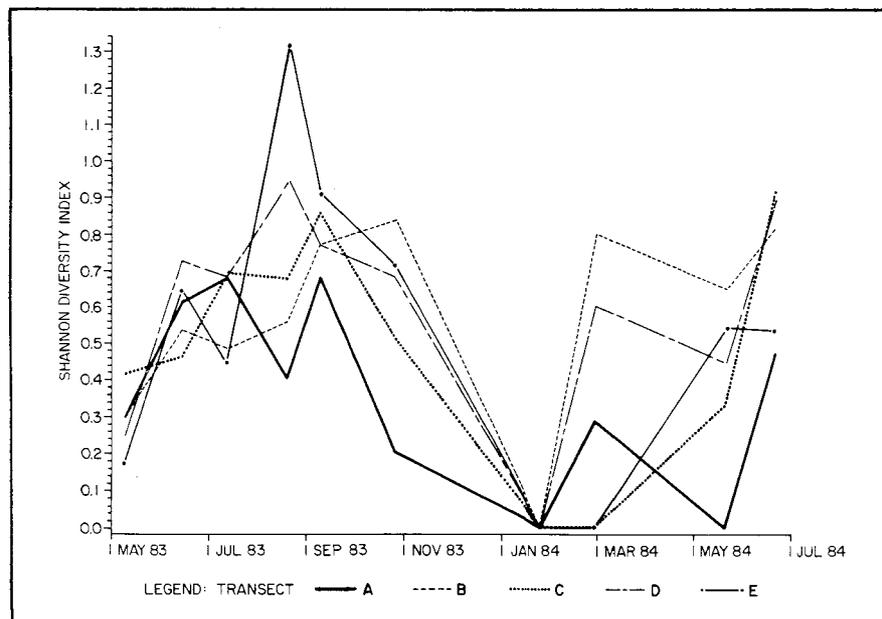
FIGURE 14. Average Shannon diversity at each transect by date (Chironomid families separately identified).
