**The Aquatic Plant Community  
of  
Emerson Lake,  
Clark County, Wisconsin  
2006**

**Deborah Konkel  
Wisconsin Department of Natural Resources  
Eau Claire, WI  
May 2007**

# The Aquatic Plant Community in Emerson Lake, Clark County 2006

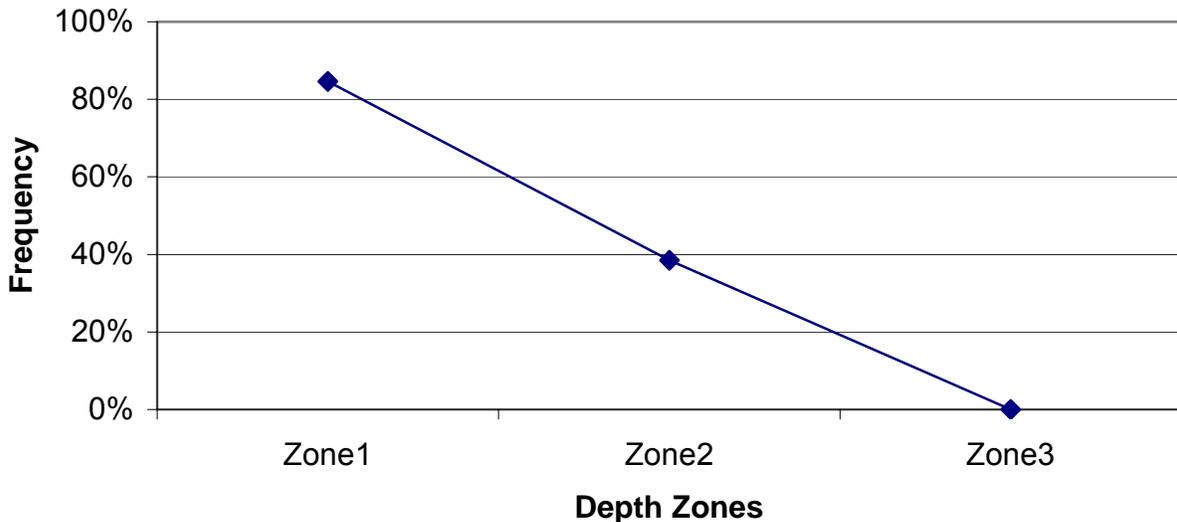
Filamentous algae was found at 50% of the sample sites at the time of the survey, more abundant in the shallow zone (Figure 1).

**Figure 1. Occurrence of filamentous algae in Emerson Lake, 2006.**

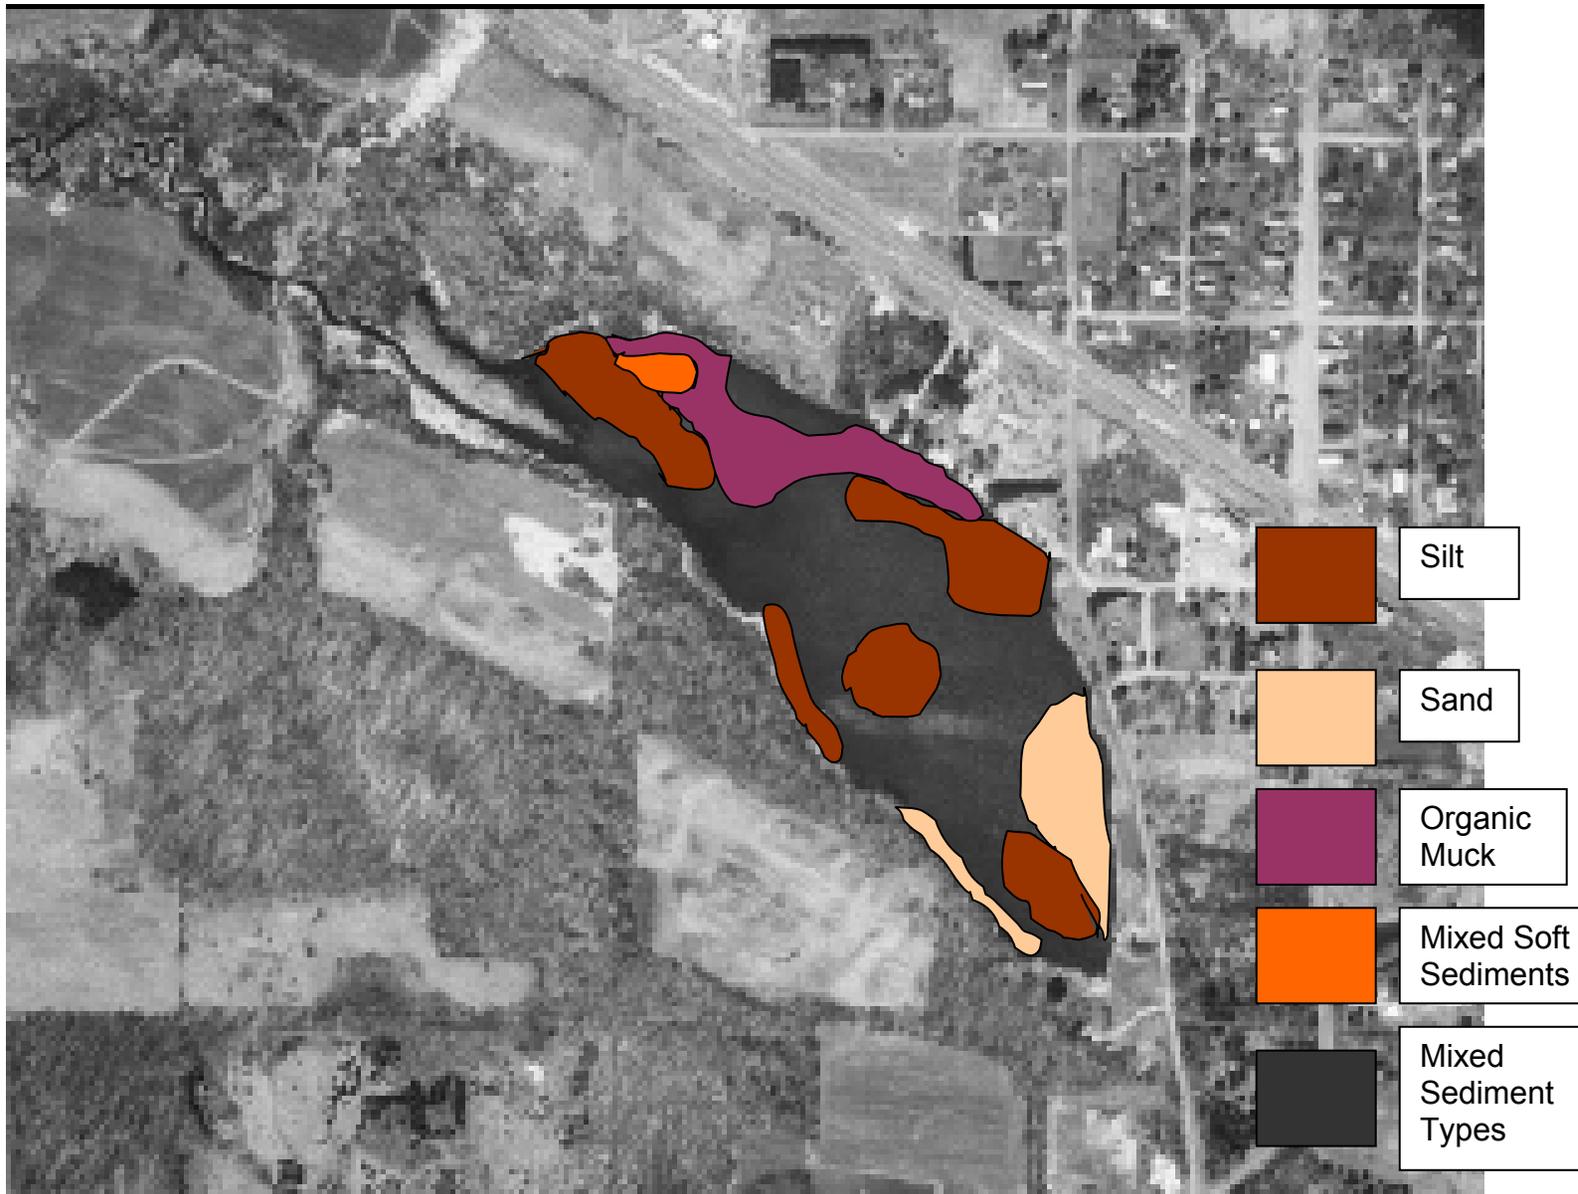
Figure 2.

**SEDIMENT COMPOSITION** – Sand, silt and mixtures of sand and silt were the most common sediments in Emerson Lake, dominating the 5-20ft depth zones (Table 2). Sand was most common in the 0-1.5ft depth zone; silt and silt mixtures were most common in the 1.5-5ft depth zone (Figure 2).

**Distribution of sediment types in Emerson Lake, 2006.**

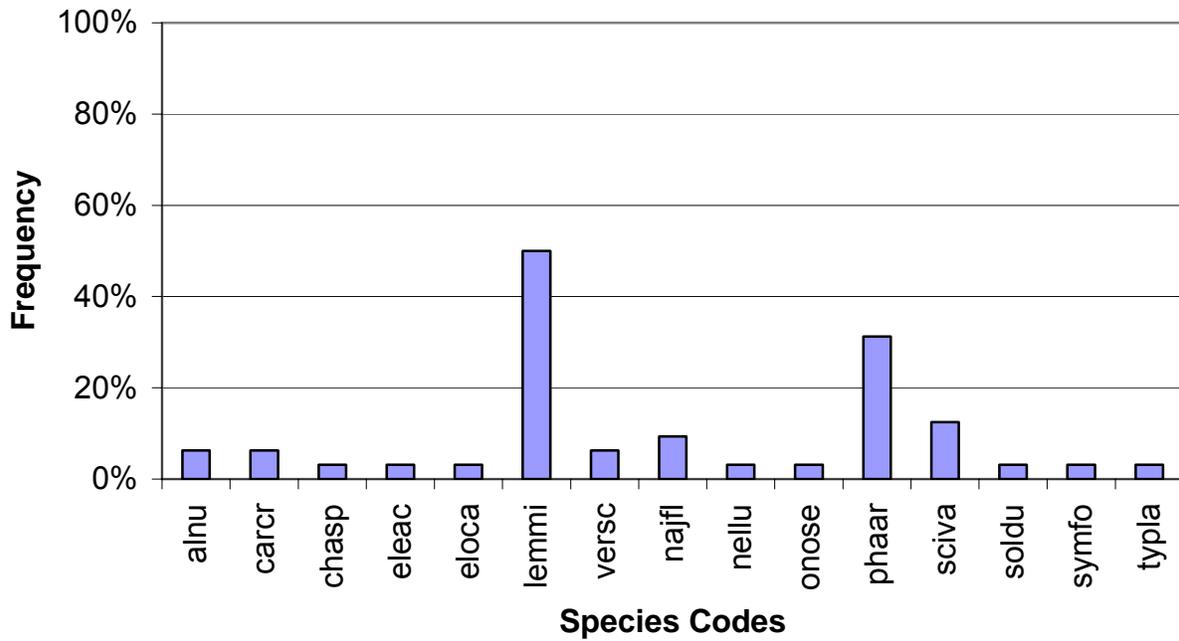
*Lemna minor* (small duckweed) was the most frequently occurring species in Emerson Lake in 2006, (50% of sample sites) (Figure 3). *Phalaris arundinacea* (reed canary grass) was a commonly occurring species, (31%) (Figure 3).

Figure 3. Frequency of aquatic plant species in Emerson Lake, 2006.

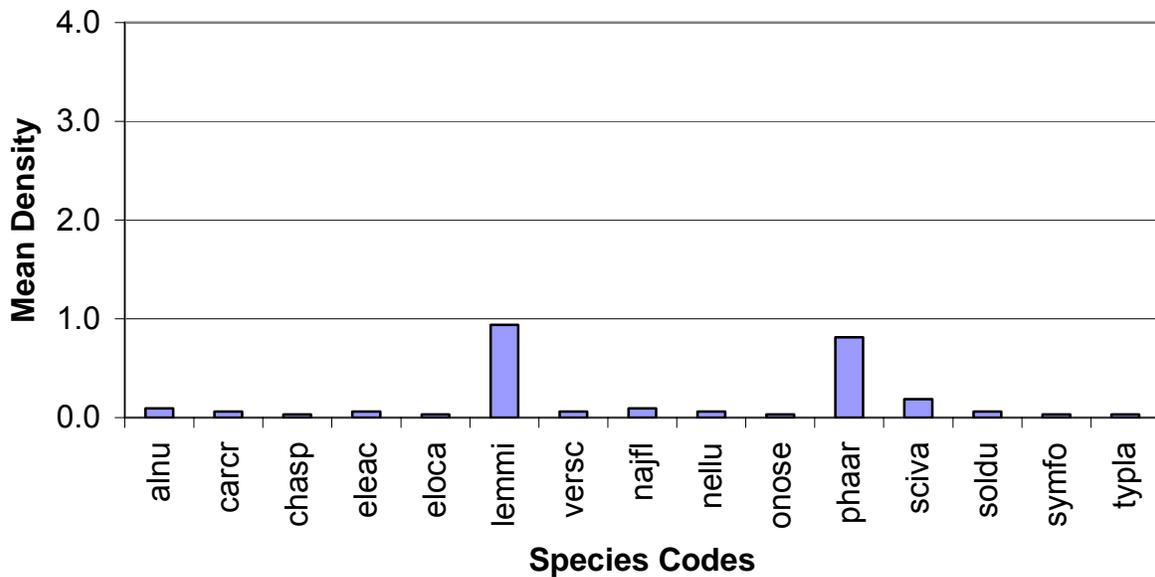
*Lemna minor* (small duckweed) was the species with the highest mean density (0.94 on a density scale of 0-4) in Emerson Lake (Figure 4). All aquatic plant species were found at low mean densities in Emerson Lake.

Figure 4. Mean densities of aquatic plant species in Emerson Lake, 2006.

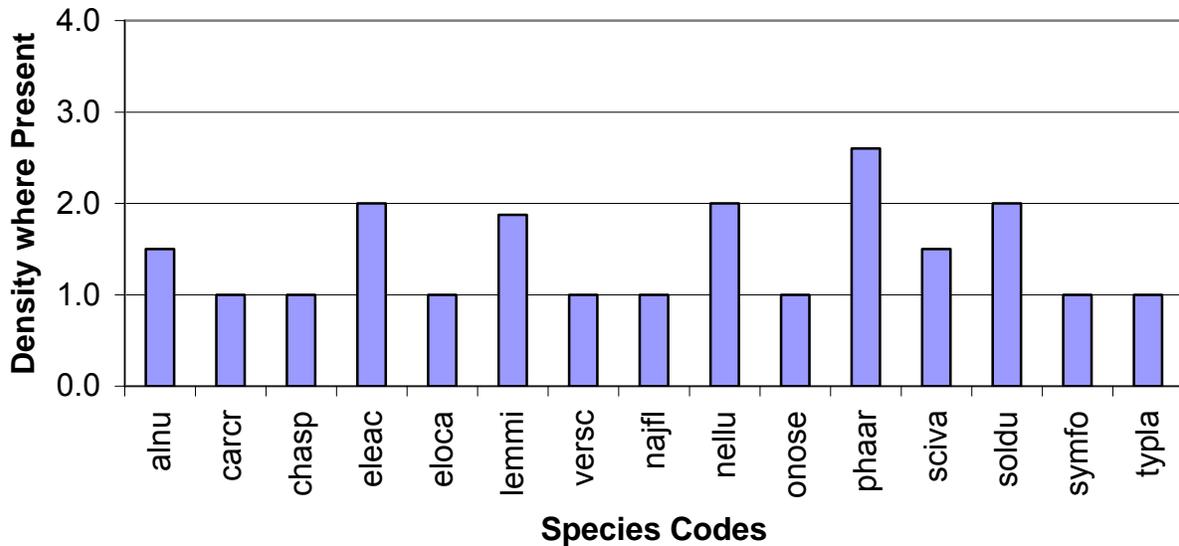
Only *Phalaris arundinacea* (reed canary grass) had a “density where present” greater than 2.5 (2.60 on a density scale of 0-4) (Figure 5), indicating that *P. arundinacea* exhibited a growth form of above average density in Emerson Lake.

**Figure 5. “Density where present”, density of growth form in Emerson Lake, 2006.**

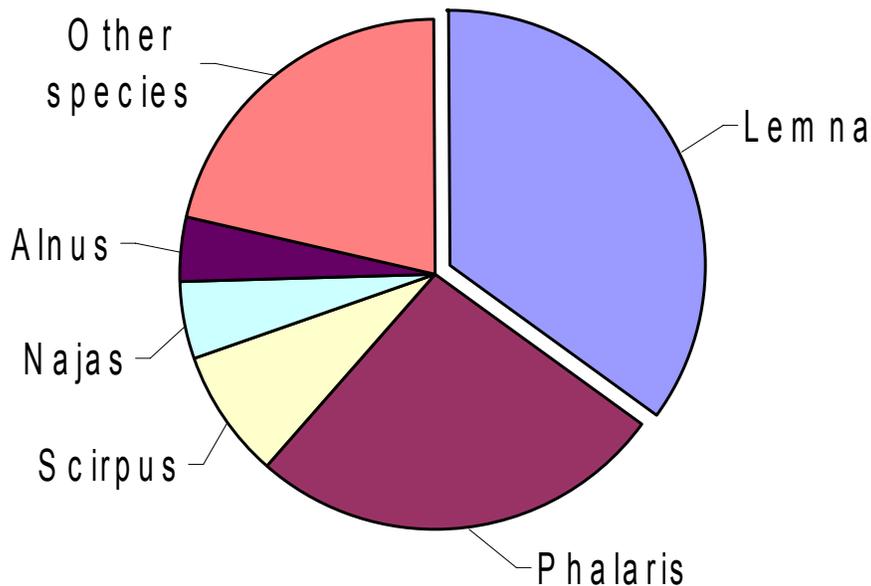
Combining the relative frequency and relative density of a species into a Dominance Value illustrates how dominant a species is within the plant community (Appendix III). Based on the Dominance Value, *Lemna minor* (small duckweed) was the dominant aquatic plant species in Emerson Lake (Figure 6). *Phalaris arundinacea* (reed canary grass) was sub-dominant. These two species alone made up two-thirds of the aquatic plant community.

**Figure 6. Dominance within the plant community, of the most prevalent aquatic plant species in Emerson Lake, 2006.**

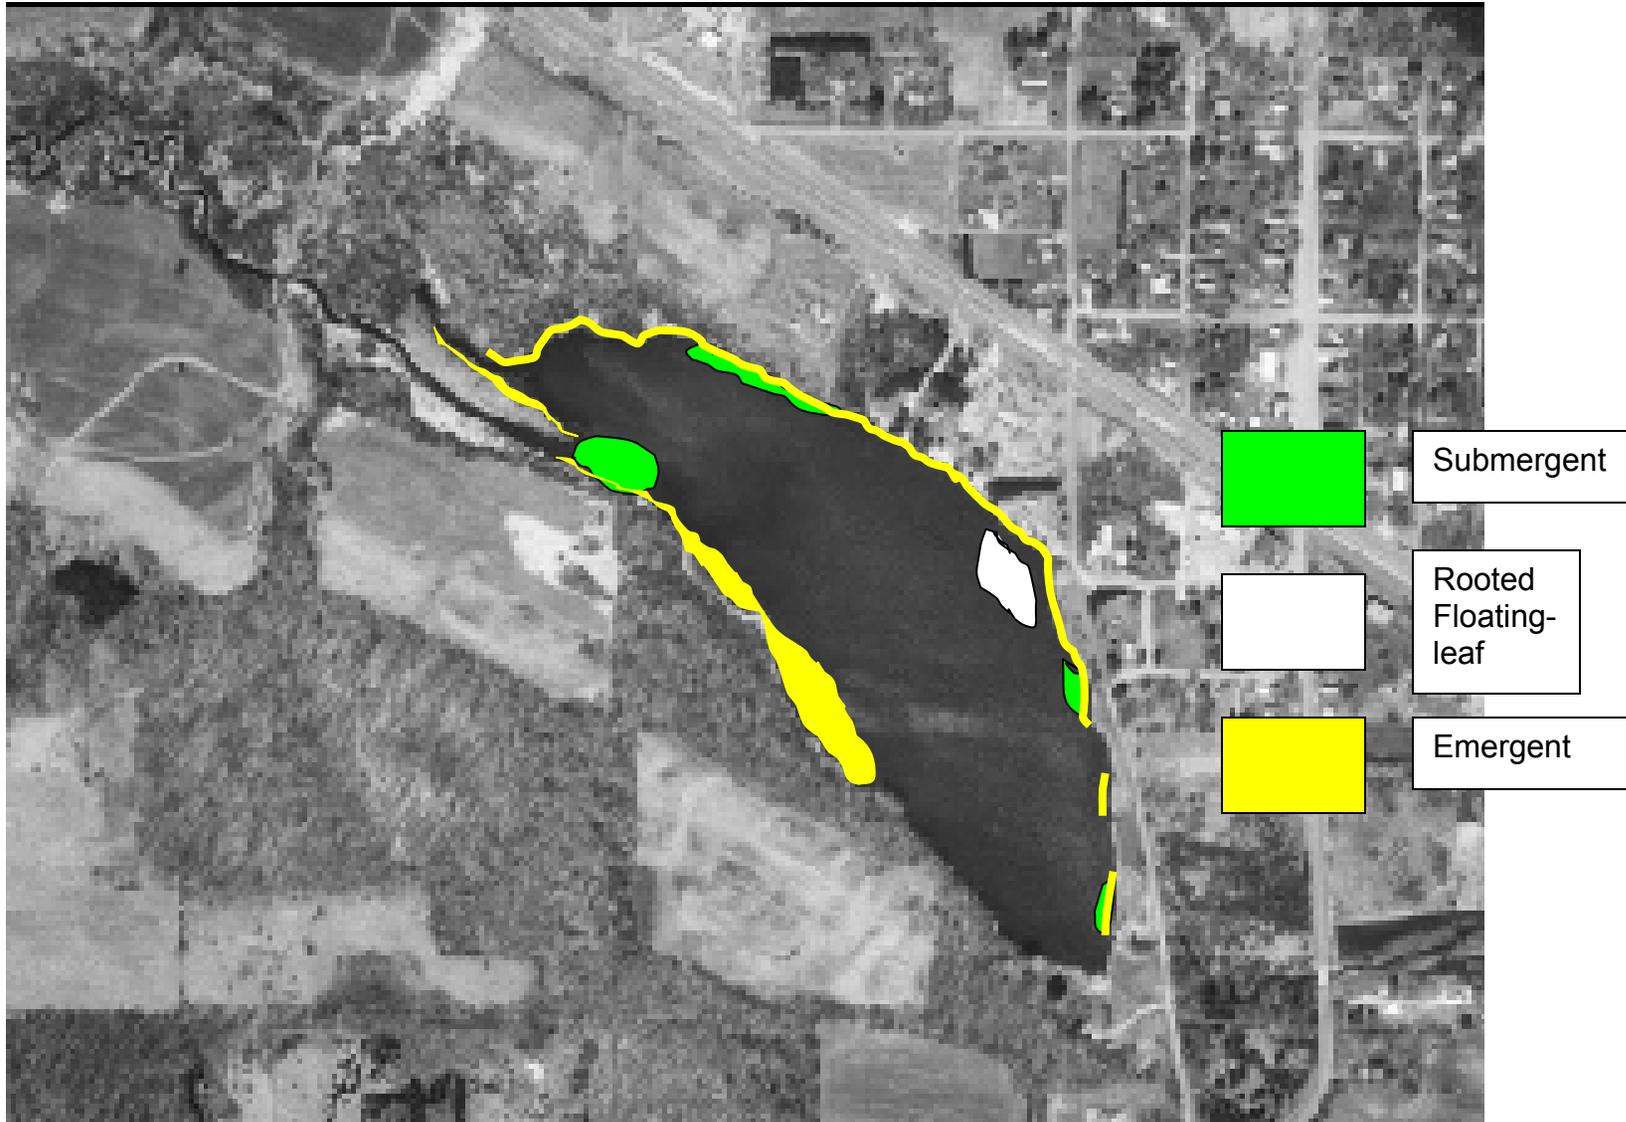
Aquatic plants occurred scattered throughout the littoral zone of Emerson Lake to a maximum rooting depth of 3.5 feet. *Nelumbo lutea* (American lotus) was found at the maximum rooting depth.

Vegetation colonized 53% of the littoral zone, 6% of the lake surface (2 acres). In 2006, approximately 1 acre (3% of the lake surface, 16% of the littoral zone) was vegetated with rooted submergent vegetation. Rooted floating-leaf vegetation colonized about 0.5 acres (2% of the lake surface, 3% of the littoral zone) and emergent vegetation colonized about 0.5 acre (2% of the lake surface, 40% of the littoral zone) (Figure 7). Free-floating duckweed species move around with the wind and the size of the mats will expand and shrink with growing conditions, so mapping it as a permanent cover is not appropriate. In July 2006, free-floating vegetation colonized 50% of the littoral zone.

Figure 7. Distribution of aquatic plants in Emerson Lake, Clark County, 2006.

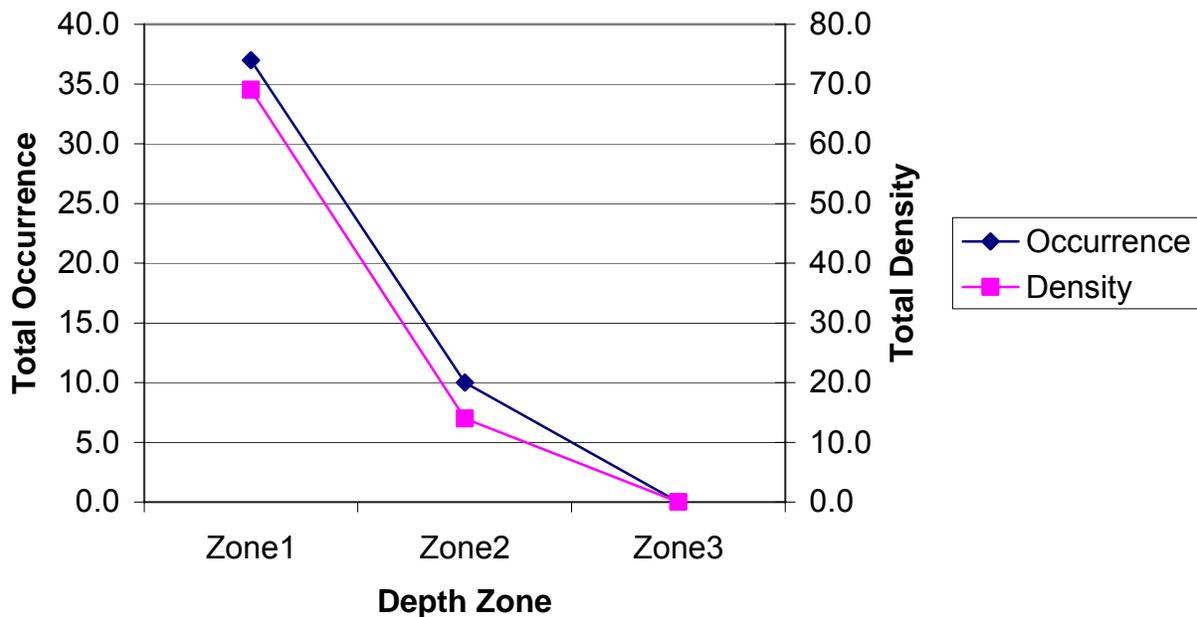
The highest total occurrence and total density of plants was in the 0-1.5ft depth zone and declined rapidly with increasing depth (Figure 8),

**Figure 8. Total occurrence and total density of aquatic plants by depth zone in Emerson Lake, 2006.**

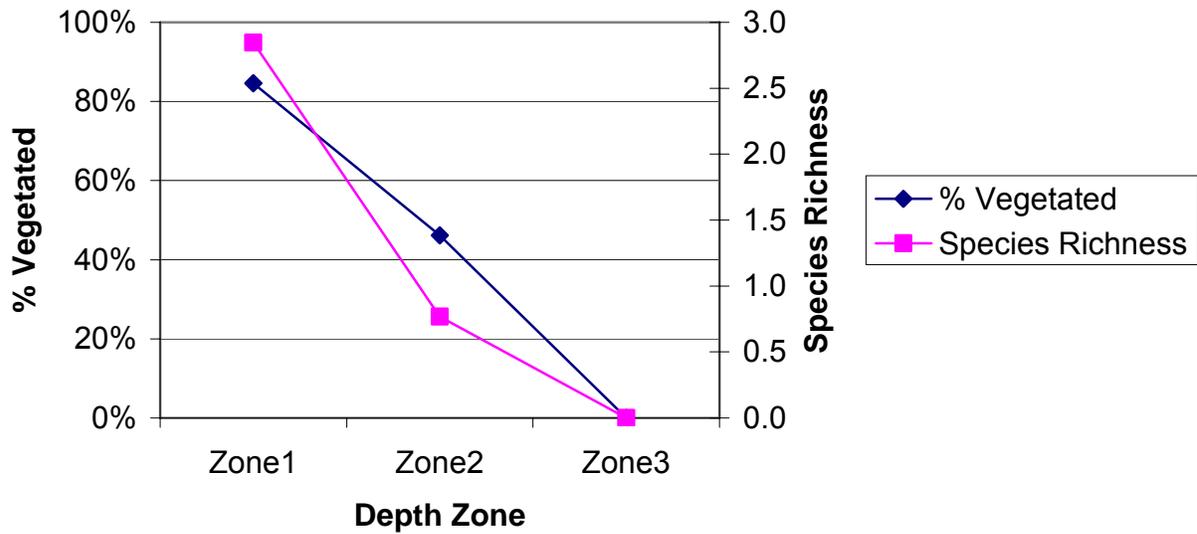
The highest percent of vegetated sites and the greatest species richness (mean number of species per site) were also recorded in the 0-1.5ft depth zone, both declining with increasing depth (Figure 9). Overall Species Richness in Emerson Lake was 1.47.

**Figure 9. Percent of vegetated sites and Species Richness (mean number of species per sample site) by depth zone in Emerson Lake, 2006.**

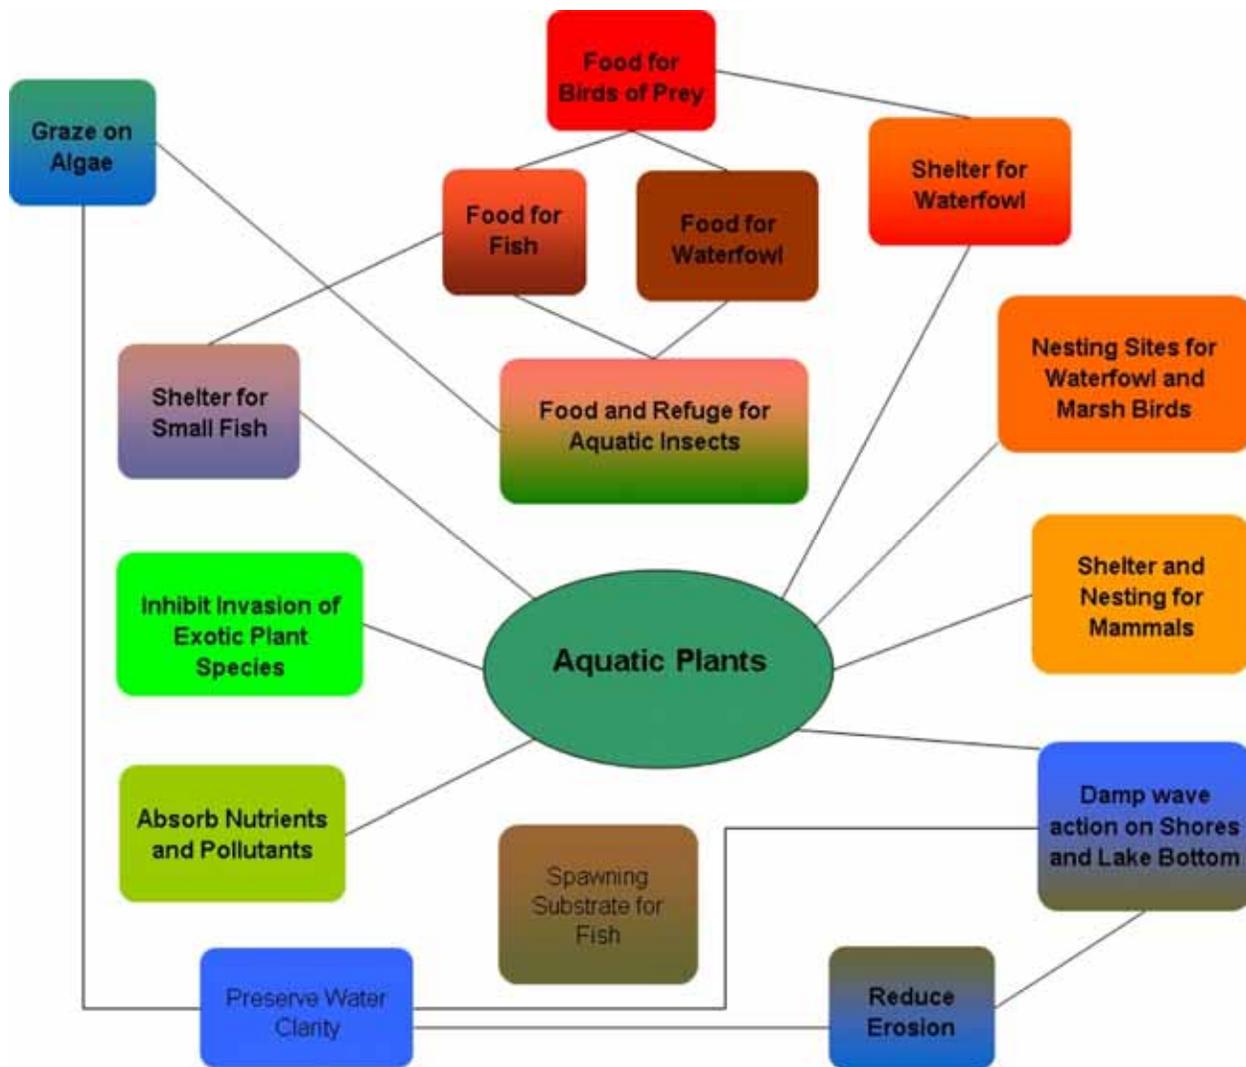
A healthy aquatic plant community plays a vital role within the lake community (Figure 10). This is due to the role plants play in 1) improving water quality 2) providing valuable habitat resources for fish and wildlife 3) resisting invasions of non-native species and 4) checking excessive growth of tolerant species that could out compete sensitive species, thus reducing diversity.

**Figure 10. Benefits of Aquatic Plants in the Lake Ecosystem.**

Aquatic plant communities improve water quality in many ways: they trap nutrients, debris, and pollutants entering a water body; absorb and break down some pollutants; reduce erosion by damping wave action and stabilizing shorelines and lake bottoms; remove nutrients that would otherwise be available for algae blooms (Engel 1985).

Aquatic plant communities provide important fishery and wildlife resources. Plants (including algae) start the food chain that supports many levels of wildlife, and at the same time produce oxygen needed by animals. Plants are used as food, cover and nesting/spawning sites by a variety of wildlife and fish (Table 10). Plant cover within the littoral zone of Emerson Lake is 53% and over the entire lake is 6%. The cover more sparse than desirable to support a balanced fishery. Game fish populations have been found to decline when submerged aquatic vegetation cover is less than 10% and greater than 60% (Valley et. al. 2004).

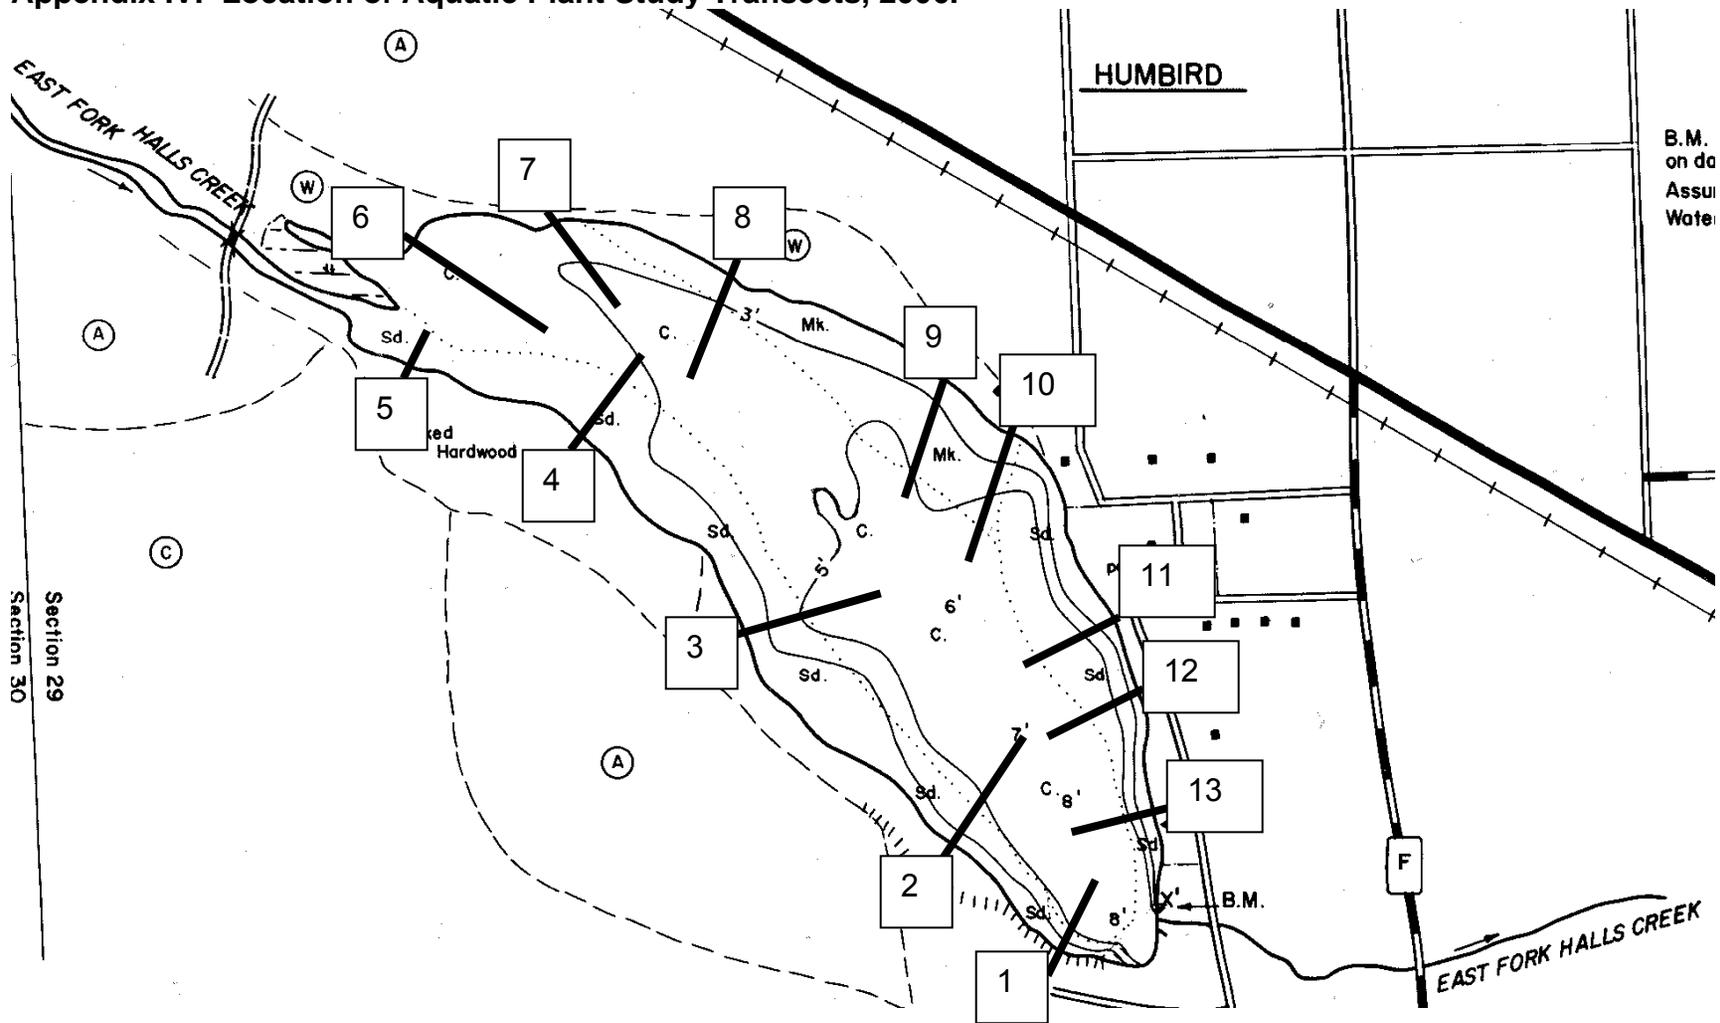
Appendix IV. Location of Aquatic Plant Study Transects, 2006.

The study design was based on the rake-sampling method developed by Jessen and Lound (1962), using stratified random placement of the transect lines. The shoreline was divided into 13 equal segments and a transect, perpendicular to the shoreline, was randomly placed within each segment (Appendix IV), using a random numbers table.

Emerson Lake has an oval basin, shallow depth and a gradually-sloped littoral zone over most of the lake (Appendix IV). Gradual slopes provide a more stable substrate for rooting and a broad band of water shallow enough for plant growth. This means Emerson Lake has the potential to support aquatic plant growth over most of the lake.
