Aquatic invasive species survey of lakes with public access in Barron, Chippewa, Dunn, Eau Claire, and Rusk counties

**By Anna Mares, Sarah Braun and D. Jo Heuschele
Beaver Creek Reserve Citizen Science Center
Fall Creek, WI**

December, 2009

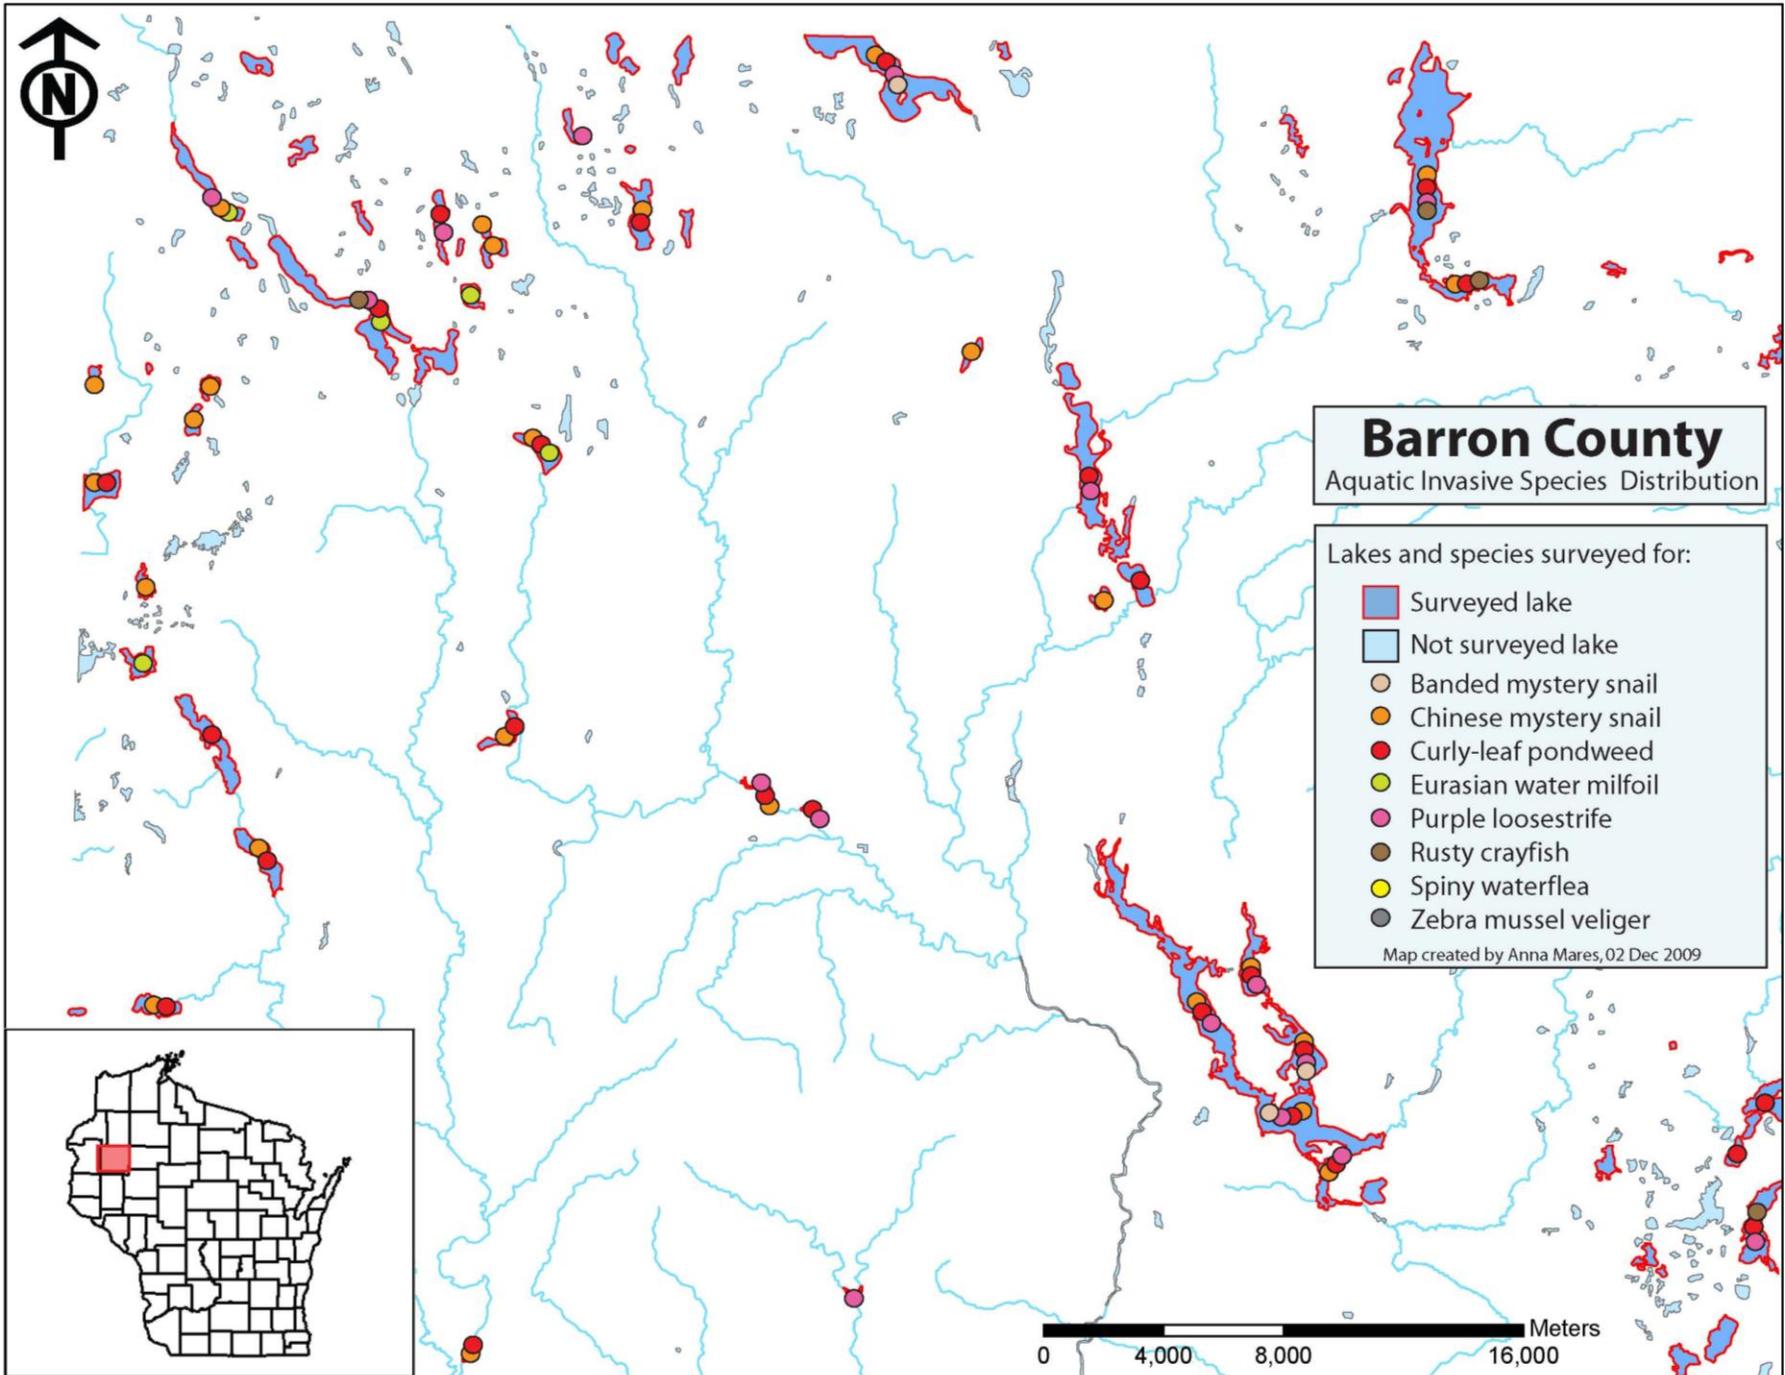
Figure 1. Distribution of eight aquatic invasive species across Barron County in lakes that were part of the five-county survey.

As of September 30, 2009, 114 lakes were sampled for one to eight species. Of the sampled lakes, zero contained zebra mussels, zero contained spiny waterfleas, 17 contained rusty crayfish, 13 contained purple loosestrife, 53 contained curly-leaf pondweed, 15 contained Eurasian water milfoil, 35 contained Chinese mystery snails, and four contained banded mystery snails. Of these, 83 were considered new occurrences. The results displayed in Tables 6, 7, and 8 are also shown in Figures 1, 2, 3, 4, and 5.

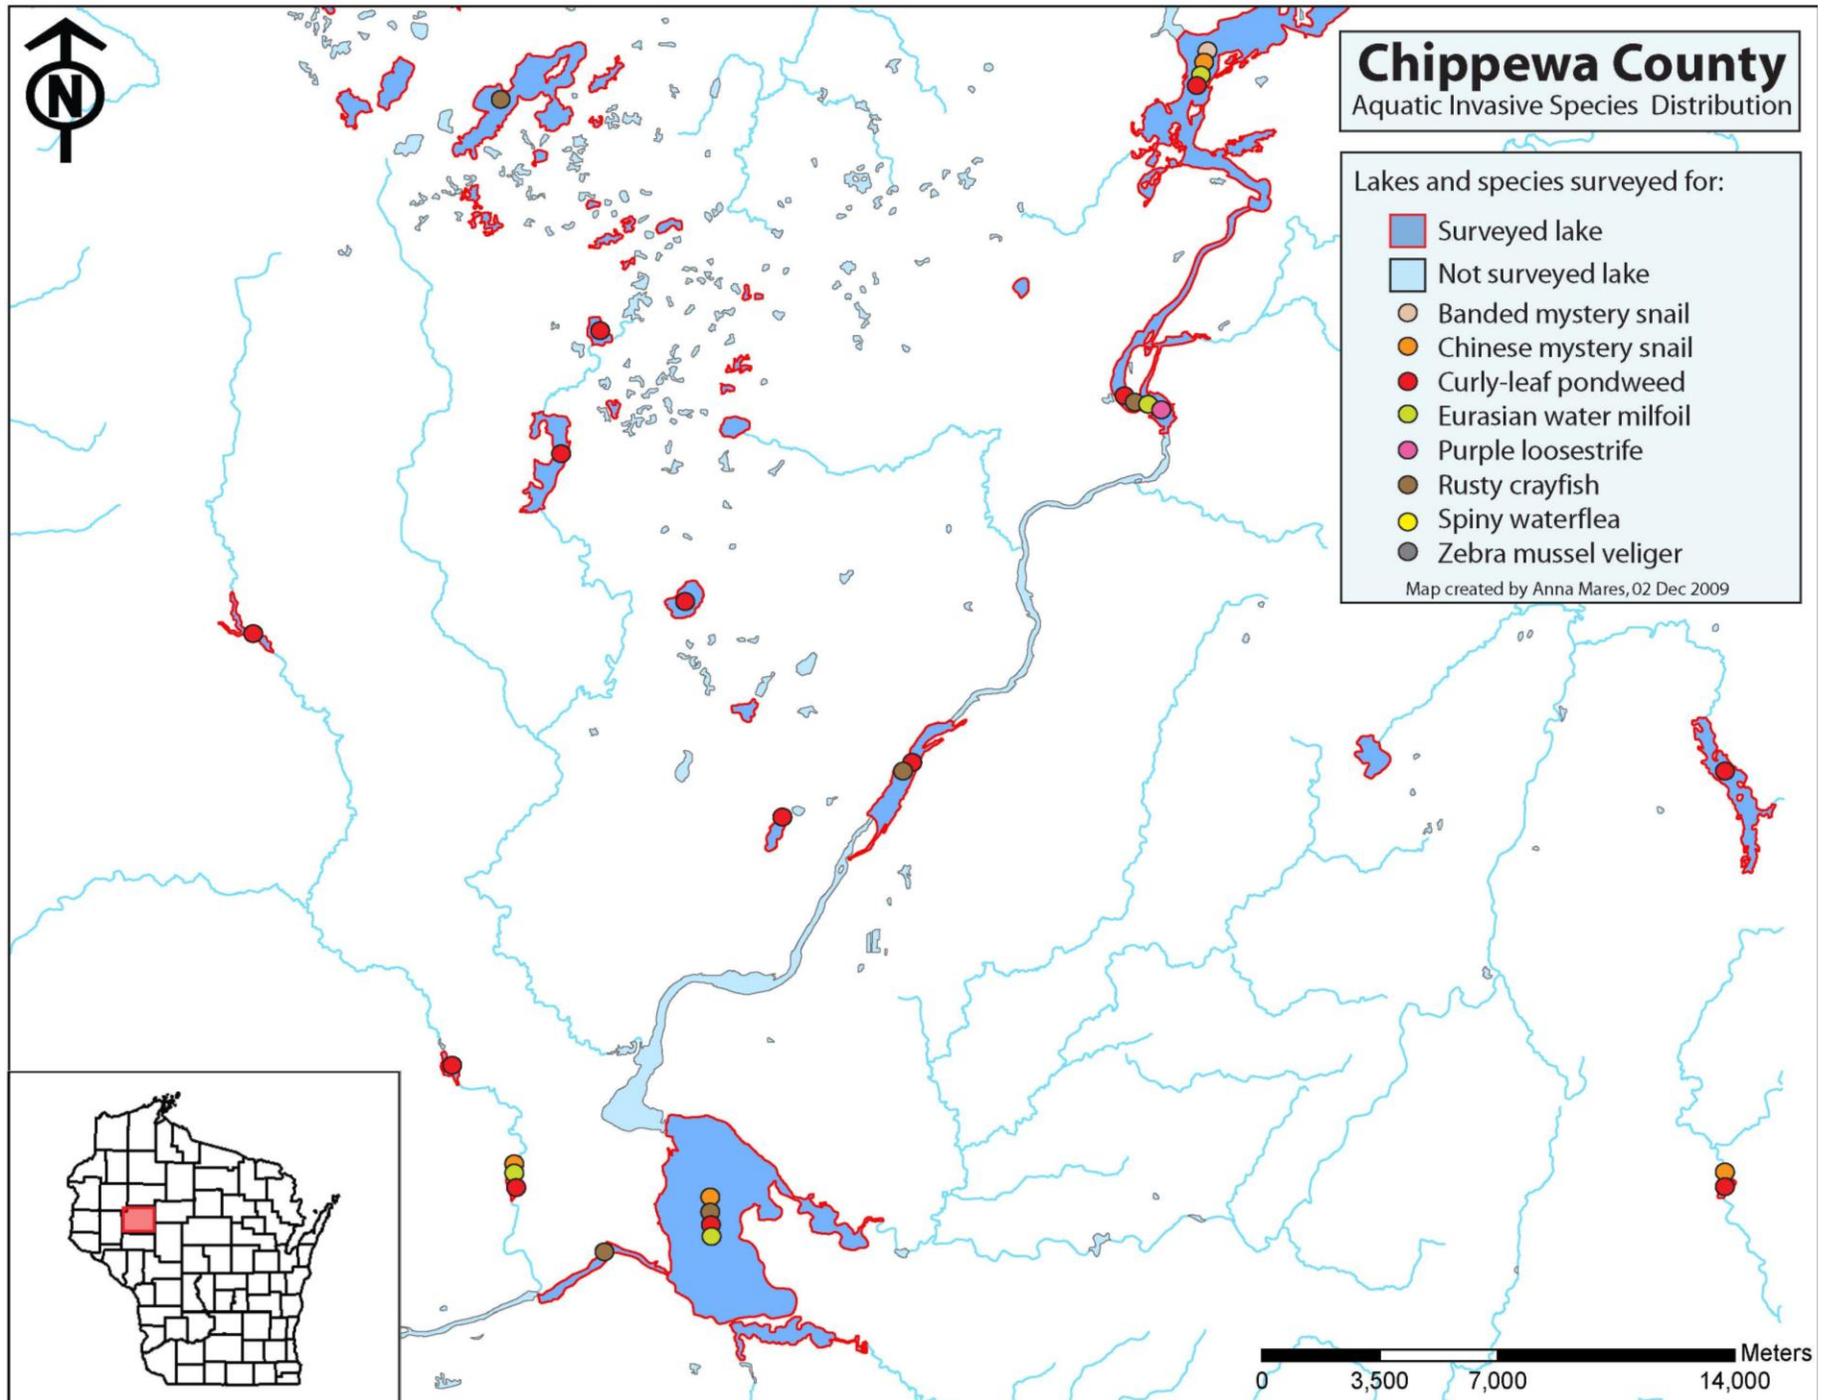
Figure 2. Distribution of eight aquatic invasive species across Chippewa County in lakes that were part of the five-county survey.

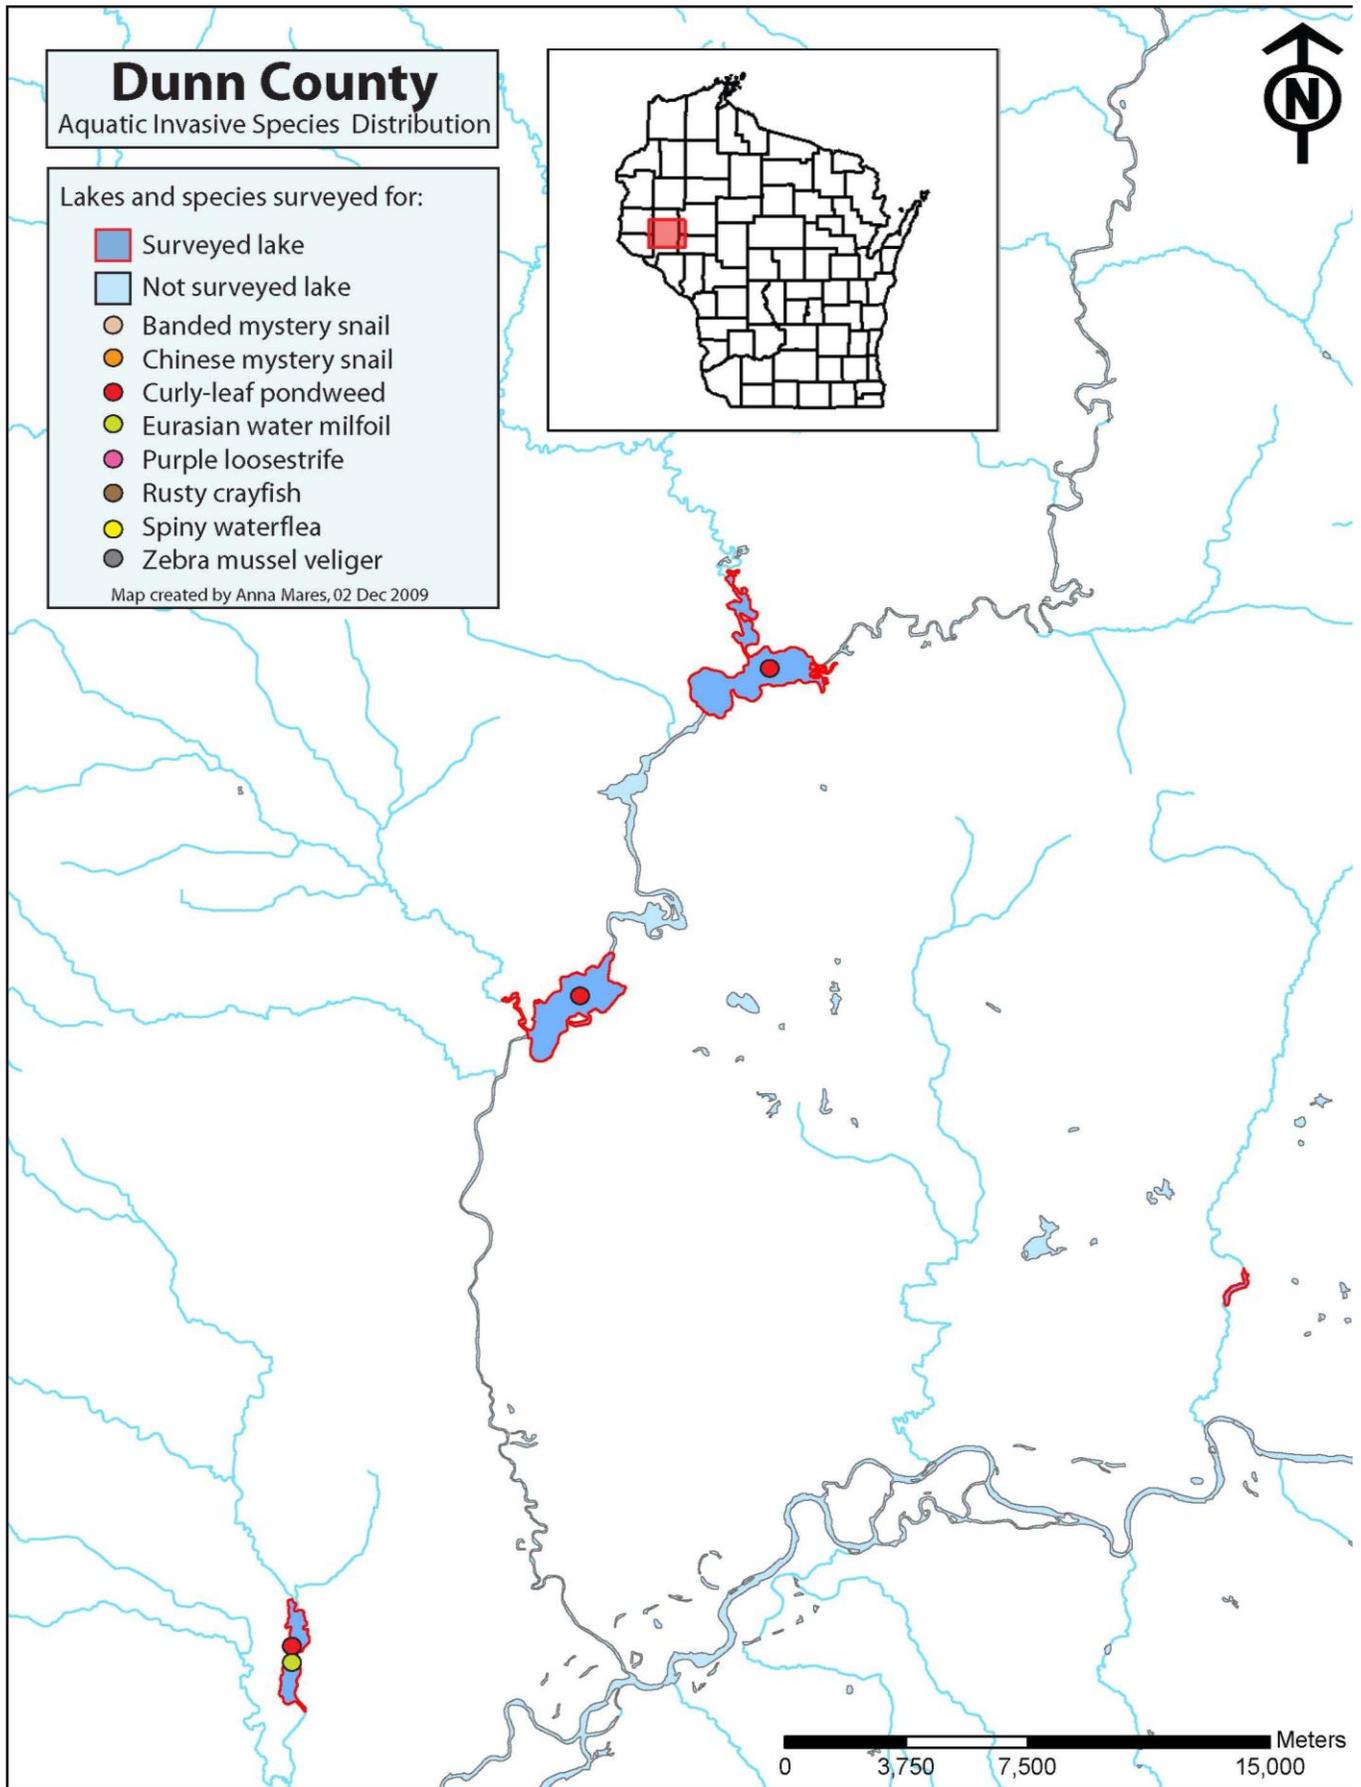
Figure 3. Distribution of eight aquatic invasive species across Dunn County in lakes that were part of the five-county survey.

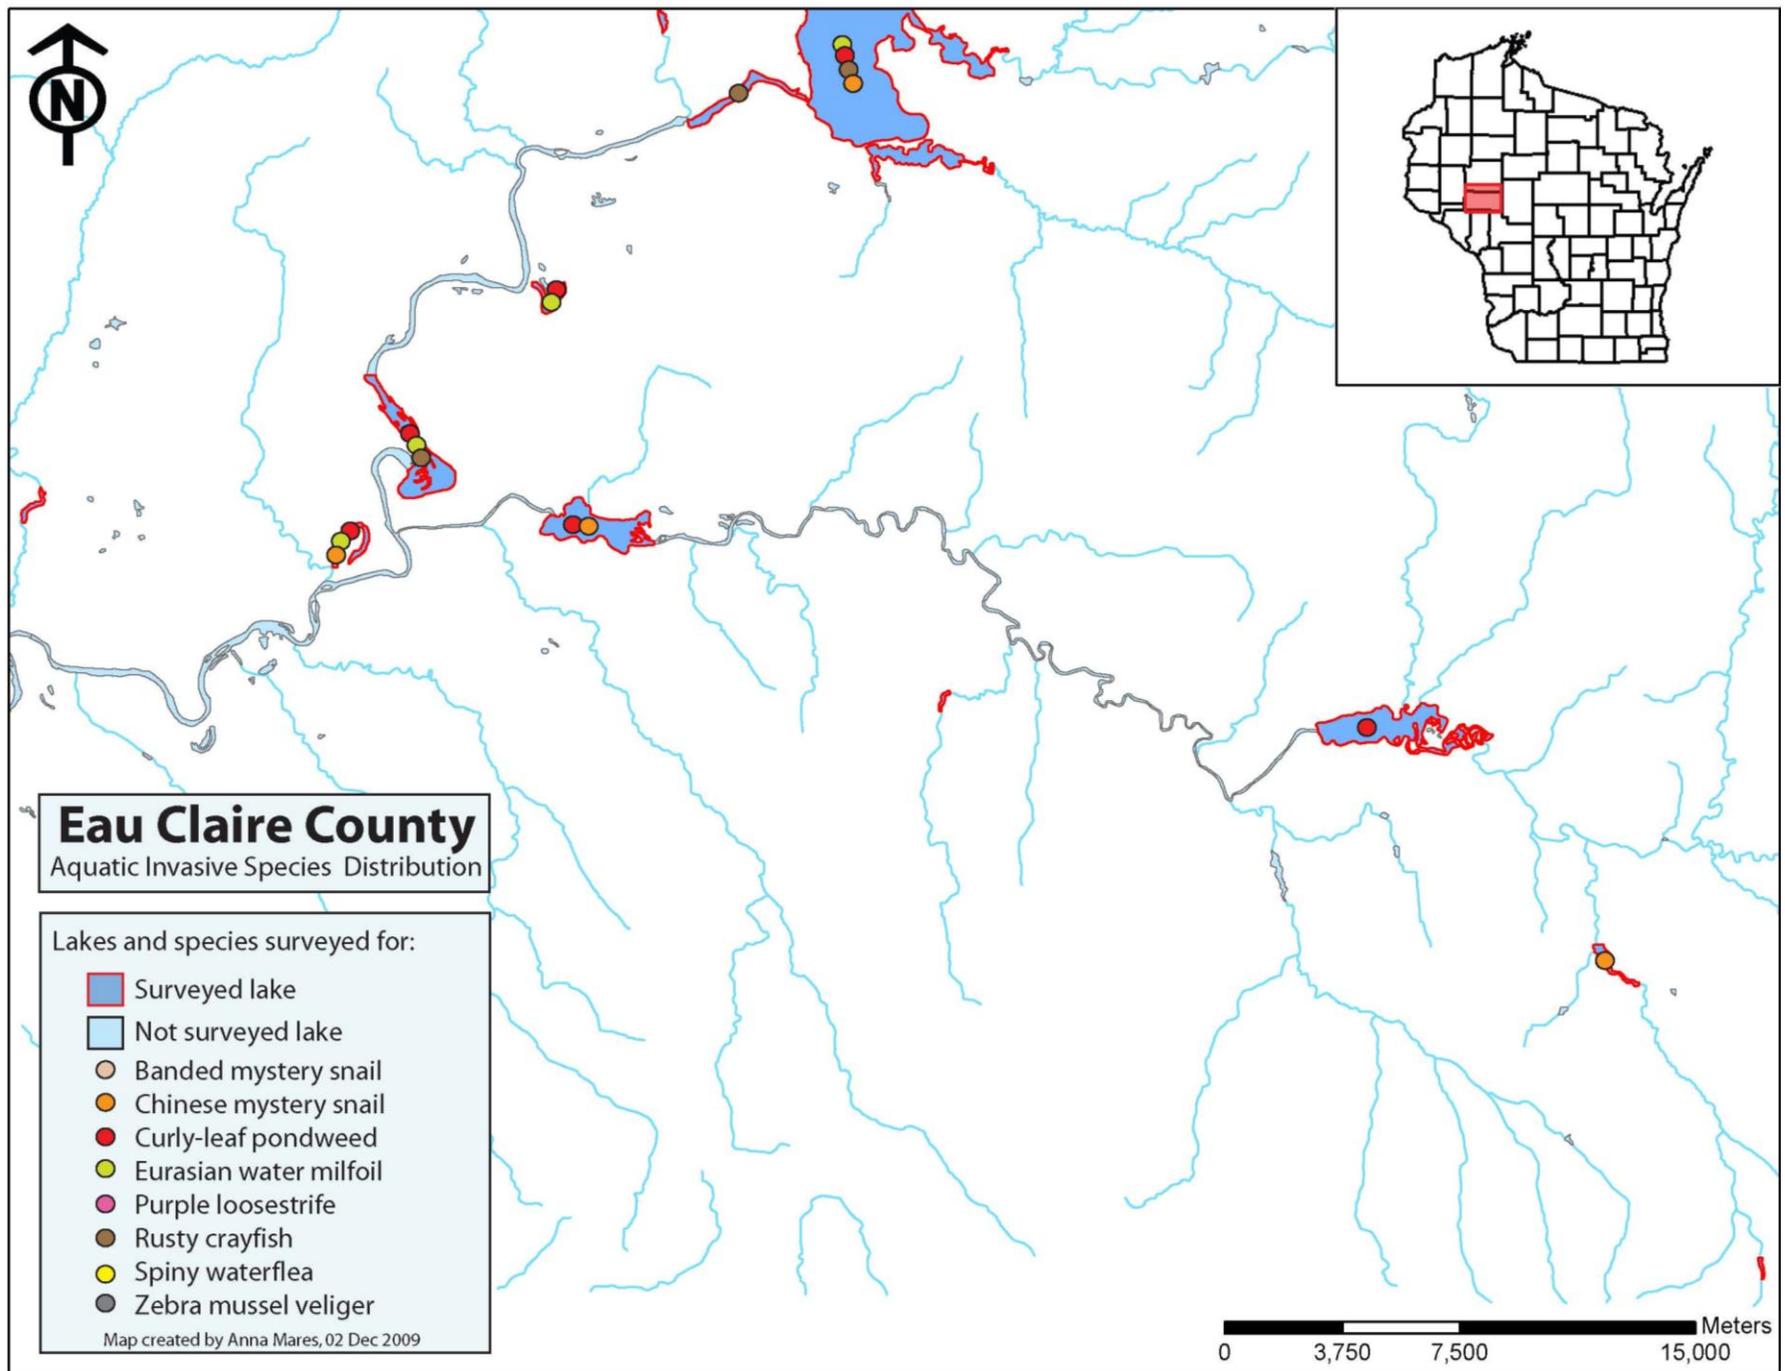
Figure 4. Distribution of eight aquatic invasive species across Eau Claire County in lakes that were part of the five-county survey.

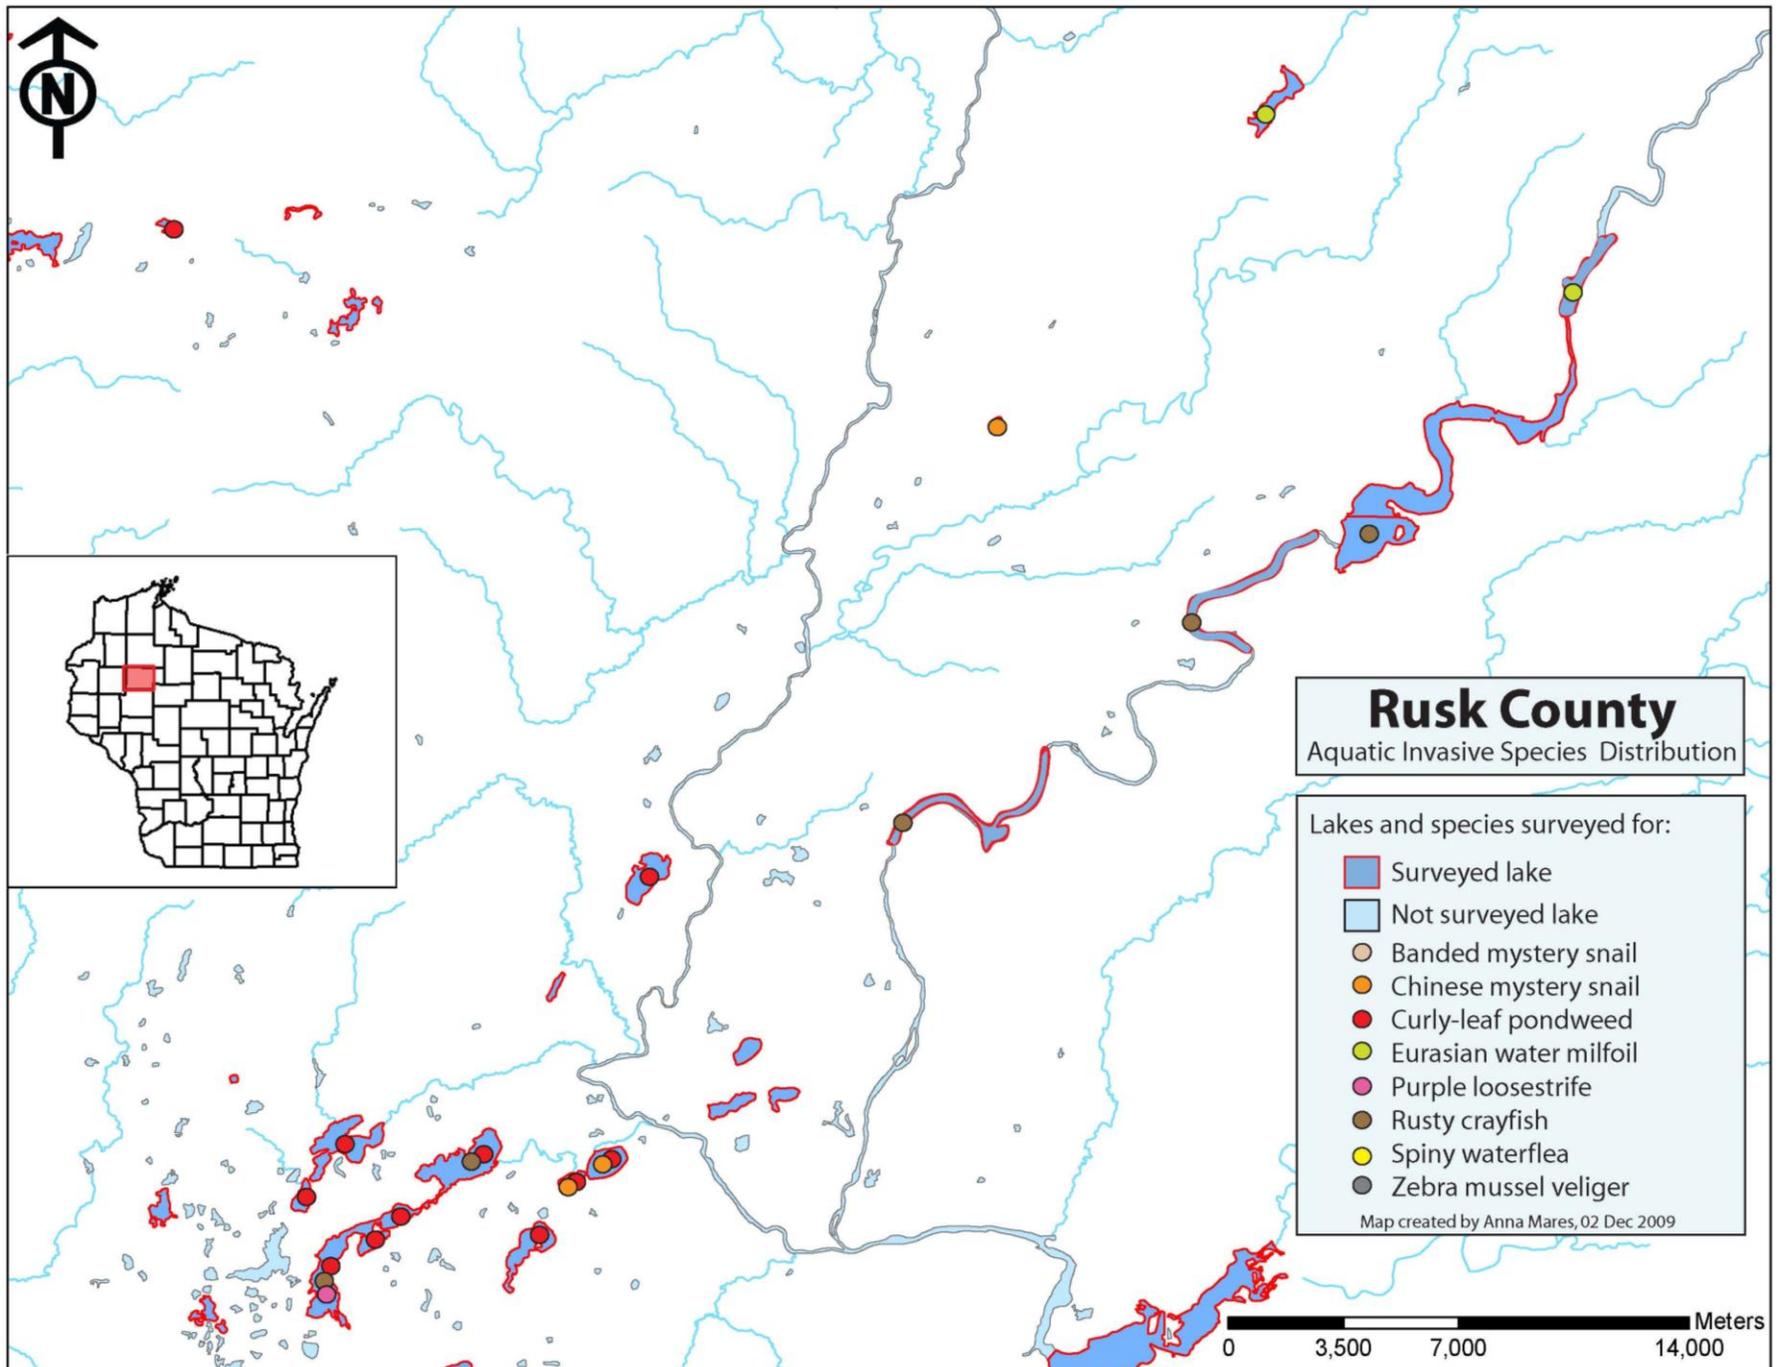
Figure 5. Distribution of eight aquatic invasive species across Rusk County in lakes that were part of the five-county survey.
