**Summary of Boat and Dive Monitoring at Boat Landings for  
Eurasian Water Milfoil (*Myriophyllum spicatum*) on  
Pipe Lake (WBIC: 2490500)  
Polk County, Wisconsin - Summer 2009**

Dick Hollar; Pipe Lakes Protection and Rehabilitation District

Endangered Resource Services, LLC  
Matthew S. Berg, Research Biologist  
St. Croix Falls, Wisconsin  
October 21, 2009

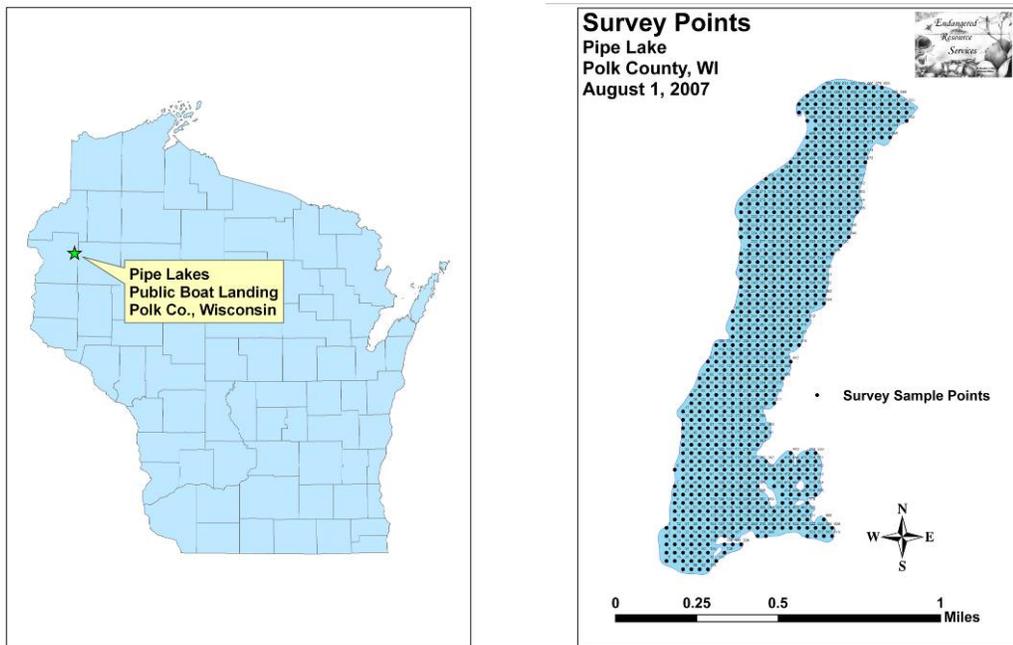
**Figure 1: Pipe Lakes, Polk Co., WI and Point Intercept Points 2007**

During the summer of 2007, an extensive point intercept plant survey found there was no Eurasian water milfoil (*Myriophyllum spicatum*) in the Pipe Lakes (Figure 1). As part of completing an Aquatic Plant Management Plan (APMP), the Pipe Lakes Protection and Rehabilitation District, Cedar Corp. and ERS, LLC decided that monthly transect surveys at the lakes' boat landings would be a prudent measure considering the increasing number of neighboring lakes that EWM has invaded (Horseshoe, Echo, Beaver Dam, Lower Vermillion, etc.). These surveys will be conducted annually until the next full Point Intercept Survey. At that time, this and the rest of the items in the lakes' APMP will be reexamined.

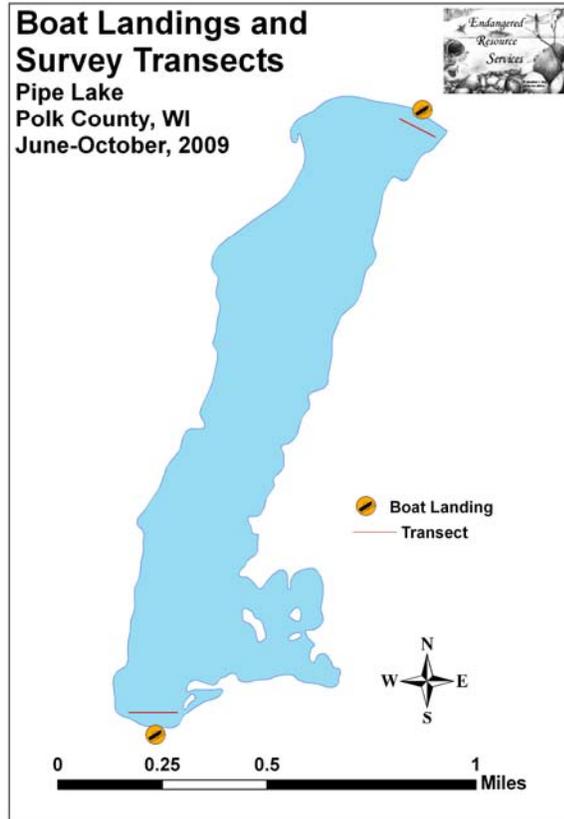
**Figure 2: Boat Landings and EWM Survey Transects 2009**

During the five months from the June-October 2009, we conducted landing inspections once a month at the north boat landing and the “unofficial” south landing on Pipe Lake (Figure 2). If conditions allowed (not raining and/or no people present swimming in area), we initially conducted a boat survey of the area. Using three 100-150m parallel transects approximately 15, 30 and 45m from shore; we motored at idle speed looking for any evidence of EWM’s characteristic red growth top. Once we had finished the three transects, we returned to our starting point using a stitch pattern that crossed back and forth over all three lines to look for any plants we may have missed between the transects.

Following the boat inspection, we surveyed using SCUBA gear, compass and an underwater vehicle along those same transects with the return to start again using a stitch pattern to maximize coverage of the area. Because Pipe Lake is essentially an elongated bowl and it was easy to do, on the first and final surveys of the year, we conducted a boat survey along the shoreline of the entire lake to look for EWM in the zone of growth it would most likely be found in.

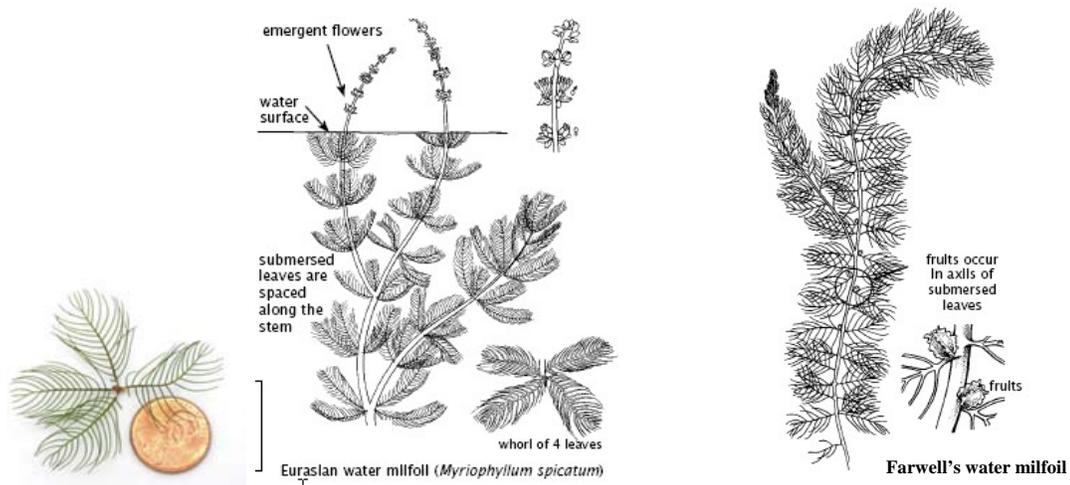
**Figure 3: EWM and Farwell's Water Milfoil Identification**  
(Hill et al. in Maine's Field Guide to Aquatic Invasive Species and Crow and Hellquist 2006)

We again found Farwell's water milfoil in the sheltered bays in the southeast corner of Pipe Lake where it forms a small number of dense underwater beds in shallow water over thick organic muck. It can be told from EWM by its normal number of leaflets numbering <16 whereas EWM normally has >26 leaflets (Figure 3). EWM also has an emergent flower stalk where Farwell's flowers are scattered along the stem and look like tiny nuts. During our September visit, we collected several specimens and sent them to a molecular geneticist from Grand Valley State in Michigan. He requested the samples of this rare native milfoil because Farwell's is known from only a handful of lakes throughout the upper Midwest. His research is trying to understand why this species and others associated with it are rare despite being widely distributed.
