*Beaver Dam Lake Aquatic Plant Survey  
and Management Plan*

*Prepared for  
Beaver Dam Lake Management District*

*January 2006*

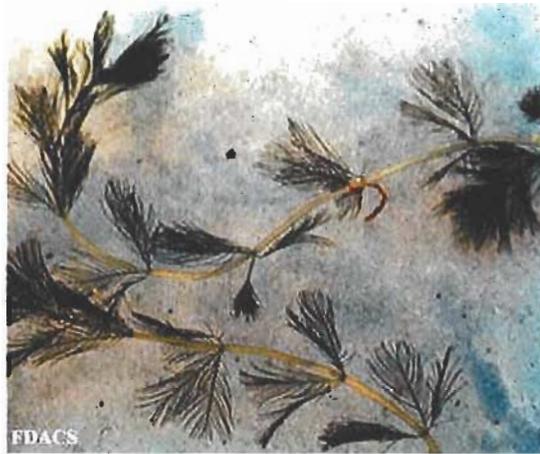
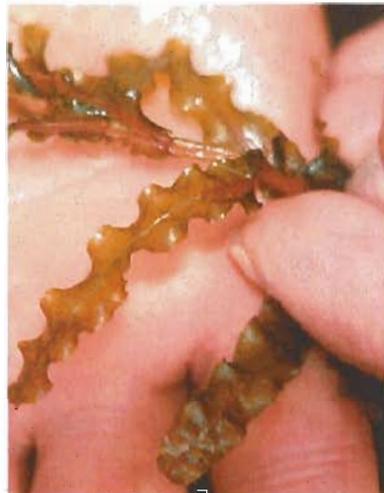
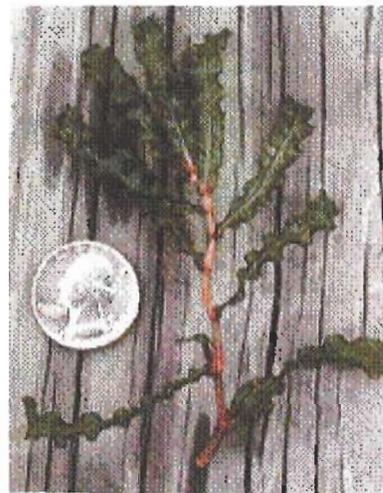
Beaver Dam Lake has a healthy aquatic plant community that is of higher quality and is less tolerant to disturbance than the plant community of the median Wisconsin lake. The presence of EWM and CLP are of concern because these species are not native to this region and have caused problems in lakes throughout the United States by out competing native plants and developing objectionable dense growths (See Figure 32). The lake's CLP community is relatively stable and has changed little during the past 6 years. EWM is of greater concern because it has caused problems (i.e., displacement of native species, rapid spread, dense growths, particularly at the lake's surface) within Beaver Dam Lake in the past and will likely cause problems in the future unless managed prudently. EWM was introduced into the lake during the 1990's, spread rapidly, and covered approximately 230 acres by 1999. Annual 2,4-D treatments during 2000 through 2005 have reduced EWM coverage to approximately 89 acres in 2005. Continued management is needed to prevent an increase in EWM coverage and, if possible, attain additional reductions in EWM coverage.

**Figure 32 Beaver Dam Lake Aquatic Invasive Species (AIS)—Eurasian Watermilfoil (EWM) and Curlyleaf Pondweed (CLP)**

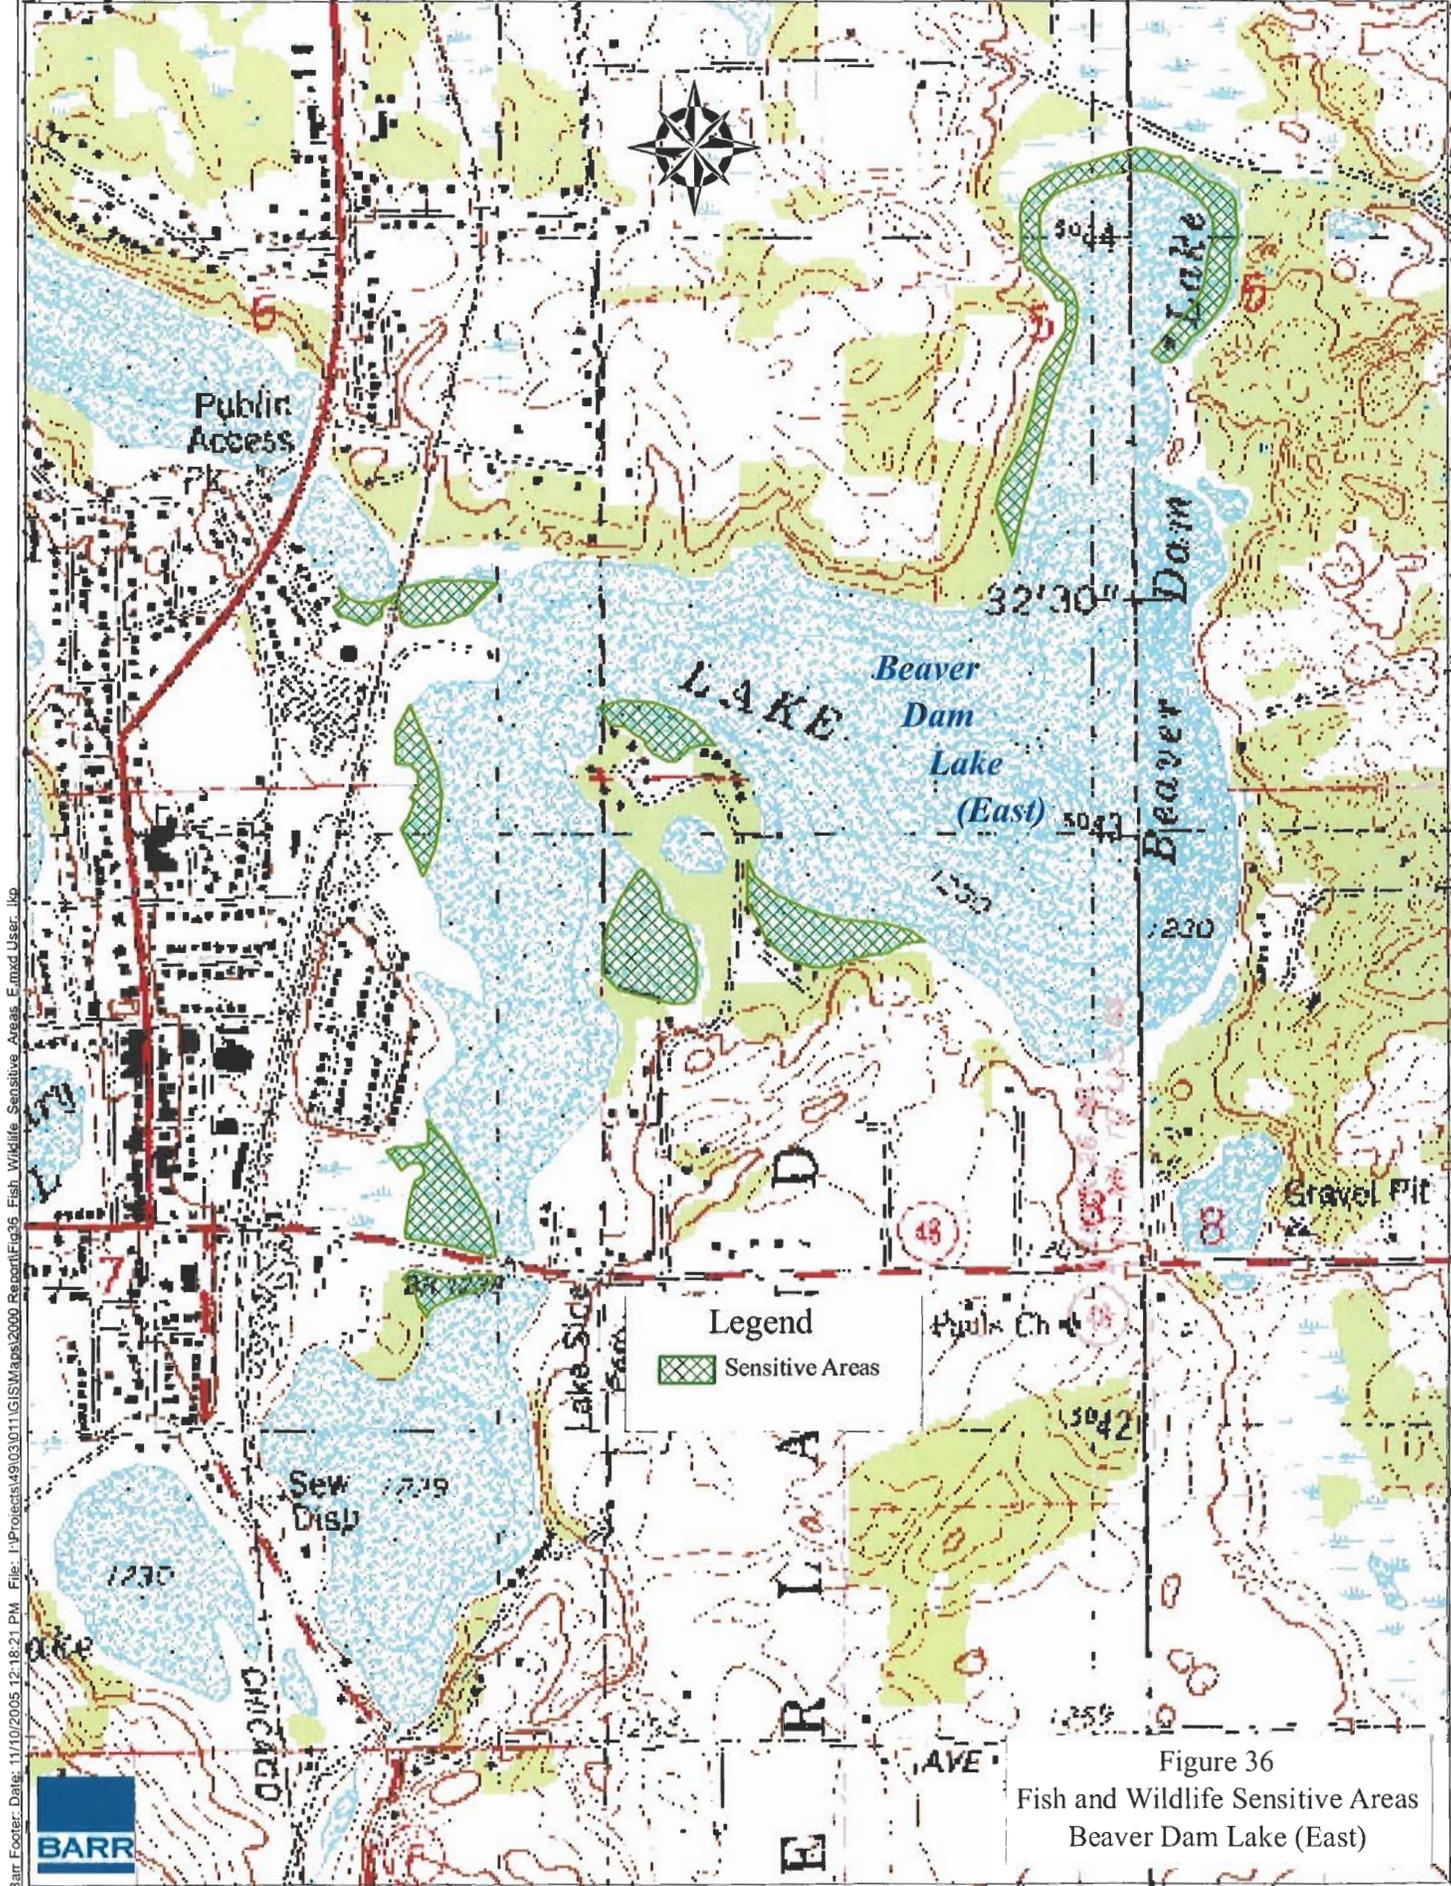
In addition to human uses, the lake provides habitat for fish, waterfowl, and other animals. The Wisconsin Department of Natural Resources (WDNR) has identified fish and wildlife sensitive areas in Beaver Dam Lake (See Figures 36 and 37). Sensitive areas include habitats that are integral to the lake ecosystem such as nesting sites or fish spawning areas. To protect sensitive areas, plant management within sensitive areas is restricted by the WDNR.

Figure 36  
Fish and Wildlife Sensitive Areas  
Beaver Dam Lake (East)
