Date: May 8, 2007

From: Bernie Michaud, Earth Tech

**Subject: Plymouth Mill Pond Background Watershed Assessment**

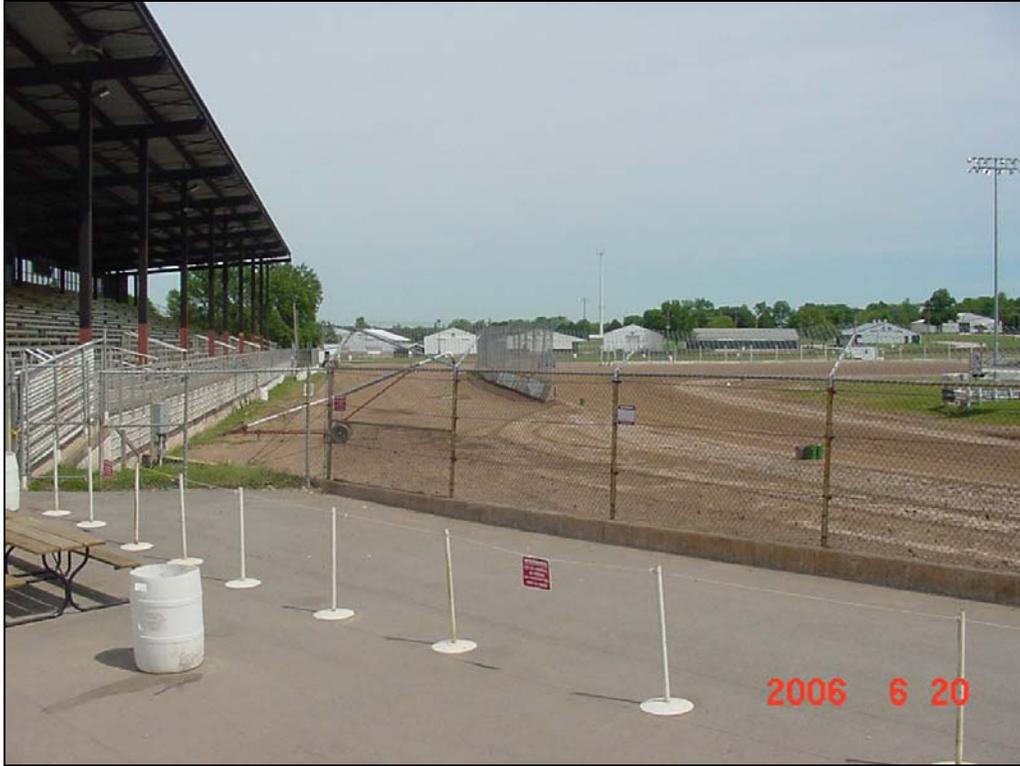
The County Fairgrounds are east of mill pond in the City of Plymouth. The fairgrounds drain directly to mill pond via storm sewers. The fairgrounds have a dirt racetrack for car racing with associated grand stands and barns for livestock. Midget car racing occurs throughout the summer with the County Fair occurring in late summer. This is when the livestock barns are most used, but at the time of the survey fresh horse manure was found near the barns.

The fairgrounds may be a significant source of non-point source pollution to Mill Pond. The dirt track racetrack could generate loadings of mud, oil, grease and gasoline. According to Curtis Nickels of the WDNR, a sediment trap by the racetrack grandstands, a French drain in the infield, and another on the west side of the racetrack has been installed in the past several years in an effort to prevent this non-point source pollution from entering the mill pond. There have been anecdotal observations of the storm sewer outfall going into Mill Pond from the race track area, flowing brown during rain storms. The areas near the barns are paved and are drained by storm sewer inlets. Manure from these areas could easily enter Mill Pond directly from these areas.

Site 1 - Dirt Racetrack

The one site that perhaps deserves some additional investigation is the County Fairgrounds. Given its proximity to and direct discharge to Mill Pond, non-point source pollution from this site could have a significant impact to the water quality of the pond. Drainage routes from both the racetrack and livestock area, as well as other possible pollutant sources, should be further investigated. If it is found that non-point source pollution from this site is making its way to the mill pond there are a number of practices that could be employed to try and improve the situation. These could include disconnecting the flow paths to the pond, removing the pollutant sources, or treating the runoff before it reaches the pond.

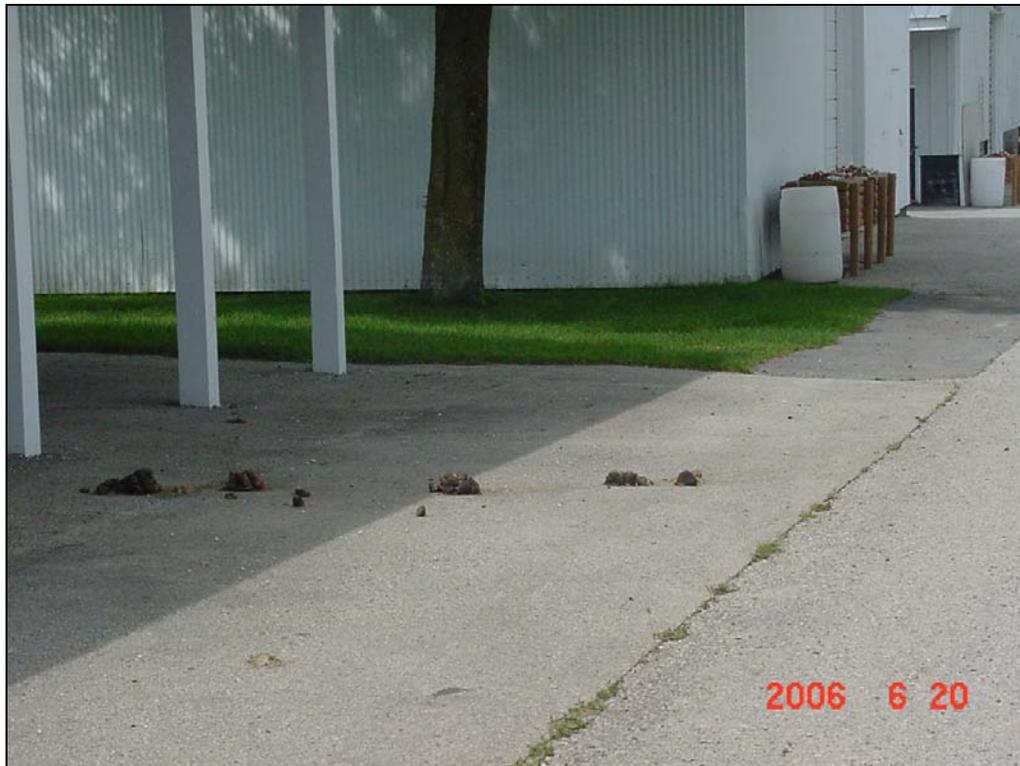
Site 1 - Manure near livestock barns

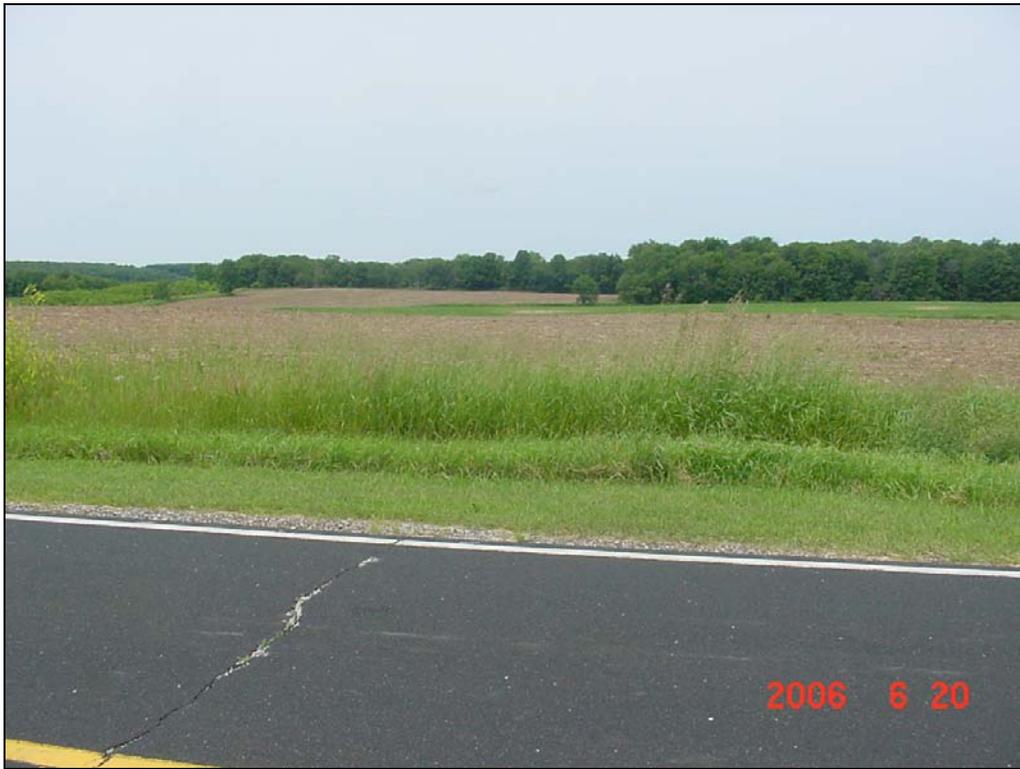
This is a farm field bordering CTH OJ to the west and just north of State HWY 23. This field drains to the Mullet River upstream of the mill pond. At the time of the windshield survey on June 20<sup>th</sup>, the field was bare with no apparent crop showing. A crop may have been planted and it may not have been apparent at the time.

There was no significant erosion evident from the highway. The field slopes were not severe. It appeared that there was a green space buffer between the field and the river. Overall, as long as the field is vegetated with a crop or other cover, this field is probably not a major source of sediment to the Mullet River.

Site 2 - Bare Farm Field West of CTH OJ

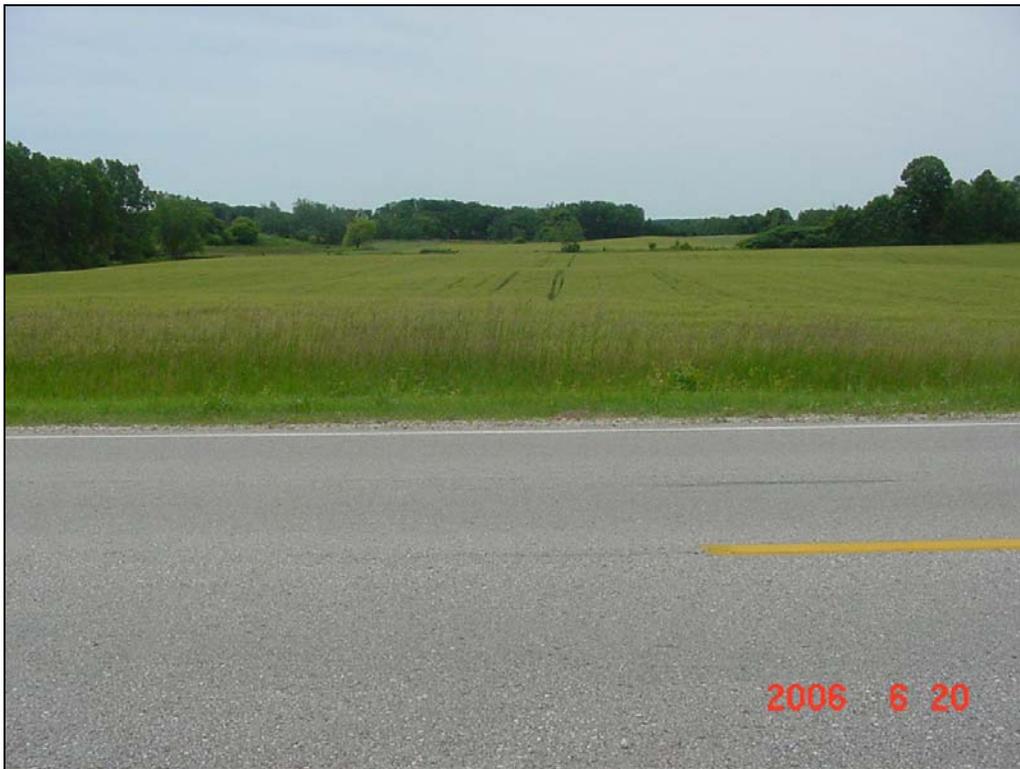
This site is an oat field just south of CTH J and west of State HWY 67. The field drains to the Mullet River upstream of Mill Pond. At the time of the survey the oats were well established. Non row crops, such as oats, provide good ground cover and have less potential sediment erosion than row crops, such as corn and soy beans.

Site 3 - Oat Field South of CTH J

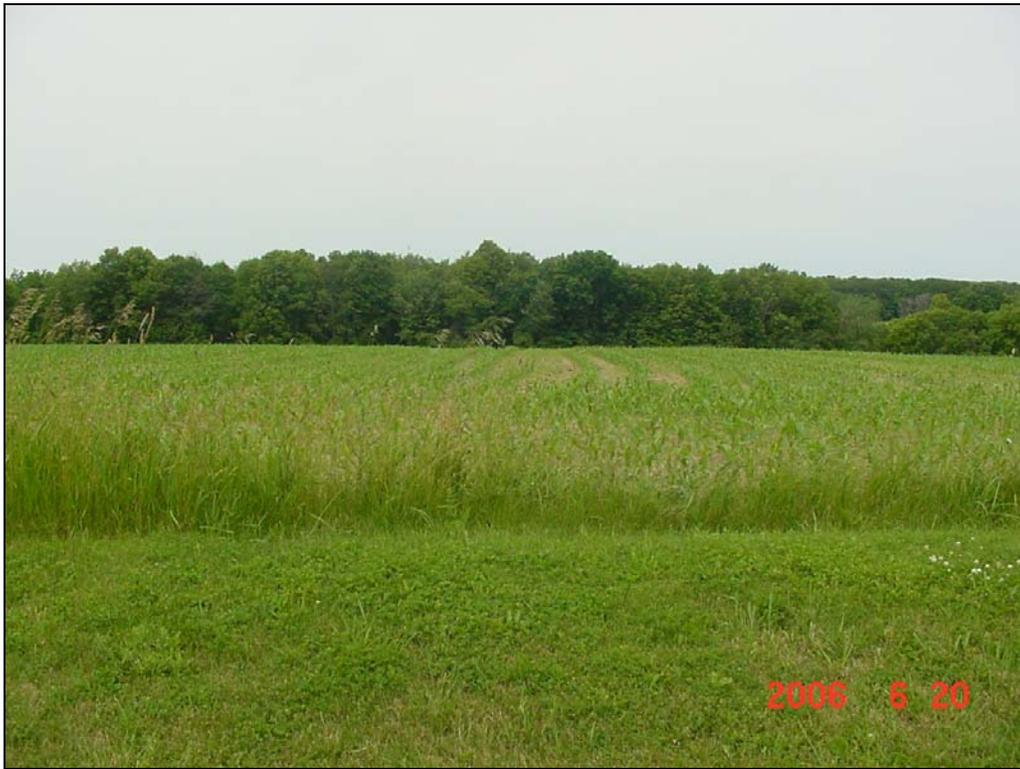
This site is west of CTH C just north of Woodland Road. The field drains to the Mullet River north of the mill pond. At the time of the survey the corn appeared well established and the field well managed.

Site 4 - Corn Field West of CTH C

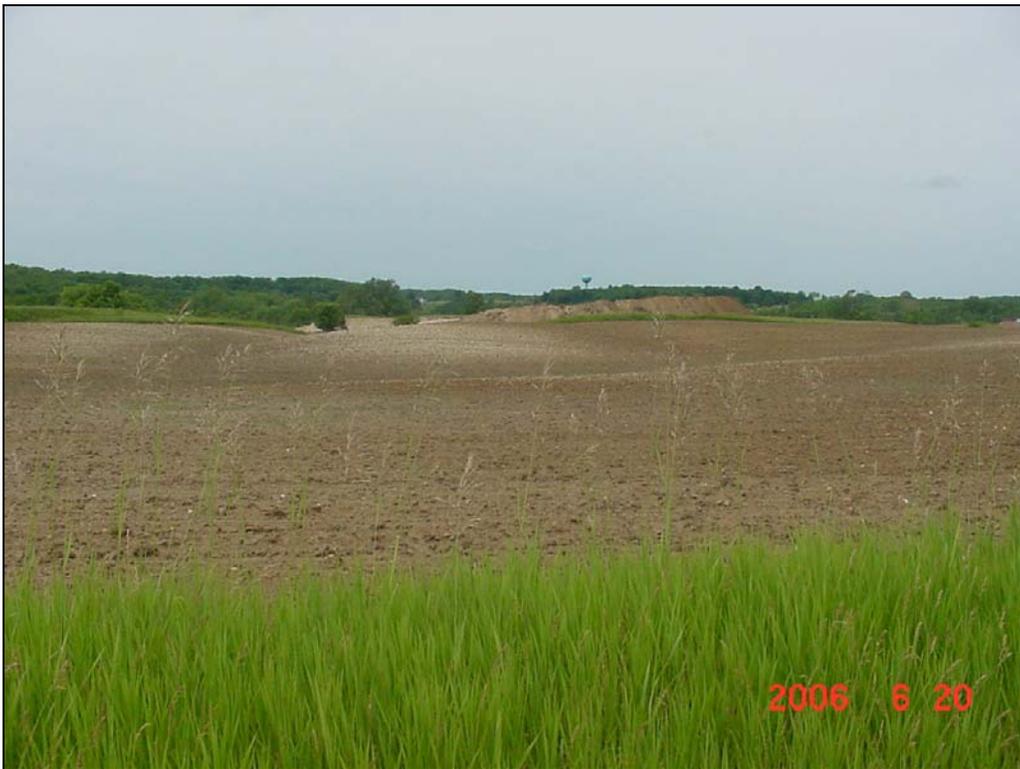
This is a farm field west of Racetrack Road and south of CTH JJ. This field drains to La Budde Creek southeast of Elkhart Lake. At the time of the windshield survey on June 20<sup>th</sup>, the field was bare with no apparent crop showing. A crop may have been planted and it may not have been apparent at the time.

There was no significant erosion evident from the highway. The field slopes were not severe. It appeared that there was a green space buffer between the field and the river. Overall, as long as the field is vegetated with a crop or other cover, this field is probably not a major source of sediment to La Budde Creek.

Site 5 - Bare Field West of Racetrack Road

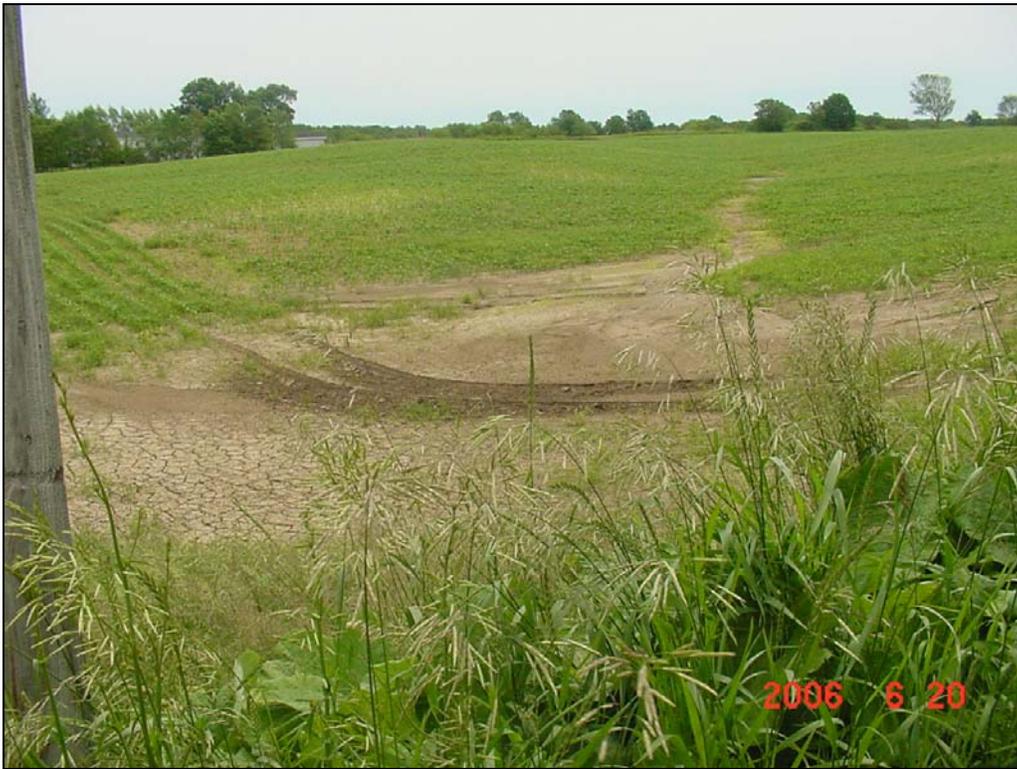
This corn field drains to the corner of this intersection with no apparent outlet. If this field did freely drain it would drain to La Budde Creek. There is an accumulation of eroded sediment at the corner of this field as well as an eroded flow path through the field as shown in the photo. The corn is not growing very well in this field as compared to other corn fields in the watershed, perhaps due to relatively poor soil conditions. If there is free drainage from this field, it could be a source of sediment to La Budde Creek.

Site 6 - Eroded Corn Field at SE Corner of Racetrack Road and Hwy. JJ

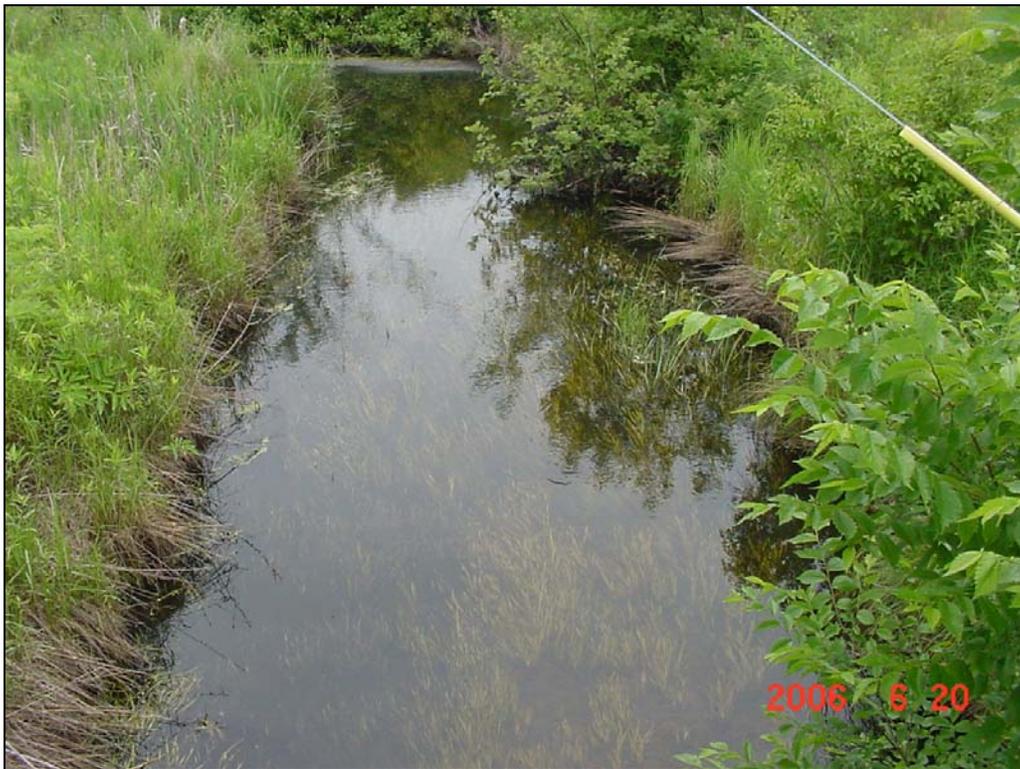
La Budde Creek was observed at a bridge crossing near Golf Course Road southeast of Elkhart Lake and just west of the railroad tracks. The creek water was relatively clear and had aquatic vegetation growing on the bottom. The stream appears to have been straightened, probably due to the construction of the railroad tracks. Despite being straightened, the creek banks are well buffered with

dense vegetation. Field observation and map review indicates the most of La Budde Creek is well buffered with green space (woods and wetlands) throughout its course.

Site 7 - La Budde Creek

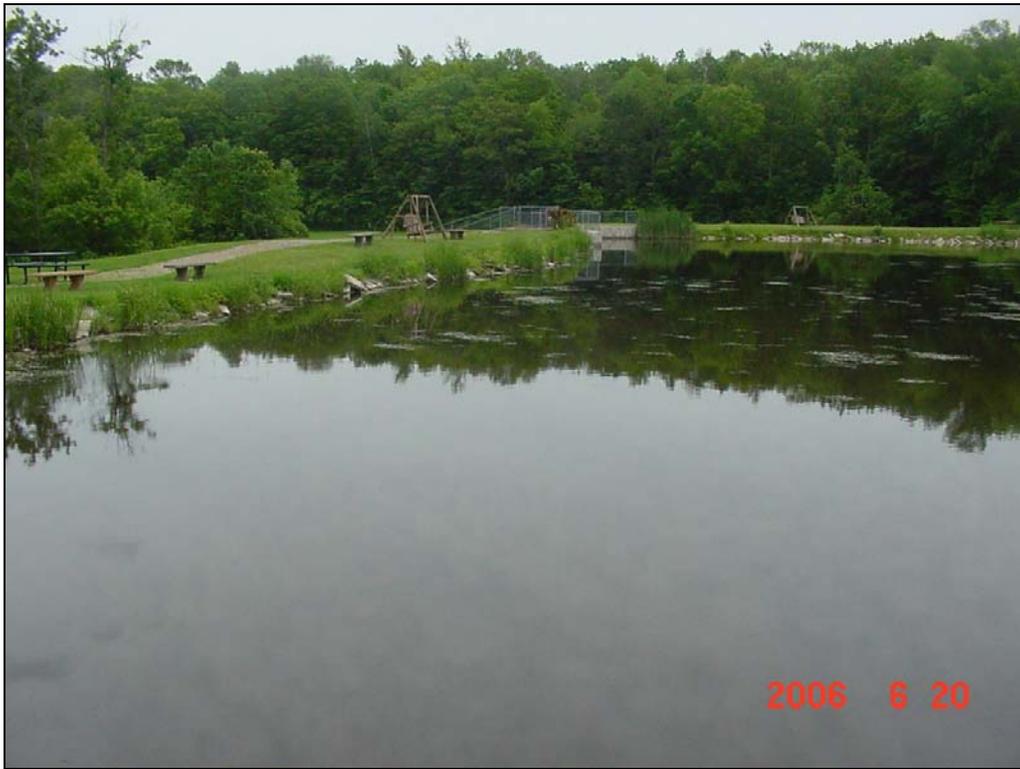
The Glenbeulah Mill Pond is the largest man made impoundment on the Mullet River upstream from the Plymouth Mill Pond. Two smaller impoundments, Otter Pond and the Camp Evelyn Pond, are located within a mile downstream from the Glenbeulah Mill Pond. The Glenbeulah dam is an earthen dam with a concrete gated section located in a Village park.

The Glenbeulah Mill Pond has an accumulation of sediment along the upstream side of the dam. There is also aquatic vegetation growth, however it is not as abundant as that in the Plymouth Mill Pond. There is little development around the shores of the pond, and the Village of Glenbeulah is small compared to the City of Plymouth. The river flowing downstream of the dam is swift flowing and relatively clear but more turbid than La Budde Creek. There are clumps of filamentous algae growing on the shallow rocks below the dam. The Glenbeulah Mill Pond and the other two smaller impoundments downstream act as sediment traps to remove sediment before it reaches the Plymouth Mill Pond.

Site 8 - Glenbeulah Dam

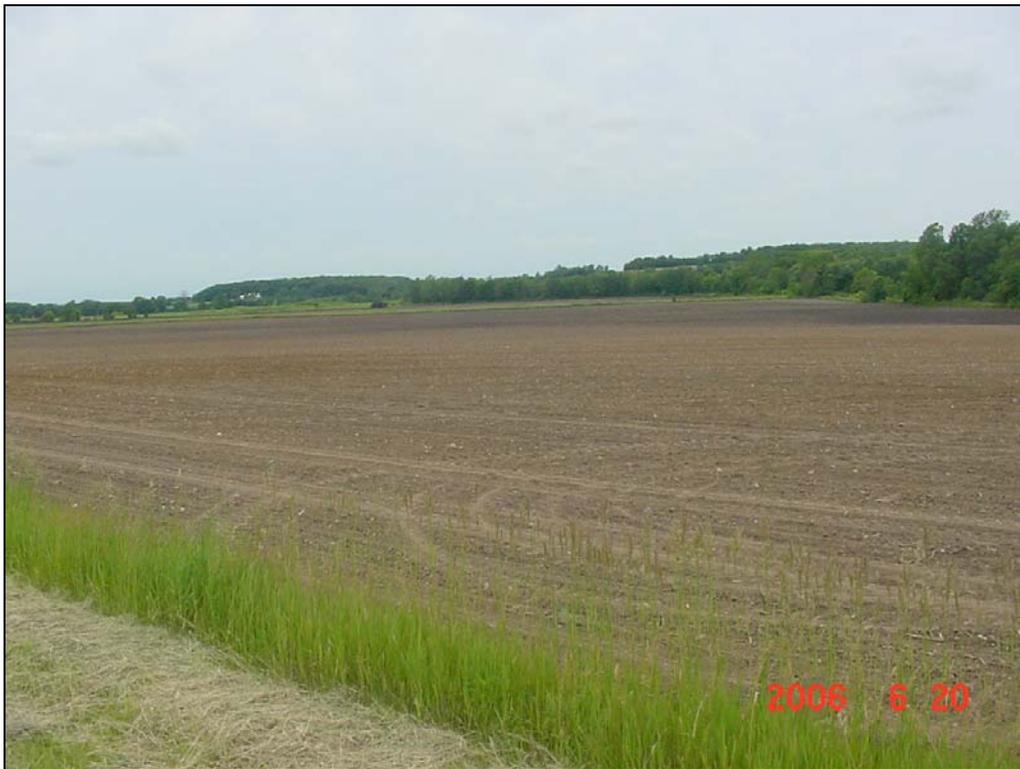
This is a farm field north of CTH A about one mile northeast of the Village of Greenbush. To the north of the field is the Mullet River. At the time of the windshield survey on June 20<sup>th</sup>, the field was bare with no apparent crop showing. A crop may have been planted and it may not have been apparent at the time.

There was no significant rill erosion evident from the highway. The field slopes were flat. There is a wooded buffer area between the field and the river. Overall, as long as the field is vegetated with a crop or other cover, this field is probably not a major source of sediment to the Mullet River.

Site 9 - Bare Field north of Hwy A looking toward the Mullet River

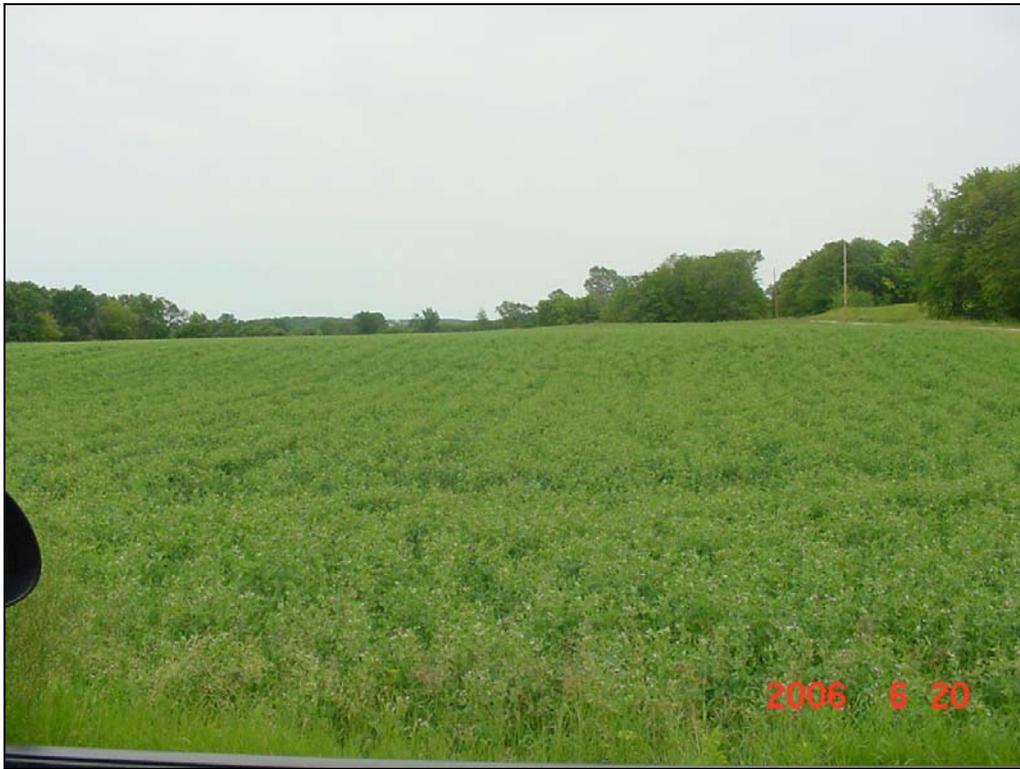
This site consists of farm field to the east and west of Spring Valley Road just north of CTH T about two miles west of the Village of Greenbush. These fields drain north to the Mullet River. The east field is in hay and the west field is in corn as shown in the photos. These fields appeared in good condition and there was a wooded buffer area along the river. These fields were typical of what was seen throughout the watershed.

Site 10 - Alfalfa Field

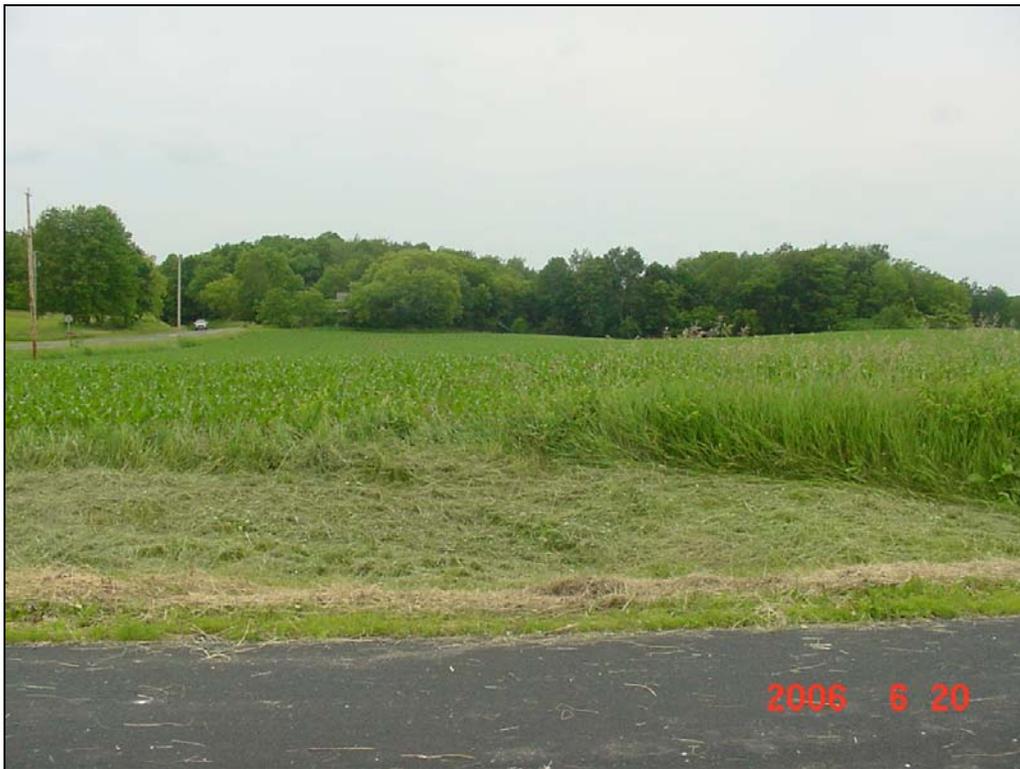
Site 10 - Corn Field

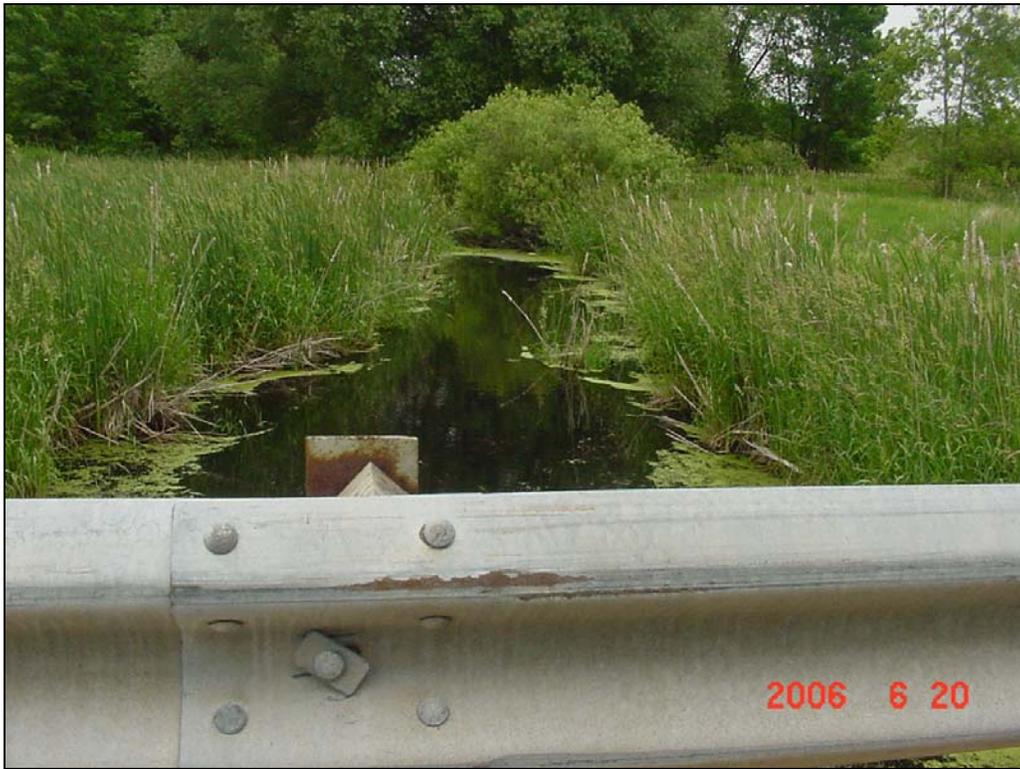
This site is the outlet to Mullet Marsh as it crosses CTH G. Mullet Lake and Mullet Marsh form the headwaters of the Mullet River. These two water bodies are surrounded by wetlands and are well buffered from sediments from the surrounding watershed. The flow at this outlet is rather sluggish. The water is clear but stained by tannins. Duckweed is present on the surface.

Site 11 - Mullet Marsh Outlet
