APPENDIX A

Lake Mohawksin Comprehensive Management Plan

A preliminary treatment area of approximately 7.1 acres (Map 1), consisting of a few dense areas of EWM within heavy traffic corridors, was used to obtain a conditional chemical application permit from the WDNR. During May, these areas were surveyed and modified slightly to avoid navigational hazards such as stumps and shallow bars (Map 1). The necessary data was supplied to the applicator, Schmidt's Aquatic Plant Control (SAPC), and an application of Navigate® (2,4-D) was completed on May 16, 2007 at 100 lbs/acre. At the time of the treatment, Cliff Schmidt (SAPC) met with A.J. Theiler, founder of FOLM, and coordinated the adjustment of a section of the navigation lane (Site A) to a position more familiar amongst riparians (Map 2). Due to this adjustment, the total treated acreage was slightly increased to 7.4 acres. The winds were light (0-5 mph) and the water temperature was 14.4°C (58°F). To aid in our understanding of the treatment, the applicator provided the approximate application path which is generated by his onboard Global Positioning System (GPS) (Map 2).

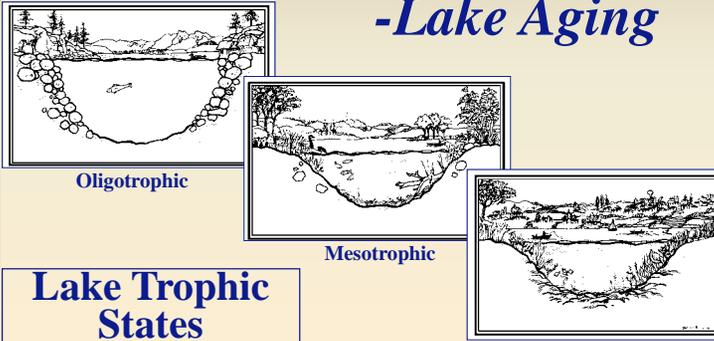
Eutrophication -Lake Aging

Lake Trophic States

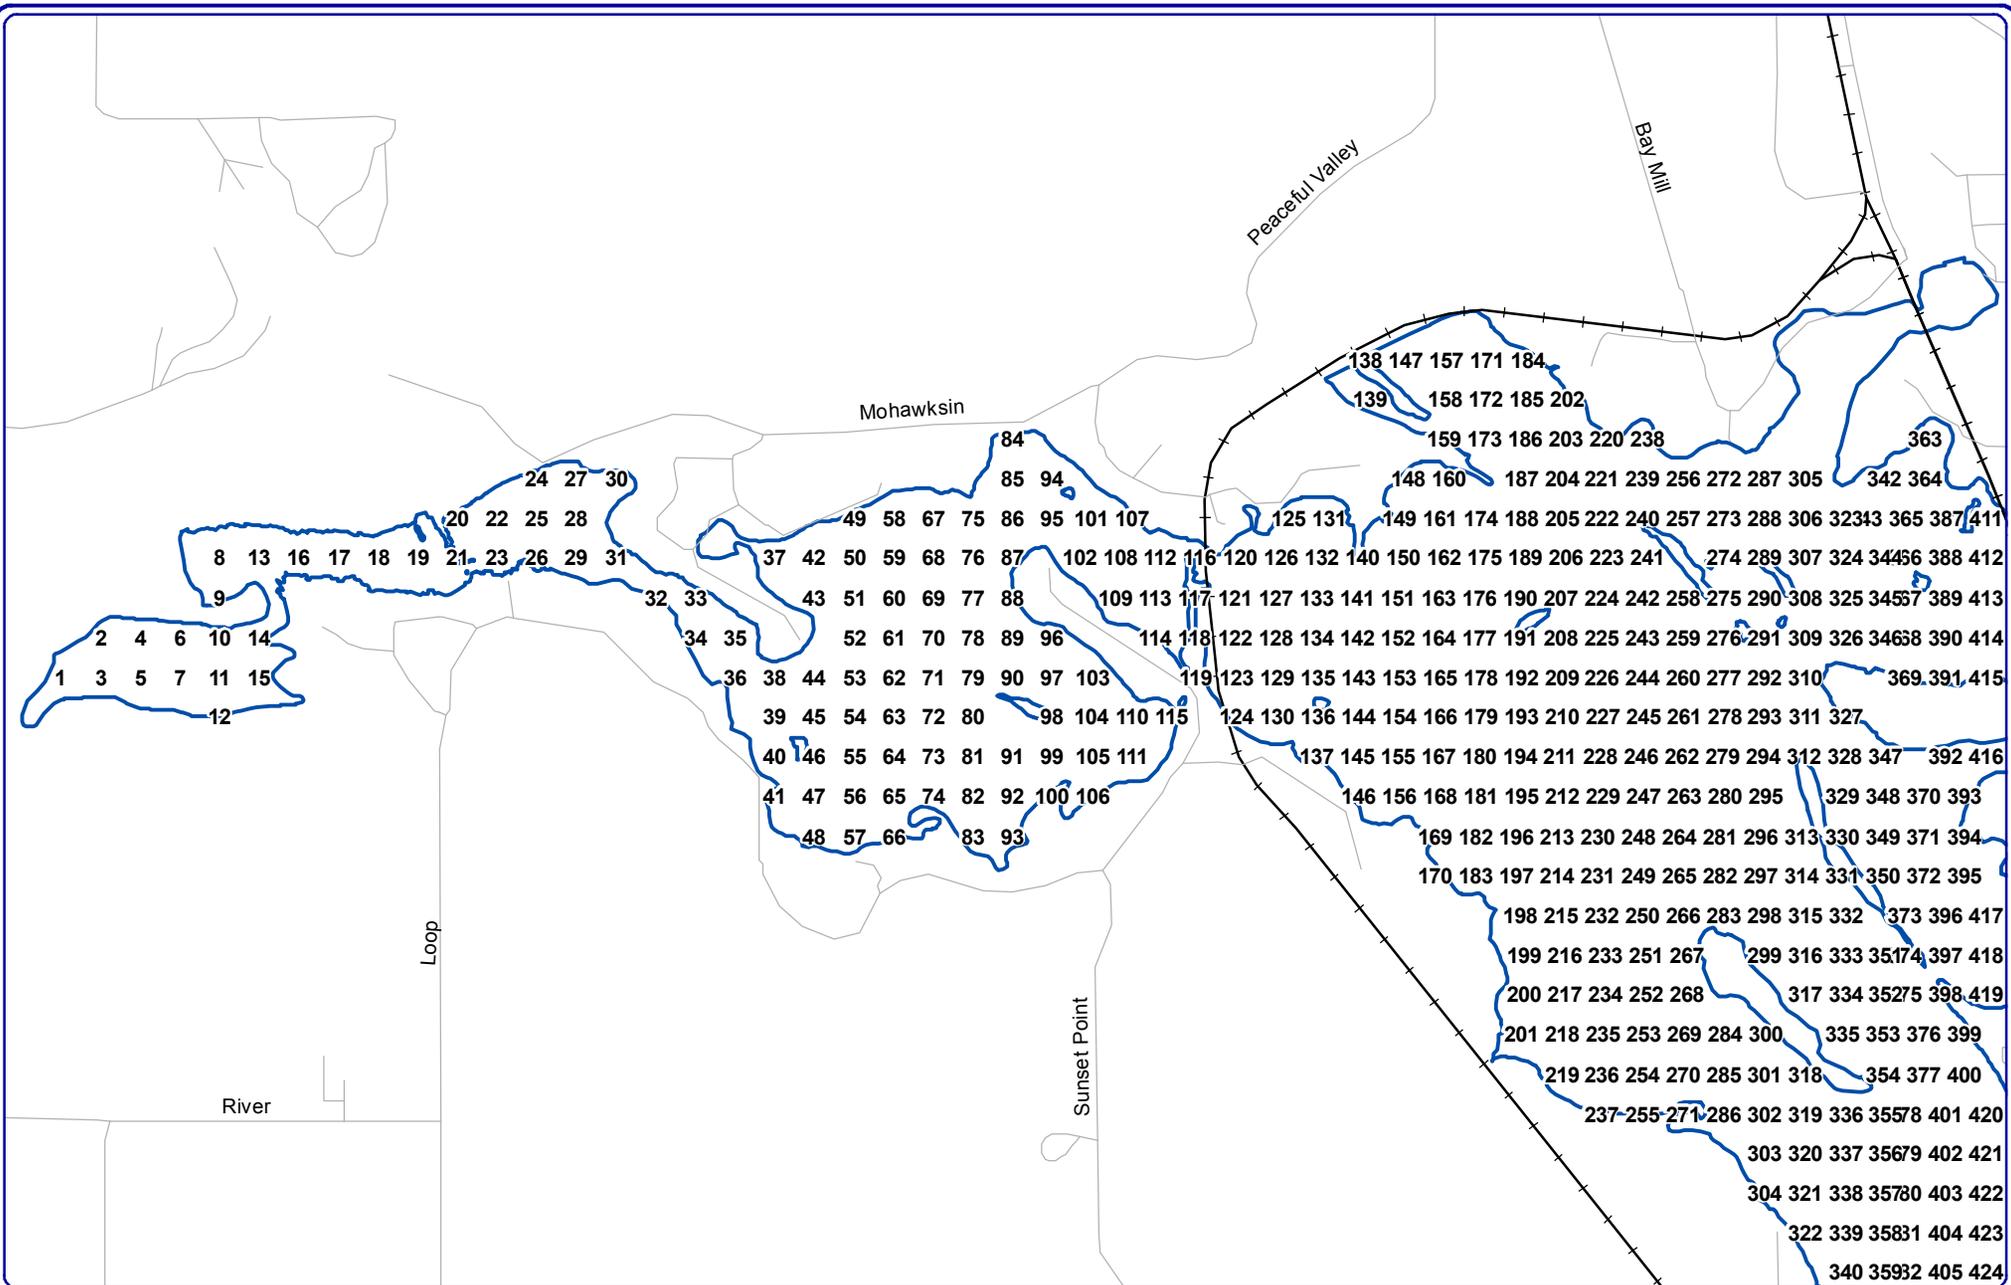
Appendix E
Lake Mohawksin
 Lincoln County, Wisconsin
**Point-intercept
 Sample Locations**

Point-intercept Sample Location

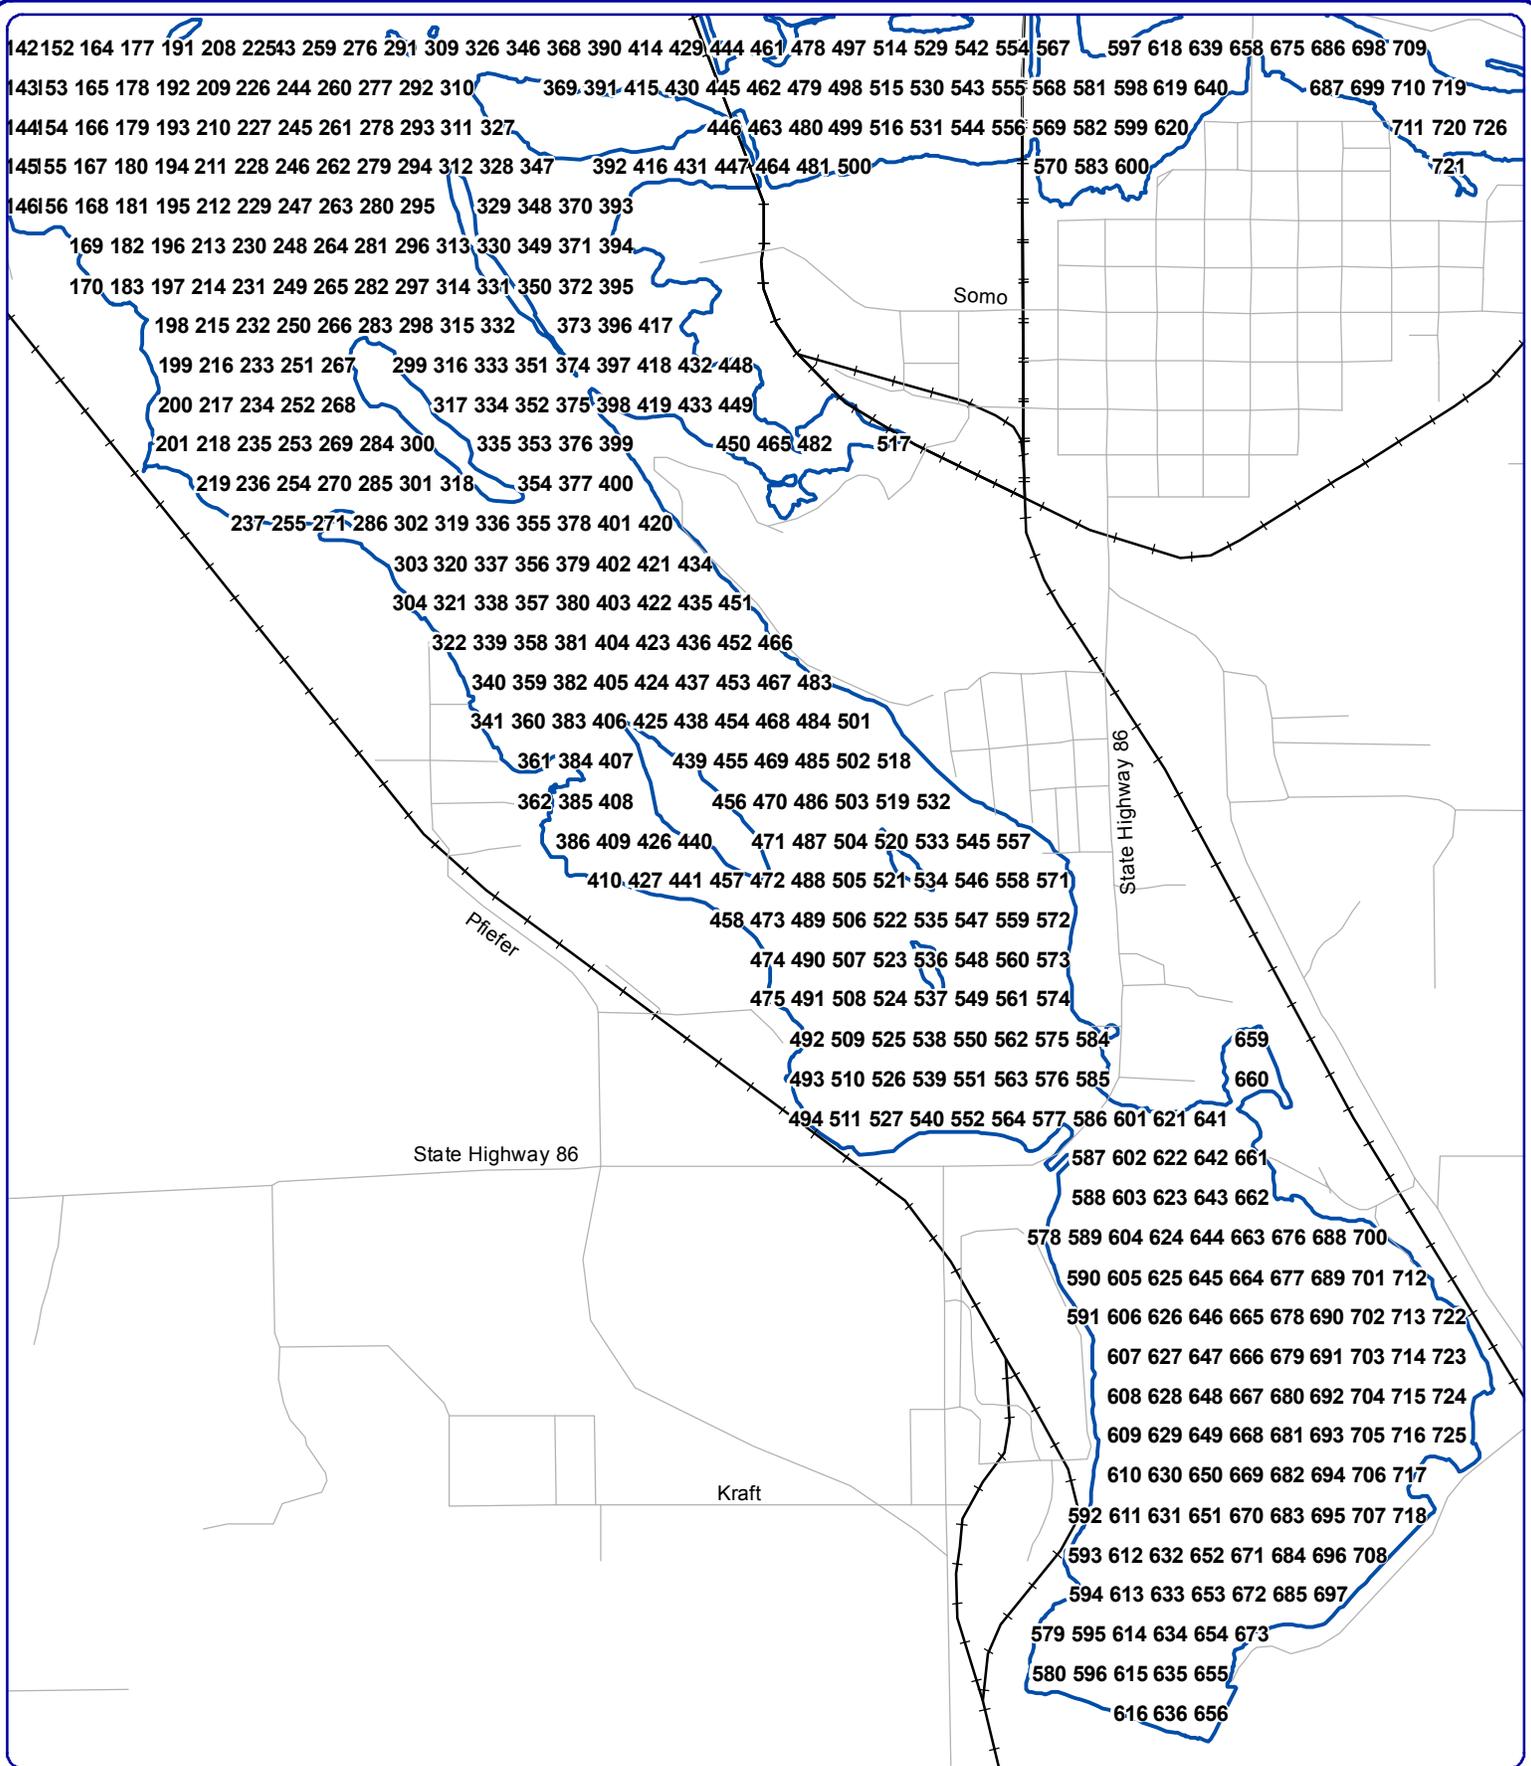
Appendix E
 Lake Mohawksin
 Lincoln County, Wisconsin
**Point-intercept
 Sample Locations**

Point-intercept Sample Location

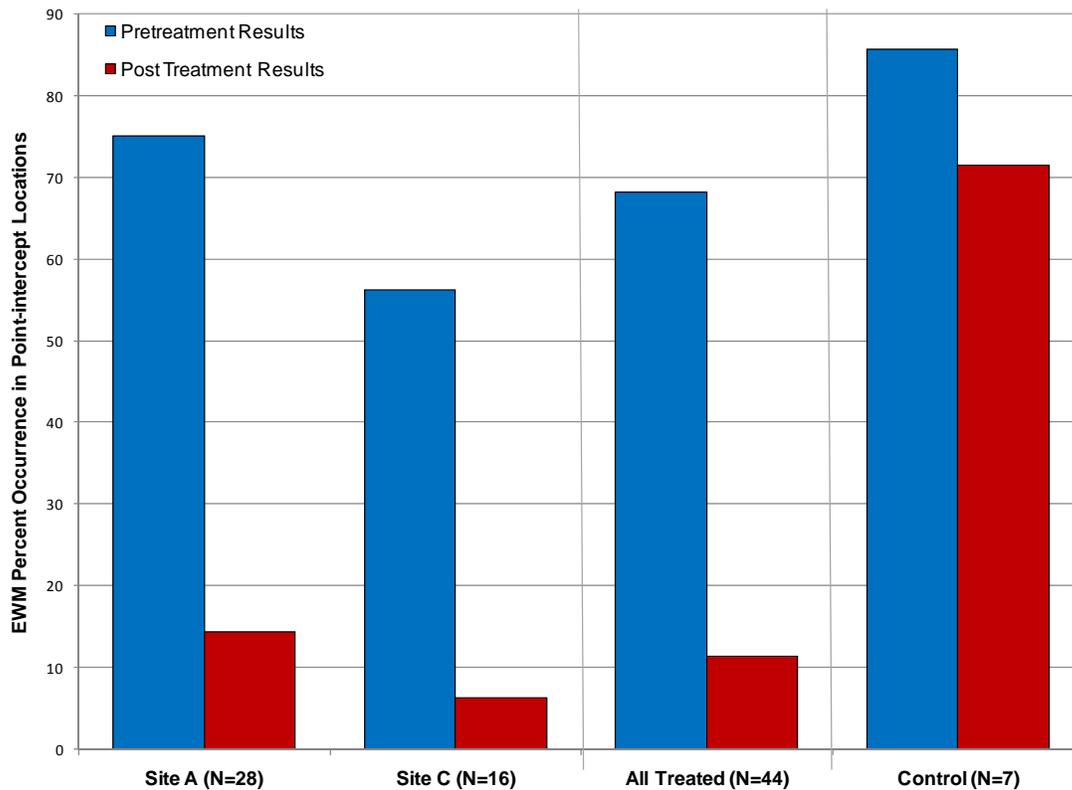
Figure 1. EWM percent occurrence in point-intercept locations displayed based on treatment site. Please note the vertical axis maximum value is 90%.

lane (Map 2) was made based on the coordination of A.J. Theiler and Cliff Schmidt. Of the 28 point-intercept locations within this treatment site, 21 (75%) contained EWM (Figure 1).

(11.4%) point-intercept locations contained EWM after the treatment (Figure 1). Many native species were observed within this treatment area including Vasey’s pondweed, a species of special concern. Actually, amounts of native plants, especially coontail, within the treatment lane made navigation a challenge. However, it was significantly easier to boat through than the surrounding mat of EWM.

Site C-07 Almost no EWM was observed within this treatment area. Presumably due to the high boat traffic that this area endures, native plants were not causing the navigational difficulties observed in Site A. Only 1 of the 16 (6.3%) point-intercept locations contained EWM after the treatment (Figure 1).

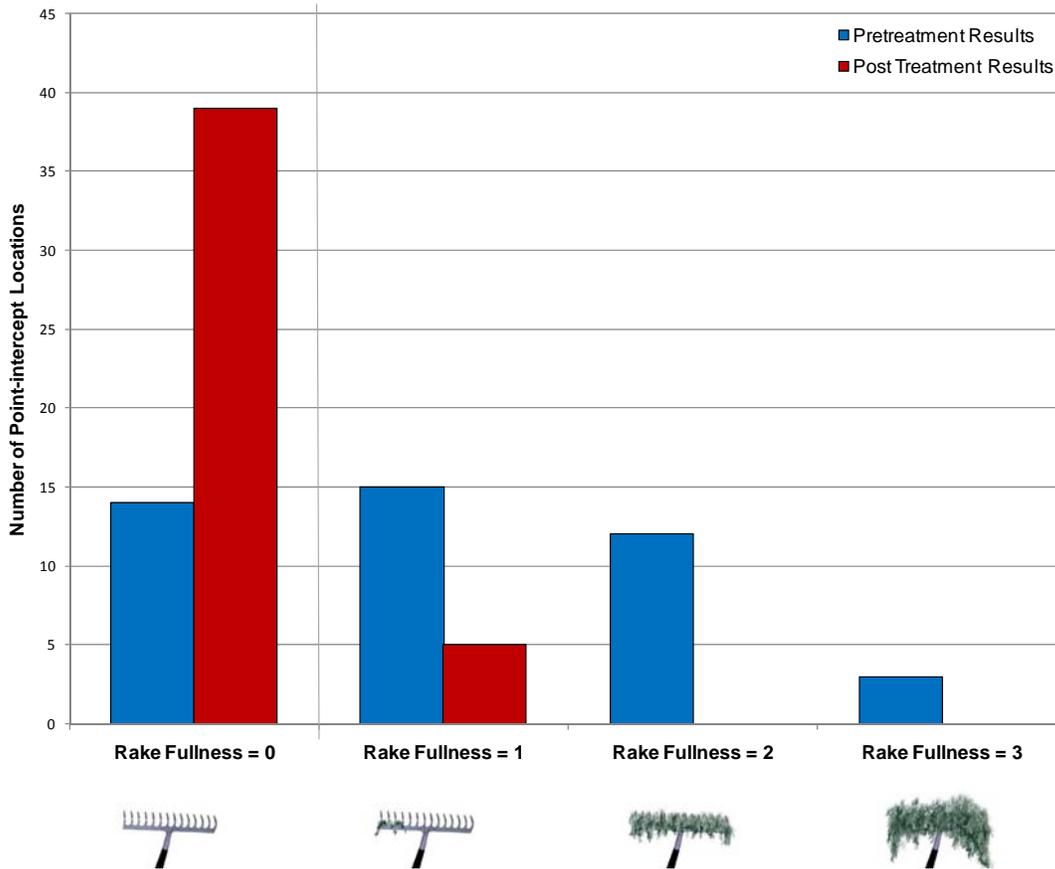
Figure 2. EWM rake fullness distribution within treated areas on Lake Mohawksin.

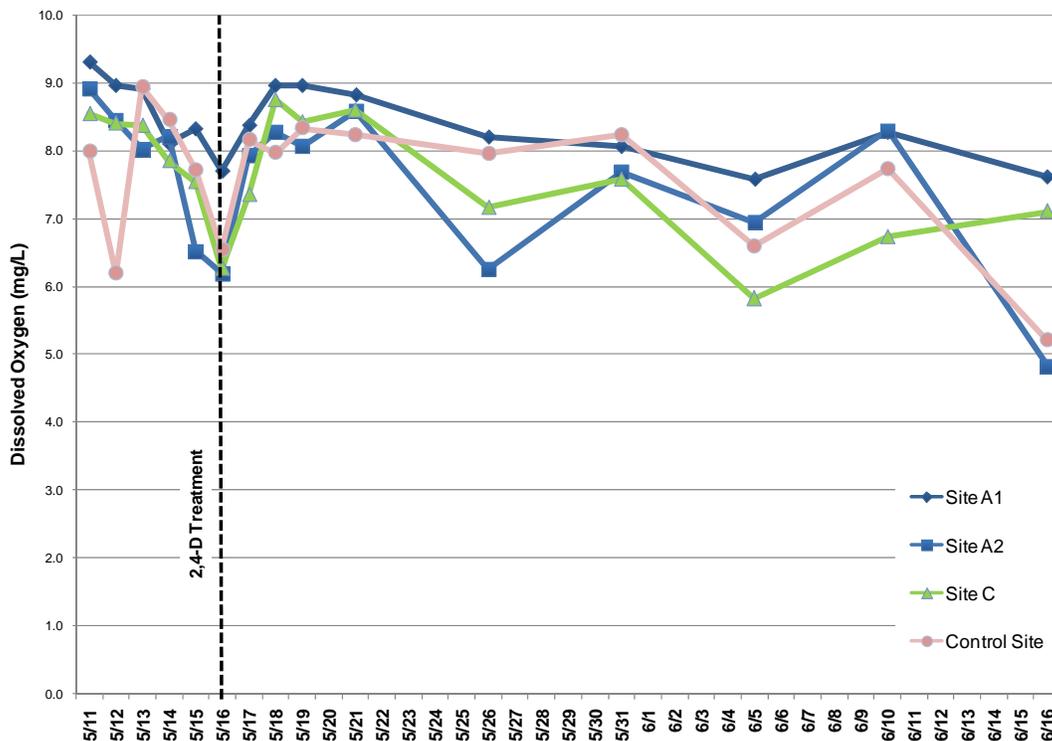
Using a dissolved oxygen probe (Hach® Model HQ30d), readings were collected at 4 locations throughout the treatment areas including 1 control site (Map 2). Monitoring started 5 days prior to treatment and occurred each day leading to treatment, the day of treatment, 1, 2, 3, and 5 days following the treatment and then continued every 5 days until 30 days post treatment (12 samples).

Figure 3. Dissolved oxygen levels observed within 4 sites in Lake Mohawksin.

The data displayed in Figure 3 clearly show that dissolved oxygen levels did not reach anoxia. There was a reduction in dissolved oxygen levels on the date of the treatment and it remains unknown if this was a result of natural variations or if it can be attributed to the herbicide application. 2,4-D is biodegraded and it is possible that microbial activity could lead to minor changes in dissolved oxygen within a treatment site. However, the control site's readings mimicked the levels found within the treatment sites, causing doubt on the hypothesis that the herbicide application caused this reduction. Perhaps since the control site was only 51 meters (170 feet) away from the navigation lane, a wider range of the herbicide's influence on dissolved oxygen may have been detected. It is important to note the following three points: (1) there was a trend of decreasing dissolved oxygen levels even before the date of application in all monitoring locations; (2) the degree of change (approximately 1 mg/L) is quite small and the values remained above 6 mg/L (significantly greater than levels considered harmful to aquatic life); and (3) the day after the treatment, when one would expect to see the levels decrease if significant biodegradation was occurring, the levels rebounded to what was observed a few days before the treatment.

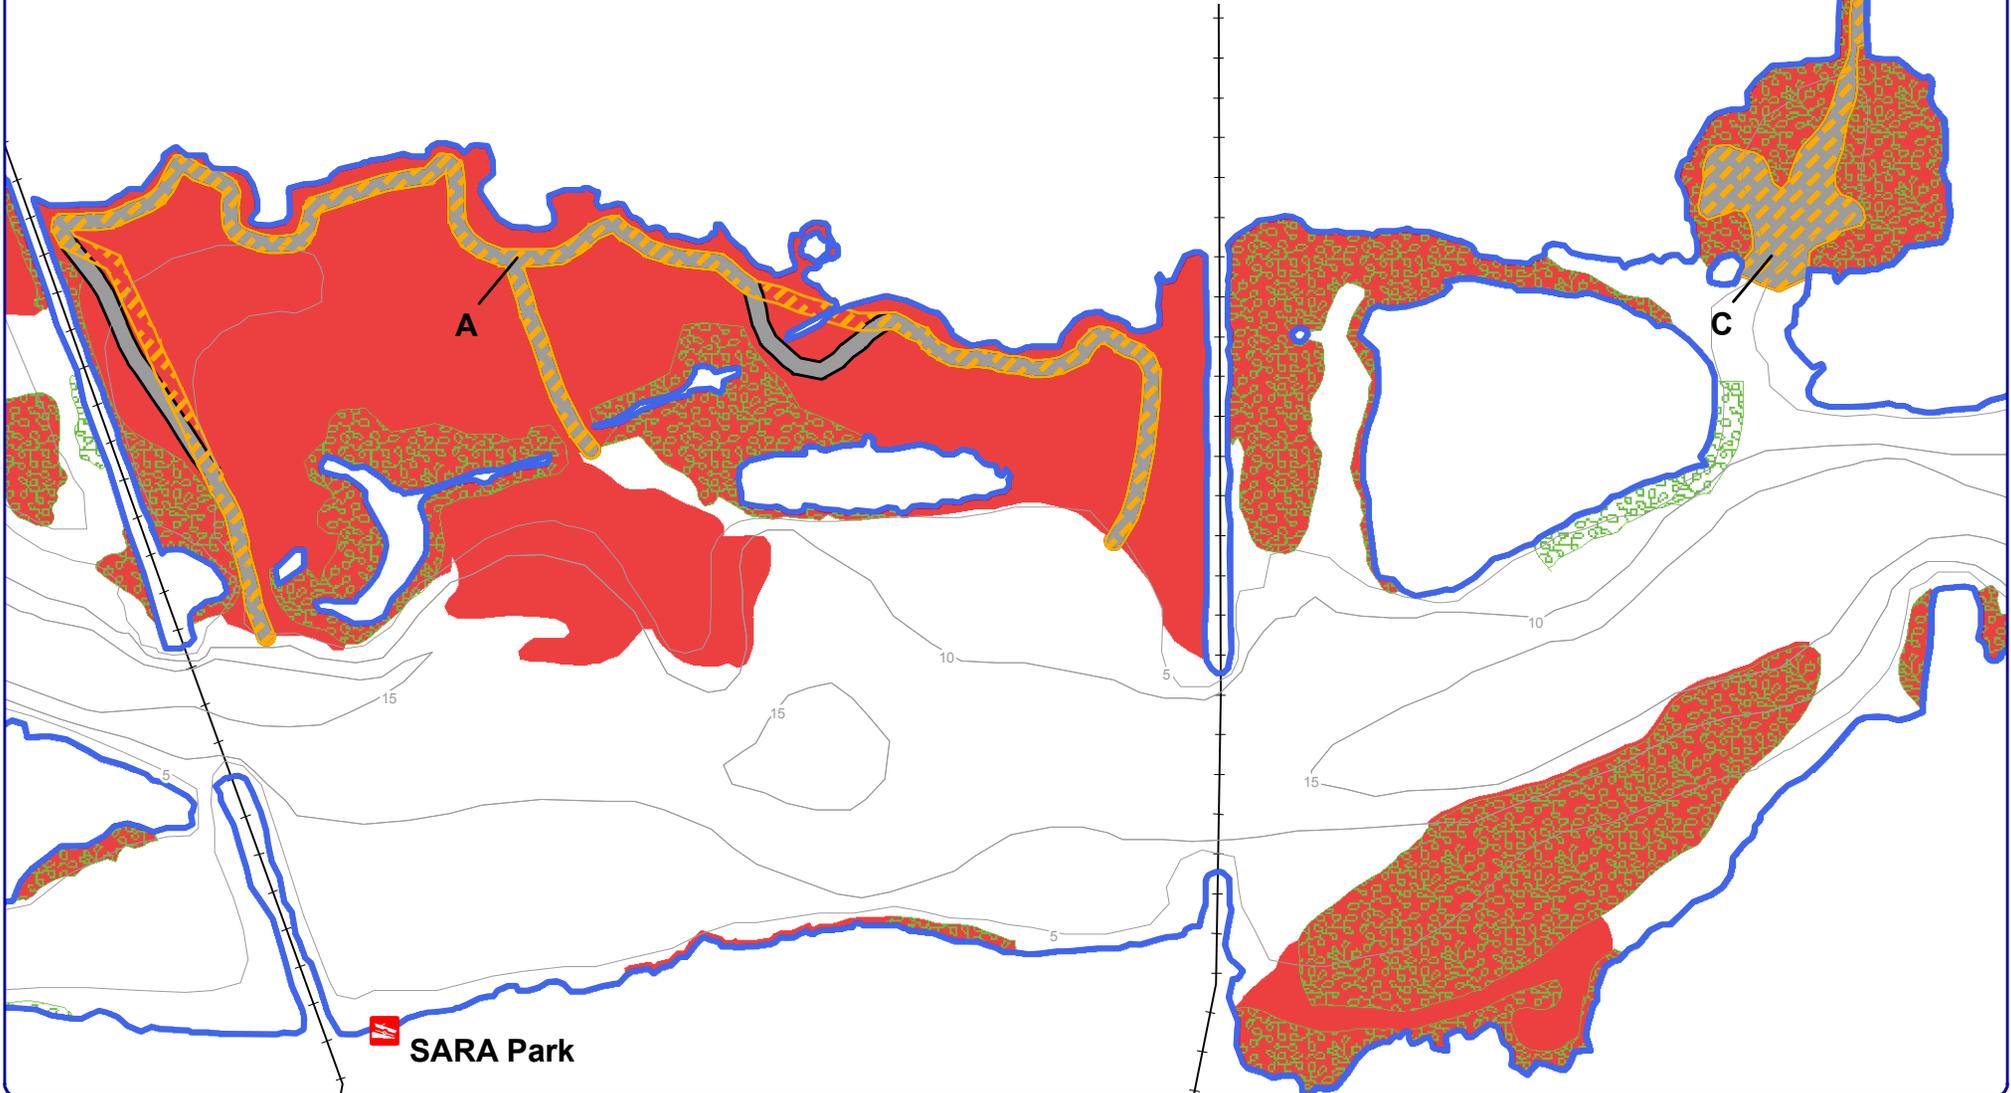
Map 1
Lake Mohawksin
 Lincoln County, Wisconsin
2007 Proposed
EWM Treatment Areas
Used for Conditional Permit

- Native Plant Community
Mapped by Onterra - Aug '06
- Eurasian Water Milfoil Location
Mapped by Onterra - Aug '06
- Proposed Chemical Treatment (7.1 Acres)
- Modified Chemical Treatment (After Pretreatment Survey)

Site A Extremely dense EWM was observed in all areas of this treatment site. Two modifications were made to the proposed navigation lane: (1) the western-most lane was adjusted to avoid several submerged stumps and (2) the east-west orientated, shoreward lane was moved to avoid a shallow bar (Map 1). As stated above, an adjustment of the eastern navigation
