A LAKE PROTECTION PLAN FOR ANVIL LAKE

VILAS COUNTY, WISCONSIN

Final Report

January, 2011

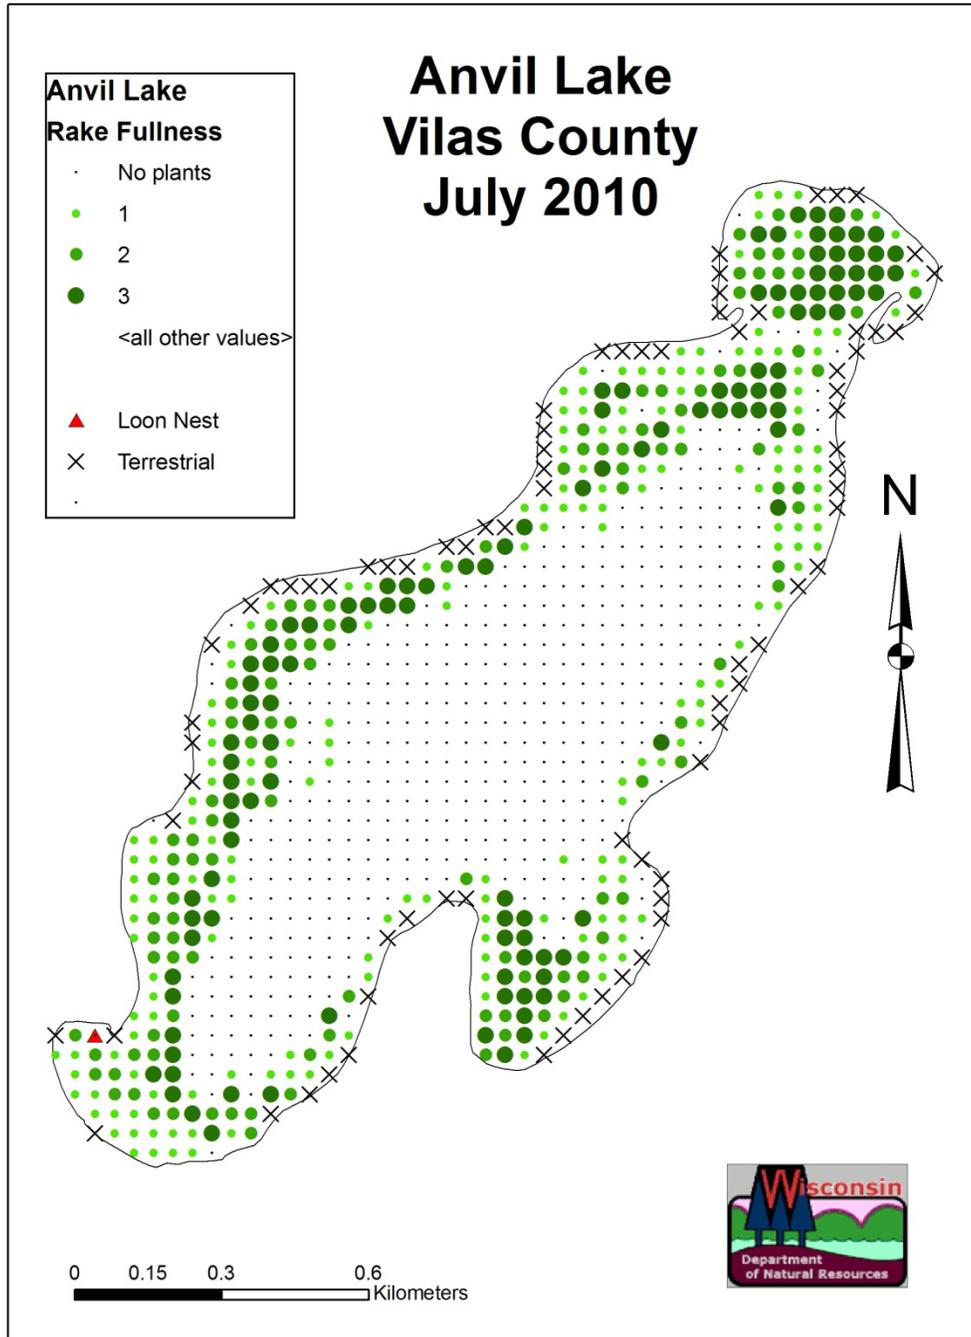
Figure 11. Rake Fullness at each site in Anvil Lake.
