Birch Lake  
180 Acres  
24 Ft. Deep

Source: Wisconsin Department of Natural Resources 608-266-2621  
Bearskin Lake – Oneida County, Wisconsin DNR Lake Map  
Date – Jun 1968 - Historical Lake Map - Not for Navigation  
A Public Document - Please Identify the Source when using it.

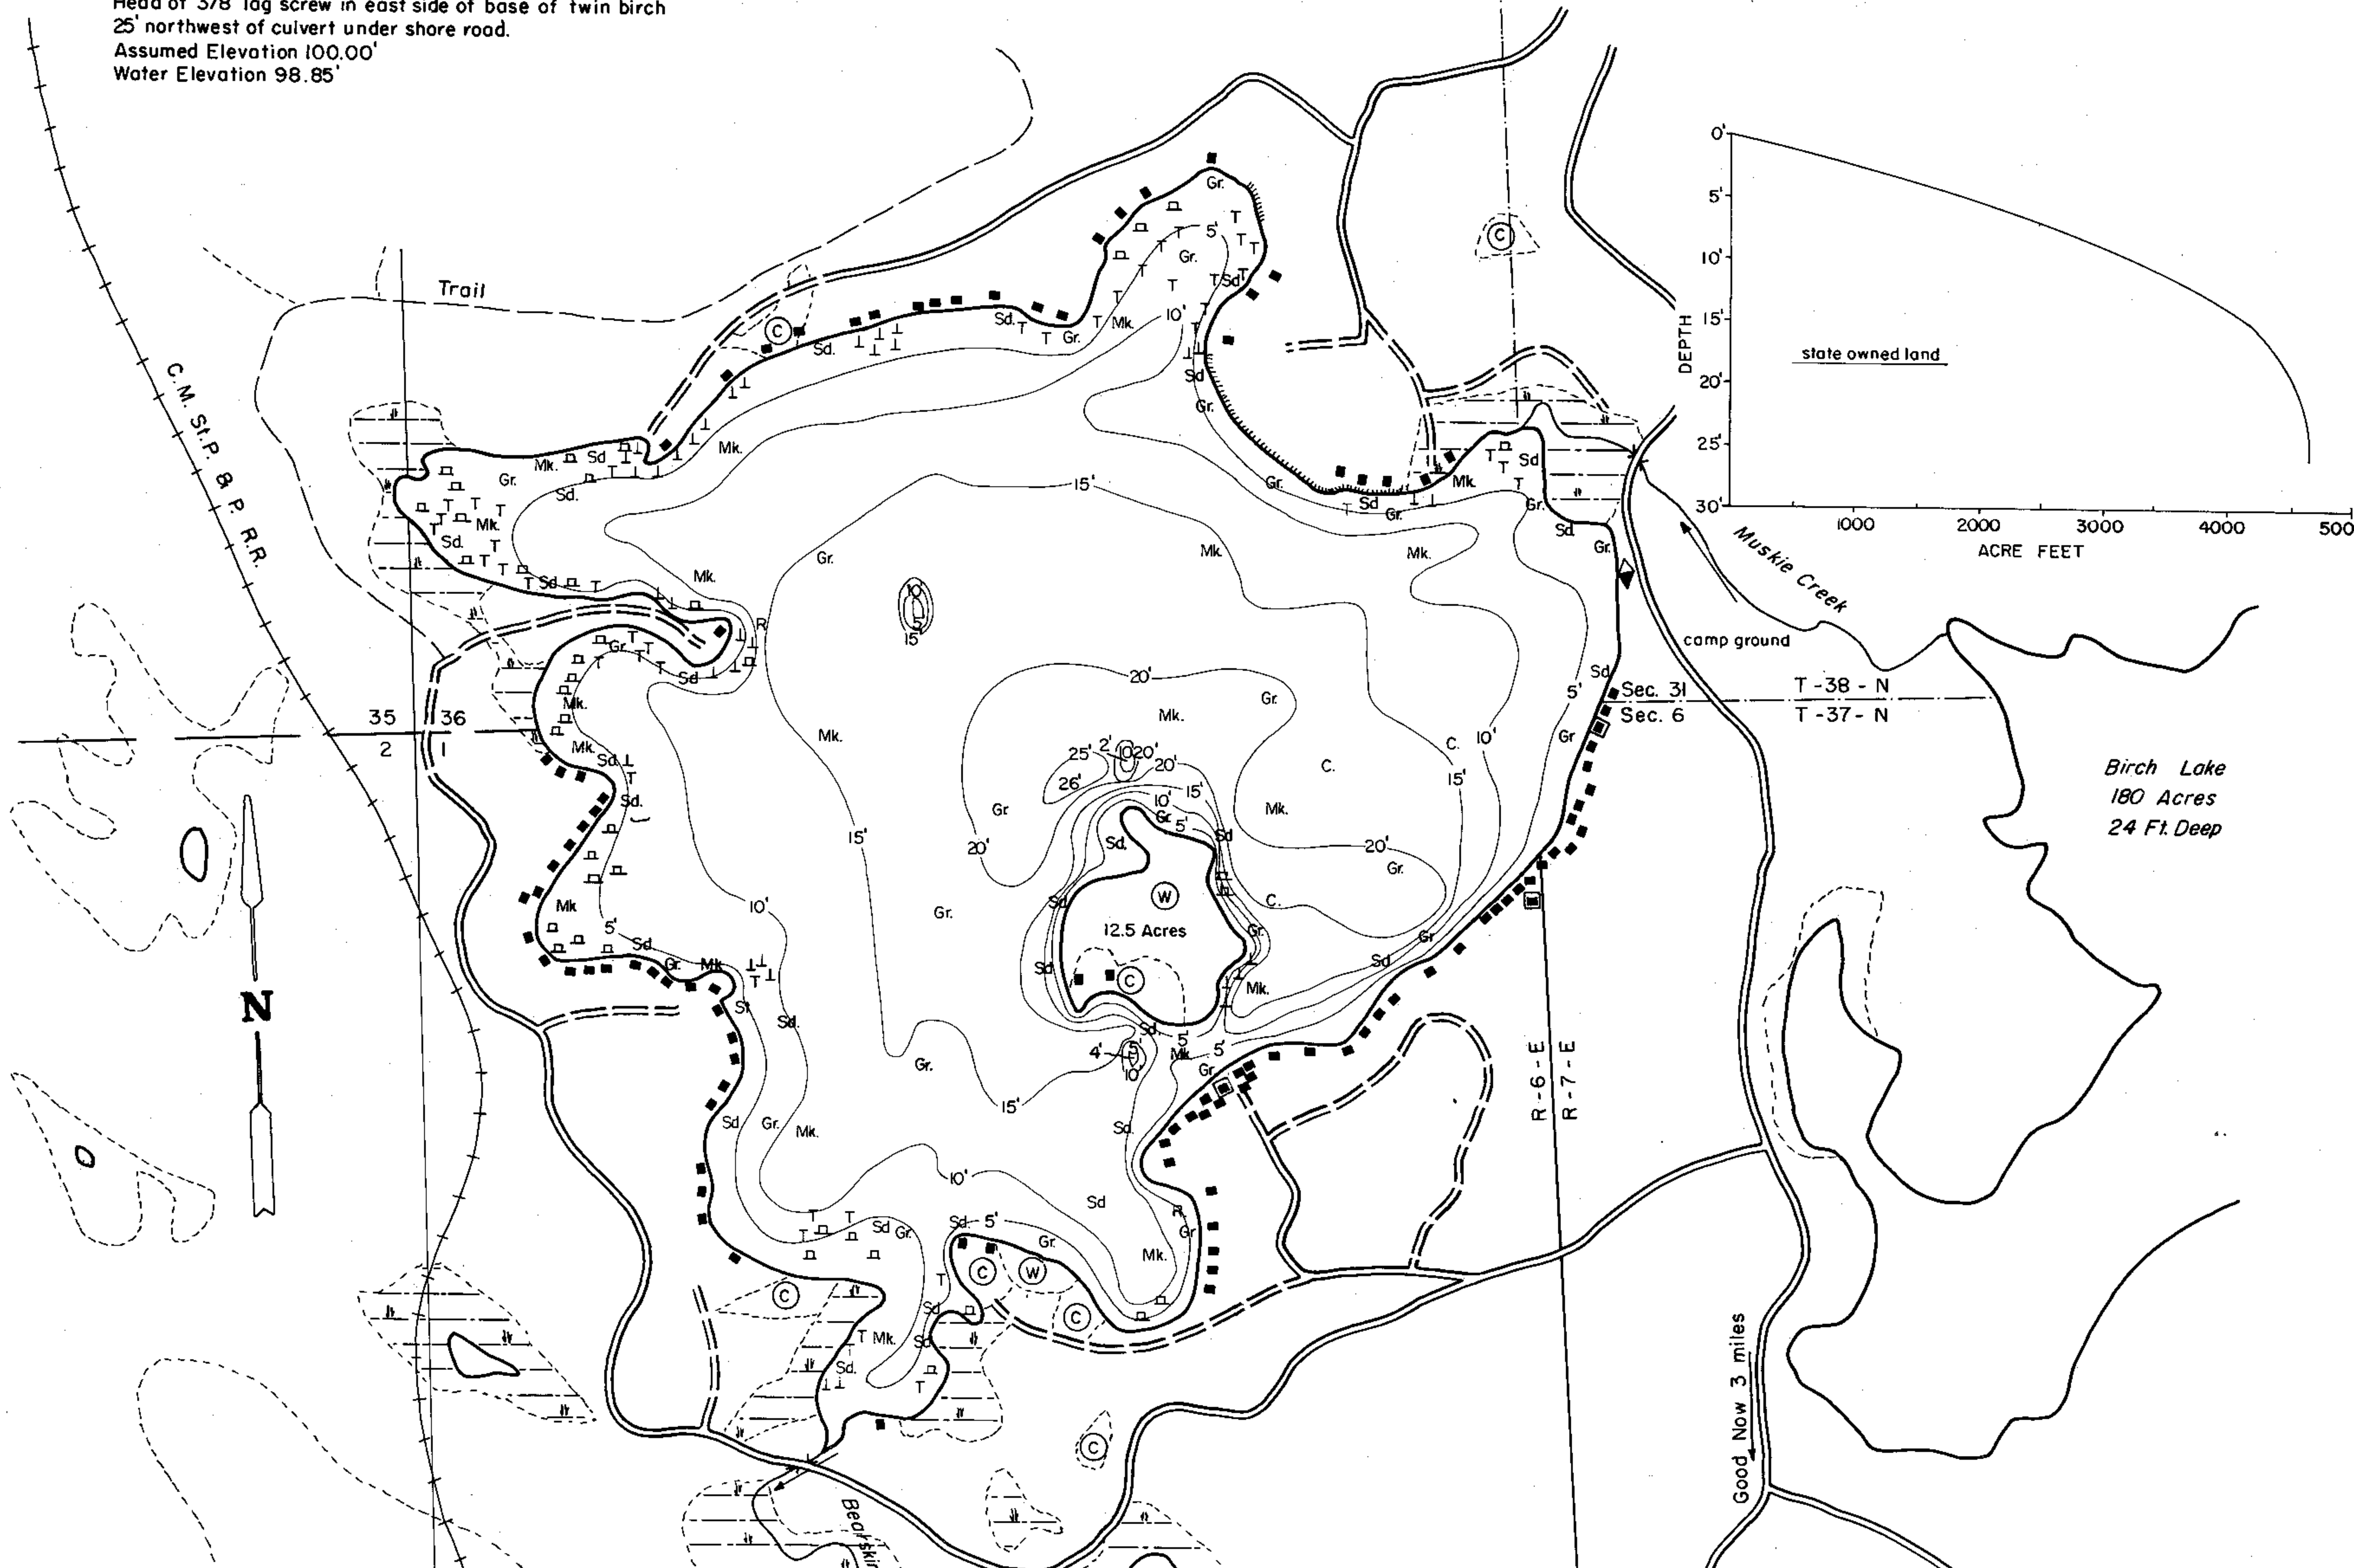
Department of Natural Resources Bench Mark 1631-A.  
Head of 3/8" lag screw in east side of base of twin birch  
25' northwest of culvert under shore road.  
Assumed Elevation 100.00'  
Water Elevation 98.85'

WATER AREA 400.3 ACRES  
UNDER 3 FT. 11.7 %  
OVER 20 FT. 7.5 %  
MAX. DEPTH 26 FEET.  
TOTAL ALK. 48 P.P.M.  
VOLUME 4636.8 ACRE FT.  
SHORELINE 5.59 MILES  
SHORELINE 4.9 MILES WITHOUT IS.
