## **WETLAND & WATERWAY DELINEATION REPORT**

EMERALD PARK LANDFILL – WESTERN EXPANSION

ADVANCED DISPOSAL SERVICES, INC

City OF MUSKEGO, WAUKESHA COUNTY, WI

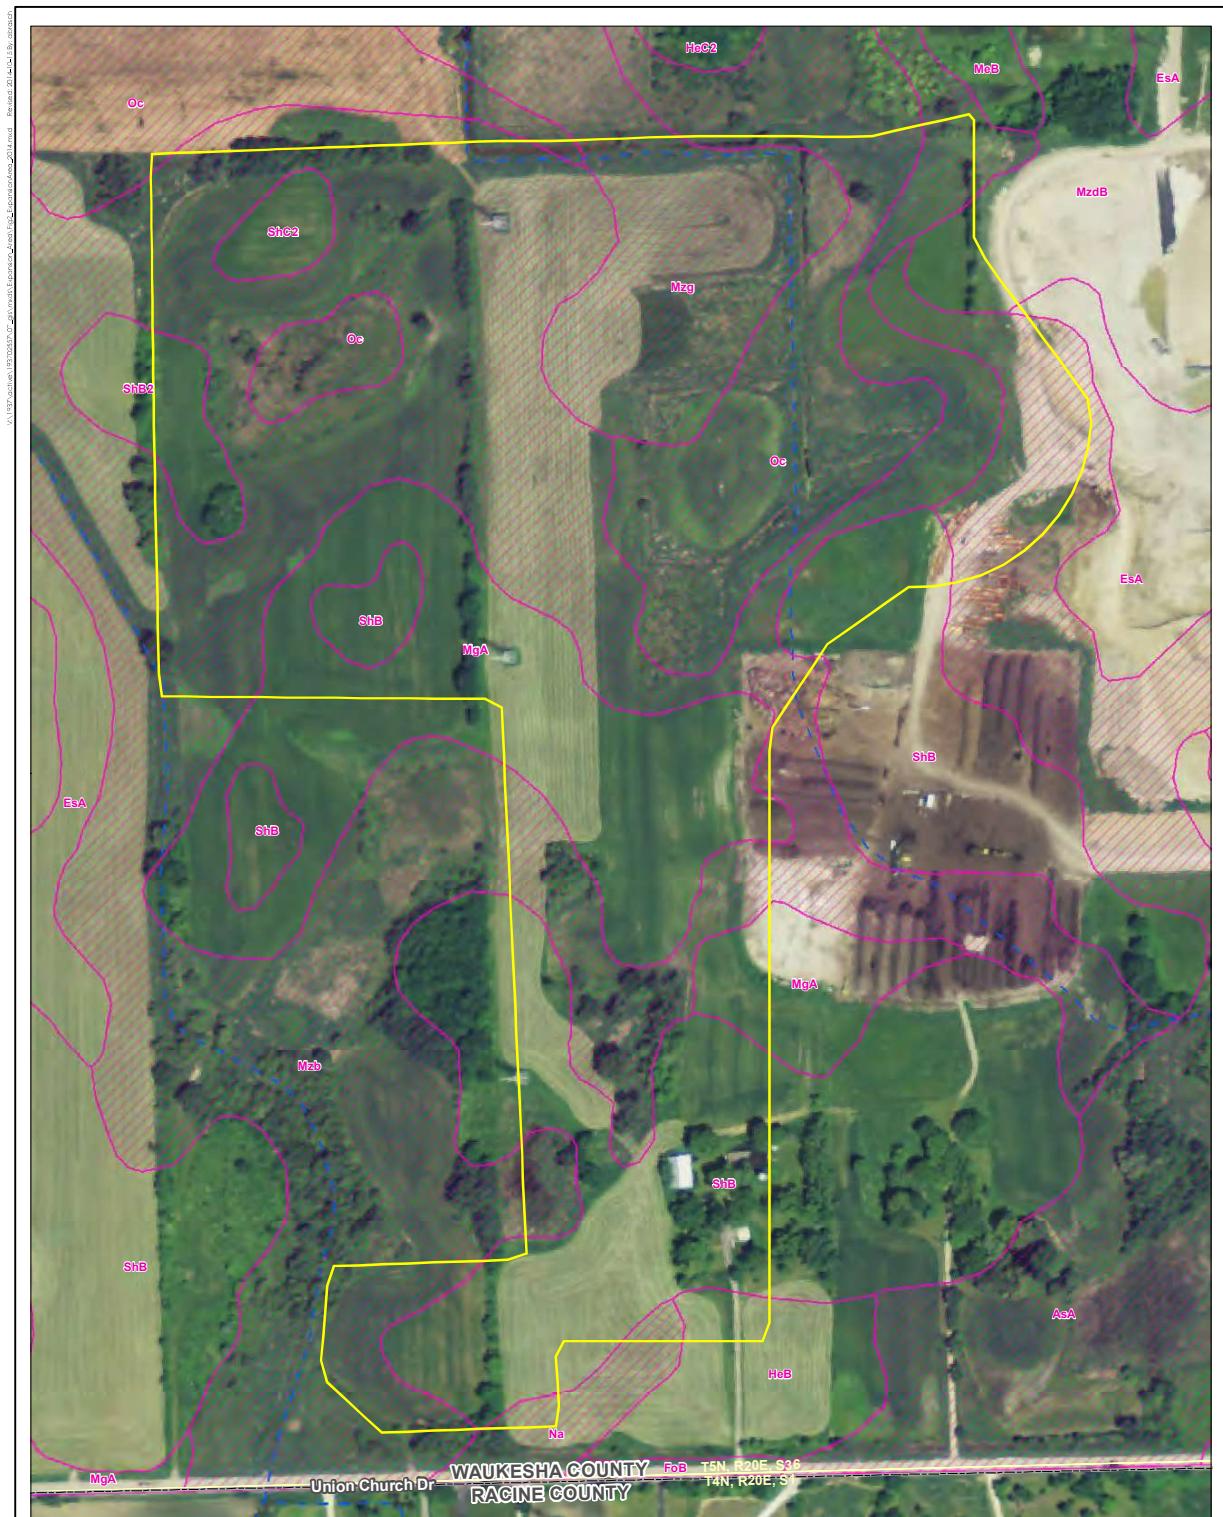
- Legend**
- Yellow Box: Expansion Boundary (2014)
  - Pink Shaded Areas: NRCS Soil Survey Data
  - Light Pink Shaded Areas: Predominantly Hydric Soils
  - Medium Pink Shaded Areas: Partially Hydric Soils
  - Darker Pink Shaded Areas: Non-Hydric Soils
  - Blue Dashed Lines: DNR 24k Hydrography
  - Blue Solid Lines: Perennial Stream
  - Blue Dotted Lines: Intermittent Stream
  - Blue Shaded Areas: Waterbody

Soils mapped in the Project Area by the NRCS Soil Survey of Waukesha County include Ashkum silty clay loam (AsA), Elliott silt loam (EsA), Hebron loam (HeB), Martinton silt loam (MgA), Montgomery silty clay loam (Mzb), Morley silt loam (MzdB), Muskego muck (Mzg), Navan silt loam (Na), Ogden muck (Oc), and Saylesville silt loam (ShB) (Figure 2).

Soil within the wetland are mapped by the NRCS as Montgomery silty clay loam, Saylesville silt loam, and Martinton silt loam (Figure 2). Field indicators of hydric soil identified at the sample points completed in W-1 included A-11 Depleted Below Dark Surface, A12-Thick Dark Surface, F3-Depleted Matrix, and F6-Redox Dark Surface per the NRCS Publication Field Indicators of Hydric Soil in the United States – version 7.0. Based on data collected at the sample points, the hydric soil criterion was satisfied.
