# **WATER QUALITY TRADING PLAN**

**VILLAGE OF SLINGER  
WASHINGTON COUNTY, WISCONSIN  
DECEMBER 2019**

RUEKERT/MIELKE  
W233 N2080 Ridgeview Parkway  
Waukesha, Wisconsin 53188-1020

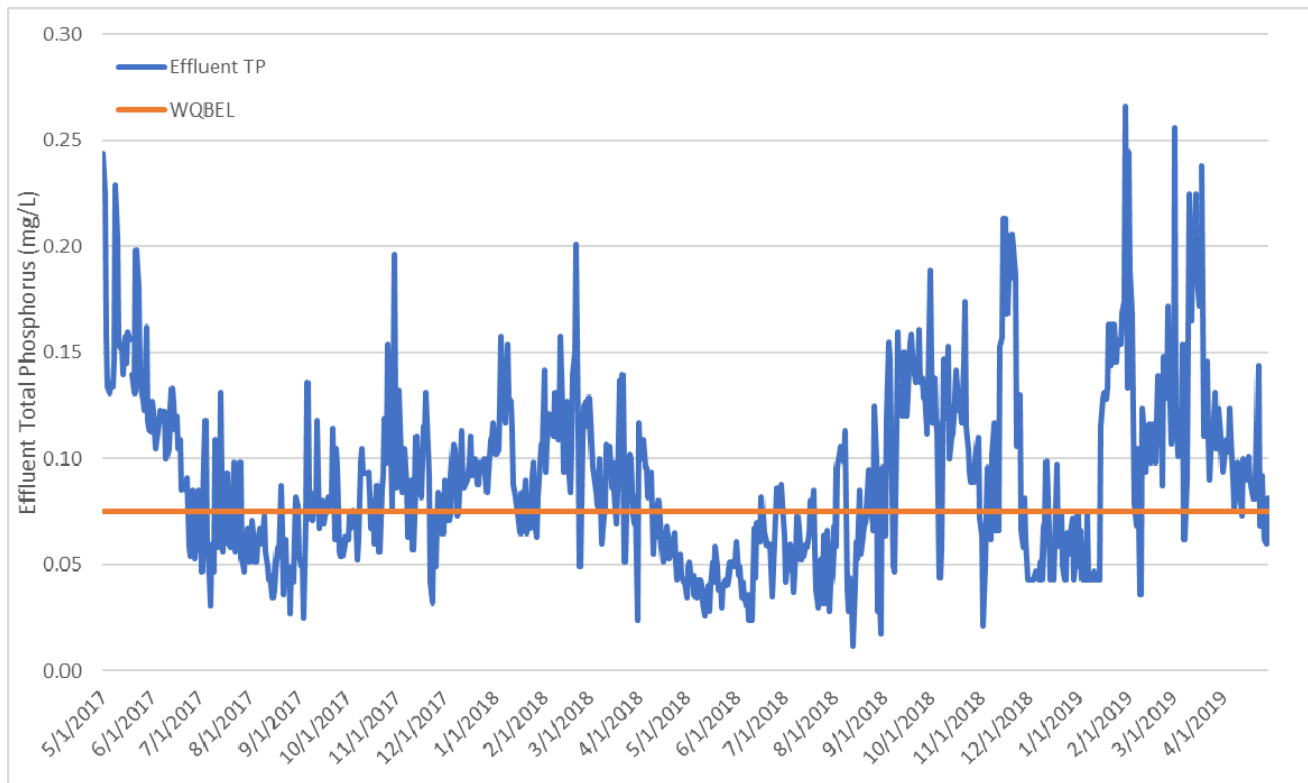
**Figure 1.** Effluent TP Concentration at the Slinger WWTF from May 2017 through April 2019

Figure 1 below summarizes effluent TP calculations at the Slinger WWTF for the past two years. This time period is a good representation of the Village's chemical and biological optimization efforts at the WWTF as continuous chemical dosing started in the middle of April 2017. In the calendar year 2018, the average effluent TP concentration was 0.083 mg/L. From May of 2018 through April of 2019, the average

effluent TP concentration was 0.090 mg/L. Over the period shown in Figure 1, the average effluent TP concentration was also 0.090 mg/L. Based on these results, the Village has determined that WQT is needed to supplement chemical optimization at the WWTF in order to meet the WQBEL.

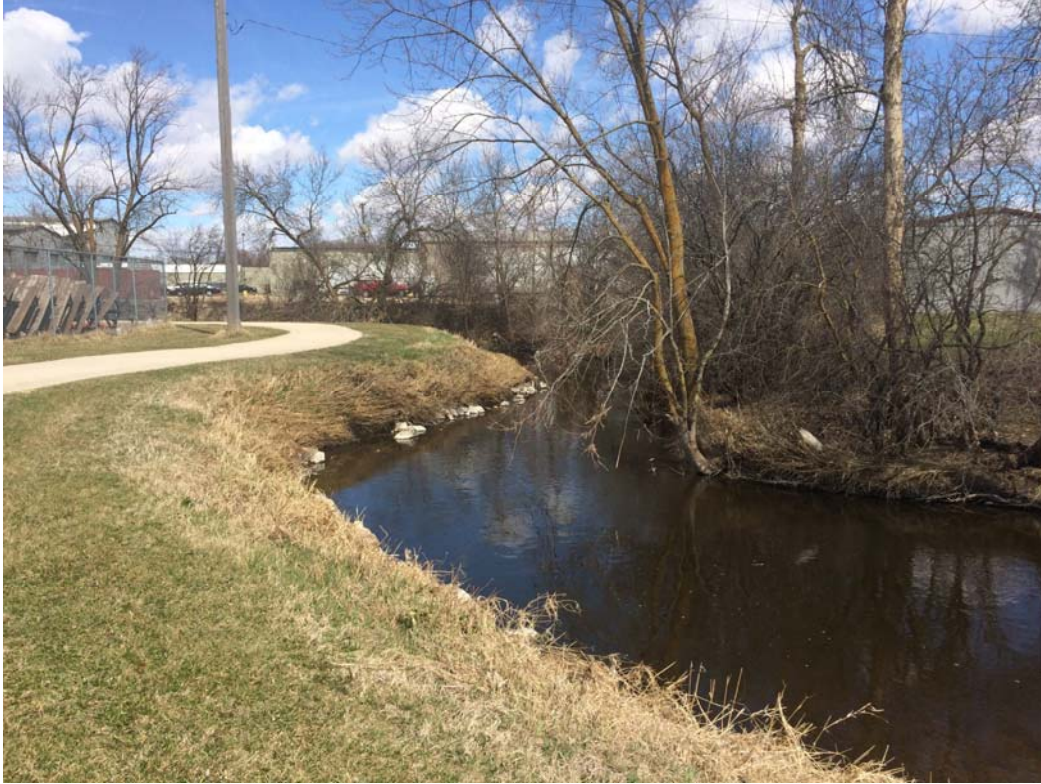
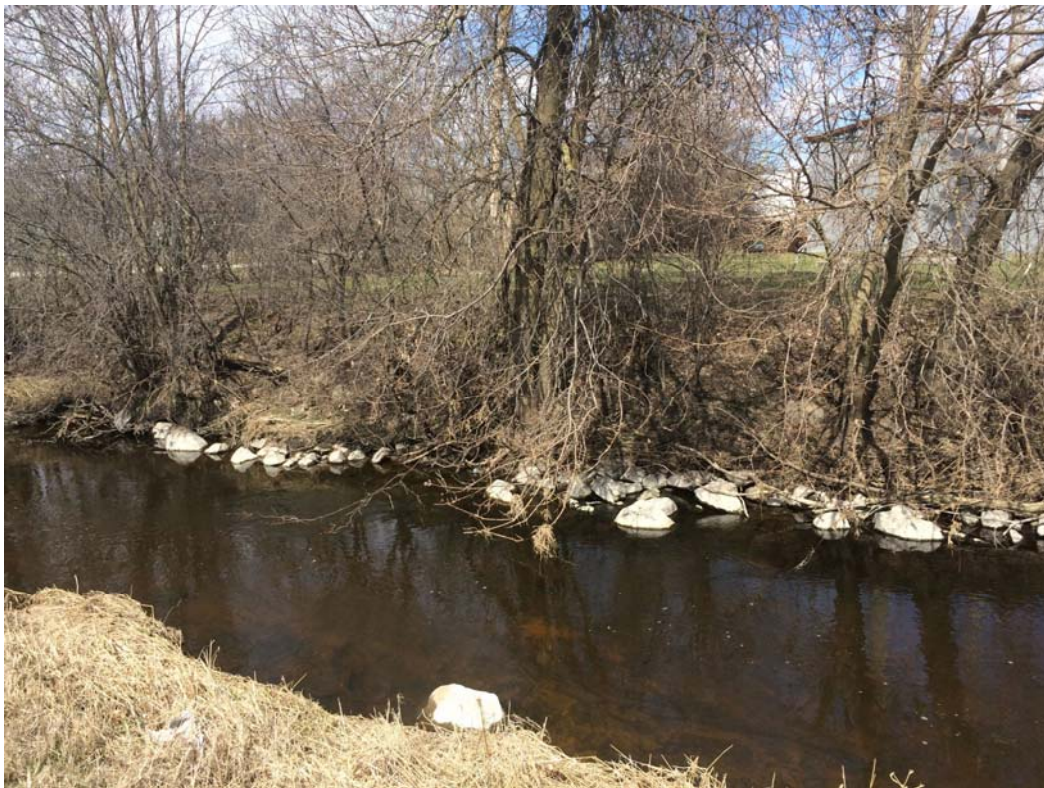
**Figure 3.** SB1/NB1 Streambank Image 1

South Bank (SB) 1 and North Bank (NB) 1 are the 220 ft. sections directly west of Grant St. The average streambank height of SB1 is 9.5 ft., and the average streambank height of NB1 is 13.5 ft. The soil TP concentration is 680 ppm and 720 ppm for SB1 and NB1, respectively. Figures 3-5 show various perspectives of the north and south bank for reference. There are three active storm water outlets in this section of the river which contribute storm water flows directly to the Rubicon River. Based on the location of these outlets, no direct scouring of the streambank was assumed to occur as a result of storm water flows.

The southern bank is vegetated but has a fairly steep slope down to the water level. Through the vegetated cover there were signs of soil loss throughout the measured streambank height, but the erodible bank height was divided by two to account for the stabilization provided by the existing vegetation. The lateral recession rate was estimated to be 0.05 ft./year per guidance included in the NRCS Streambank Erosion Estimator. The recession rate was determined to be “slight” due to some patches of bare bank, some rills, but no vegetative overhang or exposed tree roots.

The northern bank is covered with trees and brush but the soil is predominantly bare. There are exposed tree roots and other visual signs of erosion. For this reason, the entire average bank height was considered erodible, and the lateral recession rate was assumed to be 0.20 ft./year, or “moderate”.

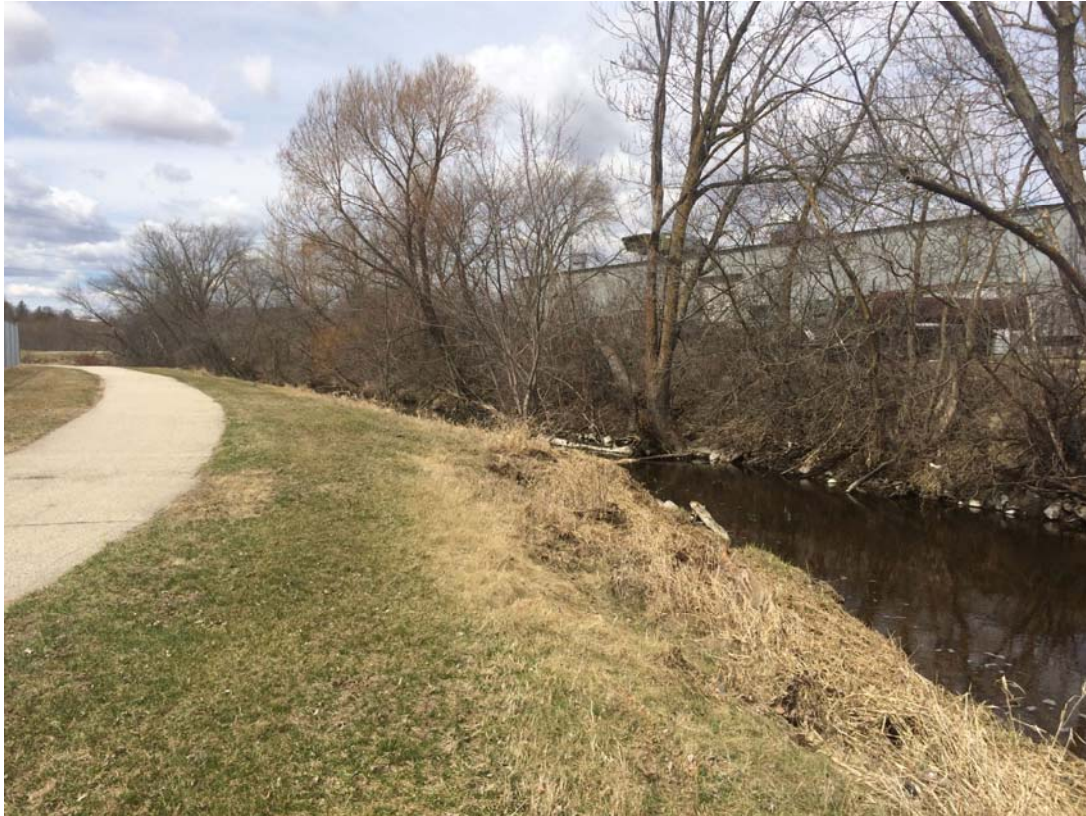
Figure 6. SB2/NB2 Streambank Image 1

South Bank 2 and North Bank 2 are the 220 ft. sections adjacent to businesses that exist north of the site, west of SB1 and NB1. The average streambank height of SB2 is 13.0 ft., and the average streambank height of NB2 is 13.3 ft. The soil TP concentration is 590 ppm and 540 ppm for SB2 and NB2, respectively. Figures 6-8 show various perspectives of the north and south bank for reference.

The southern bank is similarly vegetated to SB1 but has a gentler slope to the water level. Through the vegetated cover, there were still signs of soil loss, so the erodible bank height was again divided by two to account for the stabilization provided by the existing vegetation. The lateral recession rate was estimated to be 0.05 ft./year.

The northern bank has longer sections without trees and brush and the soil is predominantly bare. The erosion in this section was observed to be greater than NB1, with exposed tree roots, trees falling into the river, and notable signs of erosion. Again, the entire average bank height was considered erodible, and the lateral recession rate was assumed to be 0.40 ft./year, or “severe”. Erosion in this section is assumed to occur by scouring from the stream during high flows as well as by overland flow, freezing, and thawing across the entire bank. There was gravel from the parking lots of the adjacent businesses in several segments of NB2, showing that plowing and runoff from the adjacent parking lot may be contributing to the deterioration of the streambank. For this reason, measures beyond the stabilization of the section of the streambank may be required to address all causes of erosion for this section of the streambank. These measures may include the City working with the owners of the businesses adjacent to the streambank to alter their methods of snow plowing during winter months to eliminate gravel and soil being pushed towards the stream location. If working with the business owners is not effective, the Village of Slinger may consider adding a barrier along the property line of sections of the streambank most susceptible to receiving gravel and soil from the adjacent parking lot areas.

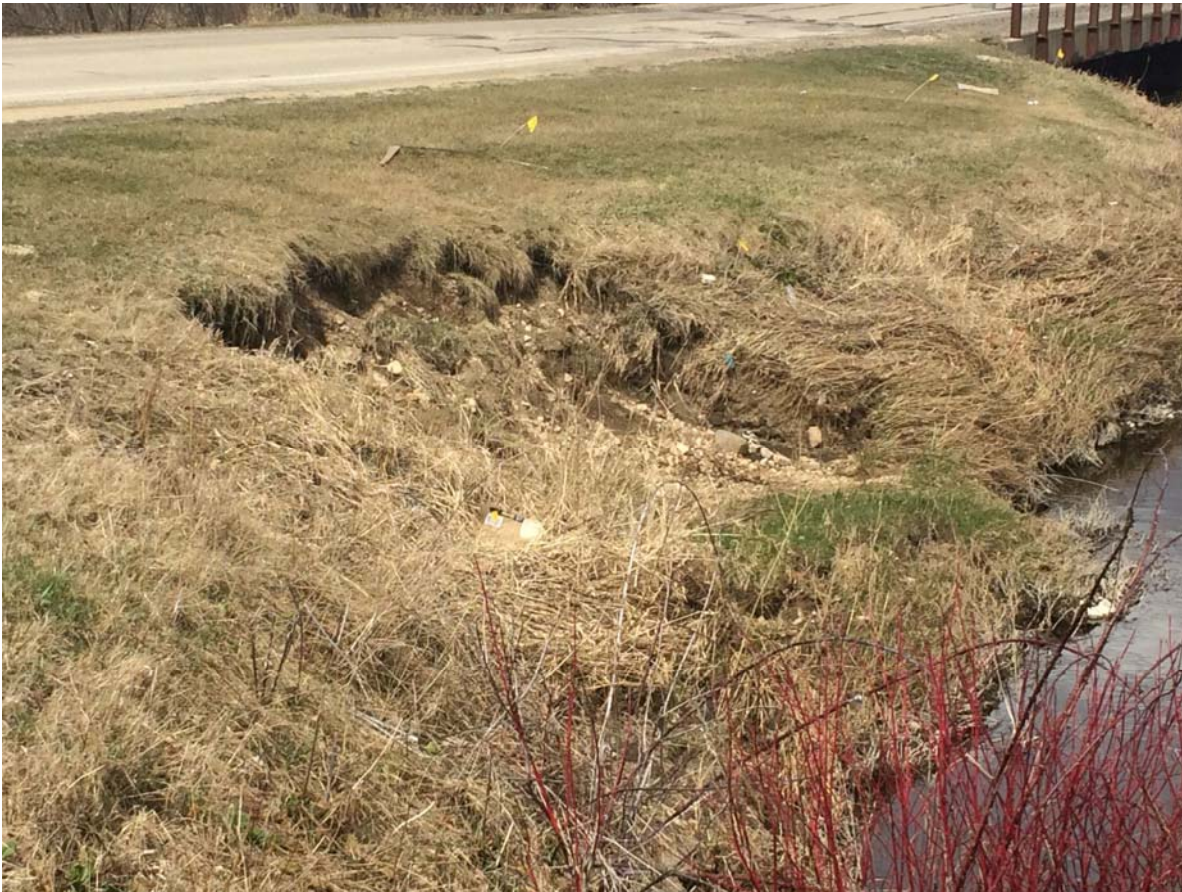
Figure 12. SB4/NB4 Streambank Image 1

South Bank 4 and North Bank 4 are the 215 ft. sections directly east of N. Wacker Dr. The average streambank height of SB4 is 13.2 ft., and the average streambank height of NB4 is 16.5 ft. The soil TP concentration is 420 ppm and 610 ppm for SB4 and NB4, respectively. Figures 12-14 show various perspectives of the north and south bank for reference.

The southern bank is similarly vegetated to past sections of the southern bank; however, there is a concentrated area of bare, eroded soil shown below in Figures 12 and 14. The City of Hartford may want to work with the Village during design and construction of streambank stabilization measures to address this specific area of the southern bank. The erodible bank height was again divided by two to account for the stabilization provided by the existing vegetation. The lateral recession rate was increased to 0.1 ft./year to account for the disrupted area of the bank as well as generally steeper slopes to the river location.

The northern bank section east of N. Wacker Dr. had a greater concentration of brush than sections NB2 and NB3. Also, there is a portion of the northern bank that serves as a depositional area in the eastern half NB4. For these reasons, the proposed length of streambank stabilization measures was reduced from 220 ft. to 130 ft per recommendation of WDNR staff. The 130-foot portion that the Village is planning to stabilize is in the northwestern portion of NB4, extending from the bridge southeast to the start of the depositional area. A lateral recession rate of 0.20 ft./year was assumed for this section of the bank as it is qualitatively similar to NB1. An erodible bank height of 12.4 ft. was assumed for the 130-foot portion of the streambank which is 75% of the average measured bank height.

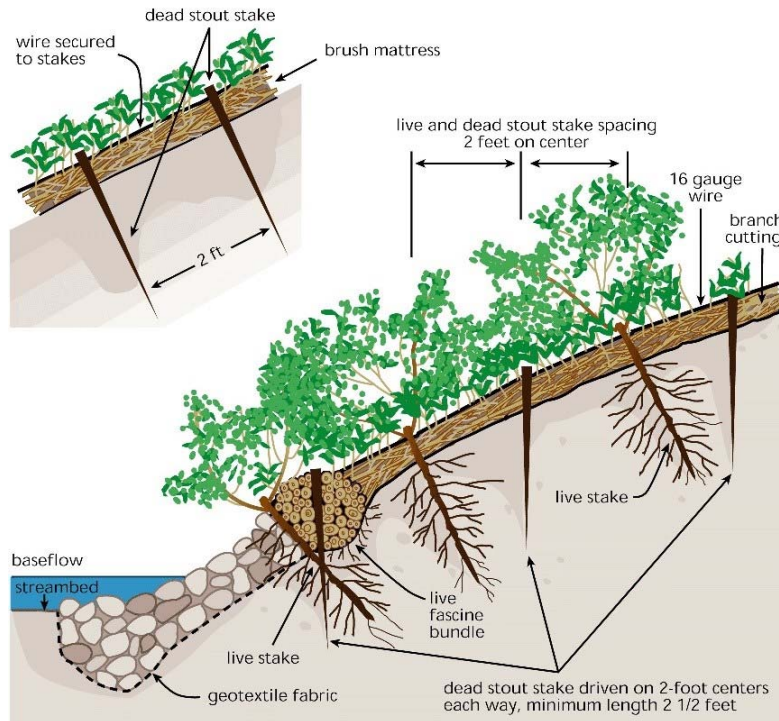
Brush matting (or brush mattresses) involves a combination of live stakes, live fascines, and branch cuttings to cover and stabilization streambanks. An example figure is shown below. A thick mat of dormant cuttings is placed on the bank and held down with stakes. The brush mattress serves as structural reinforcement as well as an area where native plantings can take root and provide vegetative stabilization. For the current project site, this technique would likely be used alongside stone toe protection to a level at or above the ordinary high water level.

**Figure 15.** Example of Brush Matting Streambank Technique. Image Credit: Stream Corridor Restoration: Principles, Processes and Practices, 10/98, by the Federal Interagency Stream Restoration Working Group (FISRWG).

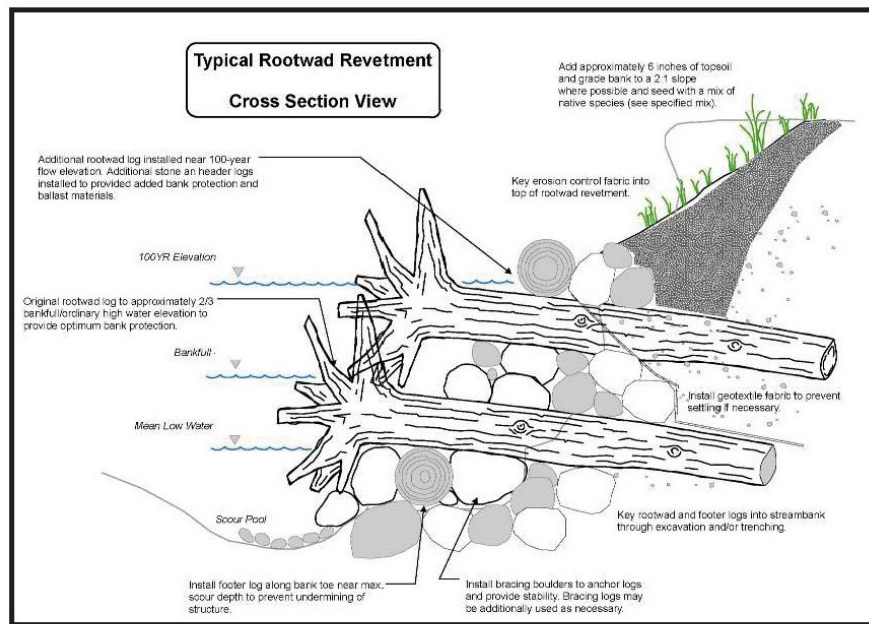
In addition to the restoration of riparian vegetation and the reduction of soil erosion, this technique is also able to improve fish habitat by shading the stream, lowering water temperatures, and offering protection from predators. Other means of fish habitat restoration will be accomplished through the arrangement of rip-rap up to the ordinary high water mark and with the installation of intermittent rootwad composites along the streambank. An example rootwad composite detail is shown below. Existing fallen trees and cleared trees along the streambank will be used in the construction of the rootwad composites. The

**Figure 16.** Typical Rootwad Composite Detail.

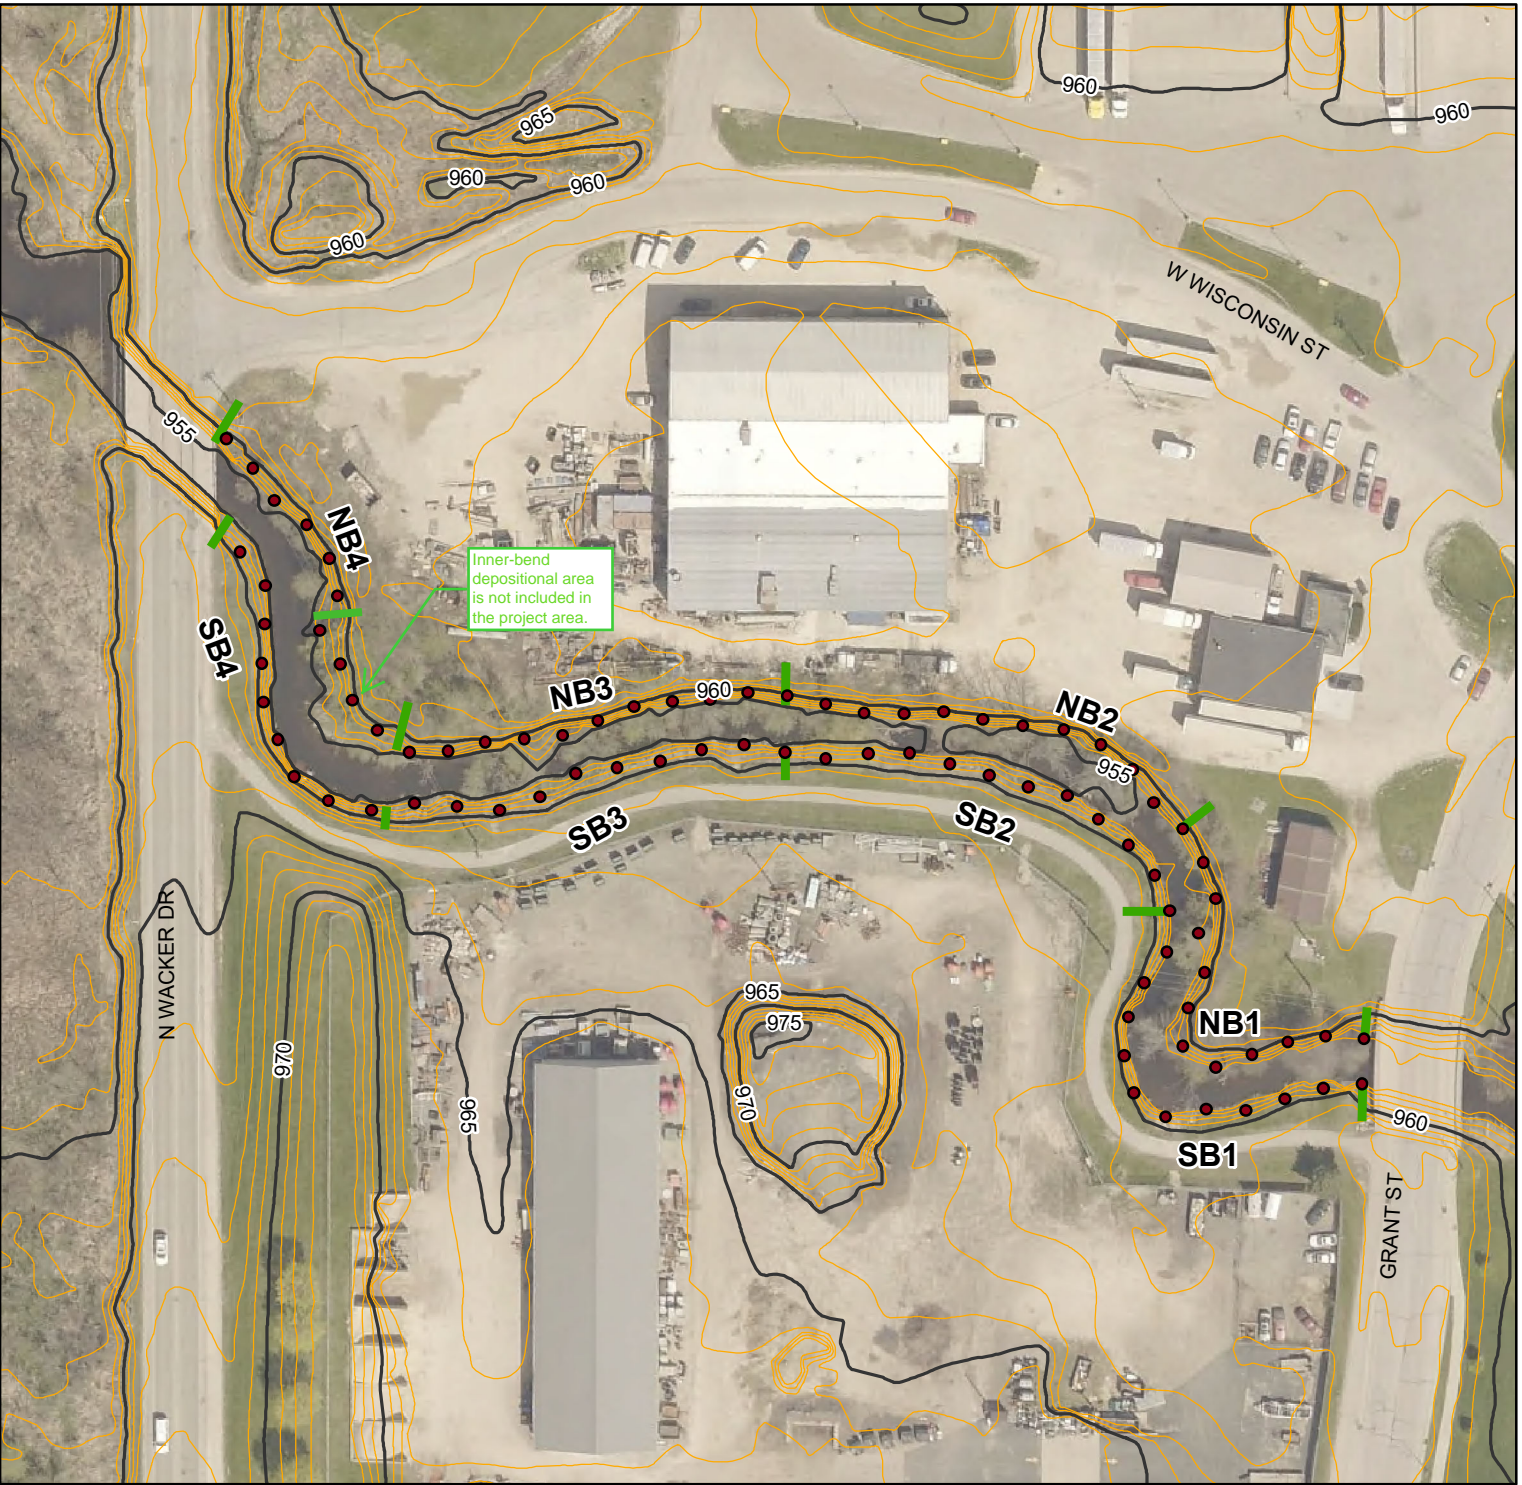
## **Streambank Stabilization Site Exhibit**

Inner-bend  
depositional area  
is not included in  
the project area.
