# WATER QUALITY TRADING PLAN

**Village of Patch Grove**  
**Wastewater Treatment Facility**  
WPDES Permit No. WI-002275-08-0  
S.T.H. '35', SW ¼, SE ¼, Sec 4, T5N, R5W  
Patch Grove, Wisconsin 53817

**Delta 3 Engineering, Inc.**

*Project Number: D20-005*

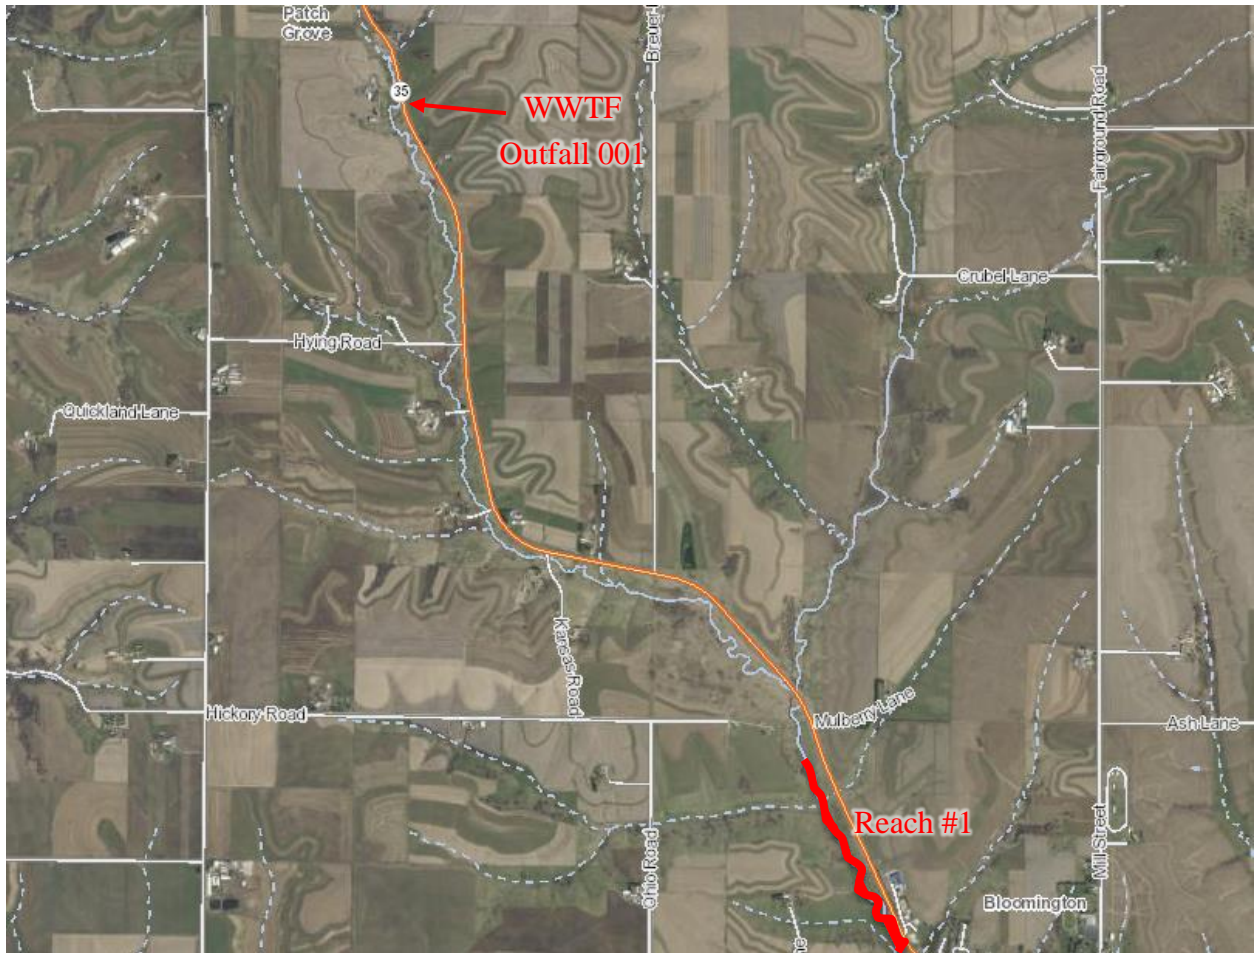
**Figure 3.1 – Stream Reach location in relation to Outfall 001.**

The Village discharges to unnamed Tributary to Blake Fork (Middle Grant River Watershed, GP05 – Grant-Platte River Basin) at Outfall 001. As mentioned previously, the Village intends to perform WQT projects within the Village’s HUC-12 #070600030201. The Village plans to perform streambank stabilization which will utilize grading and/or riprap to prevent the erosion of sediment from the streambanks. Streambank stabilization will not only prevent sediment from entering the stream, but will also prevent phosphorus, nitrogen, and other pollutants from discharging to Blake Fork. See Figure 3.1 for additional project location information.

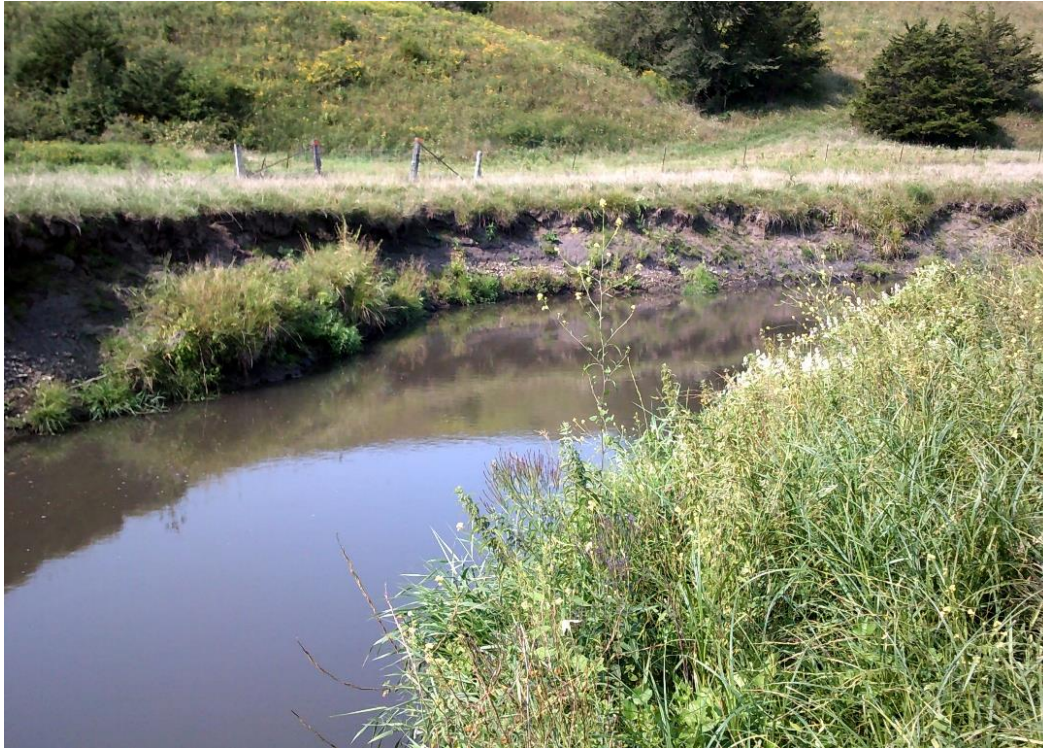
Image 1 – Bare bank, severe undercut with slump and vegetative overhang.

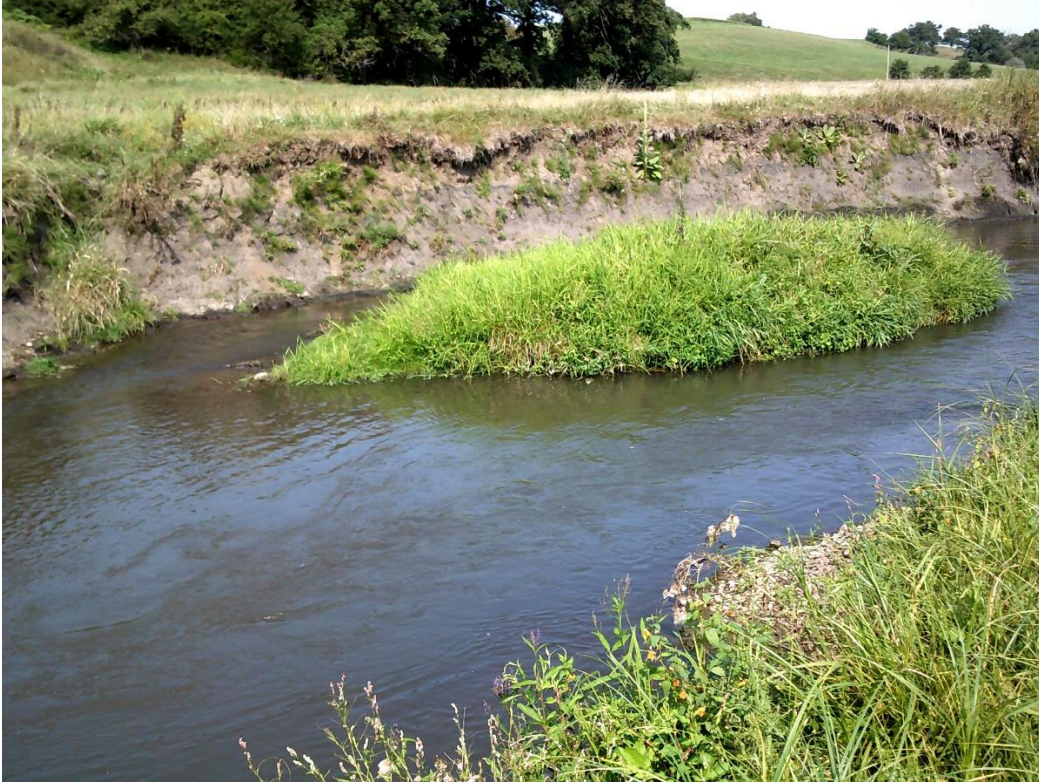
Image 2 – Bare bank and severe undercut with slump.

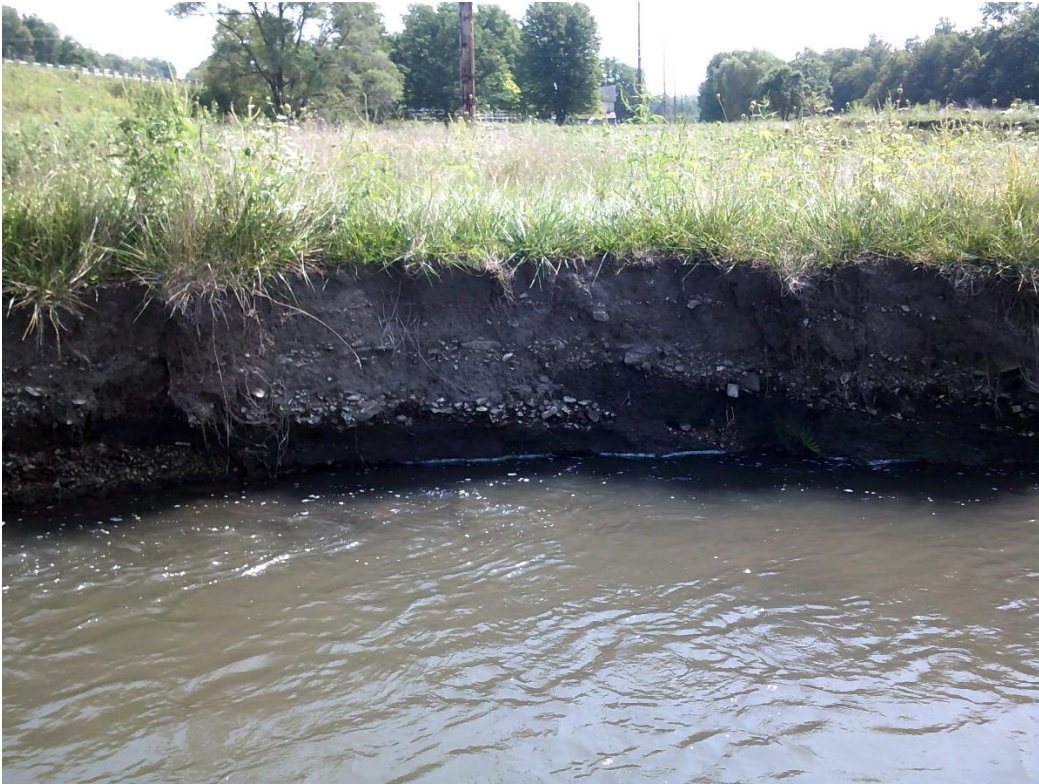
Image 3 – Bare bank, severe undercut and vegetative overhang.

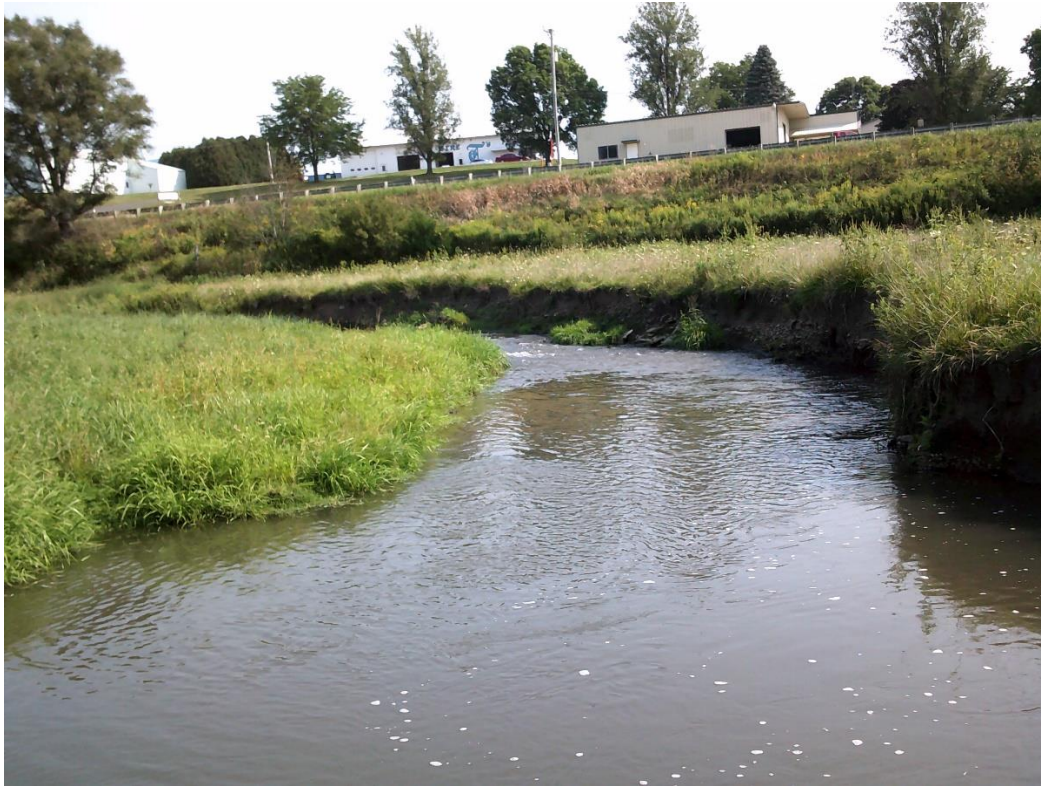
Image 4 – Bare bank, severe undercut with slump and vegetative overhang.

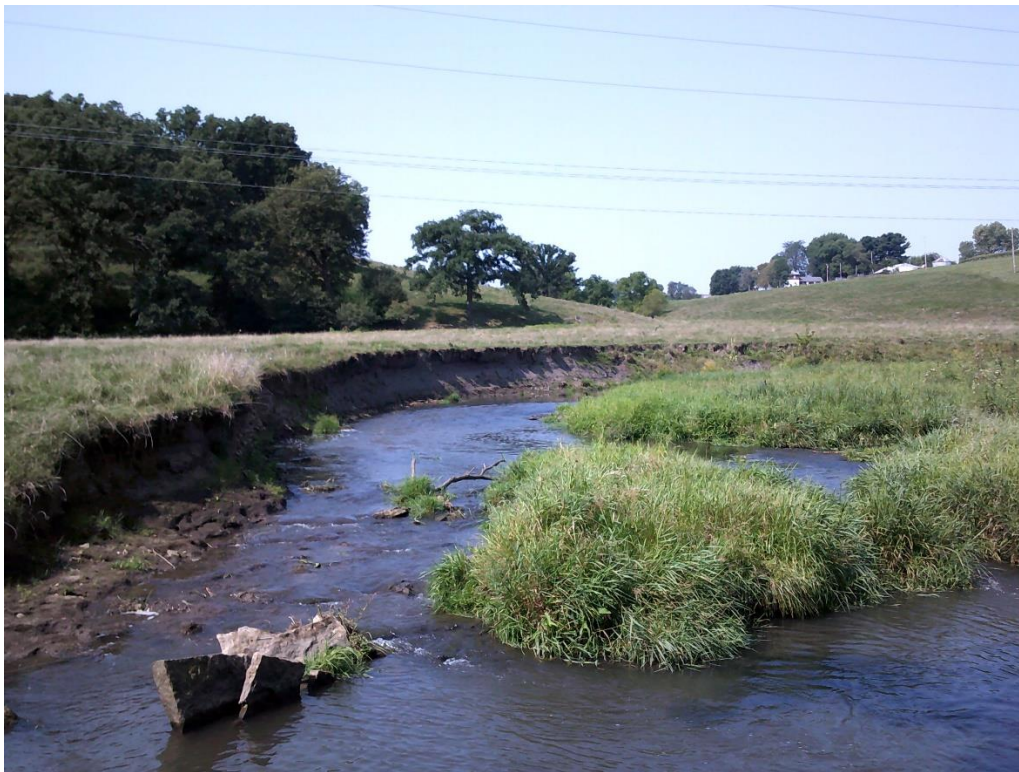
Image 5 – Bare bank, severe undercut with slump and vegetative overhang.

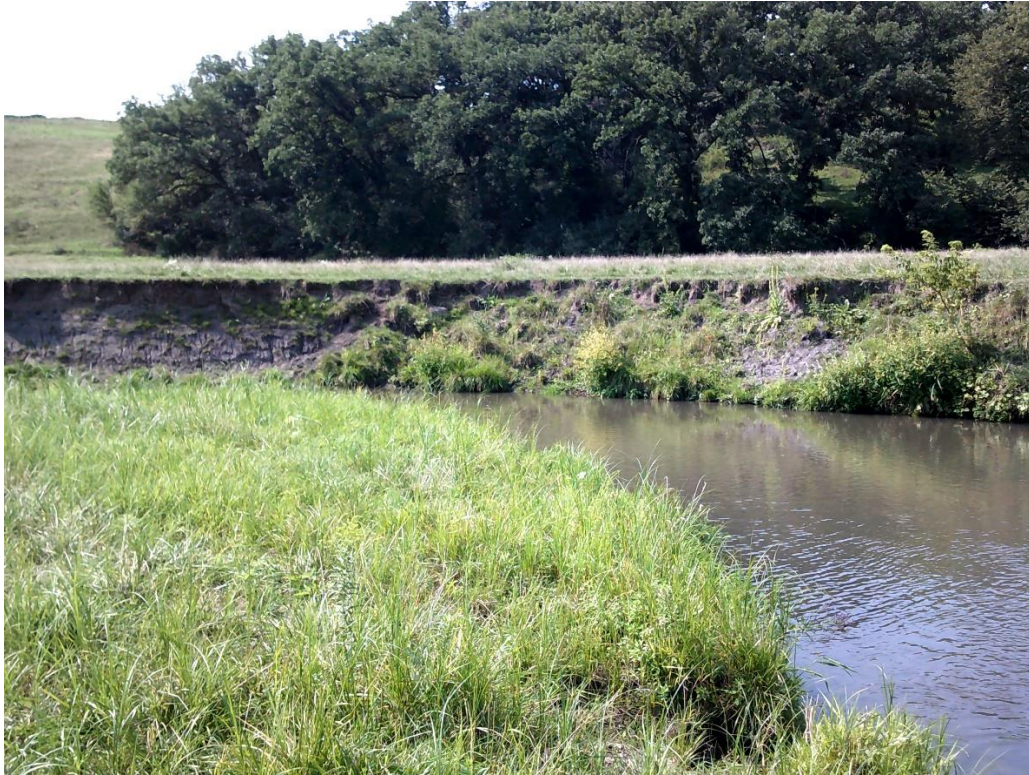
Image 6 – Bare bank, severe undercut with slump and vegetative overhang.

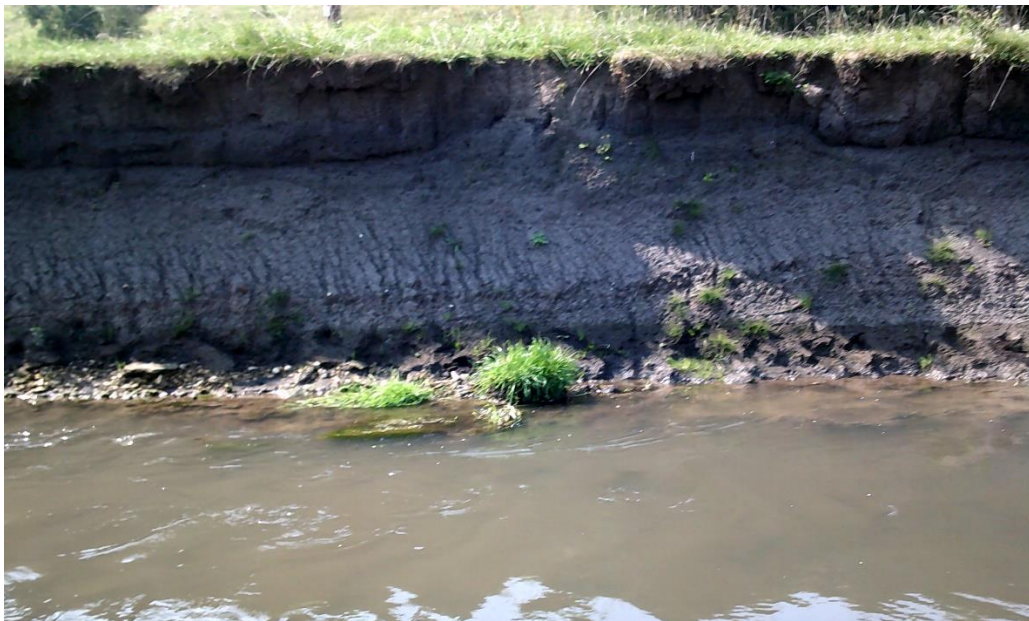
Image 7 – Bare bank, severe undercut with rills, slump, and vegetative overhang.

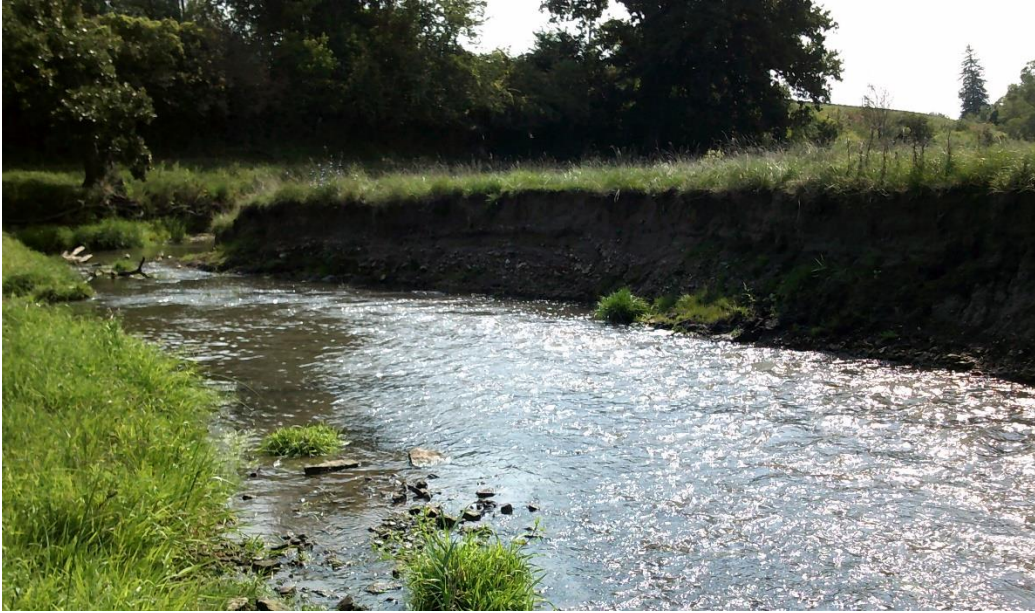
Image 8 – Bare bank, severe undercut with slump and vegetative overhang.

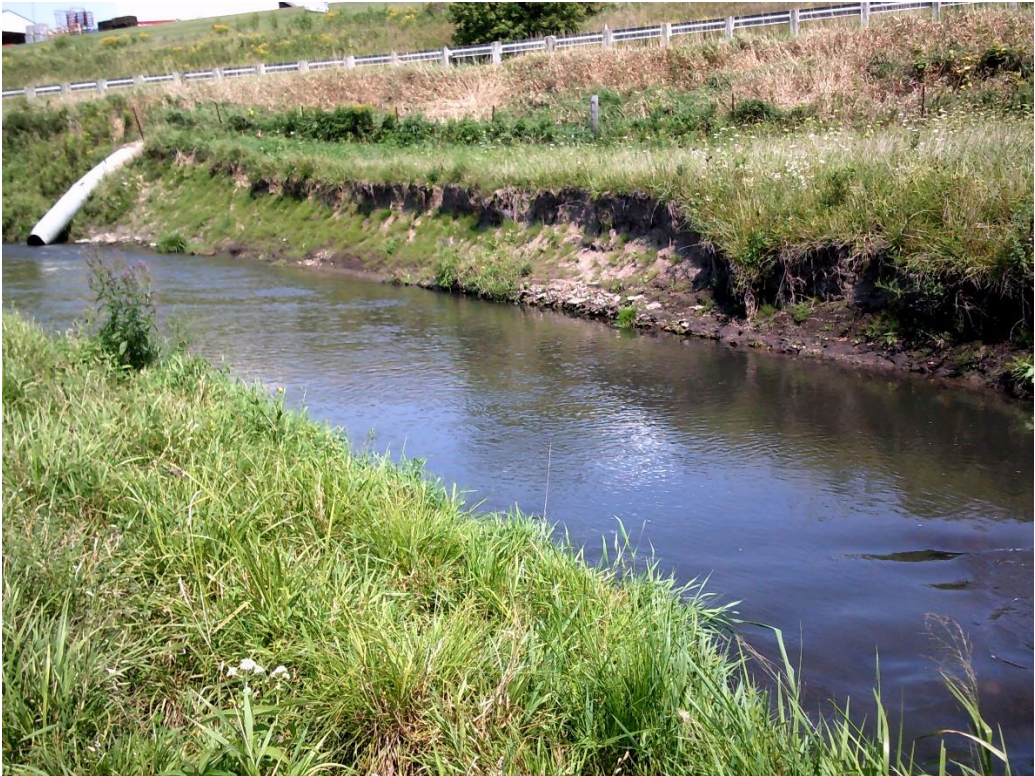
Image 9 – Bare bank, severe undercut with slump, exposed culvert, and vegetative overhang.

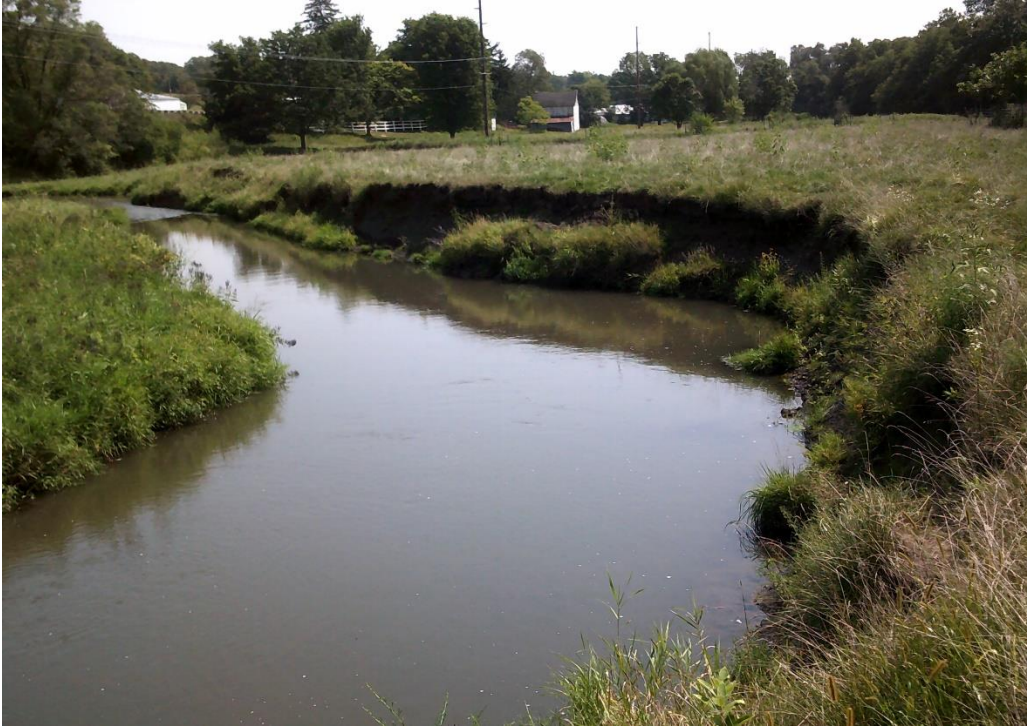
Image 10 – Bare bank, severe undercut with slump and vegetative overhang.

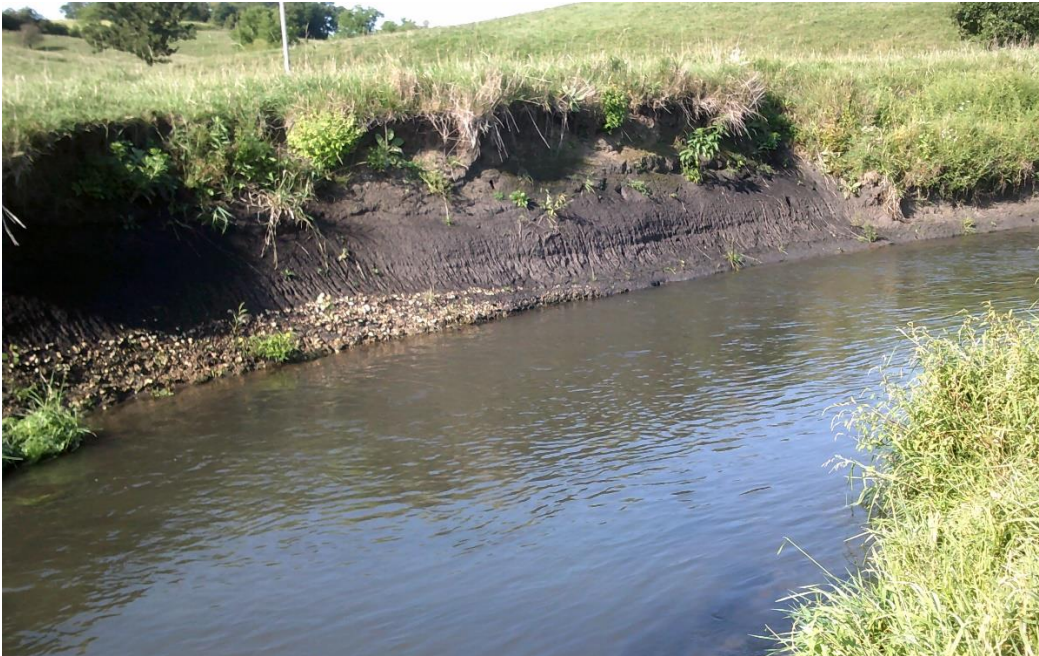
Image 11 – Bare bank, severe undercut with rills, slump, and vegetative overhang.

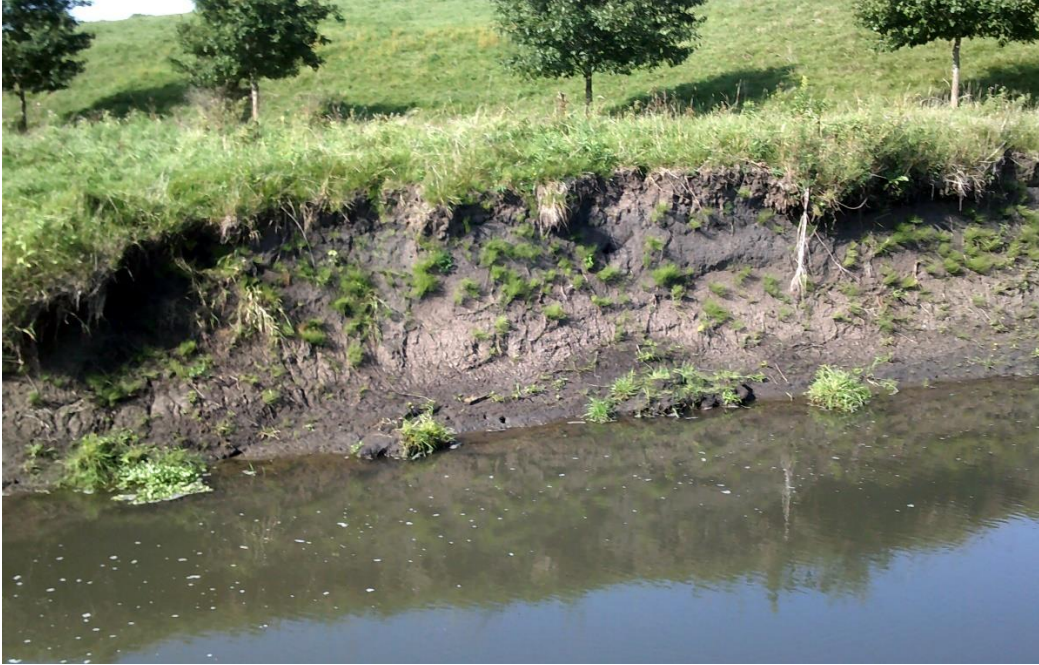
Image 12 – Bare bank, severe undercut with slump and vegetative overhang.

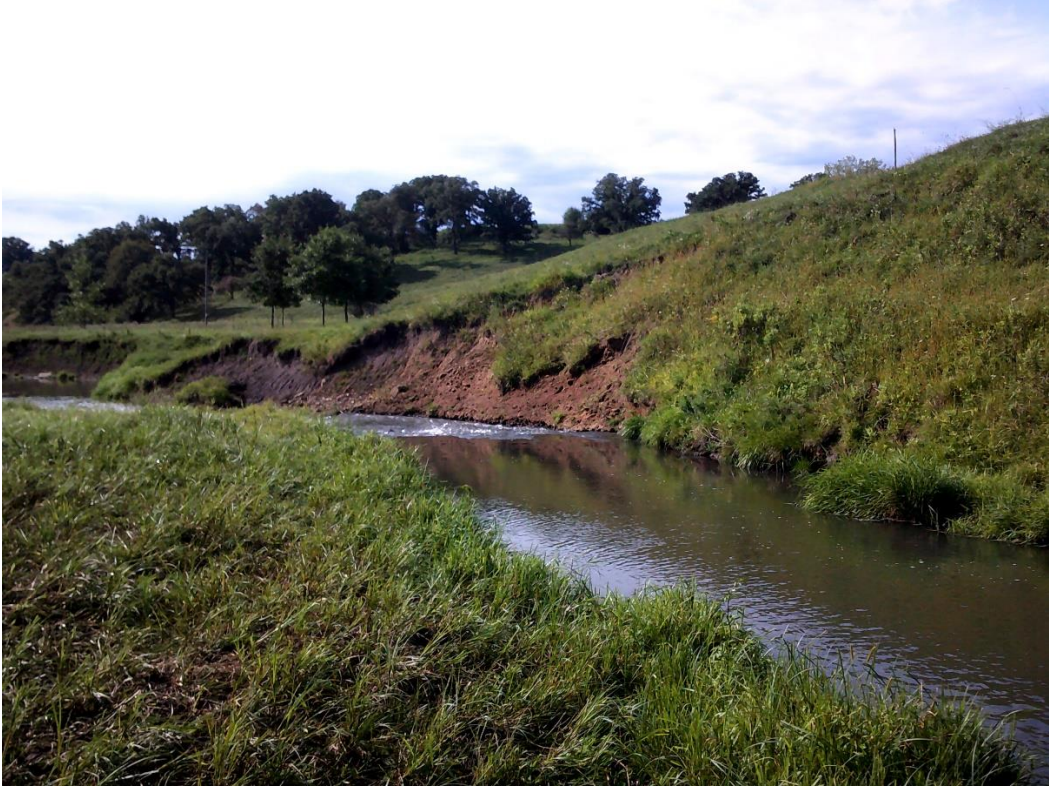
Image 13 – Bare bank, severe undercut with slump and vegetative overhang.

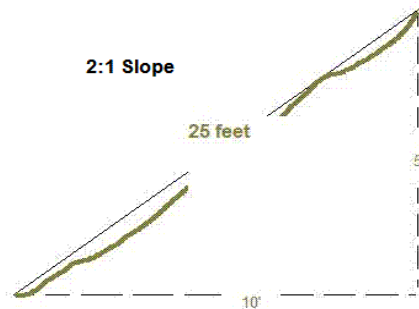
\*\* Eroding bank height is measured along the bank, not the vertical height of bank. Example: if vertical height of an eroding streambank is 5 feet, and the bank is on a 2:1 slope, the total eroding bank distance is 25 feet -- 1/2 (Base X Height).
