WETLAND DELINEATION REPORT

→ **WDNR Property & South 50' of Kohler River Trails Property
Town of Wilson
Sheboygan, WI**

Report as of
September 26, 2014

**EXCEL PROJECT # 1402630
For submittal to US Army Corps of Engineers**

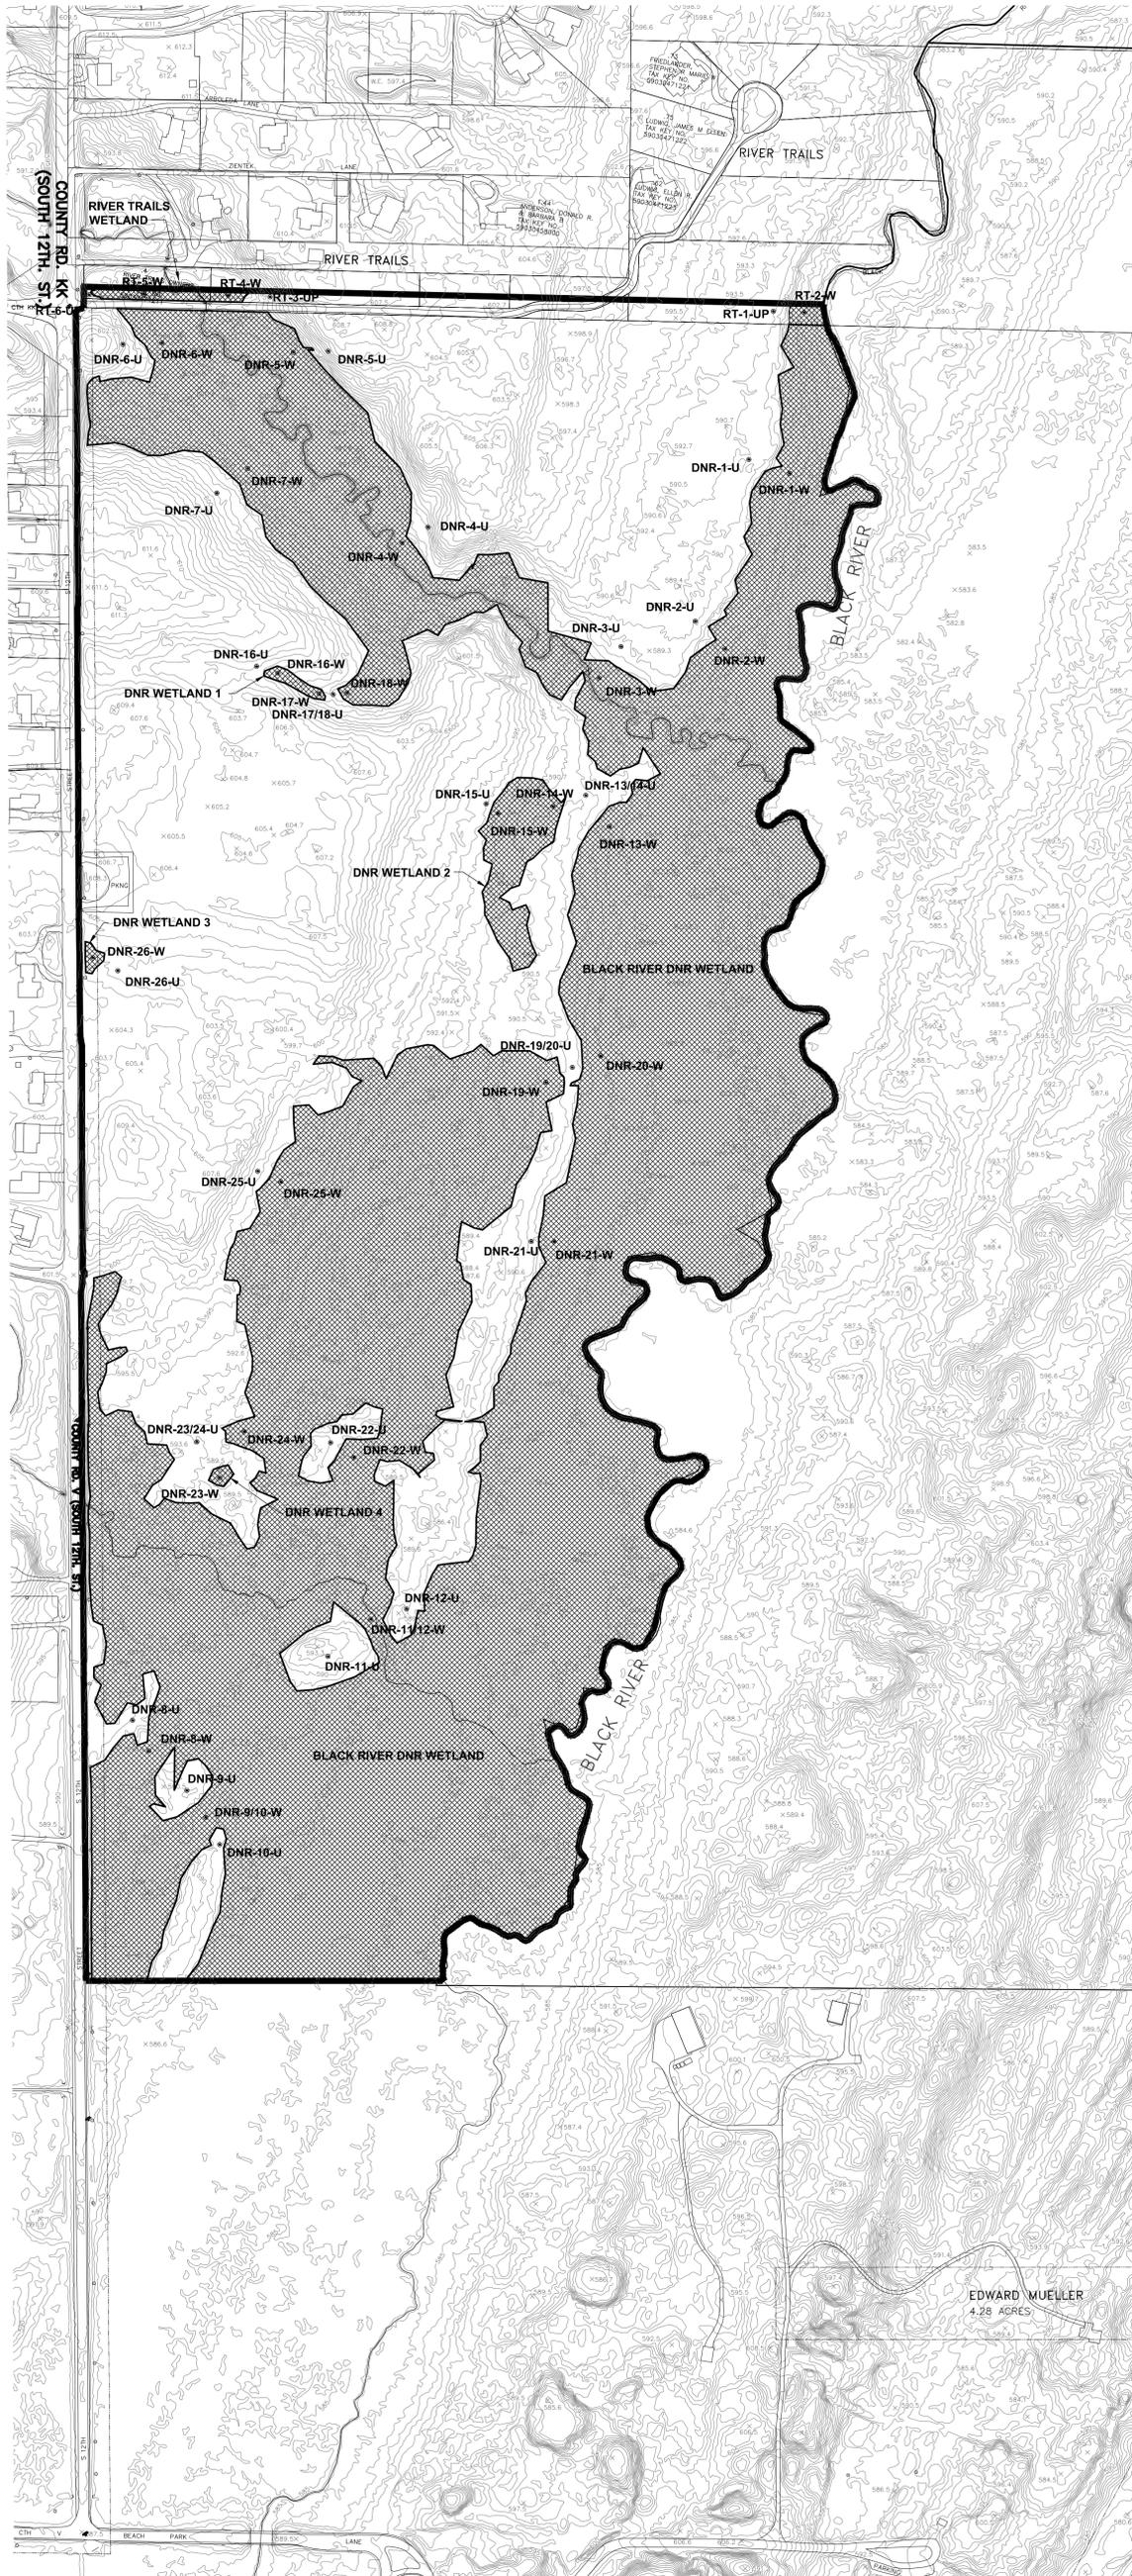
FIGURE 1 - WETLAND LOCATION MAP WITH SURVEY INFORMATION

This Wetland area identified on the site (74.04 acres) is a wooded and brushy wetland complex with wet meadow open areas along the Black River throughout the site. This wetland generally follows the topography of the Black River and much of the wetland acts as flood storage during high water elevation conditions of the River. A large, relatively flat floodplain wetland area is located in the southwest quadrant of the site which does not follow the orientation of the Black River. This area is a part of the Black River Wetland and likely acts as floodplain storage and a surface water collection area for drainage from the south and west. Additionally, two (2) streams tributary to the Black River flow through the site from west to east and both are surrounded by an extension of the Black River Wetland complex. One stream is located on the north/northwest quadrant of the property and one is located in the southern half creating fingers of wetlands connected to the Black River wetland complex.

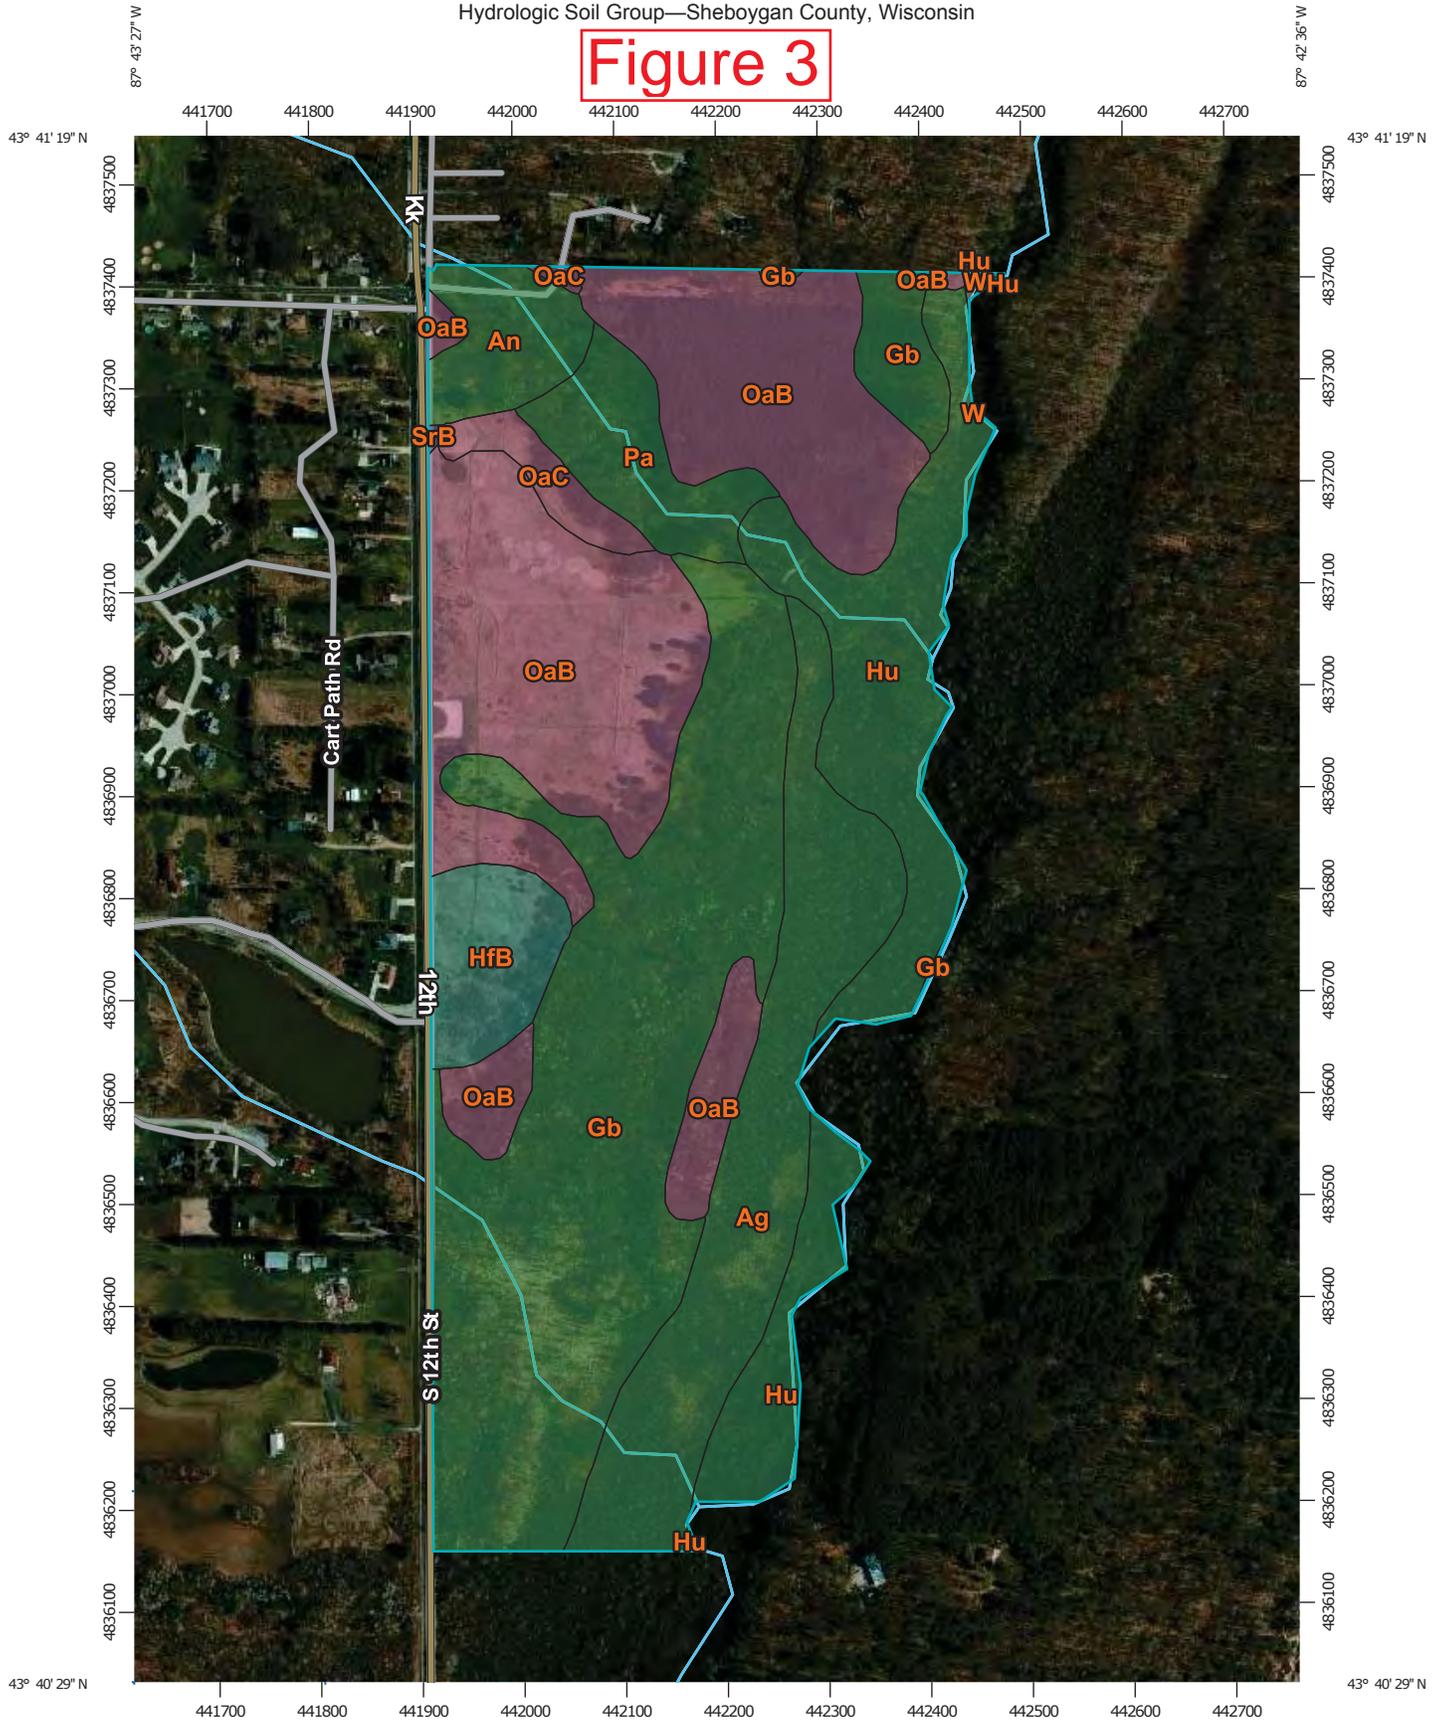
Figure 3

Hydrologic soil groups are based on estimates of runoff potential. Soils are assigned to one of four groups according to the rate of water infiltration when the soils are not protected by vegetation, are thoroughly wet, and receive precipitation from long-duration storms.

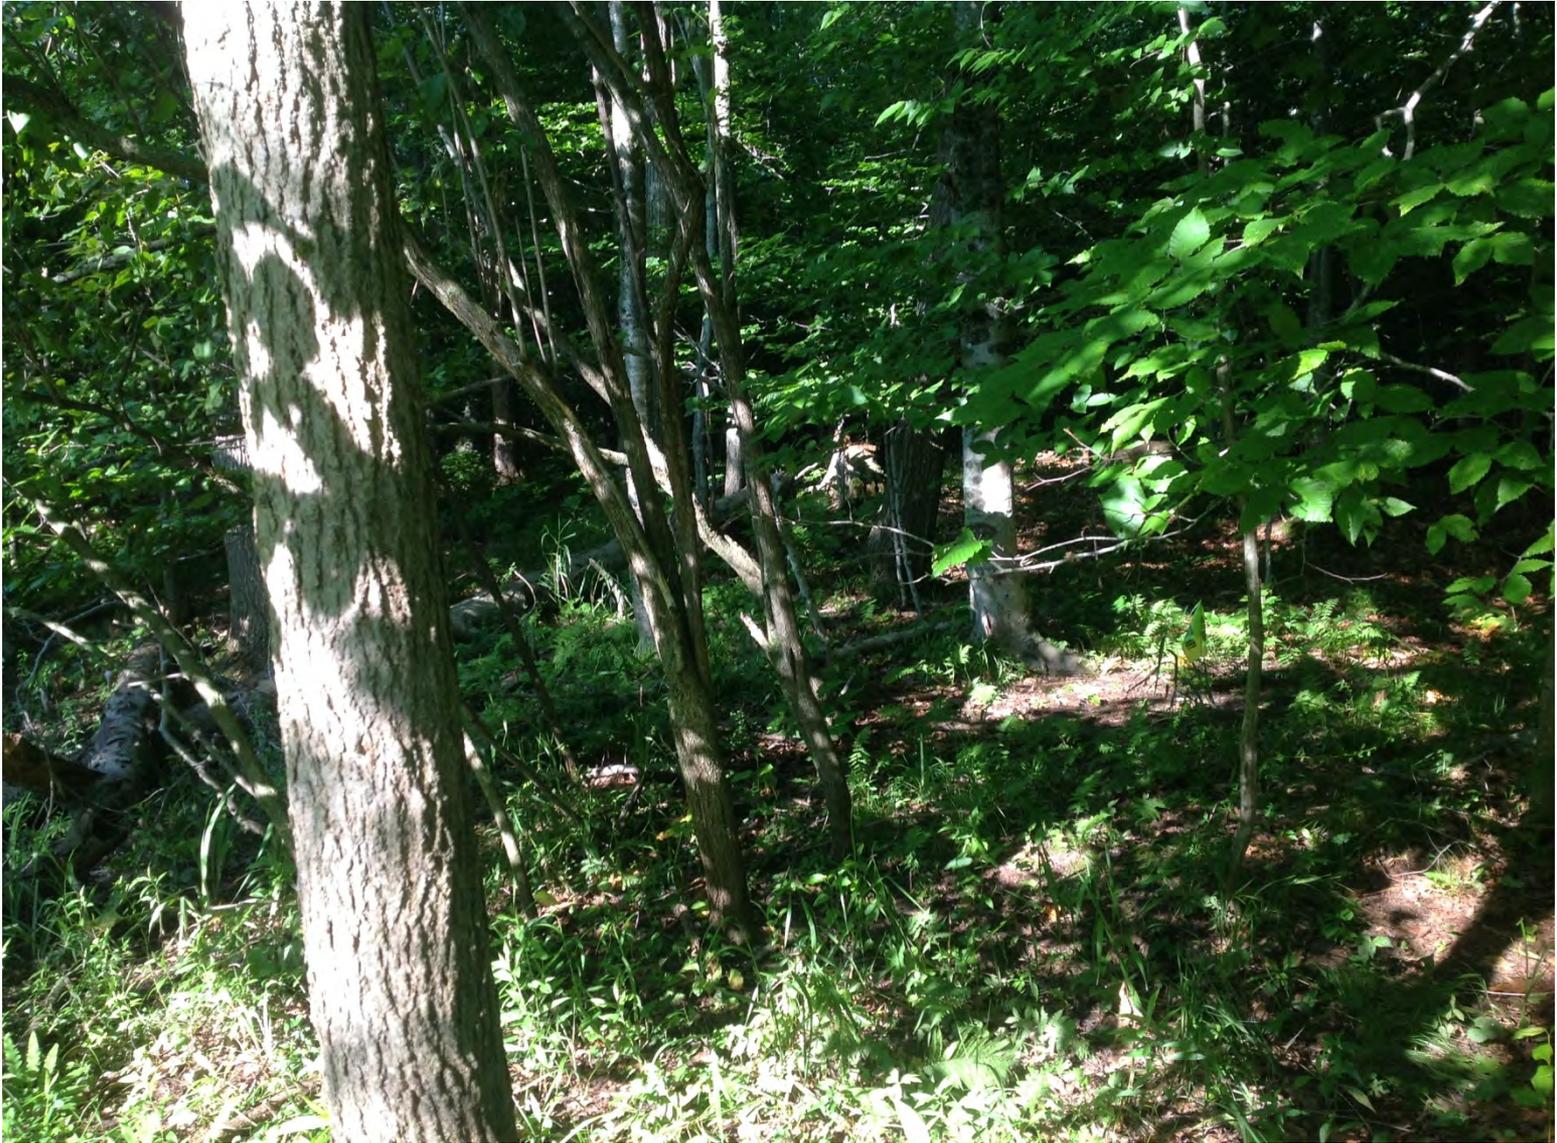
RT-1-UP

Depth (Inches)	Matrix		Redox Features				Texture	Remarks
	Color (moist)	%	Color (moist)	%	Type*	Loc**		
0-5	10 YR 2/1	100					Loam/Sand	
5-9	10 YR 5/1	50					Loam/Sand	
	10 YR 3/6	50					Loam/Sand	
9-18+	10 YR 3/6	100					Loam/Sand

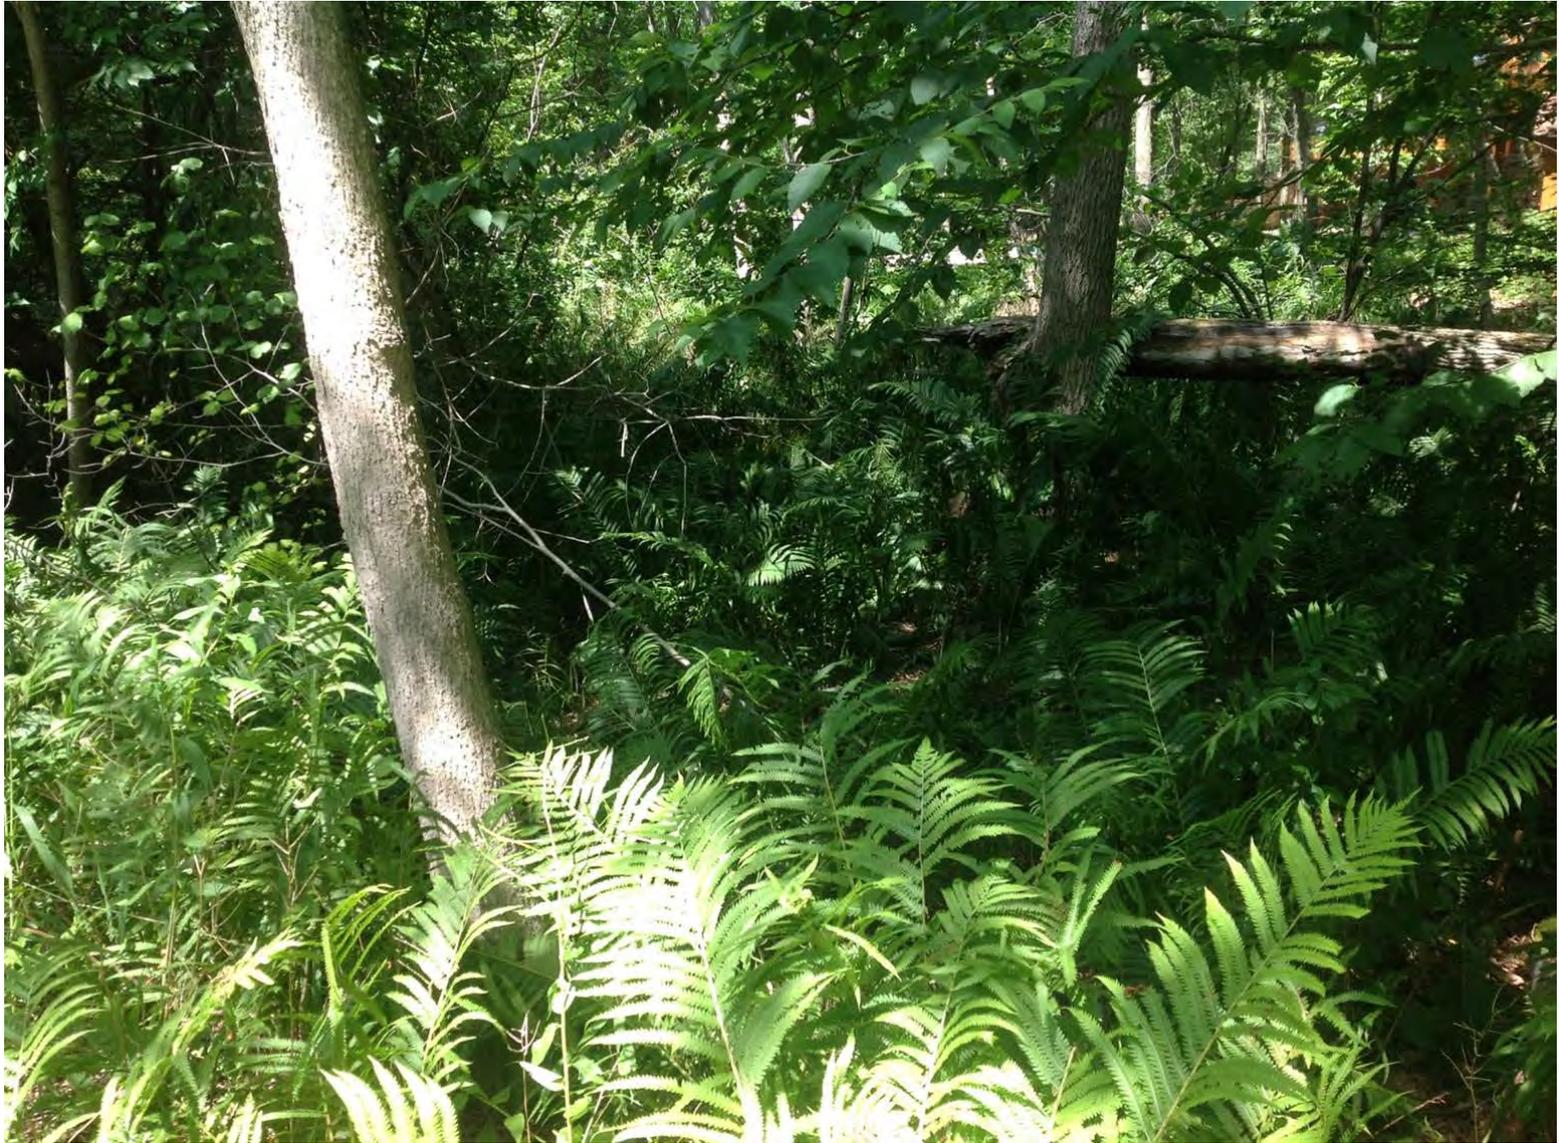
RT-3-UP

Depth (Inches)	Matrix		Redox Features				Texture	Remarks
	Color (moist)	%	Color (moist)	%	Type*	Loc**		
0-2	10 YR 2/2	100					Loam sand	Dry
2-8	10 YR 5/3	100					Loam sand	Dry
8-18+	10 YR 5/6	100					Loam sand	Dry

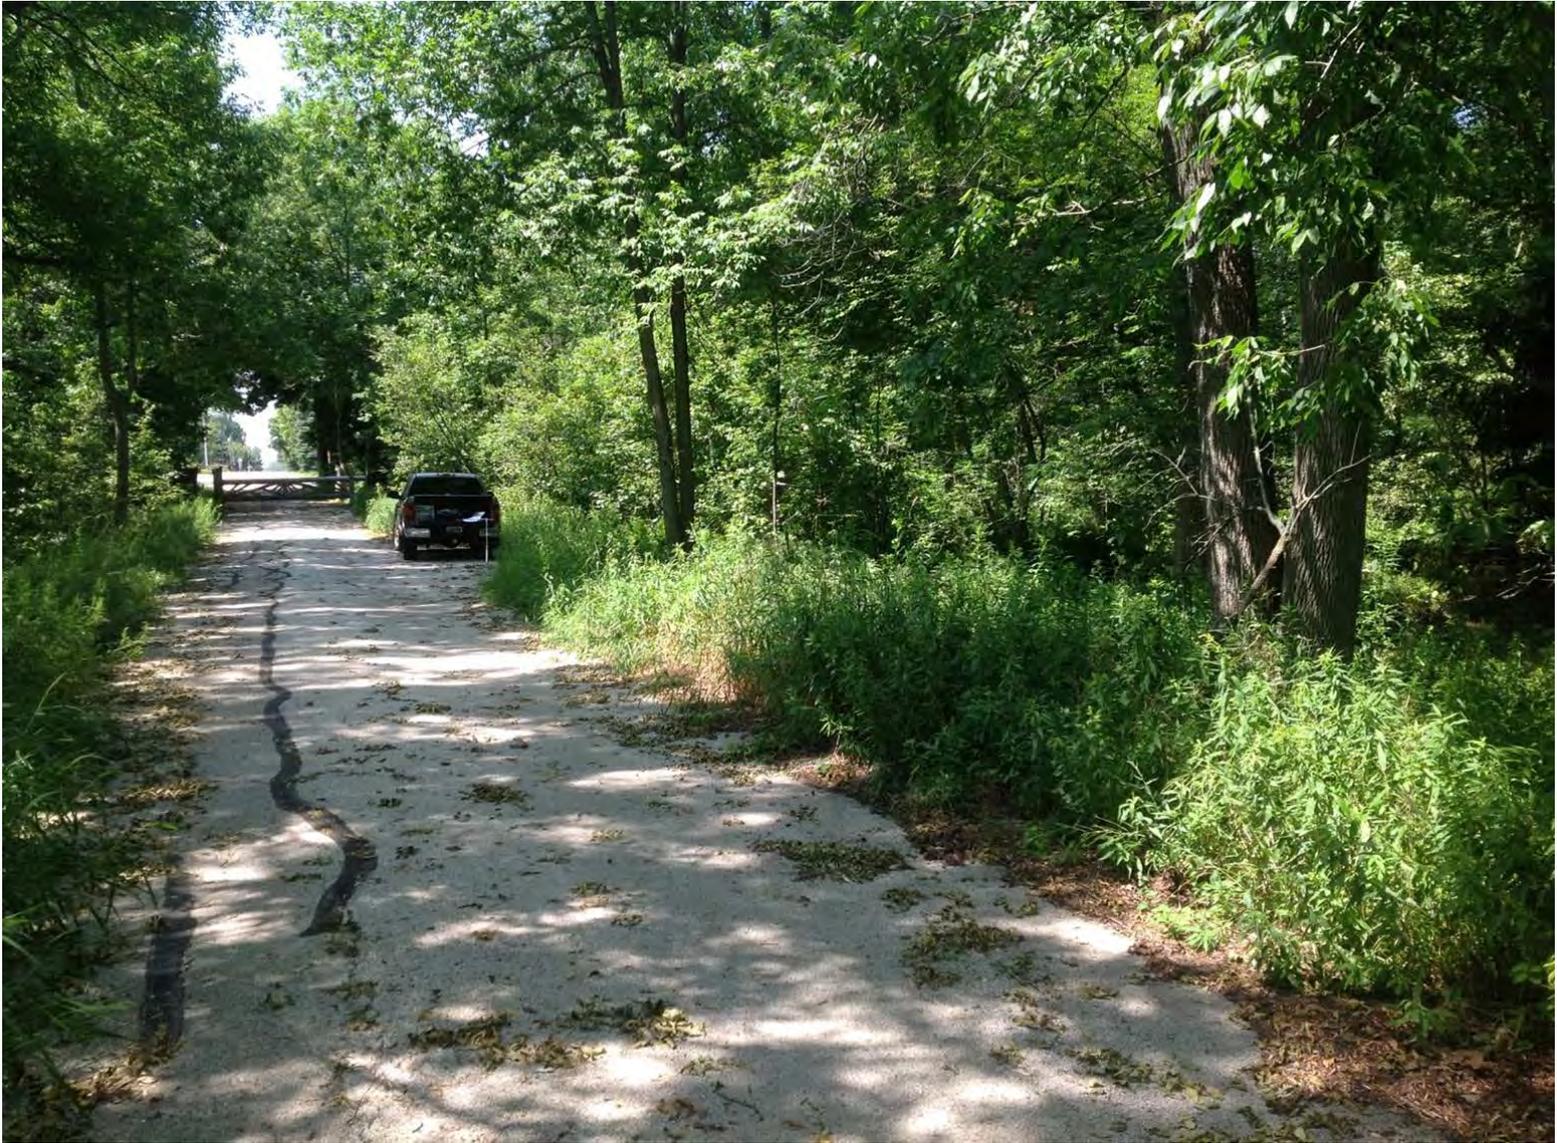
RT-4-W

Depth (Inches)	Matrix		Redox Features				Texture	Remarks
	Color (moist)	%	Color (moist)	%	Type*	Loc**		
0-3	10 YR 3/2	100					Muck	Muck
3-18+	10 YR 2/1	100					Muck	Muck
