## 2010 Water Quality Management Plan Update

Southeast Basin, Wisconsin

August, 2010

# Pike River Watershed

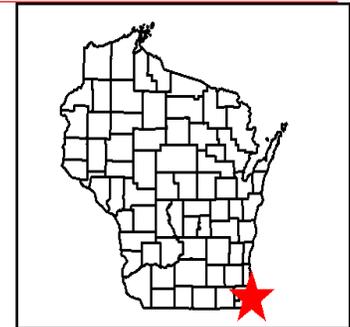
Map 1: Pike River Watershed

The Pike River Basin is a 56 square mile area that lies on the eastern side of Kenosha and Racine Counties.

Approximately 52 square miles of land eventually drain into the Pike River, which discharges to Lake Michigan in the City of Kenosha at a point approximately one mile north of the City of Kenosha Harbor.

The remaining 4 square miles of land drain directly into Lake Michigan via swales, ditches, channels and stormsewer outlets.

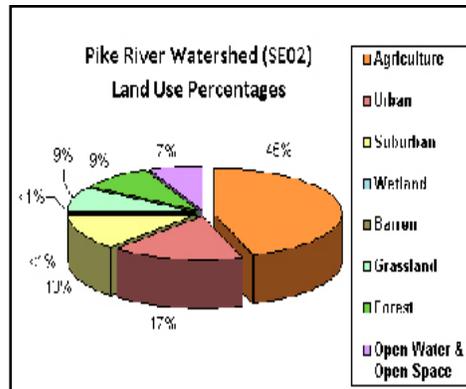
Figure 1: Land Use (2001)

Land use refers to the primary ways people develop and manage the landscape. Today, the watershed contains a mix of land use types (Figure 1 and Appendix), but 170 years ago the Pike River Basin was essentially undeveloped. Native people lived in a landscape that was rich with upland forests of oak, hickory, walnut and box elder trees. The first European settlement in the Pike River watershed, the Village of Pike River, was developed in 1835 near the mouth of the Pike River one mile north of the present City of Kenosha Harbor. Pike River once had dwellings, stores, mechanics' shops, and warehouses. But during 1842 and the following year, many of the buildings were moved to Southport (present day City of Kenosha), and the Village ceased to exist. In addition to Southport, settlements near the Pike River watershed also included Root River, (Present day City of Racine). Settlement of these areas began in 1835 and 1834, respectively. It was not until the 1950s that significant urbanization began to occur within the rest of the watershed. (SEWRPC 1983)

Although the towns and villages within the Pike River Watershed have experienced high rates of residential growth during the last two decades, agriculture remains the dominant land use. Urban and suburban land uses represent the next two largest land use types but even combined do not cover as much landscape as farmland does. Next to agriculture, grasslands and forests respectively represent the two next most common rural land uses. Wetlands and barren land covers make up less than two percent of the land area in the basin.

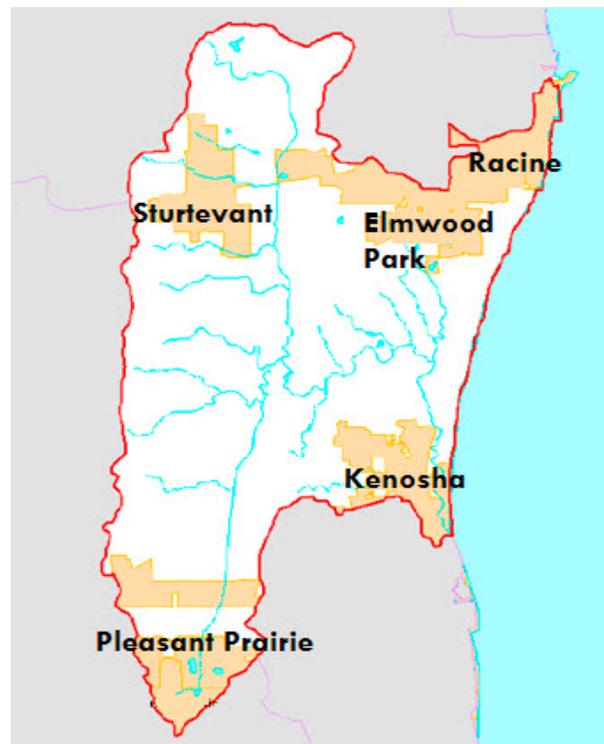
Map 2. Municipalities in the Pike River Watershed

Table 1. Civil Divisions - Pike River Basin	
Civil Division	Basin Area (square miles)
<b>Racine County</b>	
City of Racine .....	00.57
Village of Elmwood Park .....	00.15
Village of Sturtevant .....	01.56
Village of Mt. Pleasant .....	19.24
<b>Kenosha County</b>	
City of Kenosha .....	2.03
Village of Pleasant Prairie .....	0.76
Town of Somers .....	1.55
<b>Total</b>	<b>51.54*</b>

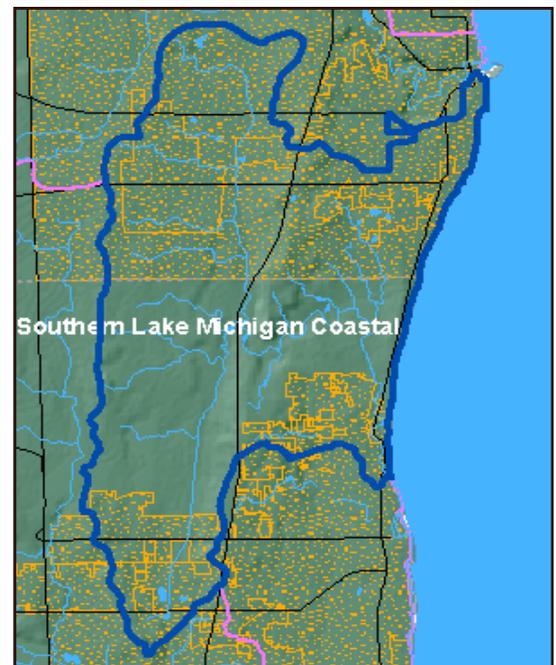
Map 3: Ecological Landscapes

This watershed is located in the middle of the Southern Lake Michigan Coastal Ecological Landscape (Map 3), which is characterized by ridge and swale topography, clay bluffs, and lake plain along Lake Michigan. Silt-loam soils overlying loamy and clayey tills are typical.

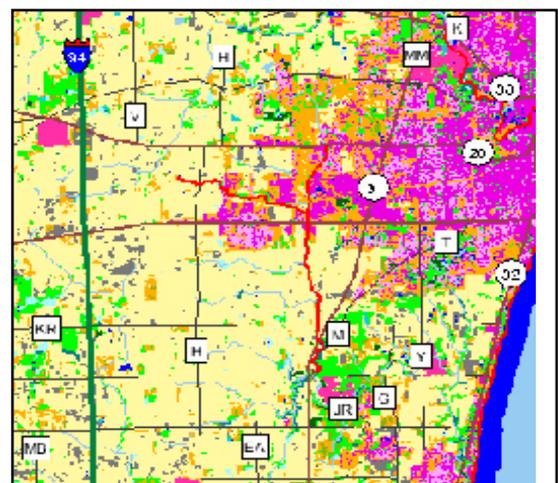
Map 4. Land Use (WisLAND) and impaired waters

Just over eight miles of streams in the Pike River Watershed are considered impaired and not meeting water quality standards. These streams are the North Branch of the Pike River from its junction with the South Branch up river 5.23 miles to State Highway 20, and the entire 2.91 mile length of Waxdale Creek in the Town of Sturtevant.

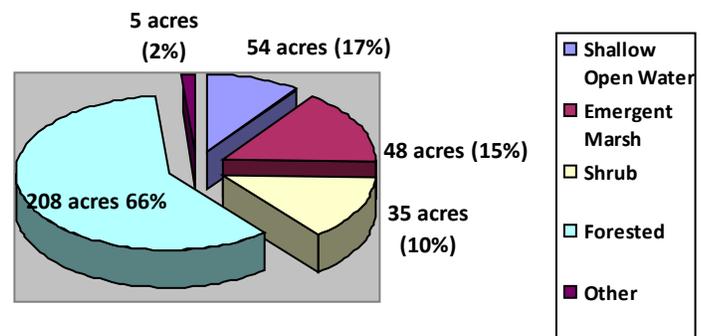
Figure 2. Wetland Types in the Pike River Watershed

lands in the watershed currently exist. Of these wetlands, forested wetlands (66%) and emergent wetlands (15%), which include marshes and wet meadows, dominate the landscape (Figure 2 (previous page)).

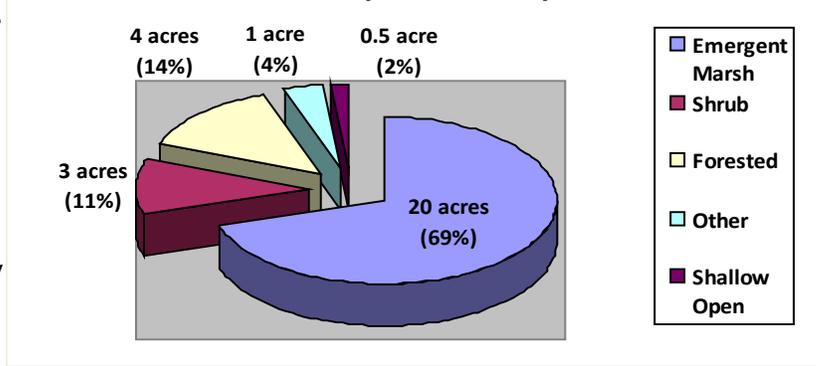
Figure 3: Portion of wetlands affected by Reed Canary Grass.

Little is known about the condition of the remaining wetlands but estimates of reed canary grass infestations, an opportunistic aquatic invasive wetland plant, into different wetland types has been estimated based on satellite imagery. This information shows that reed canary grass dominates 70% of the existing emergent wetlands, which includes wet meadows and marshes, and 15% of the remaining forested wetlands (Figure 3). Reed Canary Grass domination inhibits successful establishment of native wetland species.

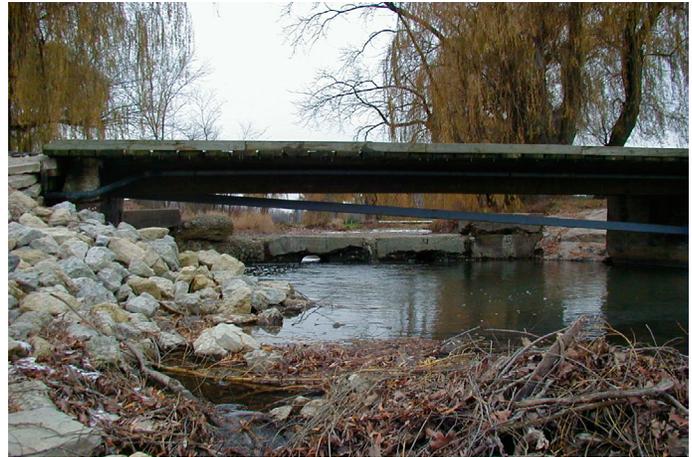
Before Restoration, Kenosha County Club Dam

In 2005, the US Fish and Wildlife Service working with WDNR and several other public and private partners removed a 1950s era dam from the Pike River approximately four miles upstream from the river's Lake Michigan outlet. A four foot high concrete dam was replaced with a series of deep pools and shallow riffles and approximately 800 lineal feet of eroding streambank was stabilized. (USFWS 2009) Salmon and steelhead can now be found above the old dam site during their annual runs from Lake Michigan. The dam had provided a source of irrigation water for a golf course and this function was preserved with the new river pools.

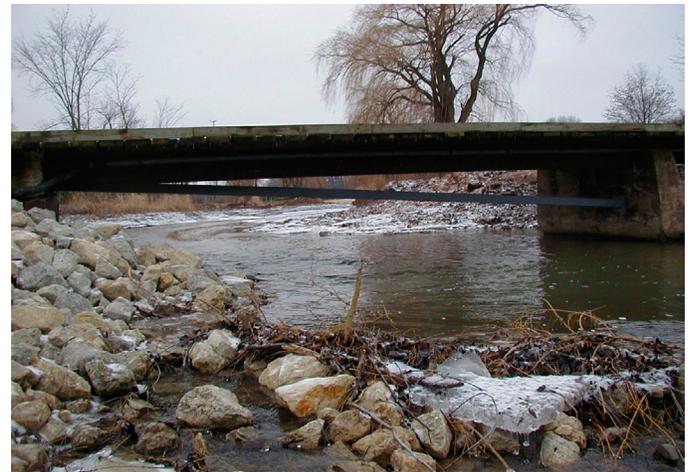
After Restoration, Kenosha County Club Dam
