## 2010 Water Quality Management Plan Update

Upper Fox River Basin , Wisconsin

August, 2010

# Fond du Lac River Watershed

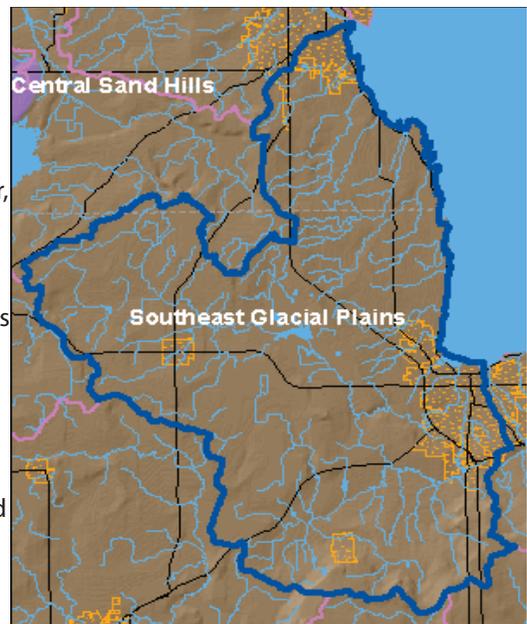
Map 2: Fond du Lac Watershed

The Southeast Glacial Plains Ecological Landscape makes up the bulk of the non-coastal land area in southeast Wisconsin. This Ecological Landscape is made up of glacial till plains and moraines. Most of this Ecological Landscape is composed of glacial materials deposited during the Wisconsin Ice Age, but the southwest portion consists of older, pre-Wisconsin till with a more dissected topography. Soils are lime-rich tills overlain in most areas by a silt-loam loess cap. Agricultural and residential interests throughout the landscape have significantly altered the historical vegetation. Most of the rare natural communities that remain are associated with large moraines or in areas where the Niagara Escarpment occurs close to the surface.

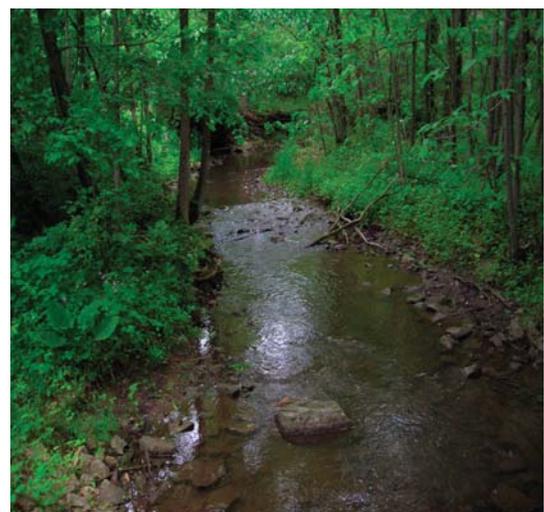
Parsons Creek (WBIC 136000) is a small cold to coolwater tributary to the East Branch of the Fond du Lac River. The stream, originating along the Niagara escarpment, is designated as Class I trout water for 1.9 miles of its length and is an Exceptional Resource Water. An additional 2.4 miles of the stream is classified as Class II trout waters (DNR, 1980). The segment upstream from Hickory Road flows from some main springs down through a wetland complex and a small county park (Hobbs Woods) and appears to have good water quality though heavily impacted by habitat modifications (Reif, 2009). Downstream from Hickory Road, Parsons Creek was, at one time, heavily impacted by agricultural practices, particularly barnyard runoff and excessive grazing along the streams banks. These impacts were addressed as part of a Priority Watershed project of the late 1990s and early 2000s.

Parsons Creek, Photo by Chad Cook UW Extension

- Parsons Creek is classified as a Class I to Class II trout stream. At present it does not sufficiently support a significant and/or reproducing brook trout population due to extensive habitat modifications and wetland degradation. Habitat improvements and wetland restoration projects should be undertaken to improve conditions.

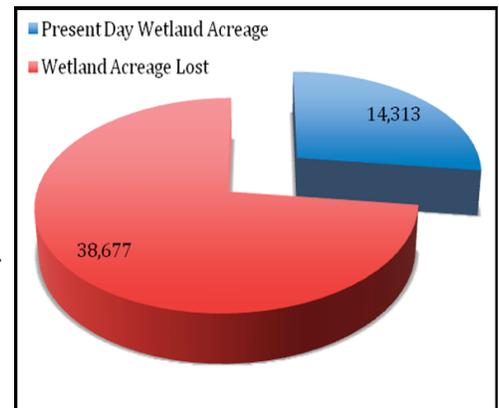
Figure 1: Fond du Lac Watershed Wetlands Lost

Despite the watershed being 14% wetland today, a significant acreage has been lost due to conversion to agricultural land. (Figure 1). Recent analysis of soil conditions suggest that historically, the watershed contained 51,190 acres of wetland which was about 33% of the entire watershed. This translates to a loss of 76% of the historic wetland acreage. Analysis also suggests that 68% of these "lost" wetlands are potentially restorable (Figure 2). The remaining wetland acres are often impacted due to excessive sediment and nutrient inputs.
