SWL&P MGP SITE Superior, Wisconsin

**GLLA RAOR Monthly Meeting
March 7, 2022**

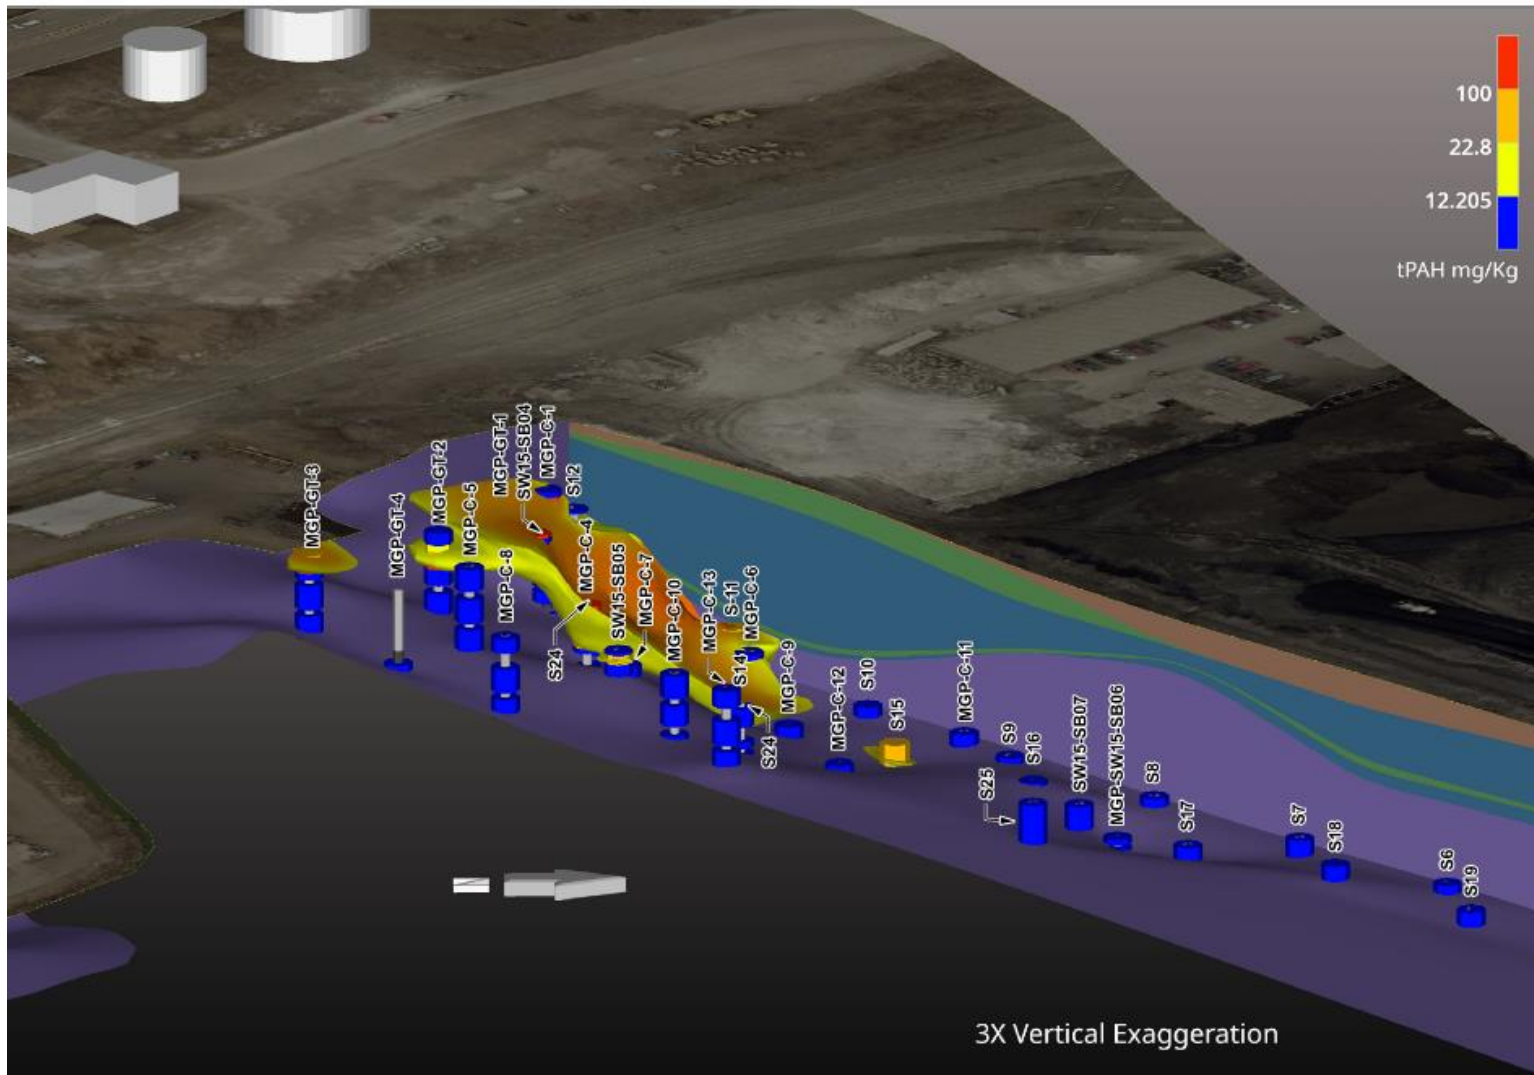
Updated tPAH Results

Orange shaded cells represent sediment samples with results above the MEC (12,205 mg/kg).
 Reddish shaded cells represent samples collected within the Miller Creek Clay Unit.

- ◆ The highest tPAH concentration of 250 mg/kg was detected in sample MGP-C-1 within the 1 to 2 feet interval bml.
- ◆ The deepest tPAH concentration > MEC (70.4 mg/kg) was found at MGP-C-1 within the 11 to 12 feet interval bml.
- ◆ PAH impacts were not found in the Miller Creek Formation nor in the several intervals above the Miller Creek Formation.
- ◆ 8 of 13 core locations showed no intervals of tPAH concentrations above the MEC: MGP-C-5, MGP-C-7, MGP-C-8, MGP-C-9, MGP-C-10, MGP-C-11, MGP-C-12, and MGP-C-13.
- ◆ Reoccupation of SW15-SB06 found no tPAH concentration above the MEC.
- ◆ Confirmed the mudline elevation from the bathymetric survey supporting the spatial interpolation model.
- ◆ Determined geotechnical conditions in the boat slip critical for maintaining stability of existing structures and shoreline.
 - Laboratory testing for geotechnical parameters are underway.

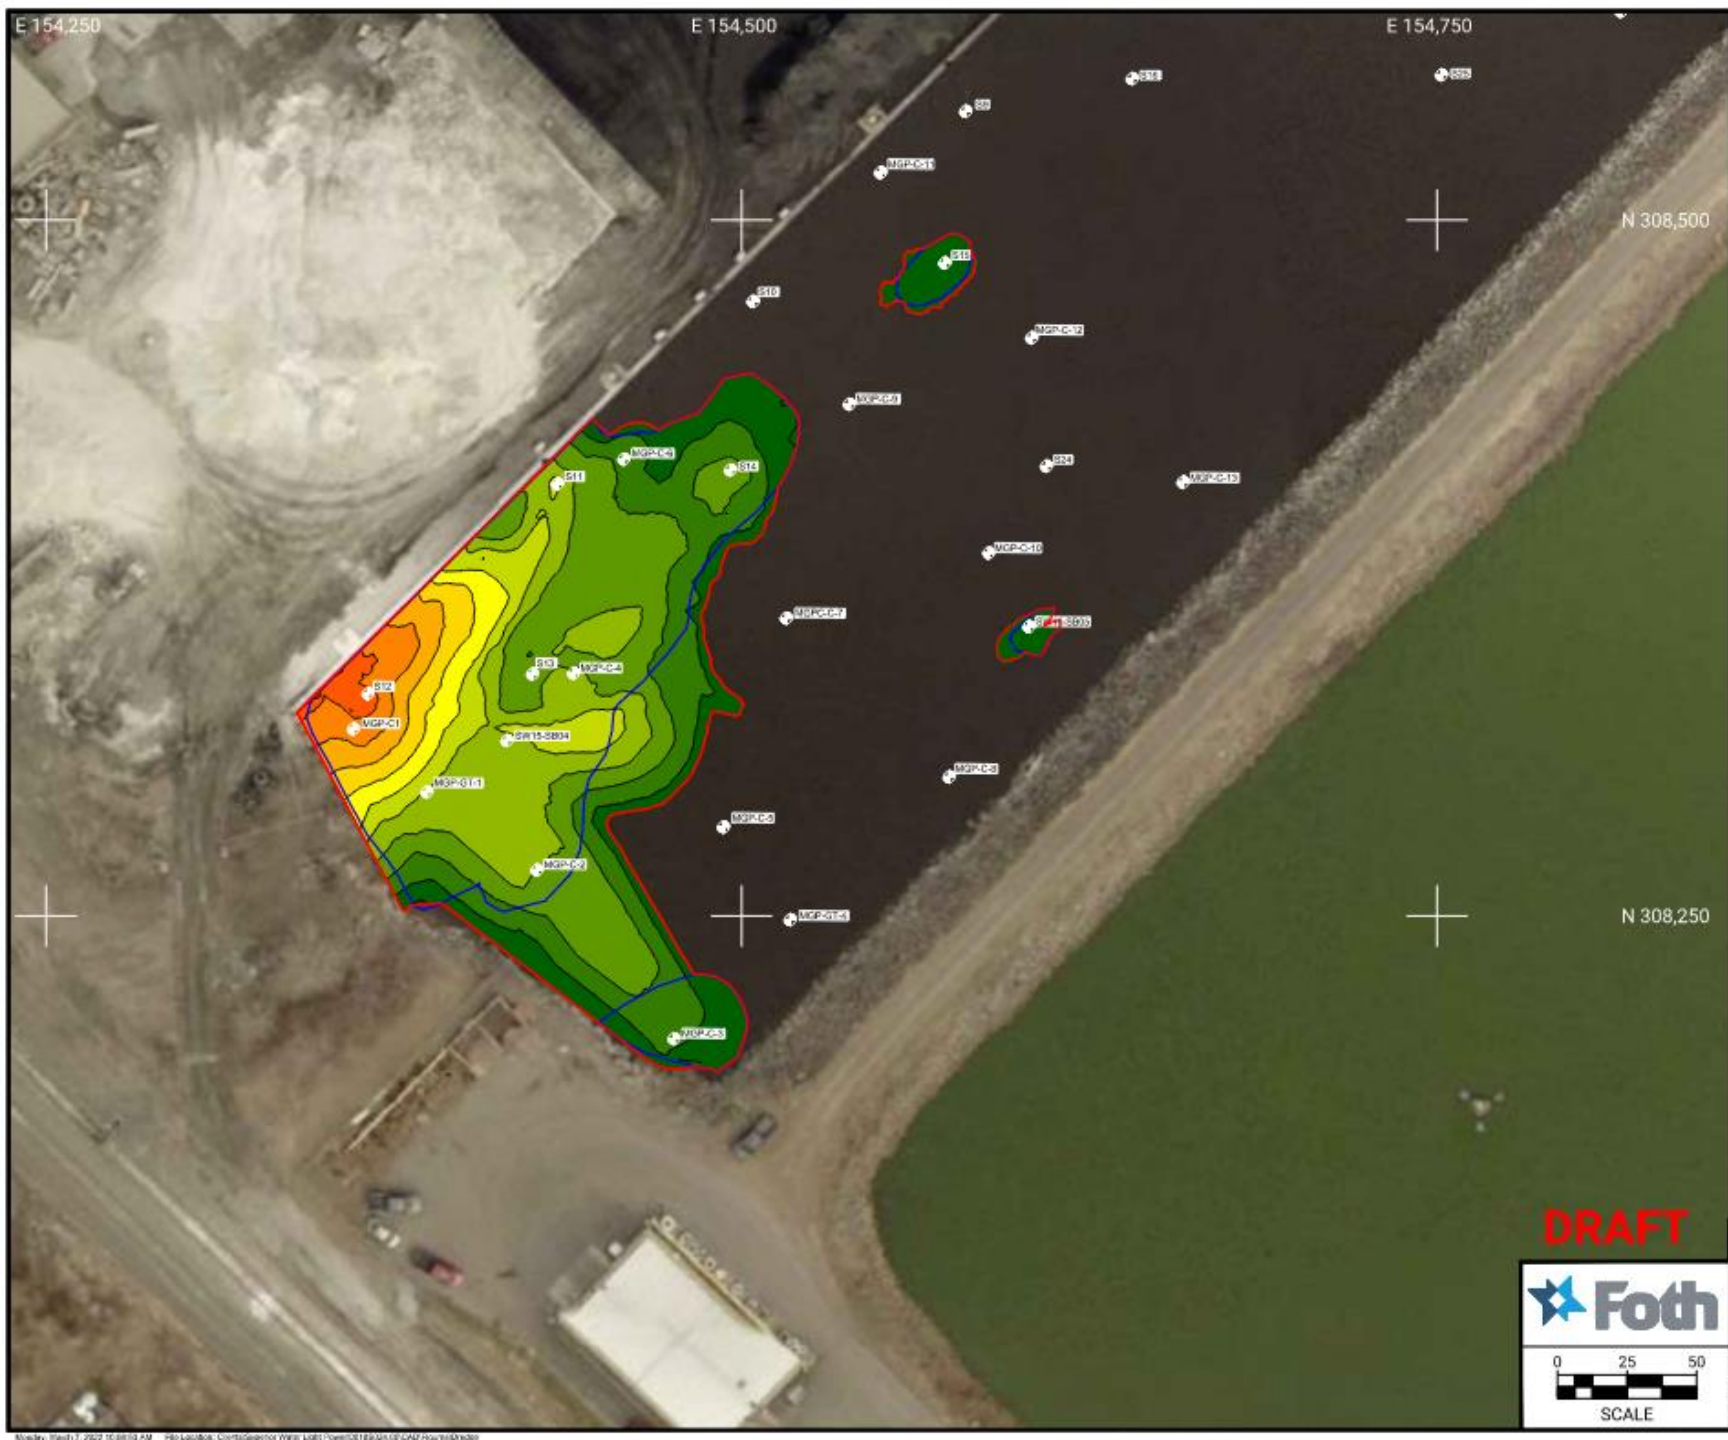
FIGURE 2-10
SEDIMENT DREDGE ISOPACH MAP
SEDIMENT REMEDIAL ACTION OPTIONS REPORT
SUPERIOR, WISCONSIN

ISOPACH MAP REPRESENTS DIFFERENCE BETWEEN JUNE 8, 2020 BATHYMETRIC SURVEY AND DESIGN DREDGE ELEVATIONS

- 0' - 2' DREDGE CUT
- 2' - 4' DREDGE CUT
- 4' - 6' DREDGE CUT
- 6' - 8' DREDGE CUT
- 8' - 10' DREDGE CUT
- 10' - 12' DREDGE CUT
- 12' - 14' DREDGE CUT
- 14' - 16' DREDGE CUT
- 16' - 18' DREDGE CUT
- 18' - 20' DREDGE CUT
- 20' - 22' DREDGE CUT

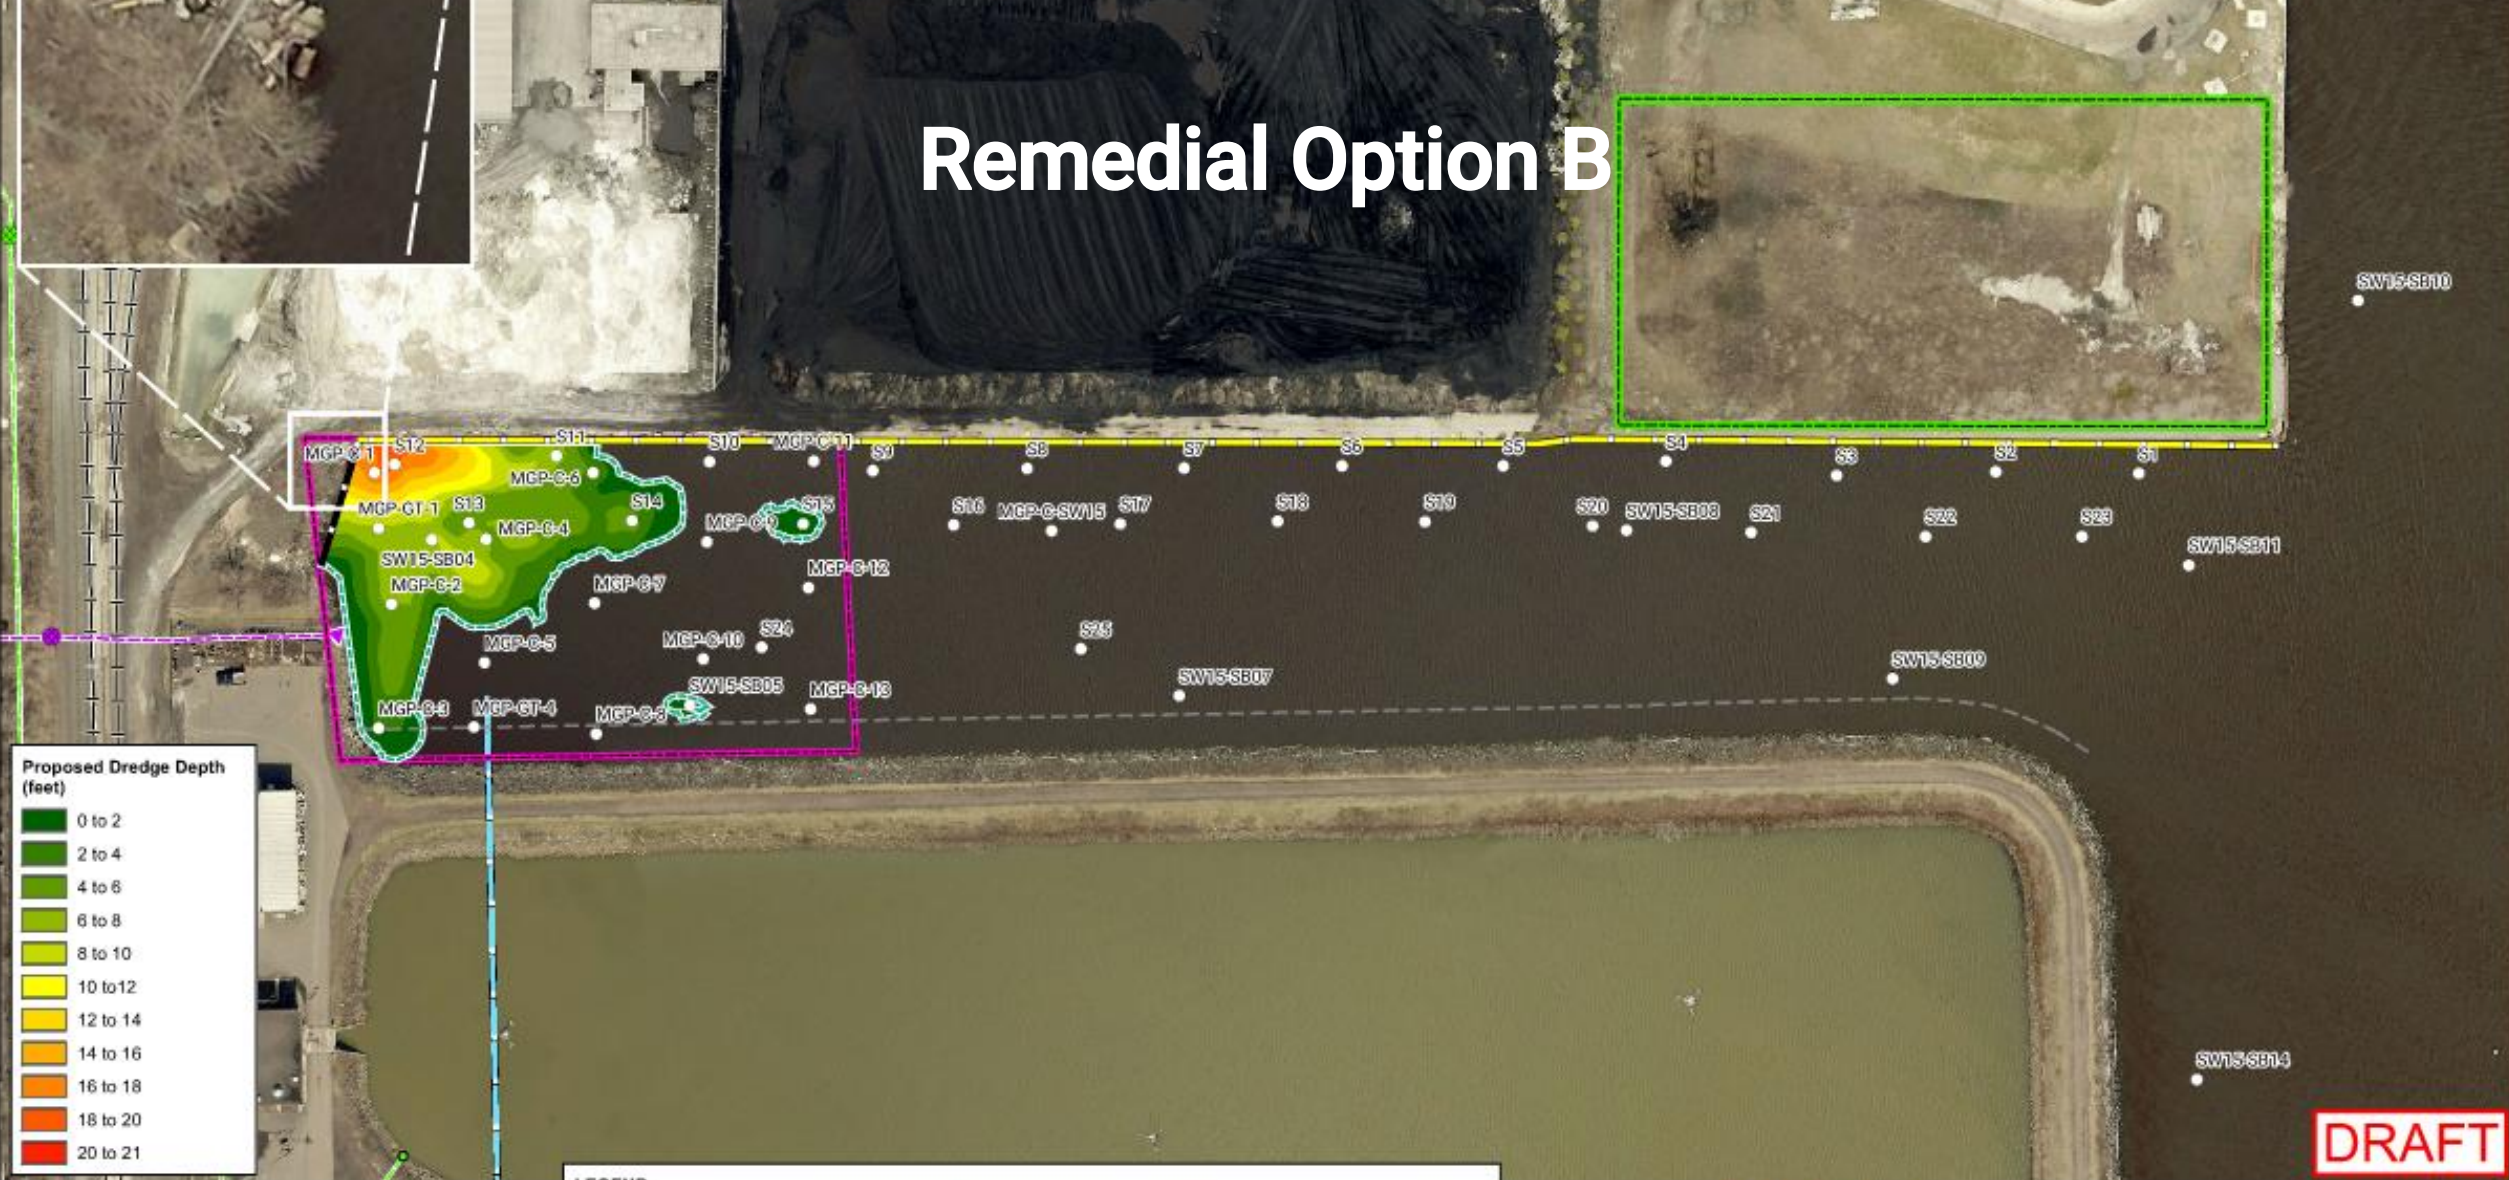
SUPERIOR WATER, LIGHT & POWER		
FIGURE 4-1		
REMEDIAL ACTION OPTION B - DREDGE AND OFFSITE DISPOSAL WITH SHEETPILE WALL		
SEDIMENT REMEDIAL ACTION OPTIONS REPORT		
SUPERIOR, WISCONSIN		
Date: FEBRUARY 2022	Revision Date:	
Drawn By: DAT	Checked By: ECH1	Project: 18S024

- Mechanical Dredging of target area where total PAH concentration exceed the MEC of 12.2 mg/kg.
- Approximate volume of sediment removed is 6,000 cy.
- Installation of a vertical sheet pile at the back of the boat slip so that sediment in front of the wall can be removed

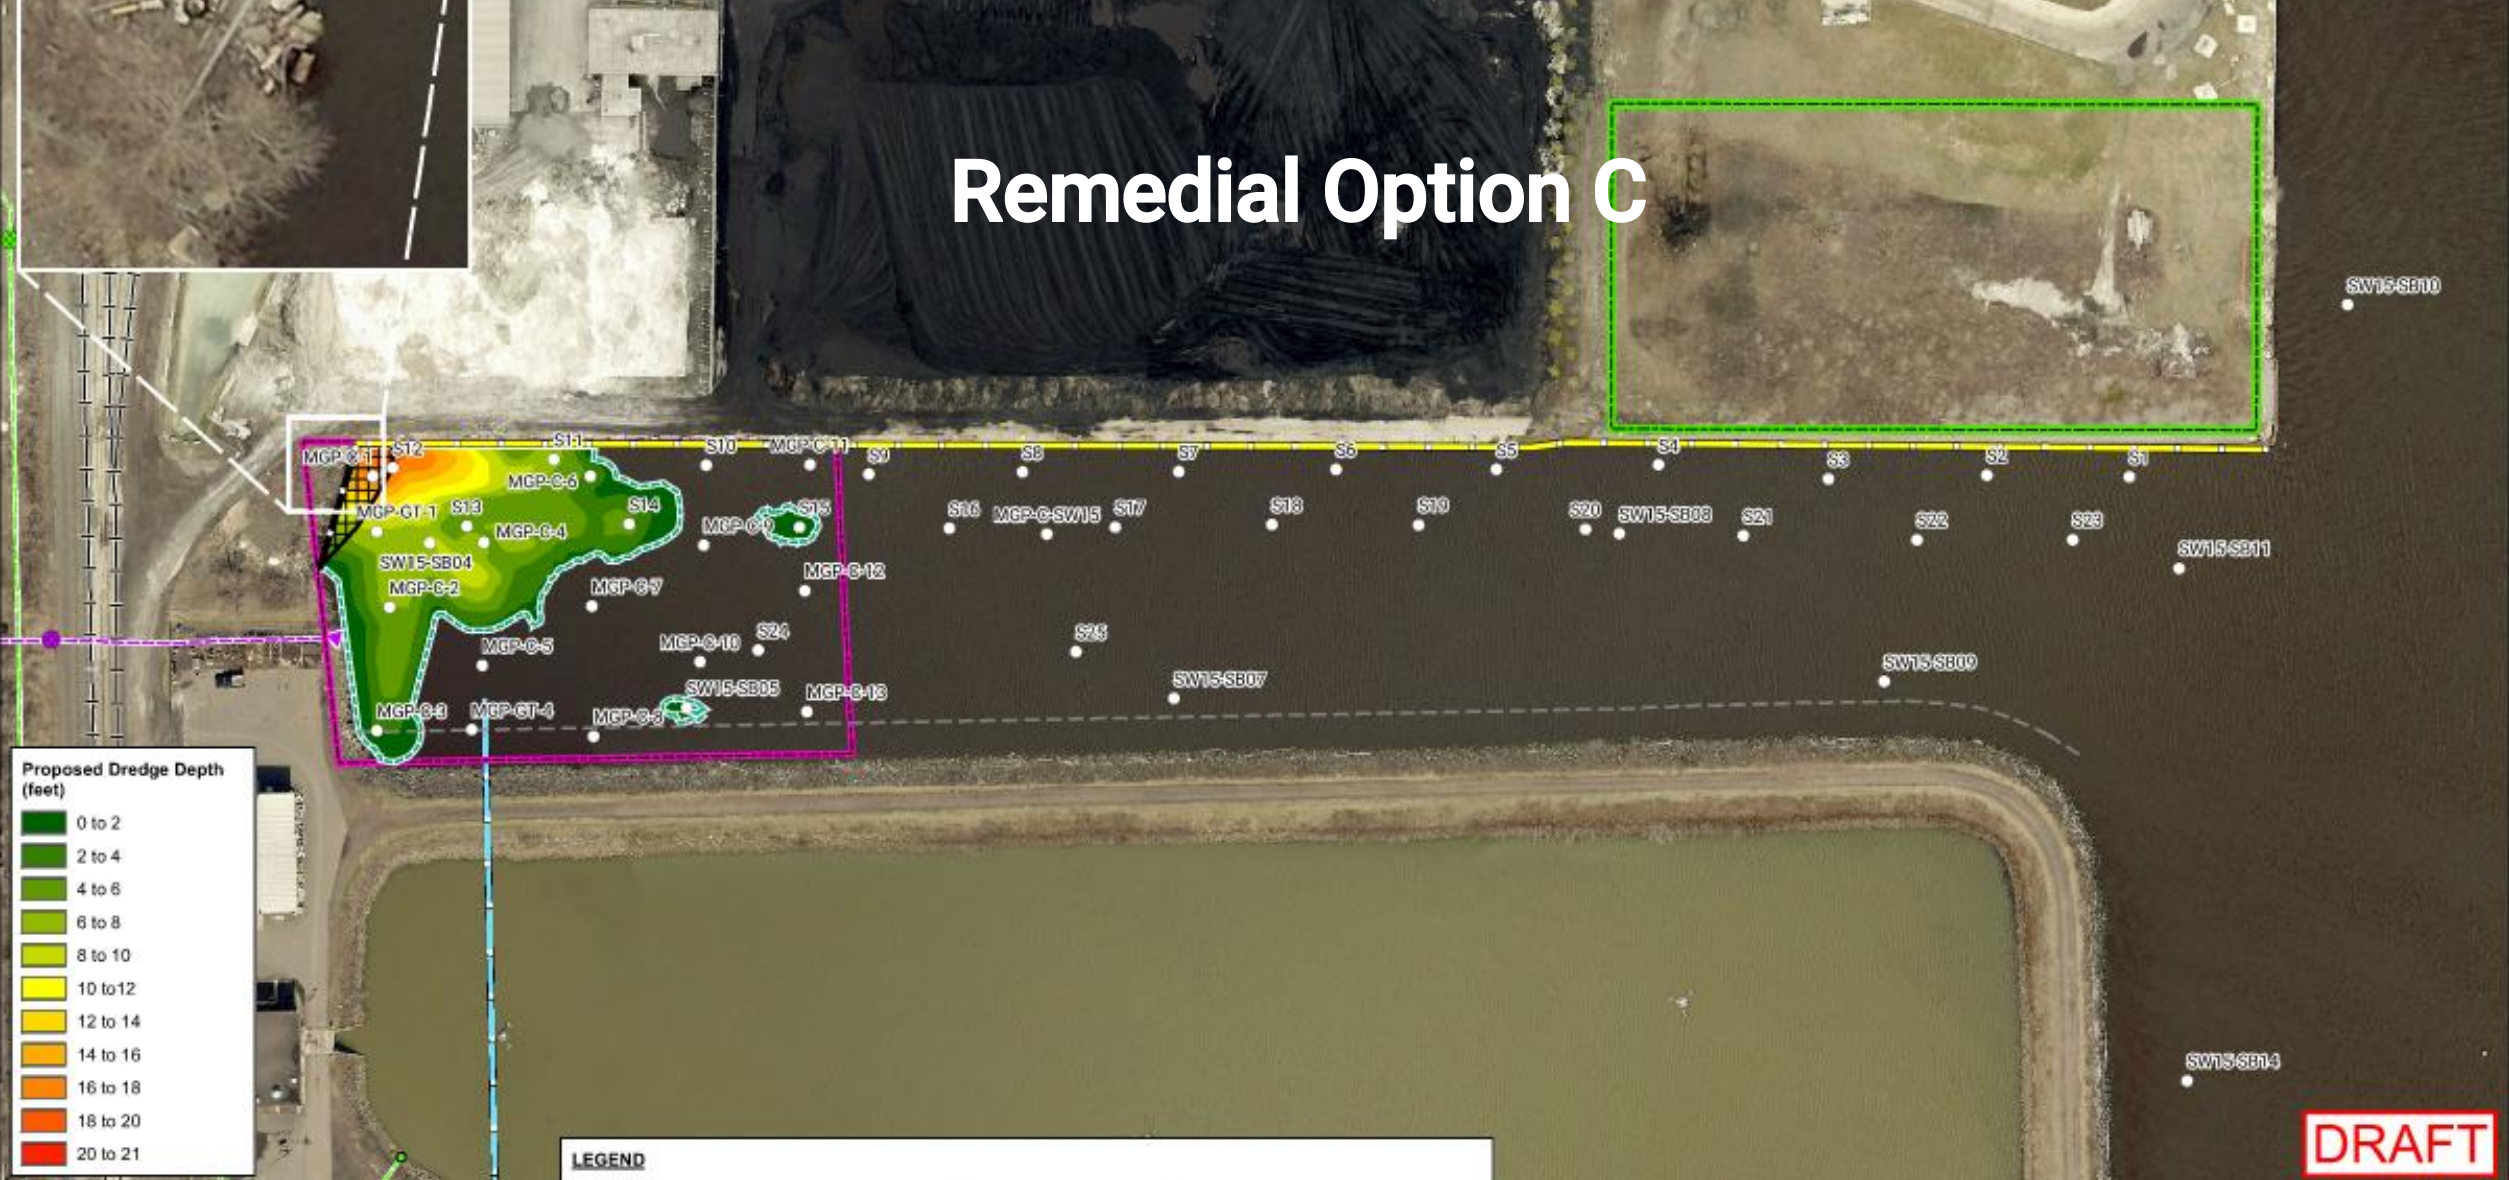
SUPERIOR WATER, LIGHT & POWER		
FIGURE 4-2		
REMEDIAL ACTION OPTION C - TARGET DREDGING/CAPPING AND OFFSITE DISPOSAL SEDIMENT REMEDIAL ACTION OPTIONS REPORT SUPERIOR, WISCONSIN		
Date: FEBRUARY 2022	Revision Date:	
Drawn By: DAT	Checked By: ECH1	Project: 18S024

- Mechanical Dredging of target area where total PAH concentration exceed the MEC of 12.2 mg/kg.
- Approximate volume of sediment removed is 5,300 cy.
- Capping along the back end of the boat slip, approximately 700 cy of impacted sediment would remain in place
