I/I and Interceptor Sewer Rehabilitation Study

Prepared for: City of Wausau, Wisconsin

Prepared by: Clark Dietz, Inc.

Date: January 2020

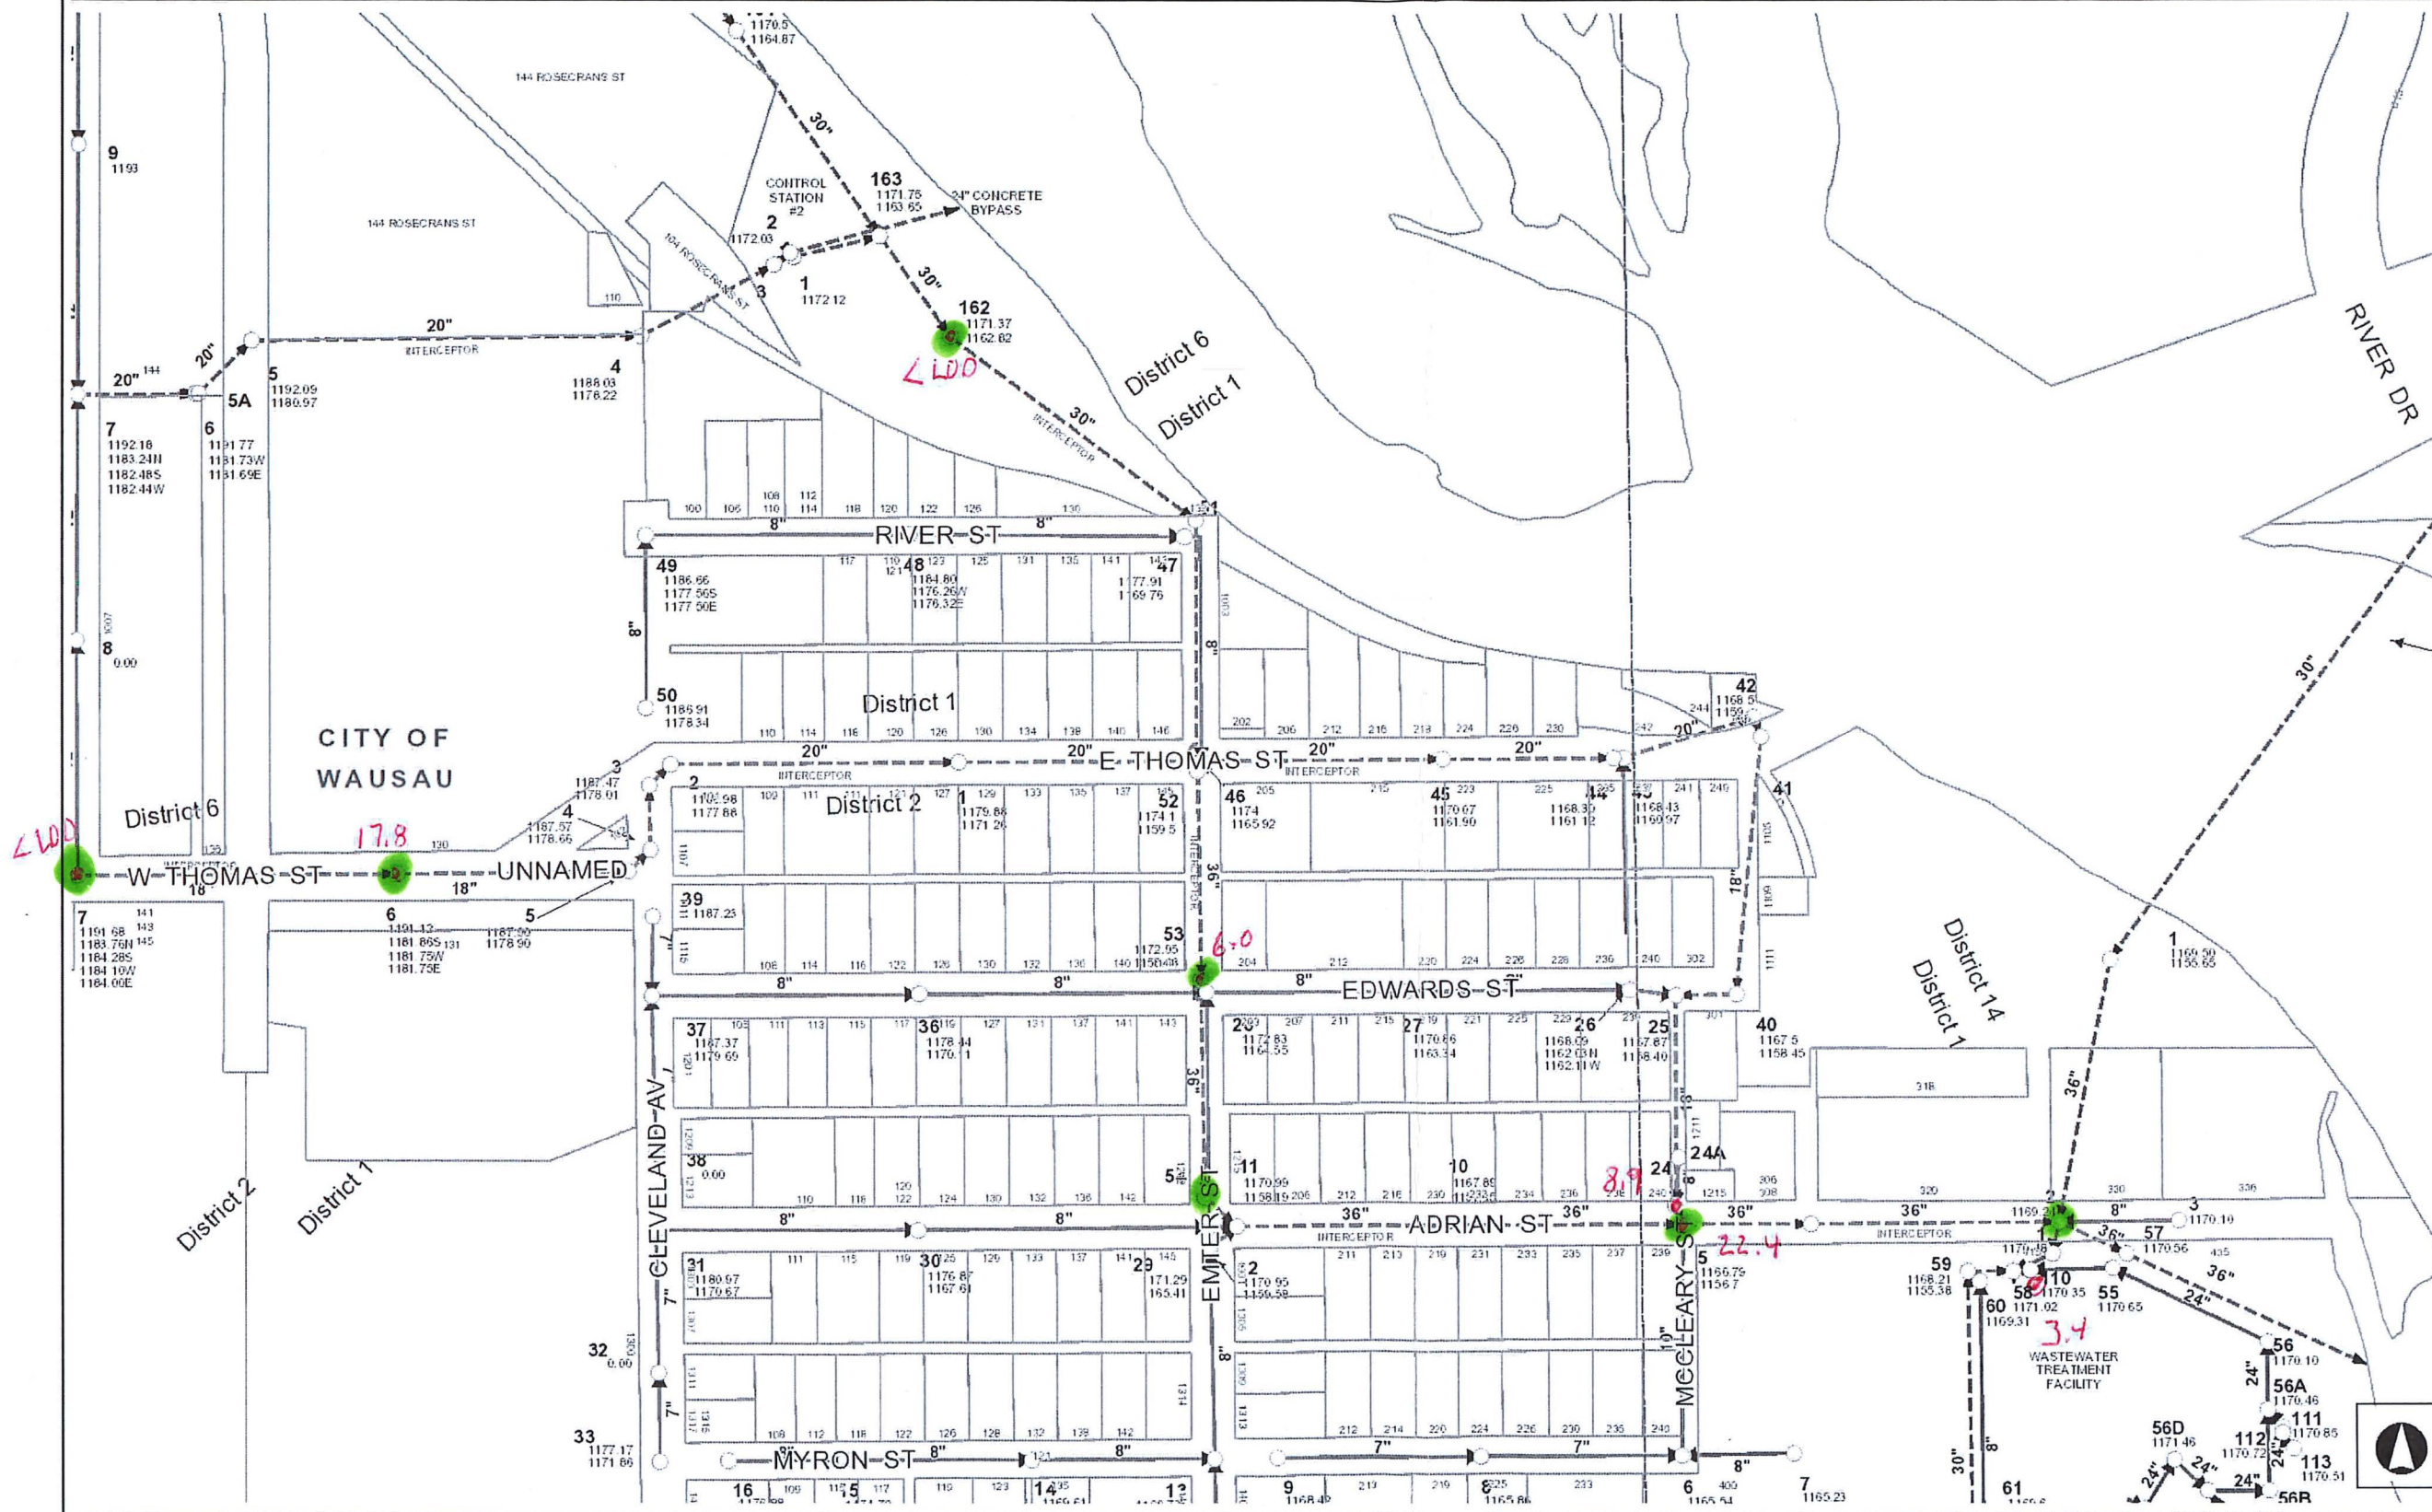
Appendix B – Wastewater Sampling Locations

Wastewater was sampled in a total of eight manholes along the interceptor sewers identified in Section 2.1. The sampling locations were selected with assistance from WDNR staff and are shown on the map in Appendix B. The sampling locations were chosen to test wastewater both upstream of and downstream of the treated groundwater discharge point as well as within the area known to contain PCP. Multiple samples were taken from the same manholes on different days to confirm/verify information and data. Samples were taken in manholes located above and below the normal groundwater levels. The sampling manholes vary in depth from approximately 8.7 feet to 17.4 feet.

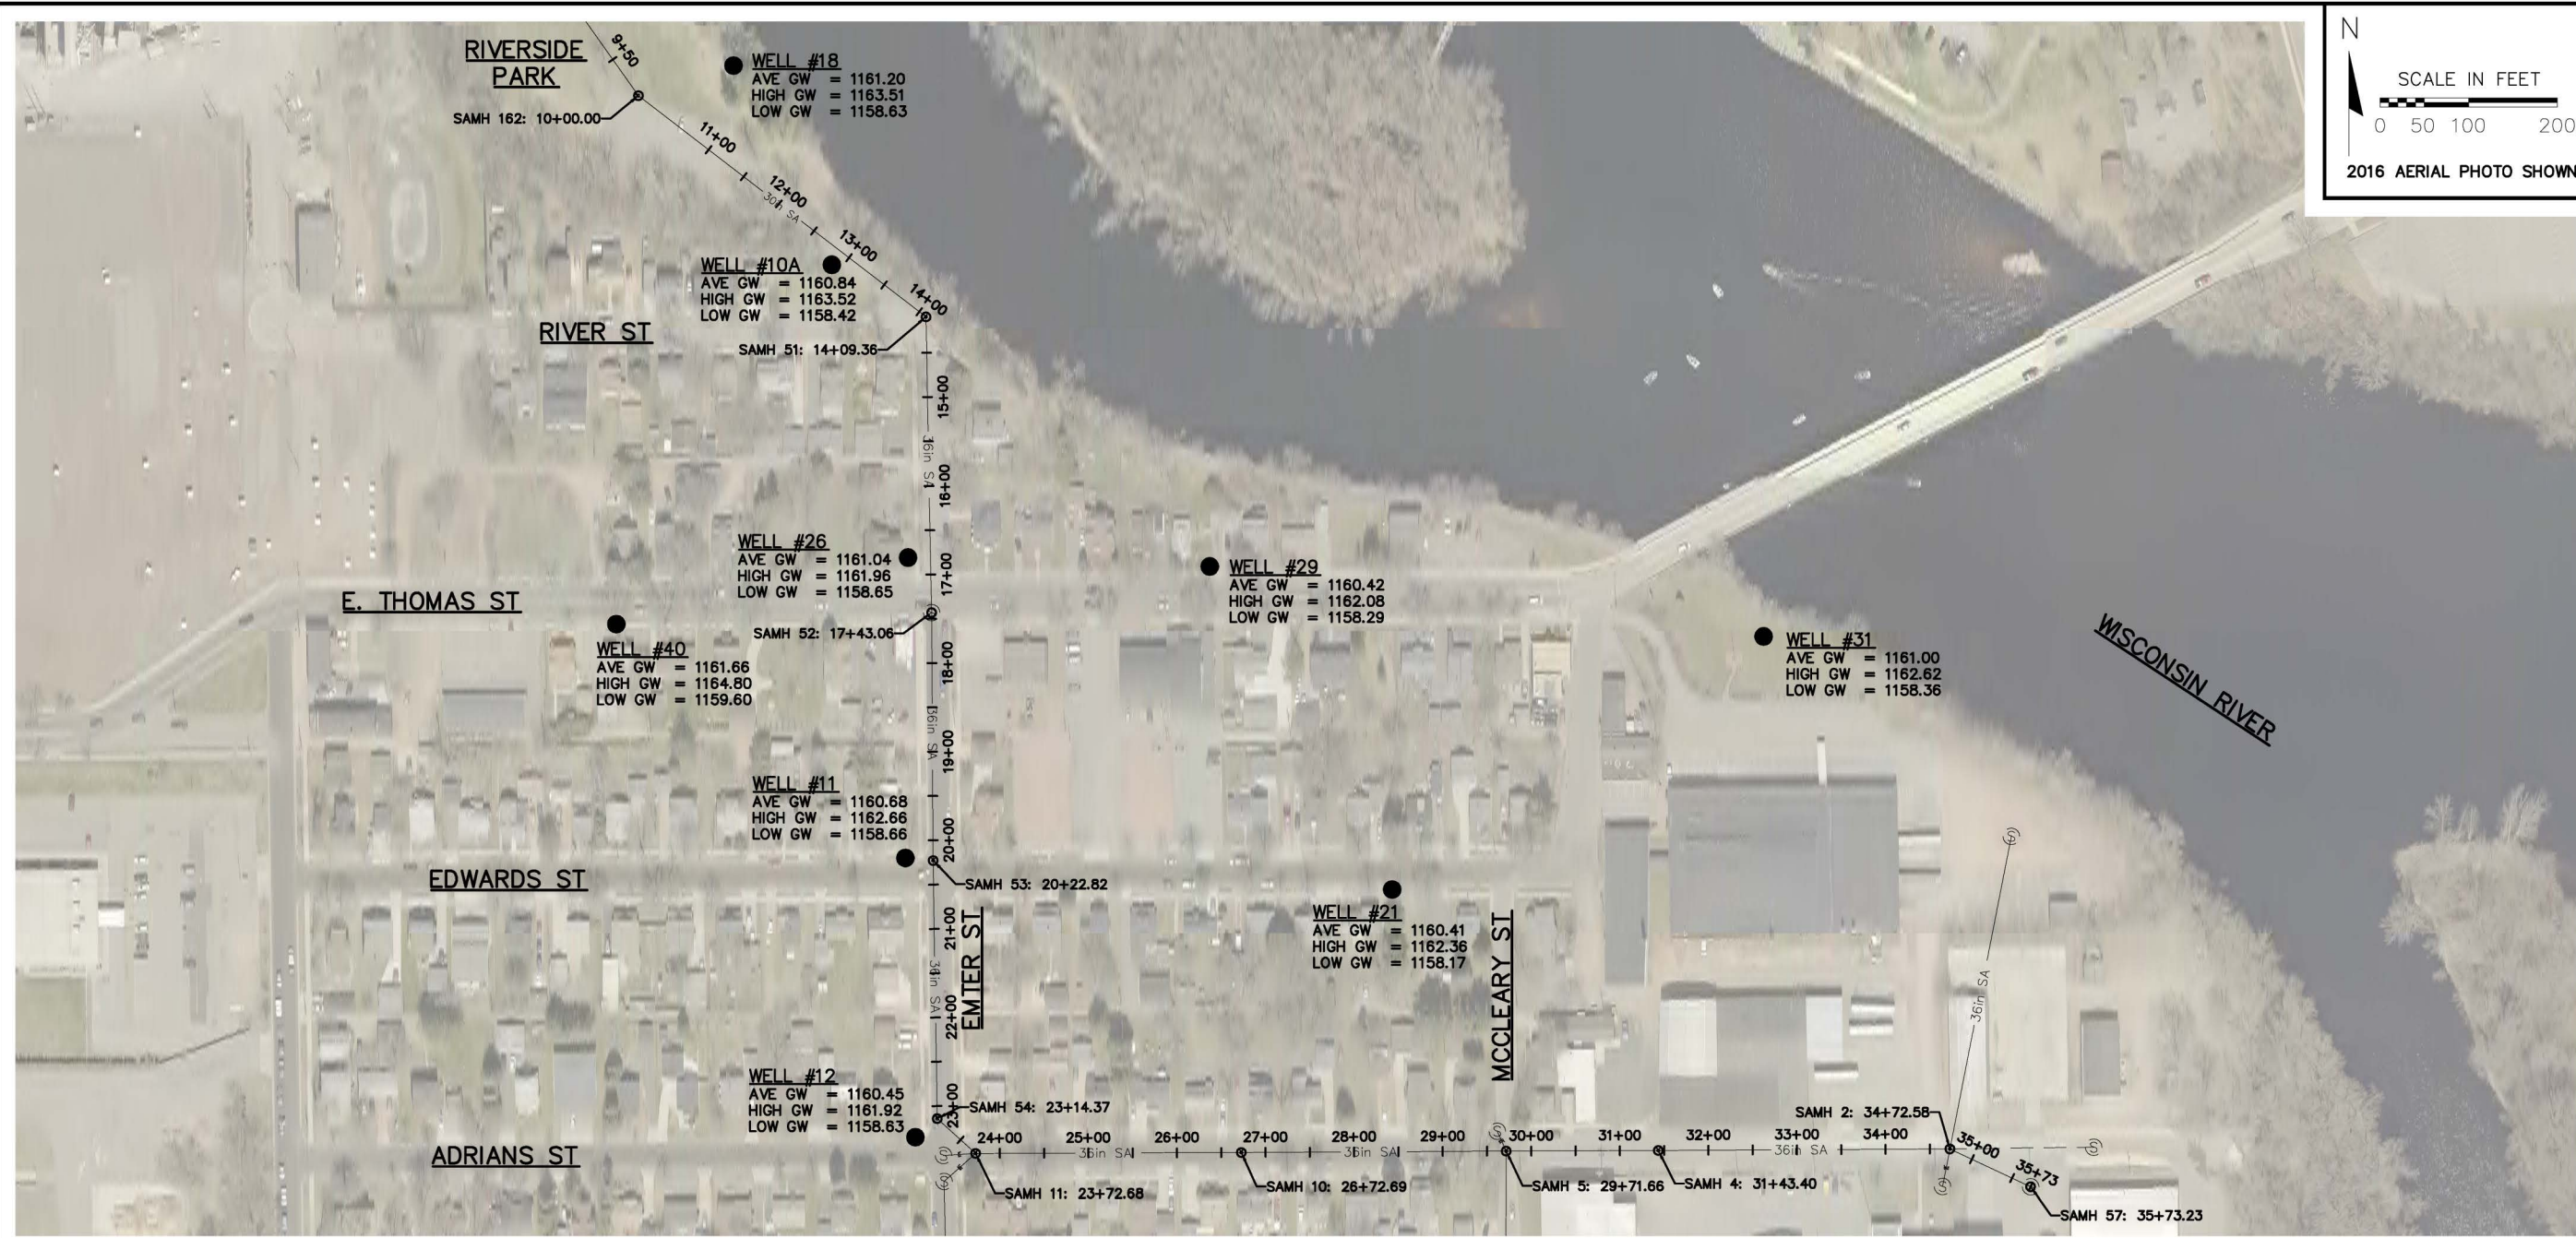
GROUNDWATER ELEVATIONS
 RIVERSIDE PARK TO WWTP
 INTERCEPTOR SEWER PLAN AND PROFILE

The map/graph in Appendix G shows the observed groundwater elevations in relation to PCP found in the wastewater samples. The map shows that manholes below the typical groundwater level are more likely to contain PCP in the wastewater. This indicates that PCP is first entering the groundwater and then entering the wastewater system.
