**PHASE I AND II REMEDY DOCUMENTATION REPORT  
CAMPMARINA, FORMER COAL GAS FACILITY  
SHEBOYGAN, WISCONSIN**

**Project No: 1313**

**Wisconsin Public Service Corporation  
P.O. Box 19800  
Green Bay, WI 54307**

**February 28, 2003**

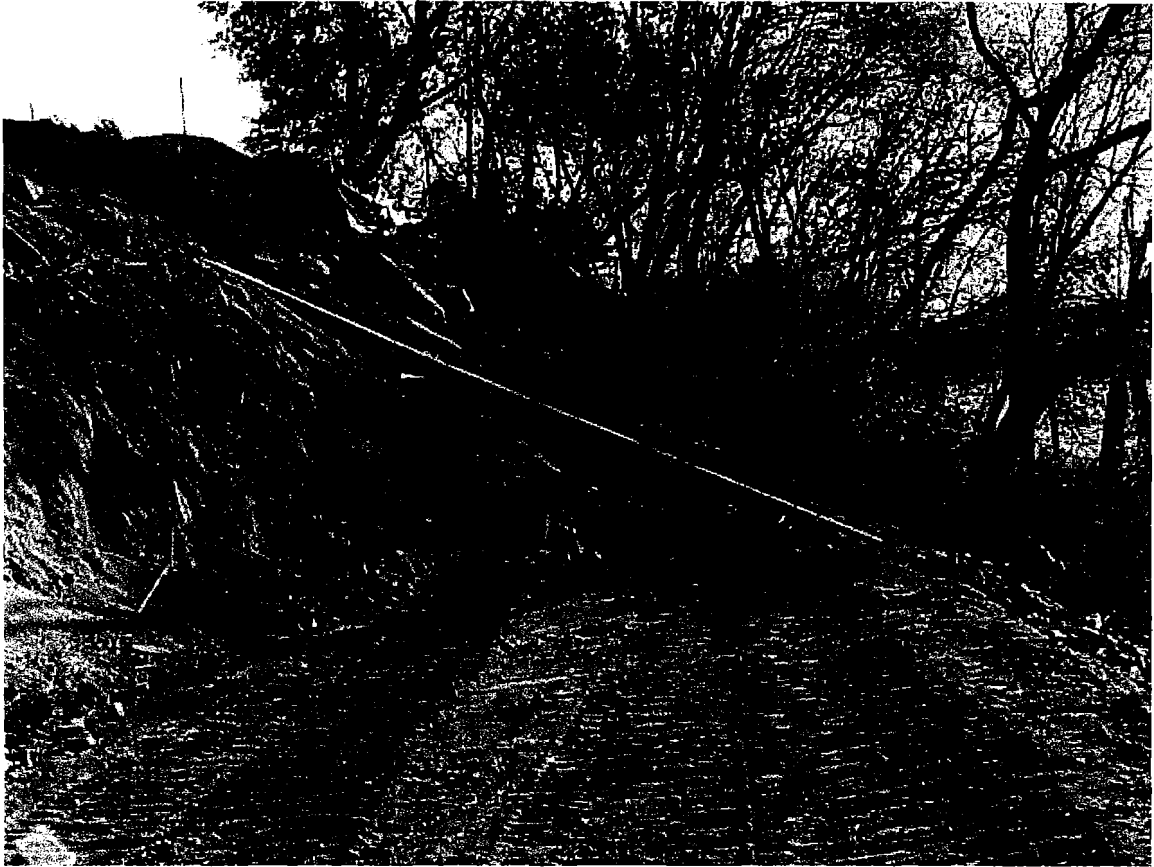
Photo 4

right-of-way and rerouted outside the perimeter of the remedial activities to the river as shown on Sheet C030 and Photo 5. The temporary sheeting was installed a minimum of five feet from the alignment for the Waterloo® sheet pile barrier.

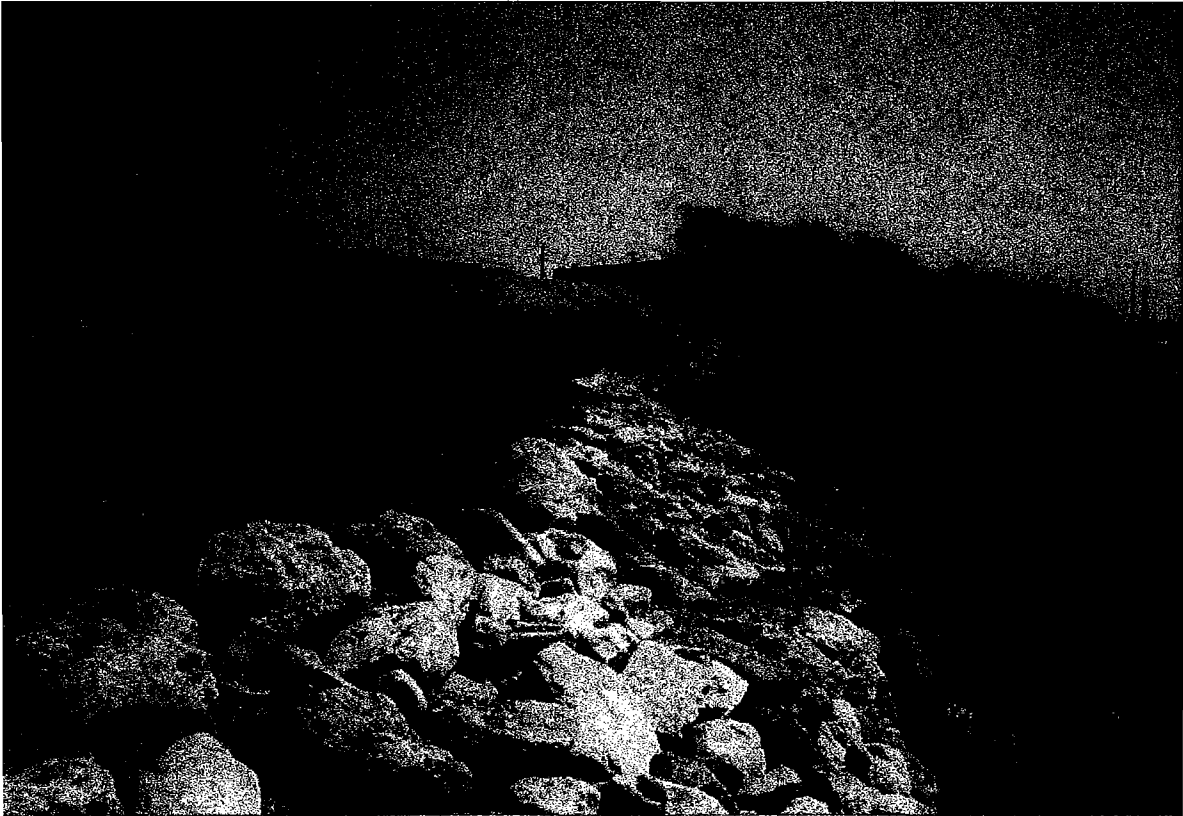
Photo 21

21. Looking south along Campmarina's riverbank. Six inches of filter gravel placed at -1 ft. elevation locations. Structural fill was placed to -1 ft. elevation at deeper section of EZ #4 excavation shown at top of photo.
22. Reconstructed riverwalk with riprap to complete Phase I.

- Excavation operations generally extended to the planned design -1 ft. elev. with the exception of one area located midway along the river bank. Obvious MGP-related affects and evidence of coal tar-like materials were observed in soils at approximately 8 to 10 feet bgs in the central portion of EZ-4 excavation (Photo 8). Consequently, an 88' x 10' area was excavated approximately two feet deeper (-3 ft. elev.). Excavation operations did not extend lower than the -3 ft. elev. due to the close proximity of the river and to minimize disturbance of river sediment. The location of the deeper excavation zone is indicated on Sheet C040.

- EZ #4: In accordance with the plans and specifications, the riverbank was restored with filter gravel, structural fill and riprap to the Phase I grades. Approximately two feet of structural fill were placed in the over excavated area from the -3 to -1 ft. elev. This was followed by a non-woven geofabric and six inches of filter gravel placed along the base of the riverbank (-1 ft. elev.) (Photo 21). A second layer of filter fabric was placed over the filter gravel followed by structural fill that was placed and compacted to restore the river bank at a slope of approximately two feet horizontal to one foot vertical. Standard Proctor results for the structural fill are presented in Appendix J. Riprap was then placed along the restored river bank as shown on Sheet C040 and Photo 22.

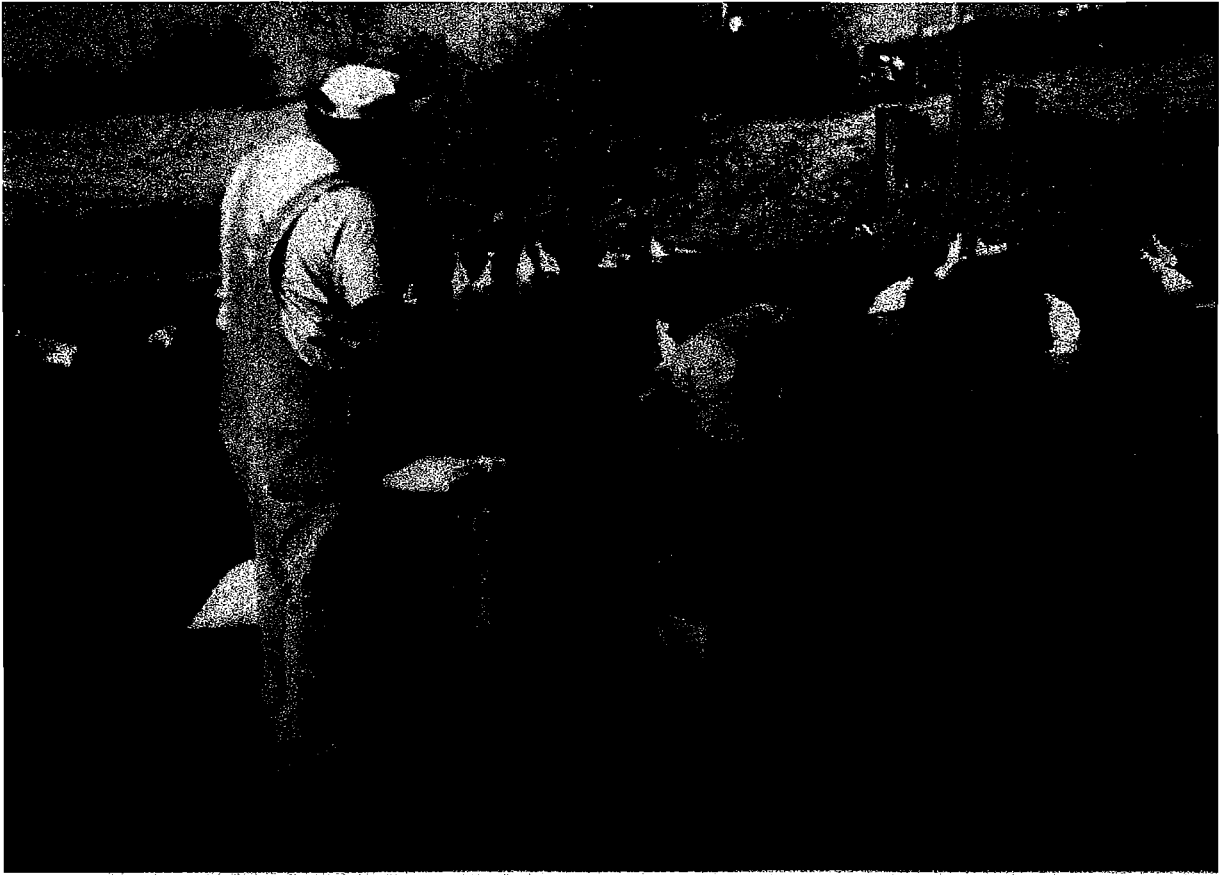
Photo 39

Geomembrane Panel Layout and Deployment Logs are provided in Appendices T1 and T2, respectively. Forty-three full panels and two partial panels were deployed from May 10 through May 19, 2001 (Photo 39). During this time, the first layer of geocomposite and the geomembrane were deployed concurrently approximately every 30 yards. Following the geocomposite, the geomembrane was laid on top. Sand bags were used to temporarily hold the geomembrane in place following deployment to prevent movement from wind.
