COVER MAINTENANCE PLAN

Property Located at: 1000 General Motors Drive (source) and 544 Kellogg Ave (adjacent fill repository).
Janesville, Wisconsin 53546

BRRTS Activity (source) #02-54-577951 and (fill) #02-54-56081 (FID# 154062810)

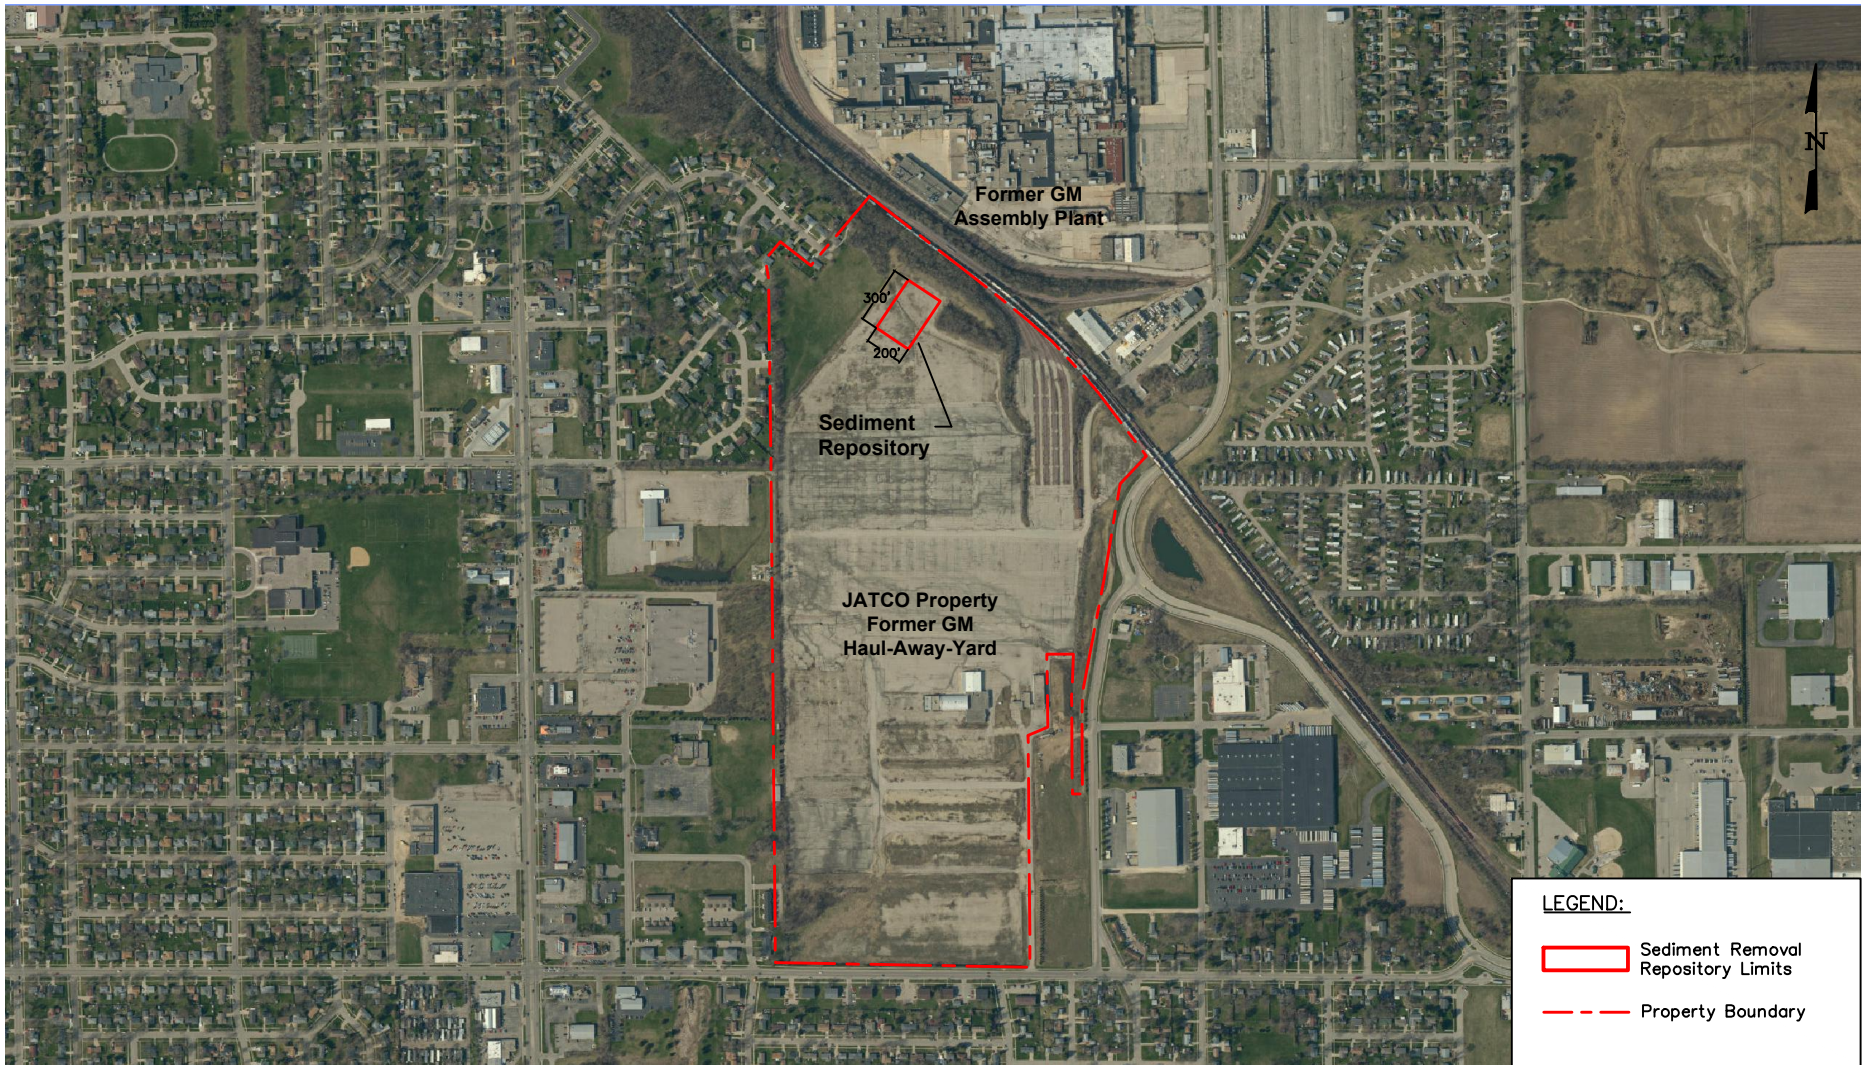
Location Map

See attached Figures showing site location, limits of disturbance and the area of the soil cover to be maintained, and a cross-section of design plan.

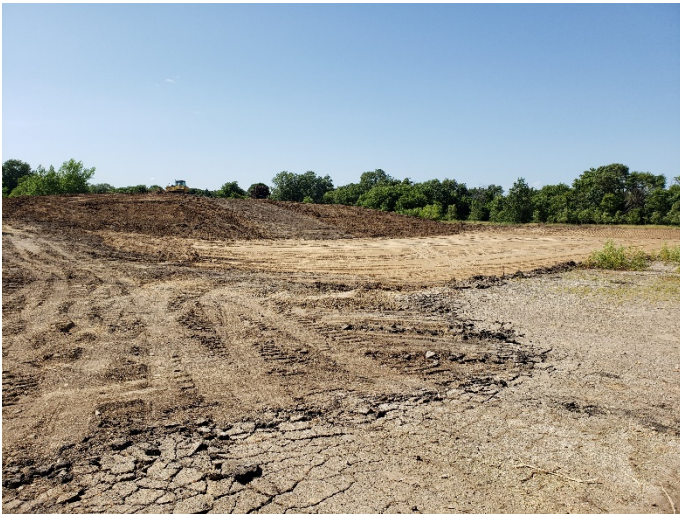
Former GM Haul Away Yard (JATCO) site receiving fill

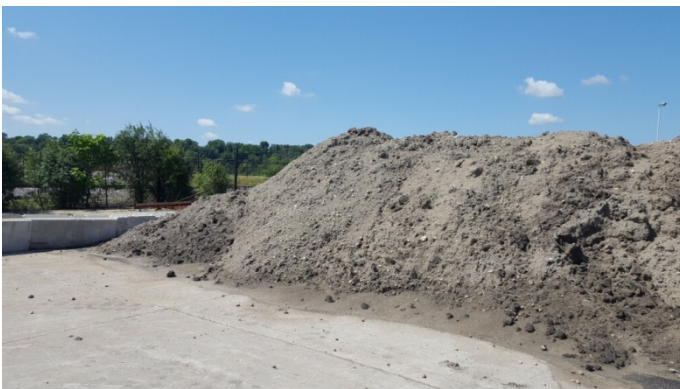
Source; Post-Dredged Dried Sediment in concrete bins

This material is dried sediment/soil that was removed from the Rock River, dewatered, and approved for beneficial reuse on the former General Motors Assembly Plant property. The material contains residual concentrations of polyaromatic hydrocarbons (PAHs) and trace metals. The material was placed and compacted at a depth from 2-feet below the ground surface (ft bgs) to approximately 6-feet below grade.
