SITE CHARACTERIZATION REPORT

Munger Landing Sediment Characterization,
St. Louis River AOC, Minnesota and Wisconsin
Site Characterization

Task Order No. 68HE0518F0693/Contract No. EP-R5-11-09

August 2019

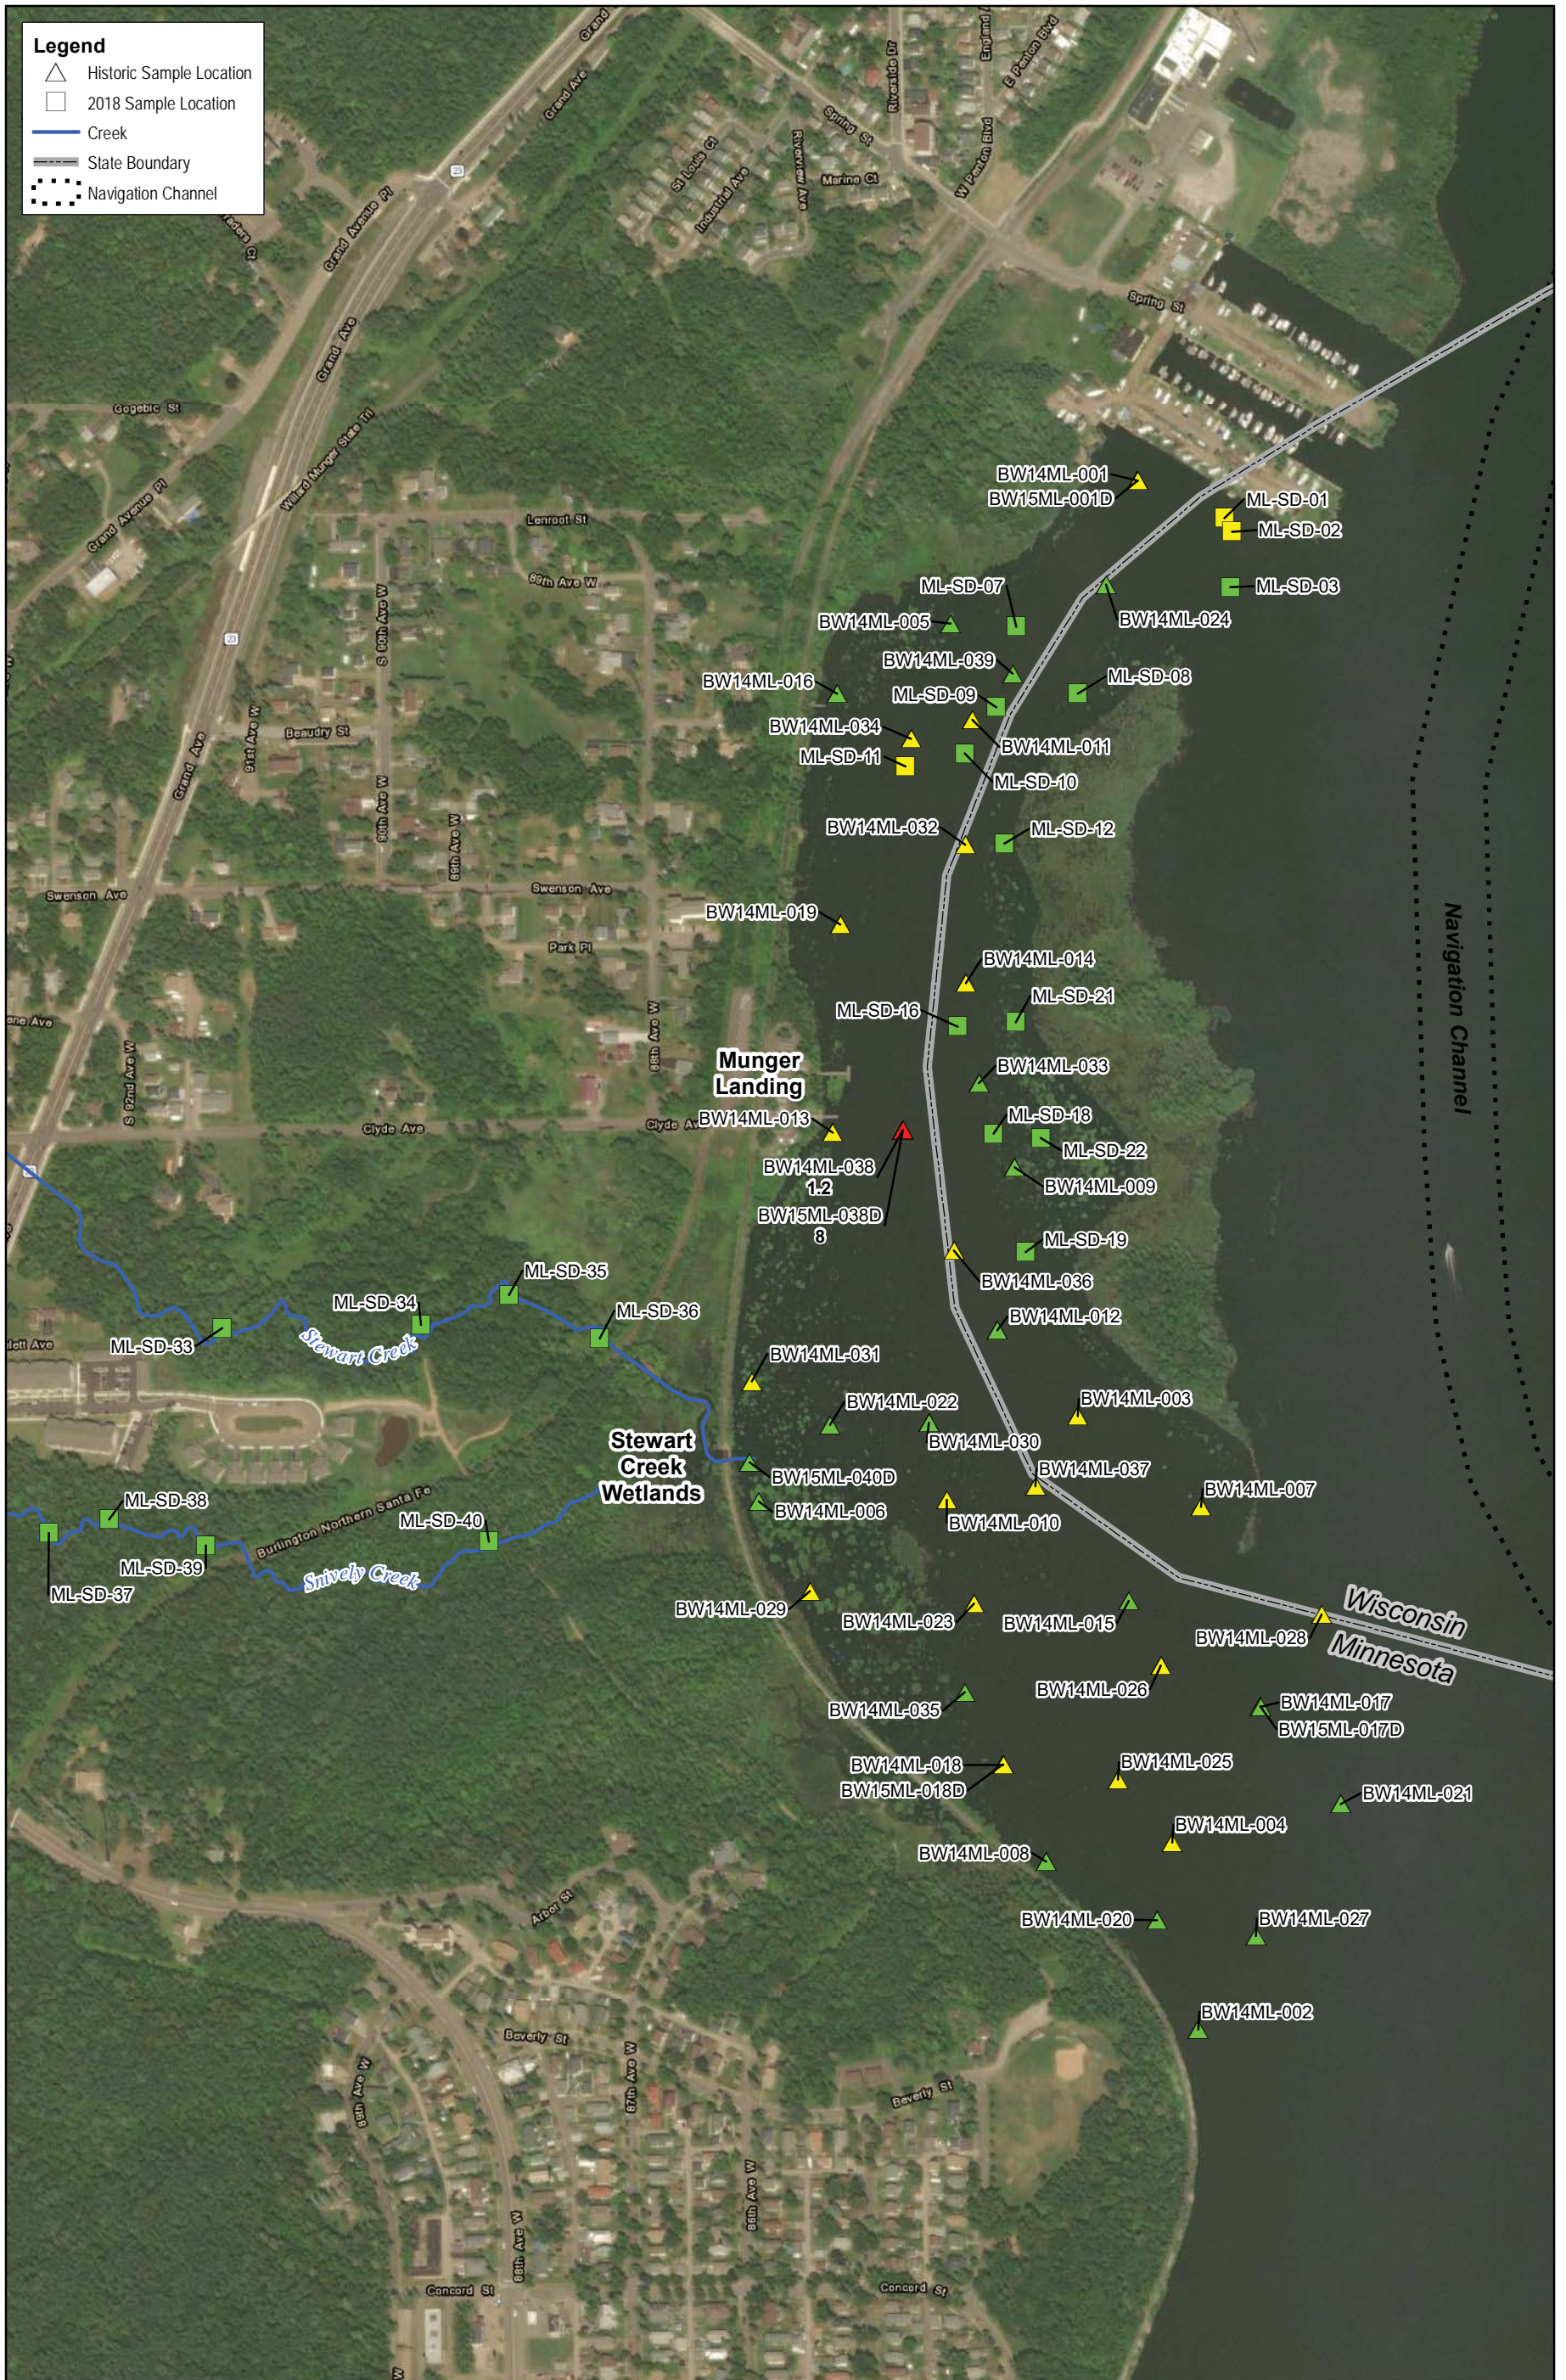
Figure 3
 Mercury Concentrations in Surface Sediment
 Munger Landing Sediment Characterization
 St. Louis River AOC, Minnesota and Wisconsin

Level I SQT exceedances for mercury were observed within the cutoff channel, with 45 percent of surface sediment and 29 percent of subsurface sediment samples exceeding the Level I SQT for mercury. Mercury exceeded the SQT midpoint at locations ML-SD-02 and BW15ML-001D, both located near the downstream extent of the project area near Spirit Lake Marina (Figure 4). Three percent of sediment samples within the channel were above the Level II SQT screening criteria for mercury. Level II SQT exceedances were found at 3 locations, BW14ML-011, located in the middle of the cutoff channel, between the Munger Landing boat launch (upstream) and Spirit Lake Marina (downstream); and co-located sample locations BW14ML-038 and BW15ML-038D, located approximately 225 feet east of the Munger Landing boat launch.

Mercury concentrations in the creeks (locations ML-SD-33 through ML-SD-40) were lower than in the river channel, ranging from nondetect to 0.054 mg/kg. SQT exceedances for mercury were not observed in the creeks.

1. 2017 DigitalGlobe Imagery Basemap.
2. All values are reported in milligrams per kilogram (mg/kg).
 - Green square: Result value is below the Level I SQT^a (0.18 mg/kg).
 - Yellow square: Result value exceeds the Level I SQT^a (0.18 mg/kg).
 - Orange square: Result value exceeds the midpoint SQT^b (0.64 mg/kg).
 - Red square: Result value exceeds the Level II SQT^c (1.1 mg/kg).

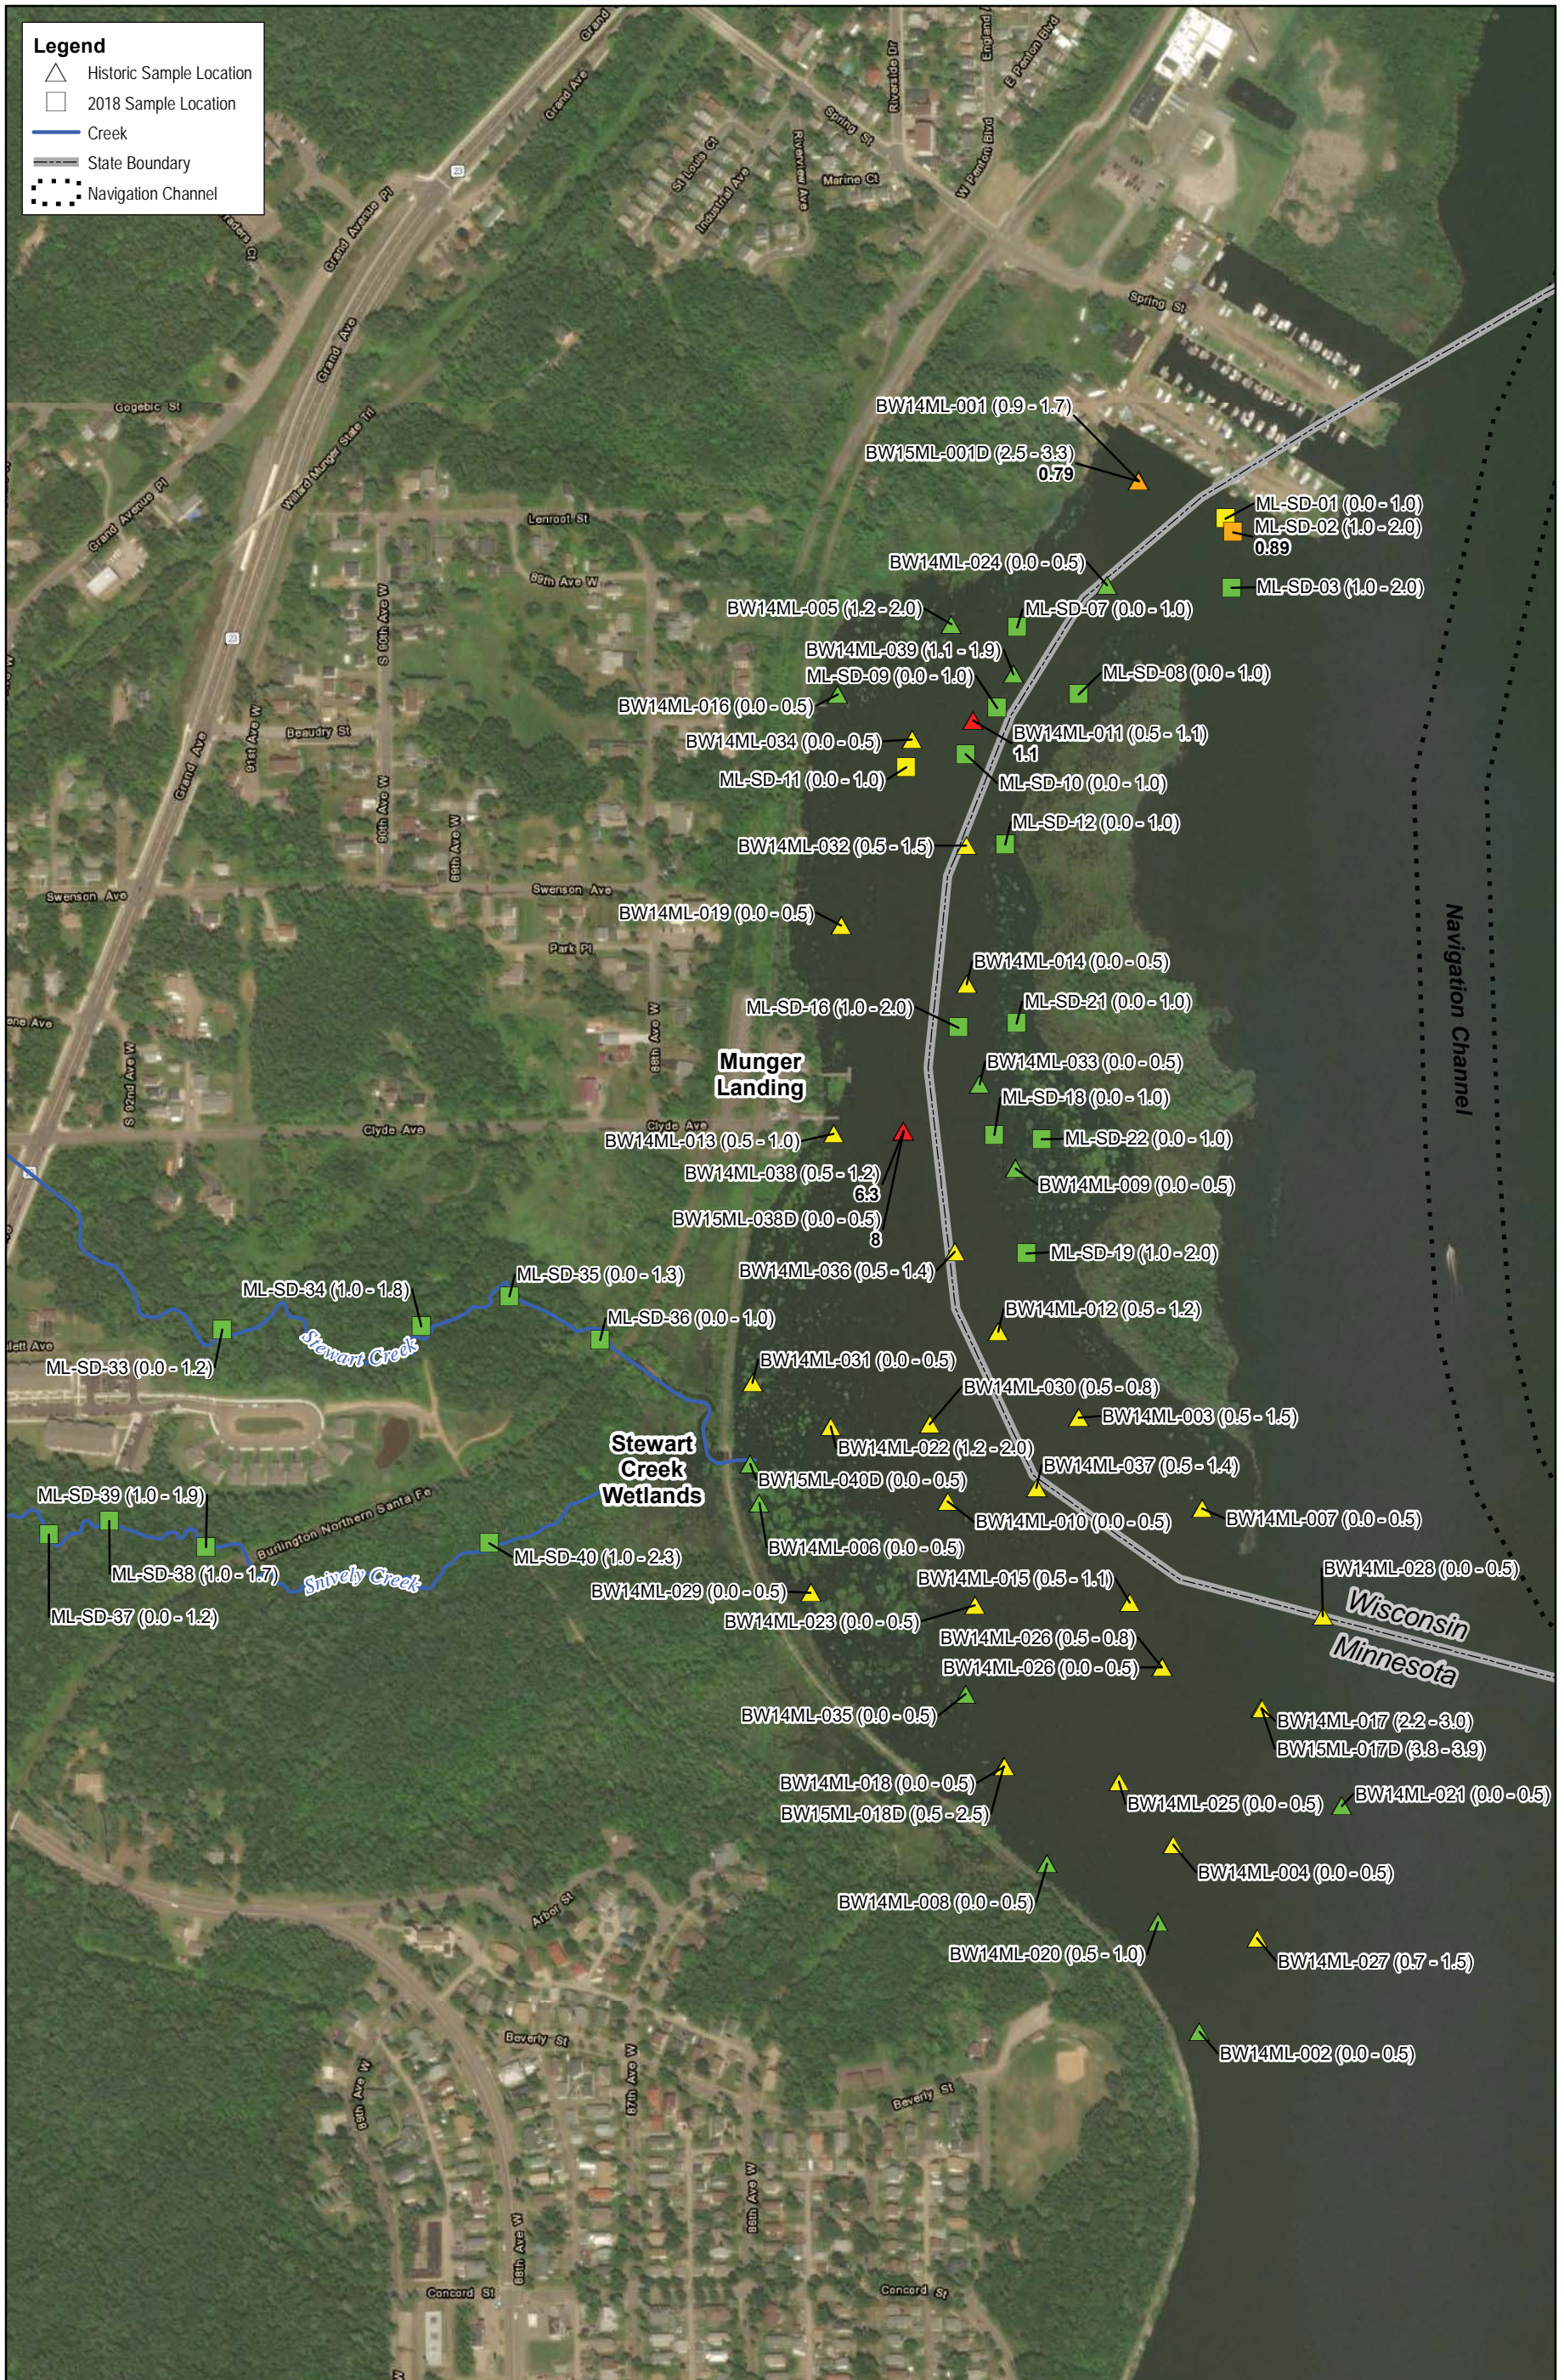
Figure 4
 Maximum Mercury Concentrations in Sediment
 Munger Landing Sediment Characterization
 St. Louis River AOC, Minnesota and Wisconsin

Notes:
 1. 2017 DigitalGlobe Imagery Basemap.
 2. Sample interval reported in feet below sediment surface (e.g., 0.0-0.1).
 3. All values are reported in milligrams per kilogram (mg/kg).
 4. Mercury concentrations are shown below the location identifier for locations with midpoint or Level II SQT exceedances.

■ Result value is below the Level I SQT* (0.18 mg/kg).
■ Result value exceeds the Level I SQT* (0.18 mg/kg).
■ Result value exceeds the midpoint SQT* (0.64 mg/kg).
■ Result value exceeds the Level II SQT* (1.1 mg/kg).

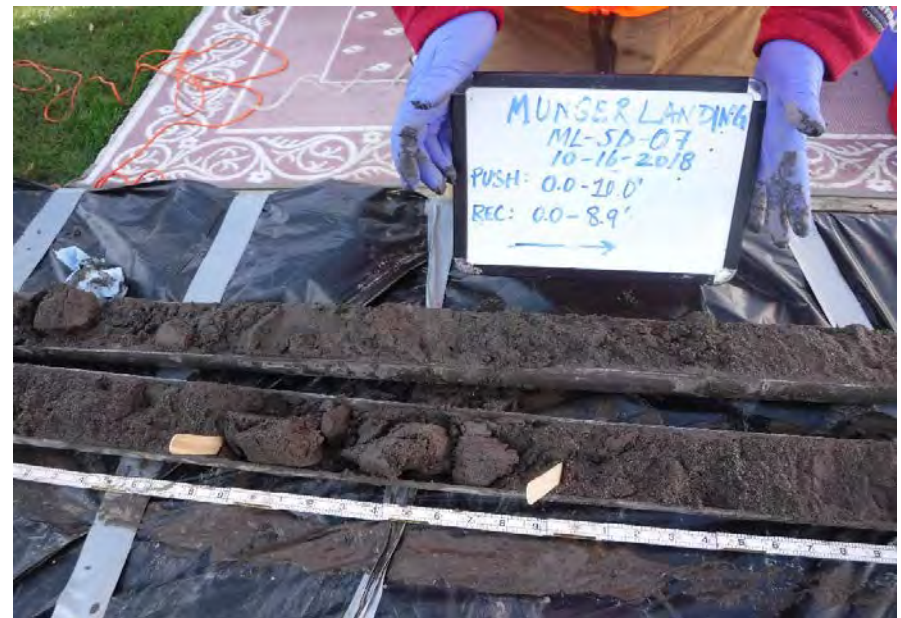
ML-SD-07 from 0.0-8.9 ft bss photo 1.JPG

Faint to light sheen was observed during processing at locations ML-SD-07 and ML-SD-39 within the project area. Sheen and odor were observed during sediment processing at ML-SD-07 located in the Munger Landing cutoff channel, and at ML-SD-39 located in Snively Creek.
