TYCO STANTON STREET FACILITY
MARINETTE, WISCONSIN
INTERIM SITE INVESTIGATION REPORT

Appendix E – Soil Boring Photograph Log

Tyco Stanton Street Facility
Interim Site Investigation Report
Marinette, Wisconsin

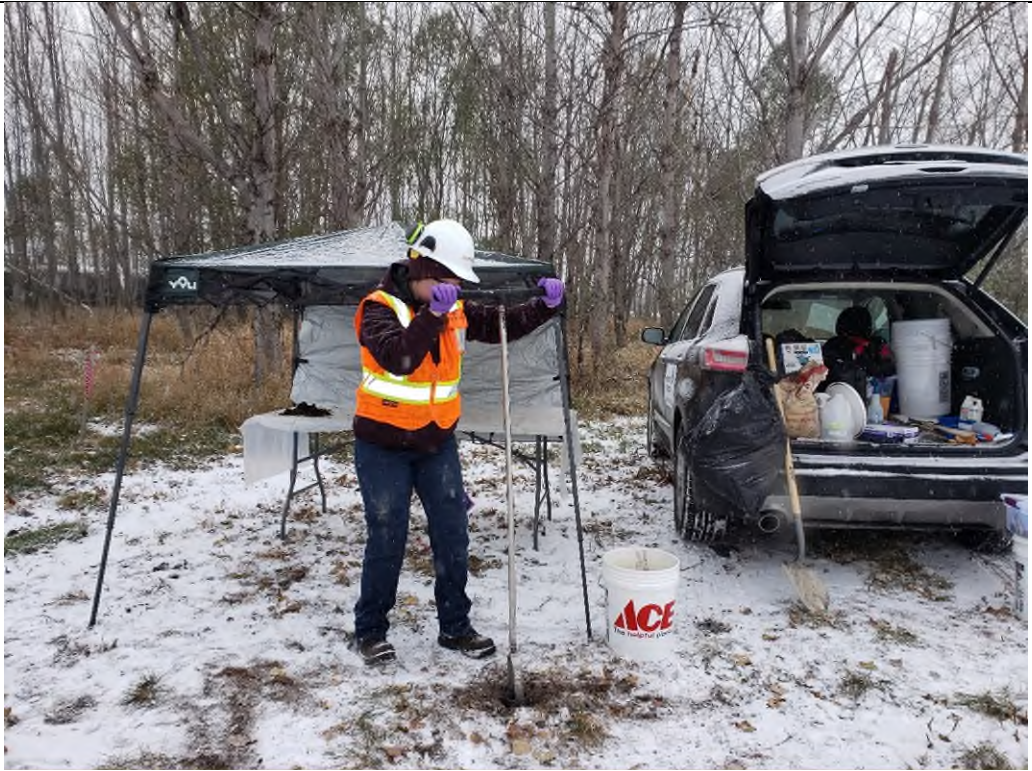
PHOTOGRAPH No: 2

LOCATION:
SS-18-01

COMMENT:
Staked location after abandonment, location was hand augured to 0.8 ft below ground surface.

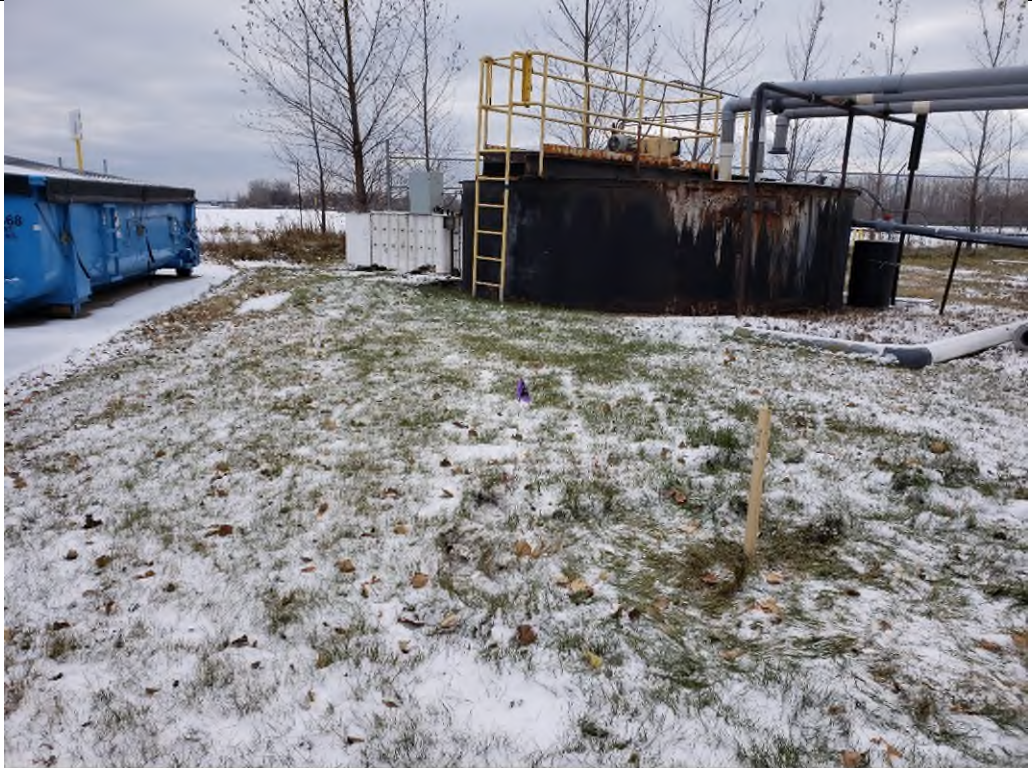
PHOTOGRAPH No: 4

LOCATION:
SS-18-04

COMMENT:
Staked location after abandonment, location was hand augured to 1.5 ft below ground surface.

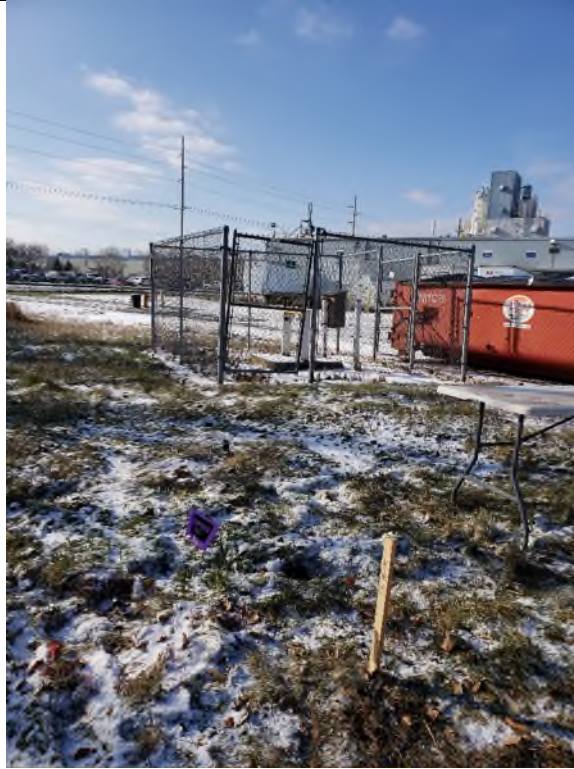
PHOTOGRAPH No: 6

LOCATION:
SS-18-05

COMMENT:
Staked location after abandonment, location was hand augured to 2.2 ft below ground surface.

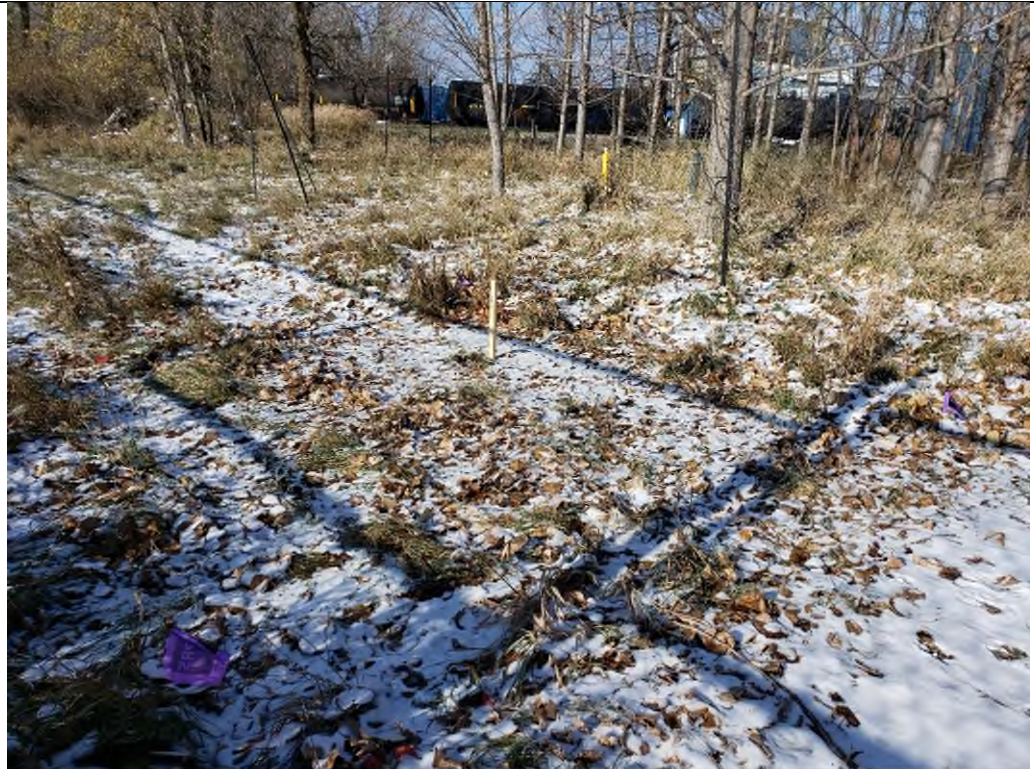
PHOTOGRAPH No: 8

LOCATION:
SS-18-03

COMMENT:
Staked location after abandonment, location was hand augured to 1.1 ft below ground surface.

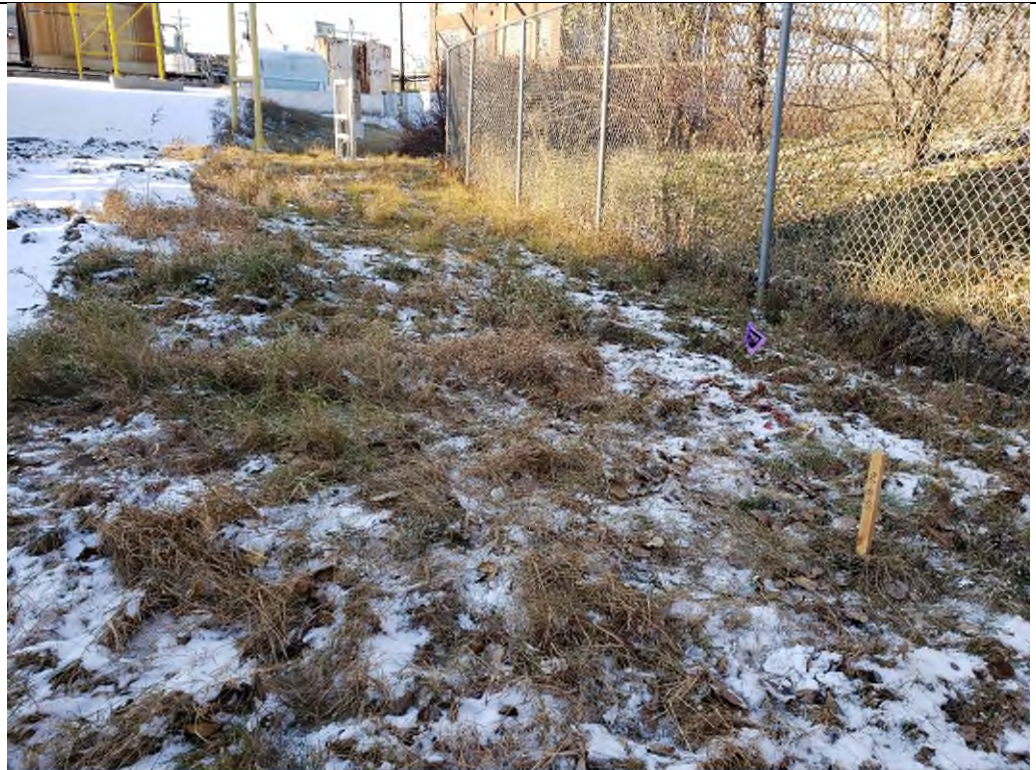
PHOTOGRAPH No: 10

LOCATION:
SS-18-06

COMMENT:
Staked location after abandonment, location was hand augured to 0.9 ft below ground surface.
