SUBJECT: Response to Site Investigation Work Plan, Interim Site Investigation Report, Conceptual Site Model and Aerial Deposition Evaluation Report
JCI/Tyco Stanton (PFAS), 1 Stanton Street, Marinette, WI
BRRTS #02-38-581955

Attachment A: Referenced Figures

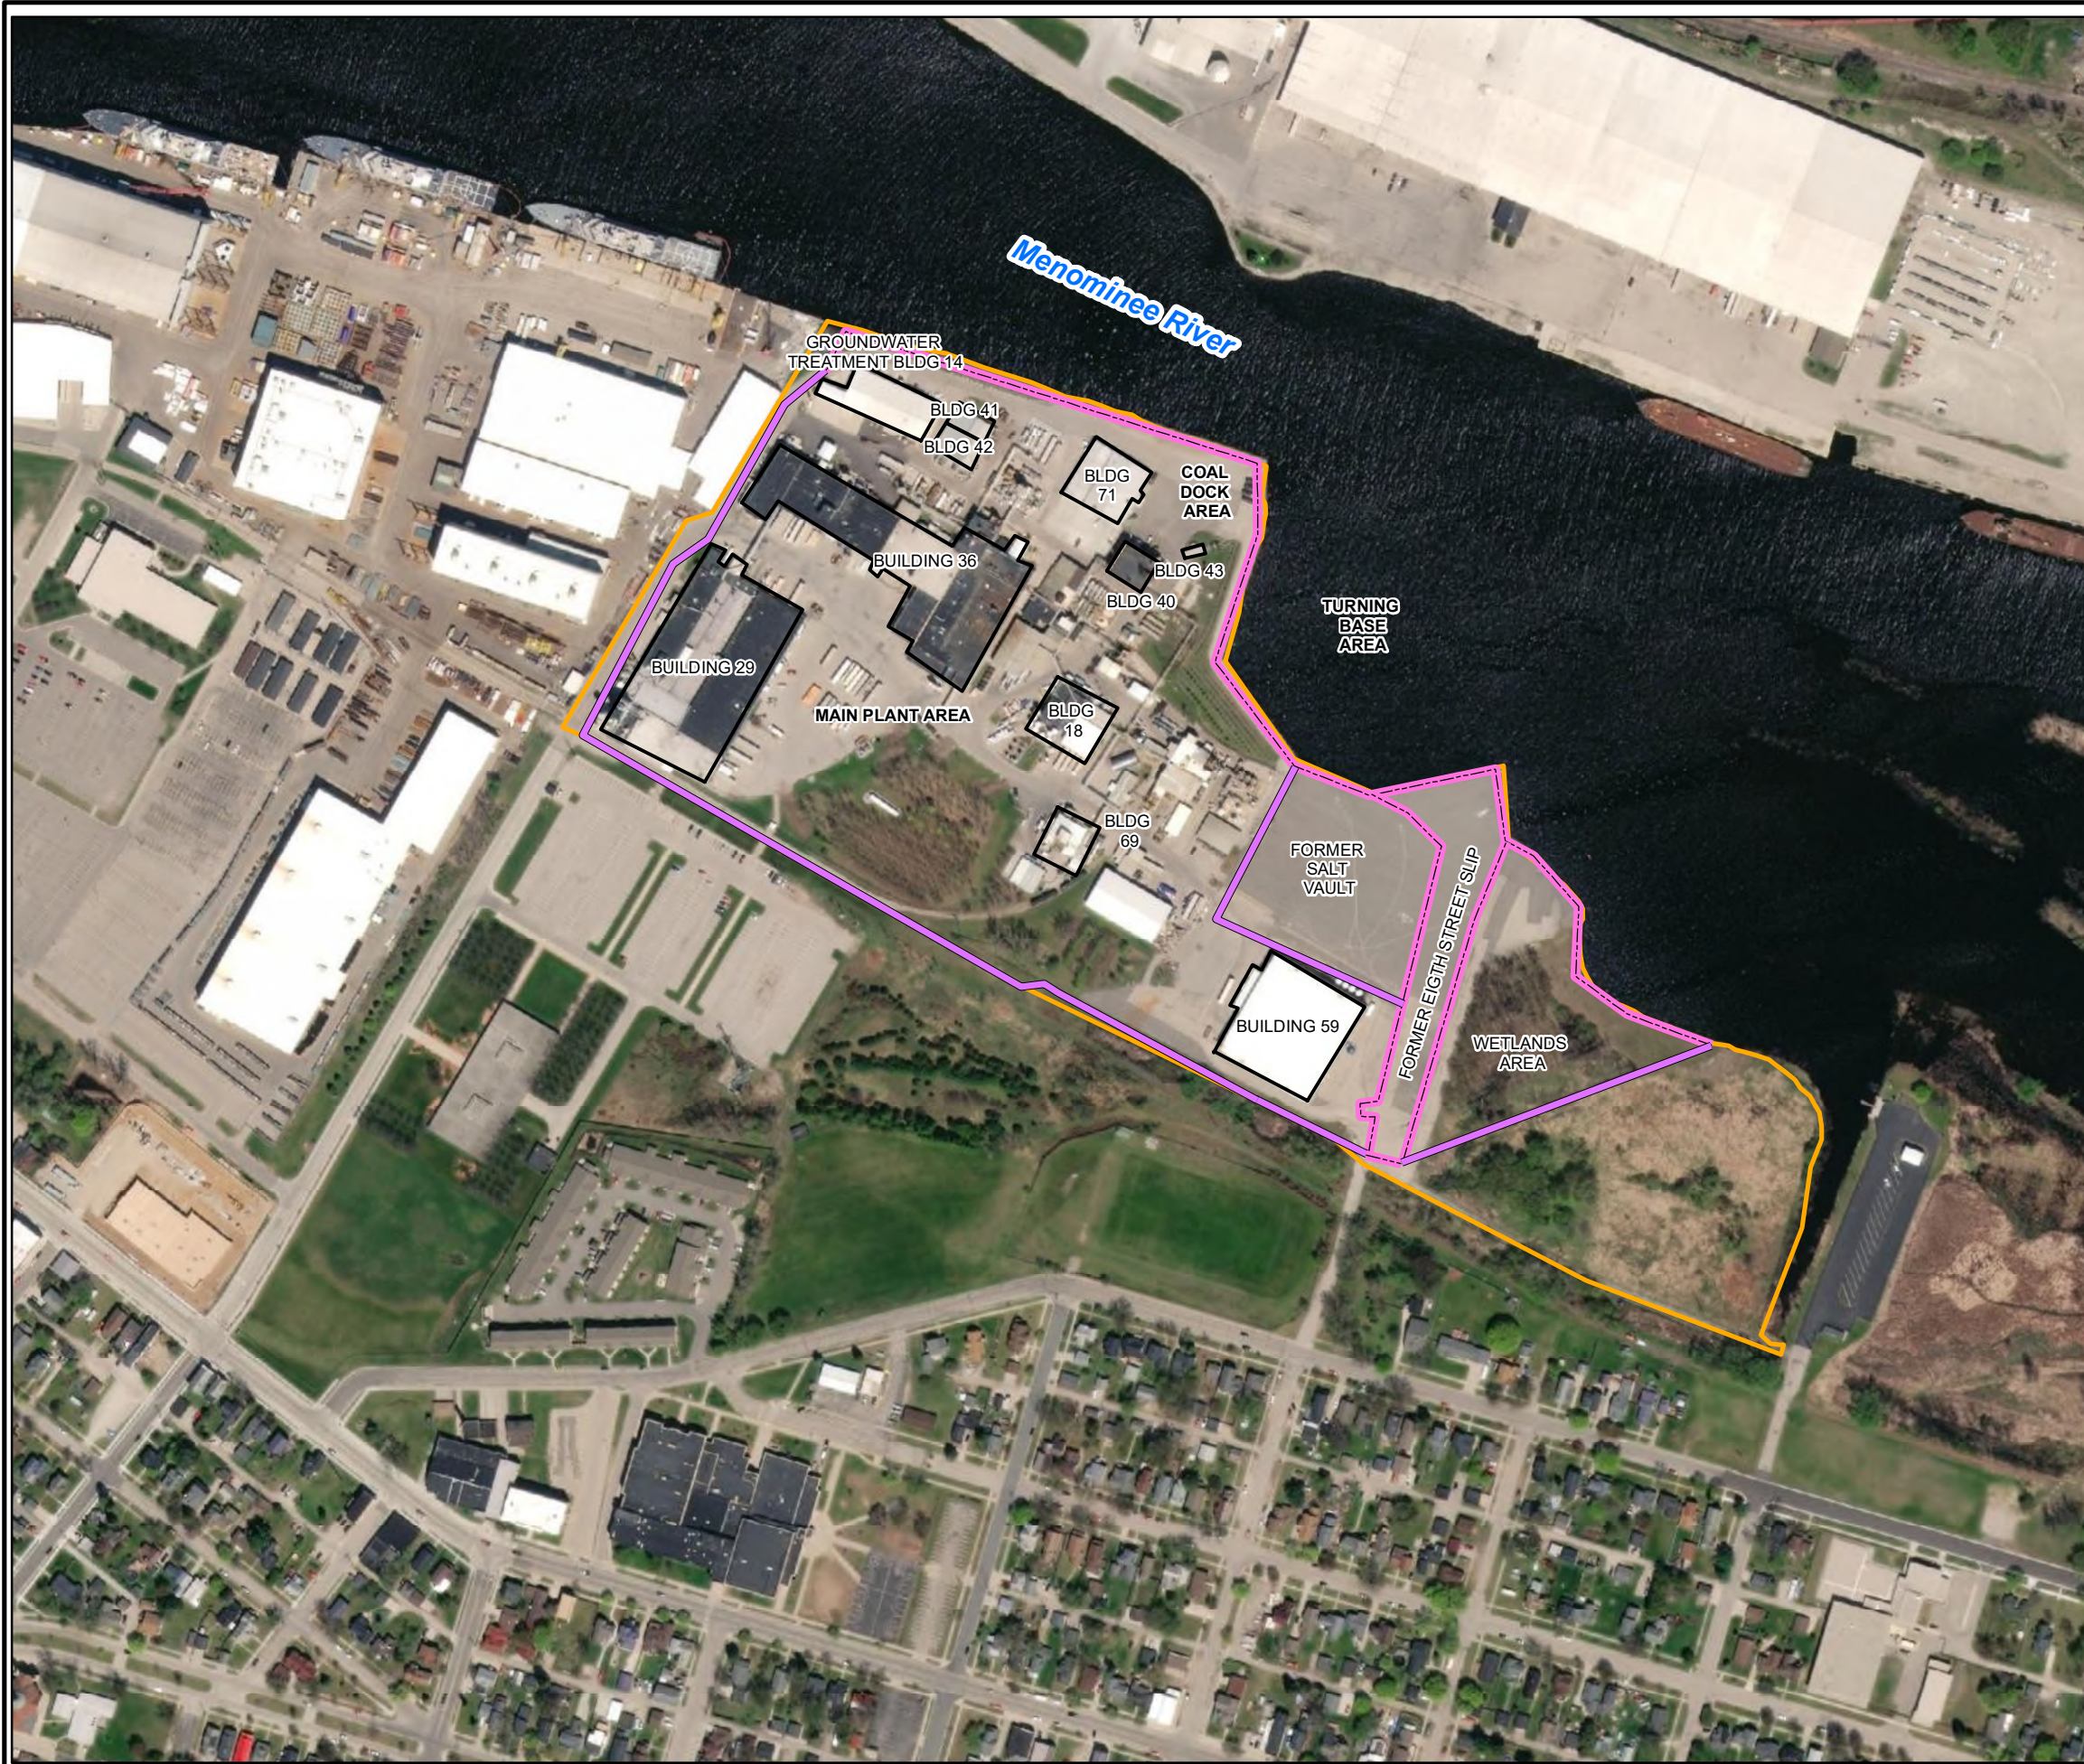
SITE LAYOUT

TYCO STANTON STREET FACILITY
MARINETTE, WISCONSIN
SITE INVESTIGATION WORK PLAN

The discharge of PFAS at the Site is associated with JCI/Tyco's operations including blending and packaging PFAS-containing aqueous film forming foams (AFFF). Currently, JCI/Tyco blends firefighting foam concentrate products and manufactures fire extinguishers and other fire suppression system hardware at the Site. It is the DNR's understanding that JCI/Tyco began distributing firefighting foam in 1964. Up until approximately 1975, it repackaged some foams manufactured by other companies including 3M and starting around 1975 JCI/Tyco began blending and packaging its own firefighting foam at the Site. JCI/Tyco's blending operations occur in Building 18, quality control testing occurs in Building 71, and storage of off-spec material occurs in Building 59. The locations of these building are shown on Arcadis' Figure 2 in **Attachment A**.

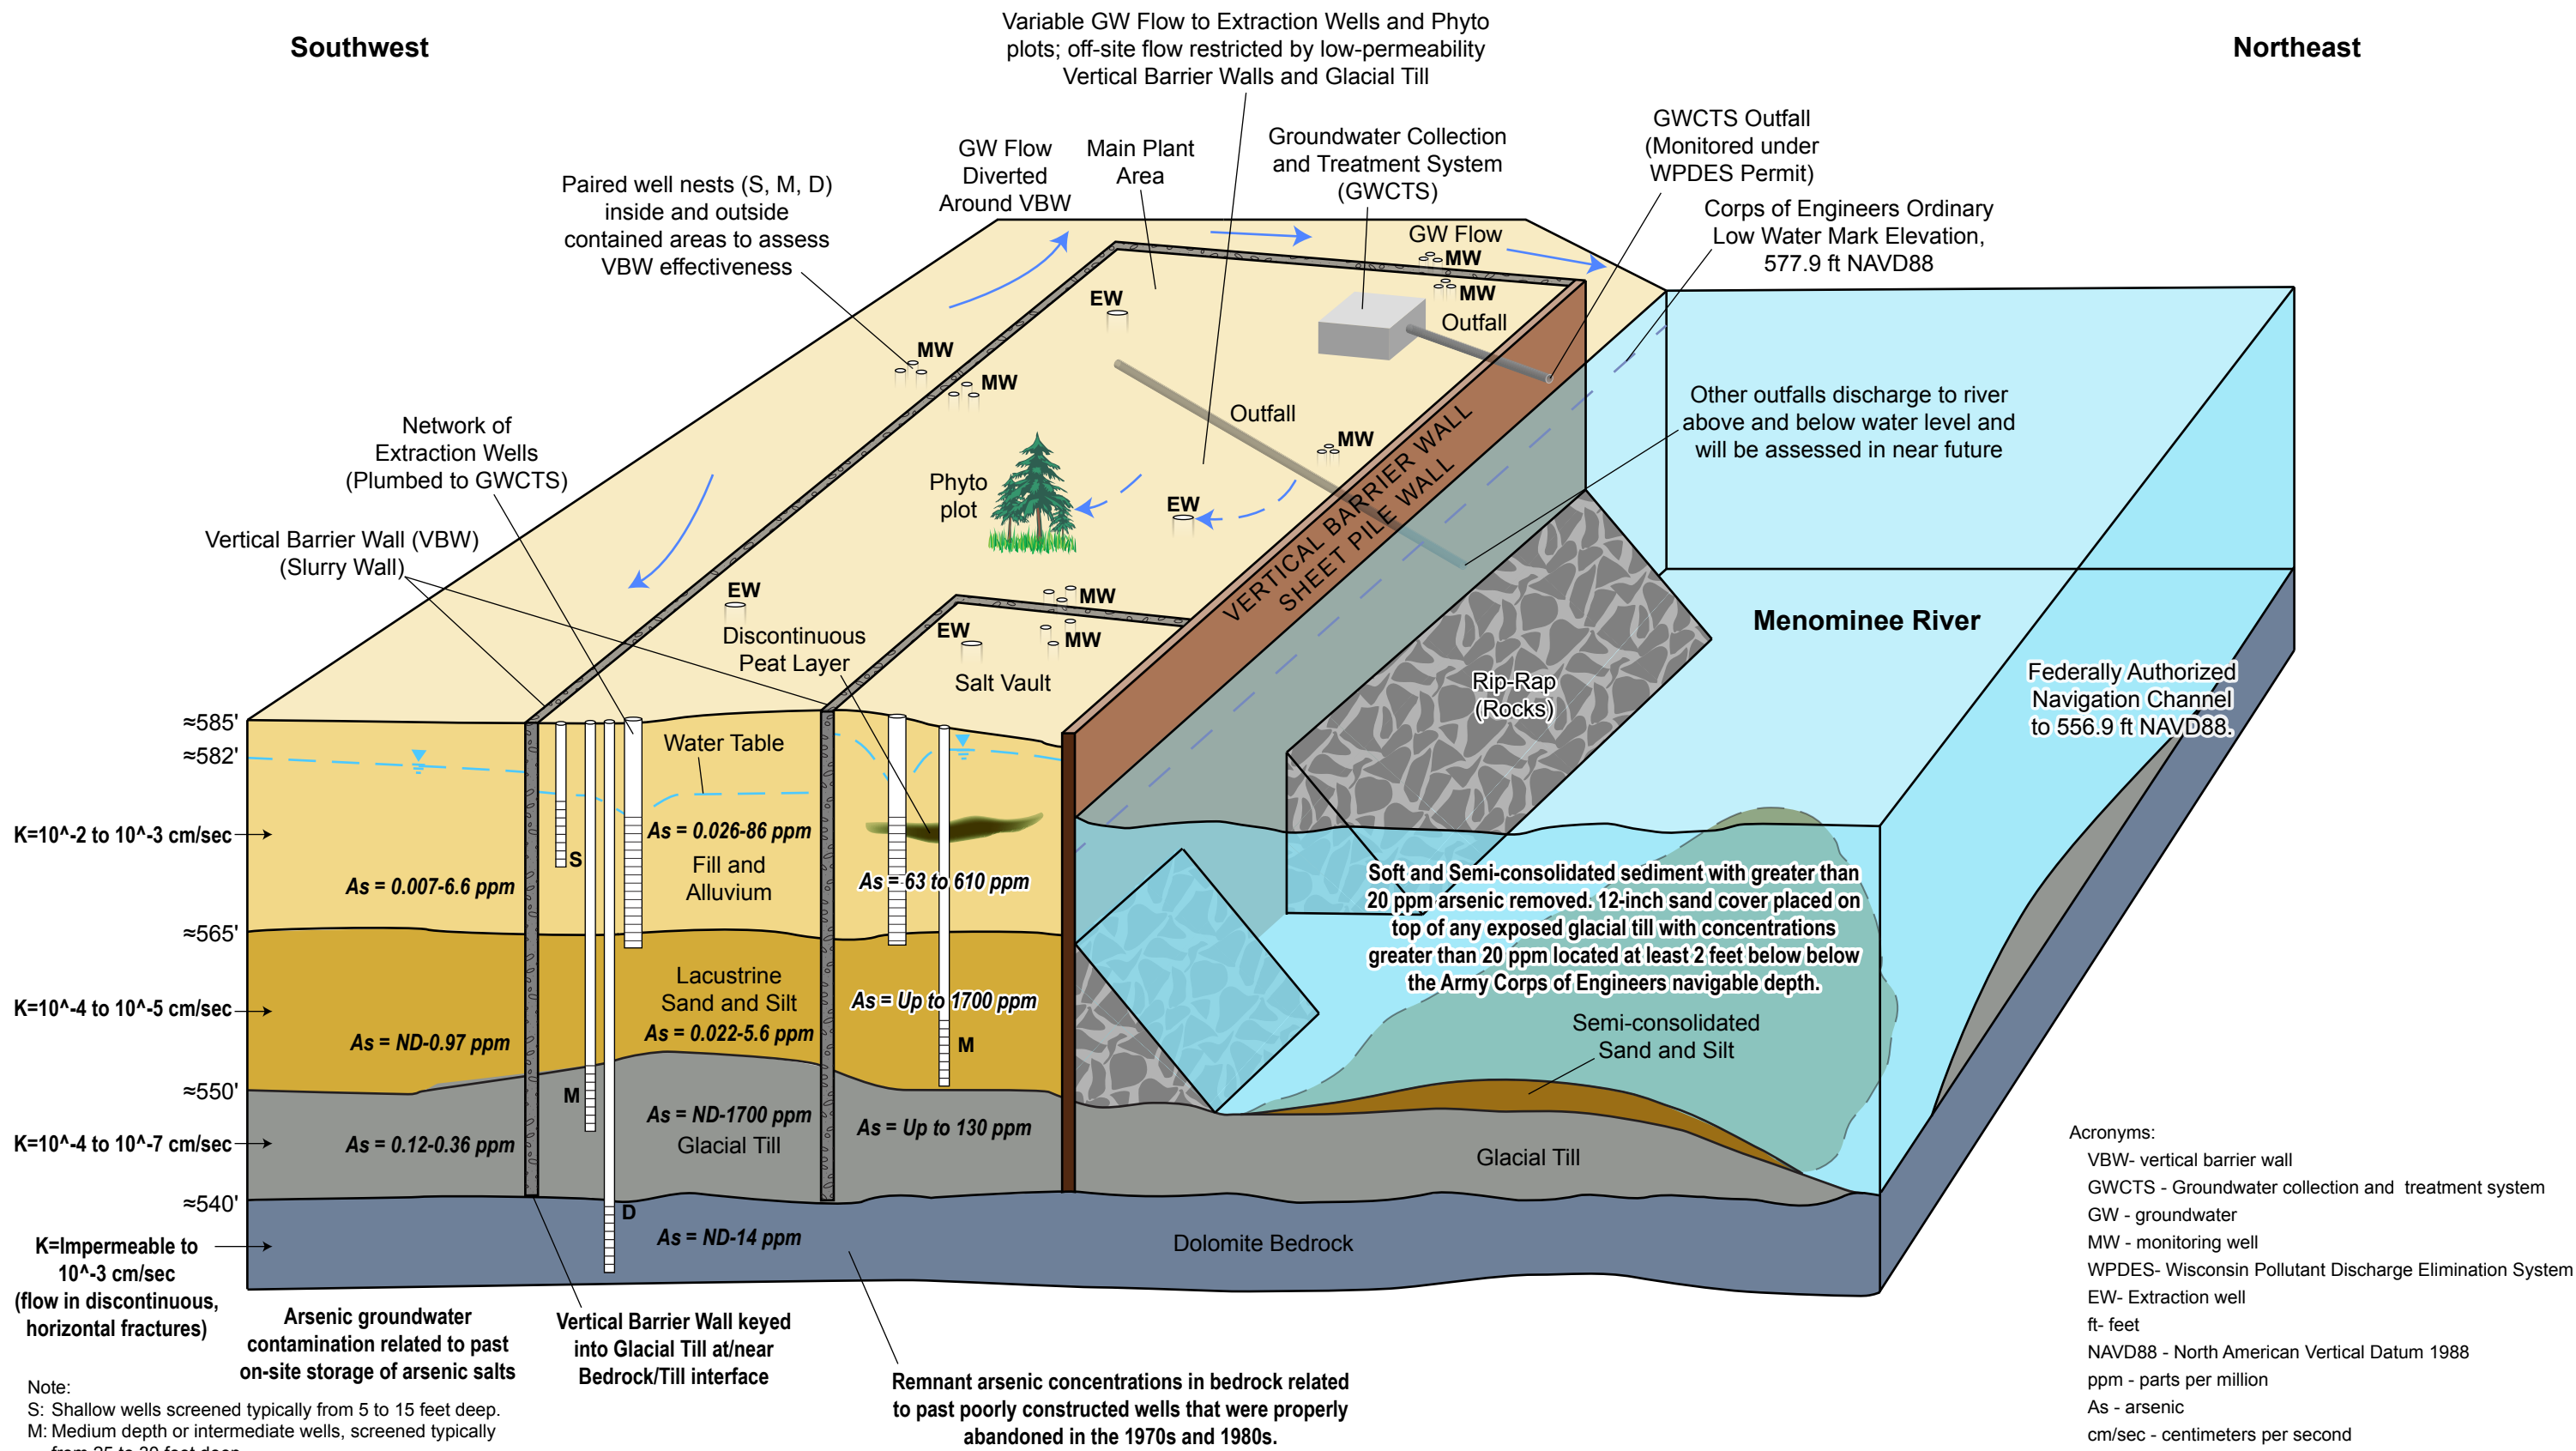
FIGURE 1-4
 Conceptual Site Model Post-barrier Wall
 Tyco Fire Products LP
 Marinette, Wisconsin

Note:
 S: Shallow wells screened typically from 5 to 15 feet deep.
 M: Medium depth or intermediate wells, screened typically from 25 to 30 feet deep.
 D: Deep wells installed and sealed within the uppermost portion of bedrock using a 5-foot long screen.

Arsenic results are from 2013-2014 and represent highest and lowest arsenic concentrations detected in each area.
 Bedrock concentrations are the range for the entire site since bedrock is located below the barrier wall system.

The 66-acre property was investigated and underwent RCRA corrective action measures for the arsenic contamination under BRRTS case #02-38-000011 ("Arsenic RCRA Site"). The conceptual layout and overviews based on the prior investigation and corrective actions are shown on CH2MHill's Figure 1-4 and Jacobs' Figure 3 in **Attachment A**.

- Groundwater in the unconsolidated zone on the property is contained, to the extent possible, within a barrier wall that was installed around the perimeter of the property by 2010. The barrier wall is keyed into the low-permeability glacial till and includes a slurry wall along the upland perimeter and a sheet pile wall along the Menominee River (see CH2MHill's Figure 1-4 and Jacobs' Figure 3 in **Attachment A**).

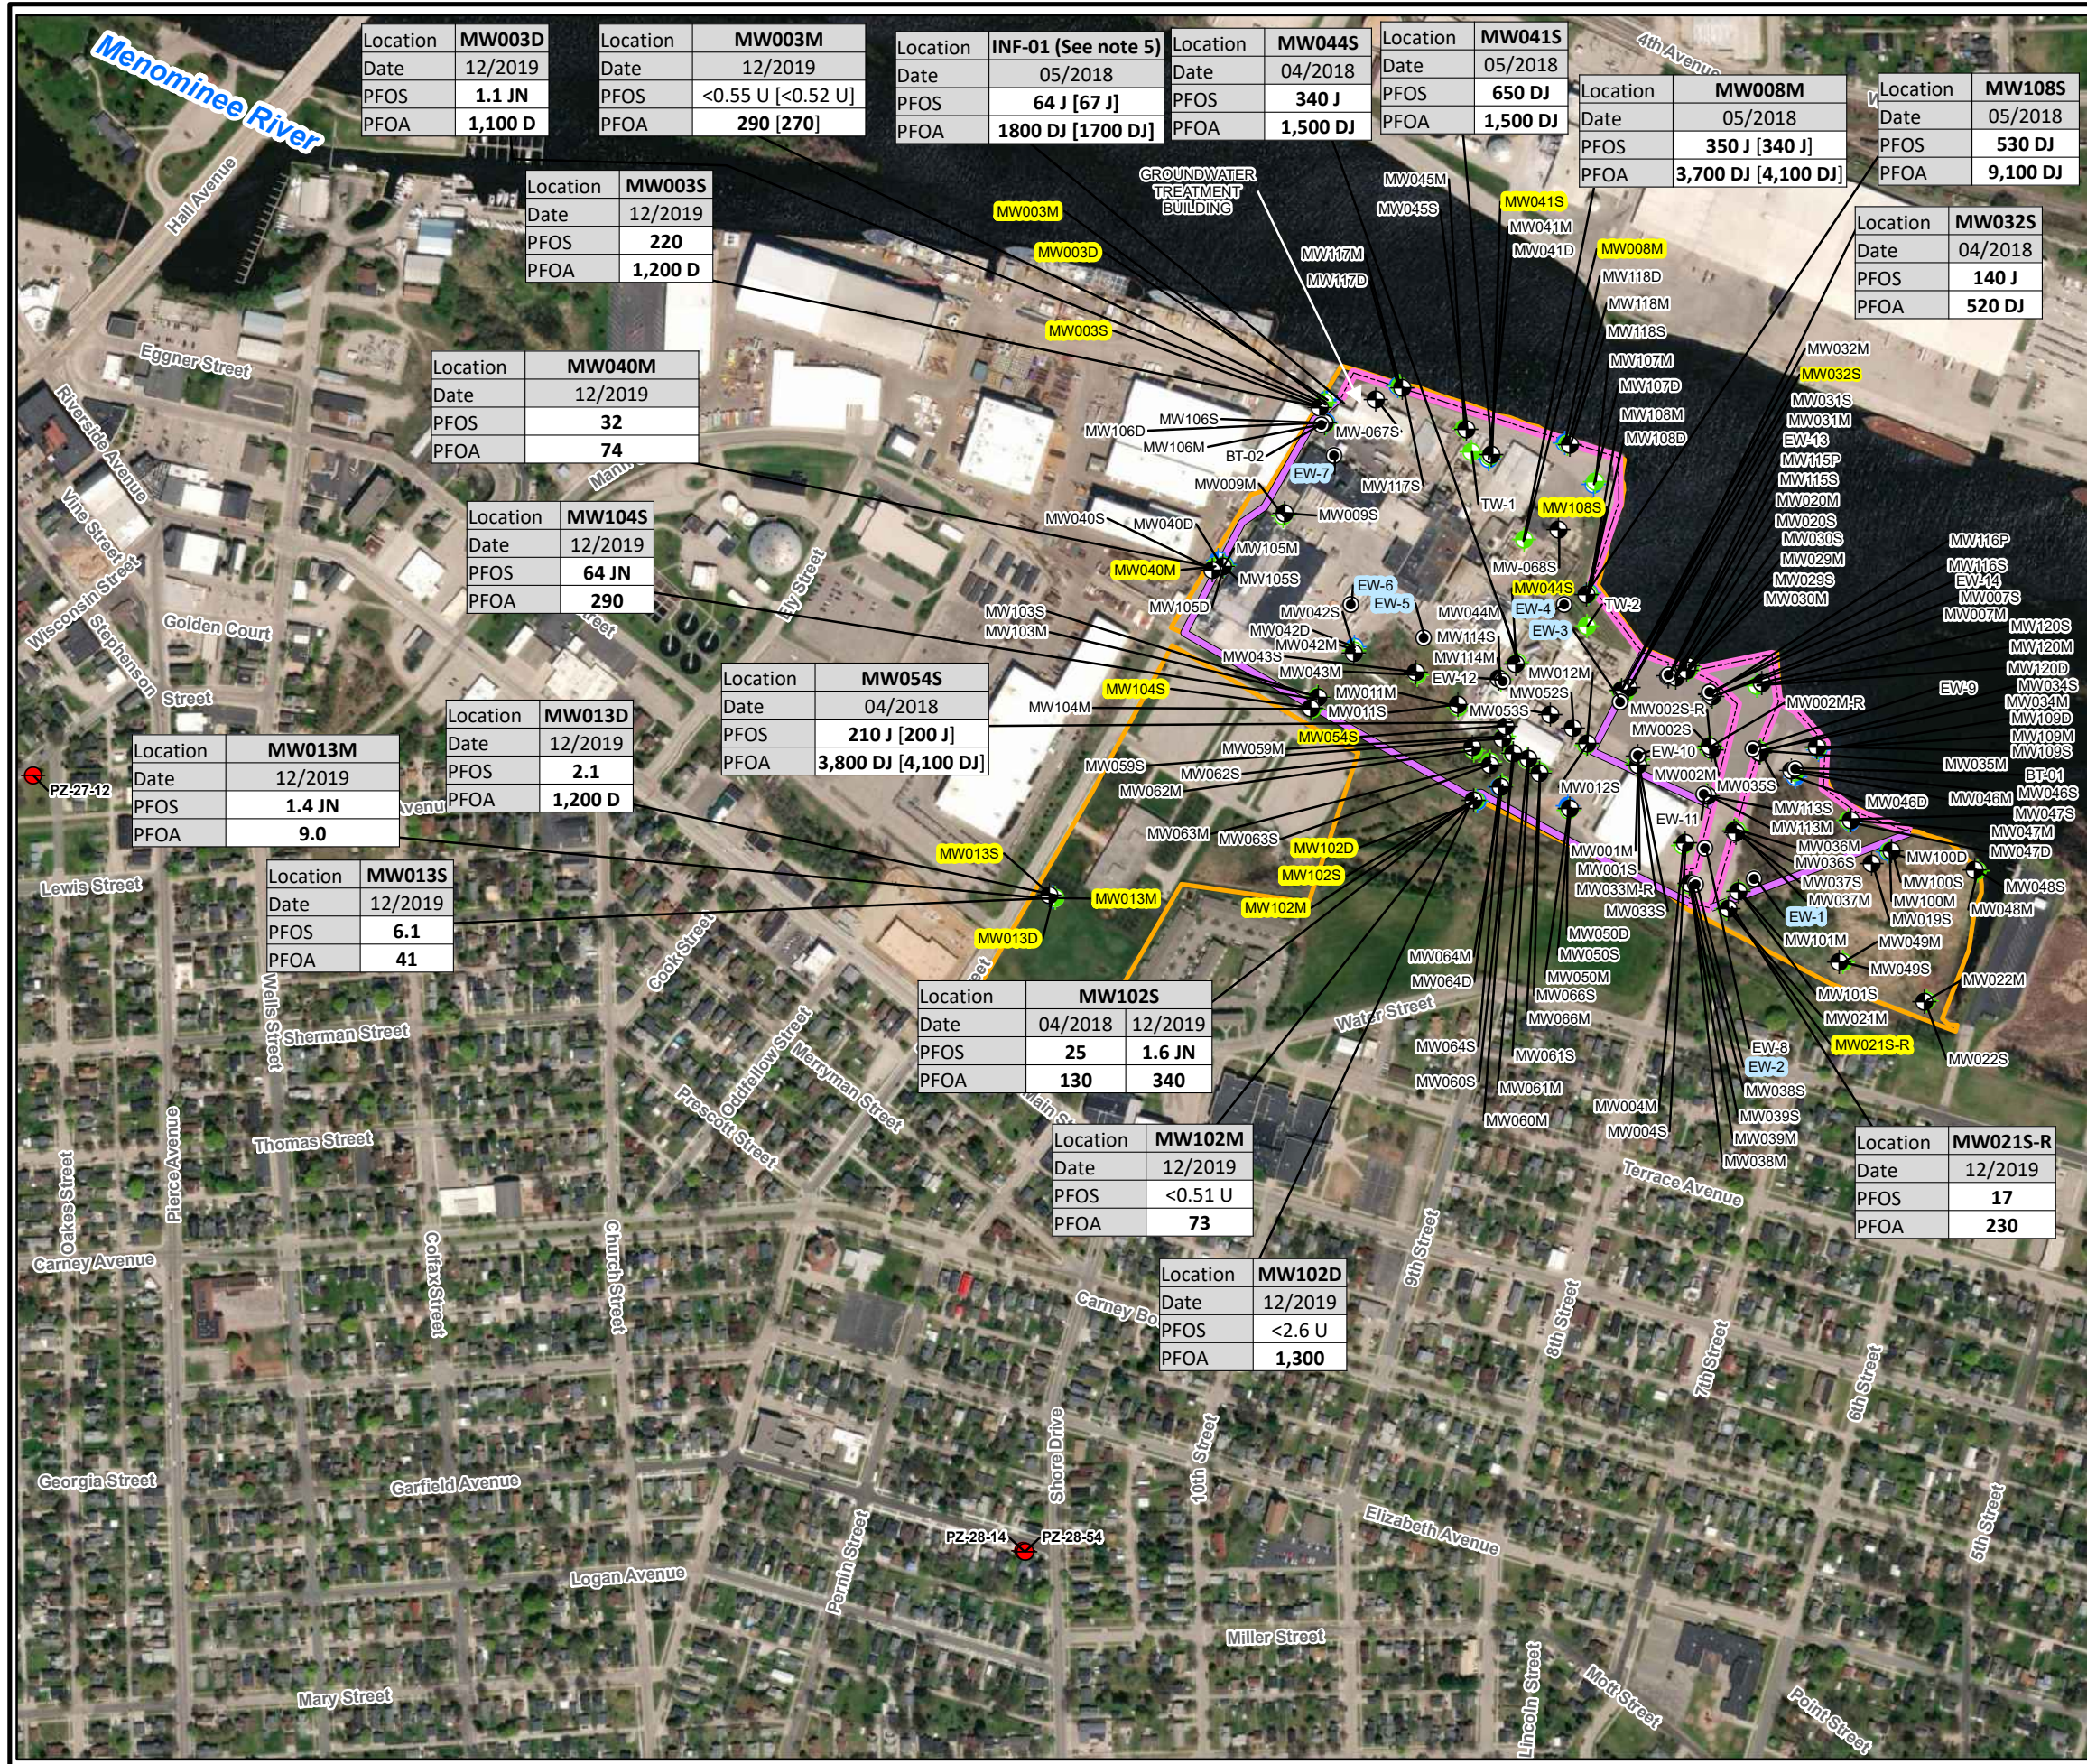
Location	MW003D	Location	MW003M	Location	INF-01 (See note 5)	Location	MW044S	Location	MW041S
Date	12/2019	Date	12/2019	Date	05/2018	Date	04/2018	Date	05/2018
PFOS	1.1 JN	PFOS	<0.55 U [<u><0.52 U</u>]	PFOS	64 J [67 J]	PFOS	340 J	PFOS	650 DJ
PFOA	1,100 D	PFOA	290 [270]	PFOA	1800 DJ [1700 DJ]	PFOA	1,500 DJ	PFOA	1,500 DJ

Location	MW003S	Location	MW008M	Location	MW108S
Date	12/2019	Date	05/2018	Date	05/2018
PFOS	220	PFOS	350 J [340 J]	PFOS	530 DJ
PFOA	1,200 D	PFOA	3,700 DJ [4,100 DJ]	PFOA	9,100 DJ

JCI/Tyco collected soil samples from seven locations and groundwater samples from 18 existing on-site monitoring wells. The sample locations are shown on Arcadis' Figures 5 and 8 in **Attachment A**. These samples were analyzed for 14 PFAS compounds. The results for PFOA and PFOS are summarized in the tables below; other PFAS were also detected.

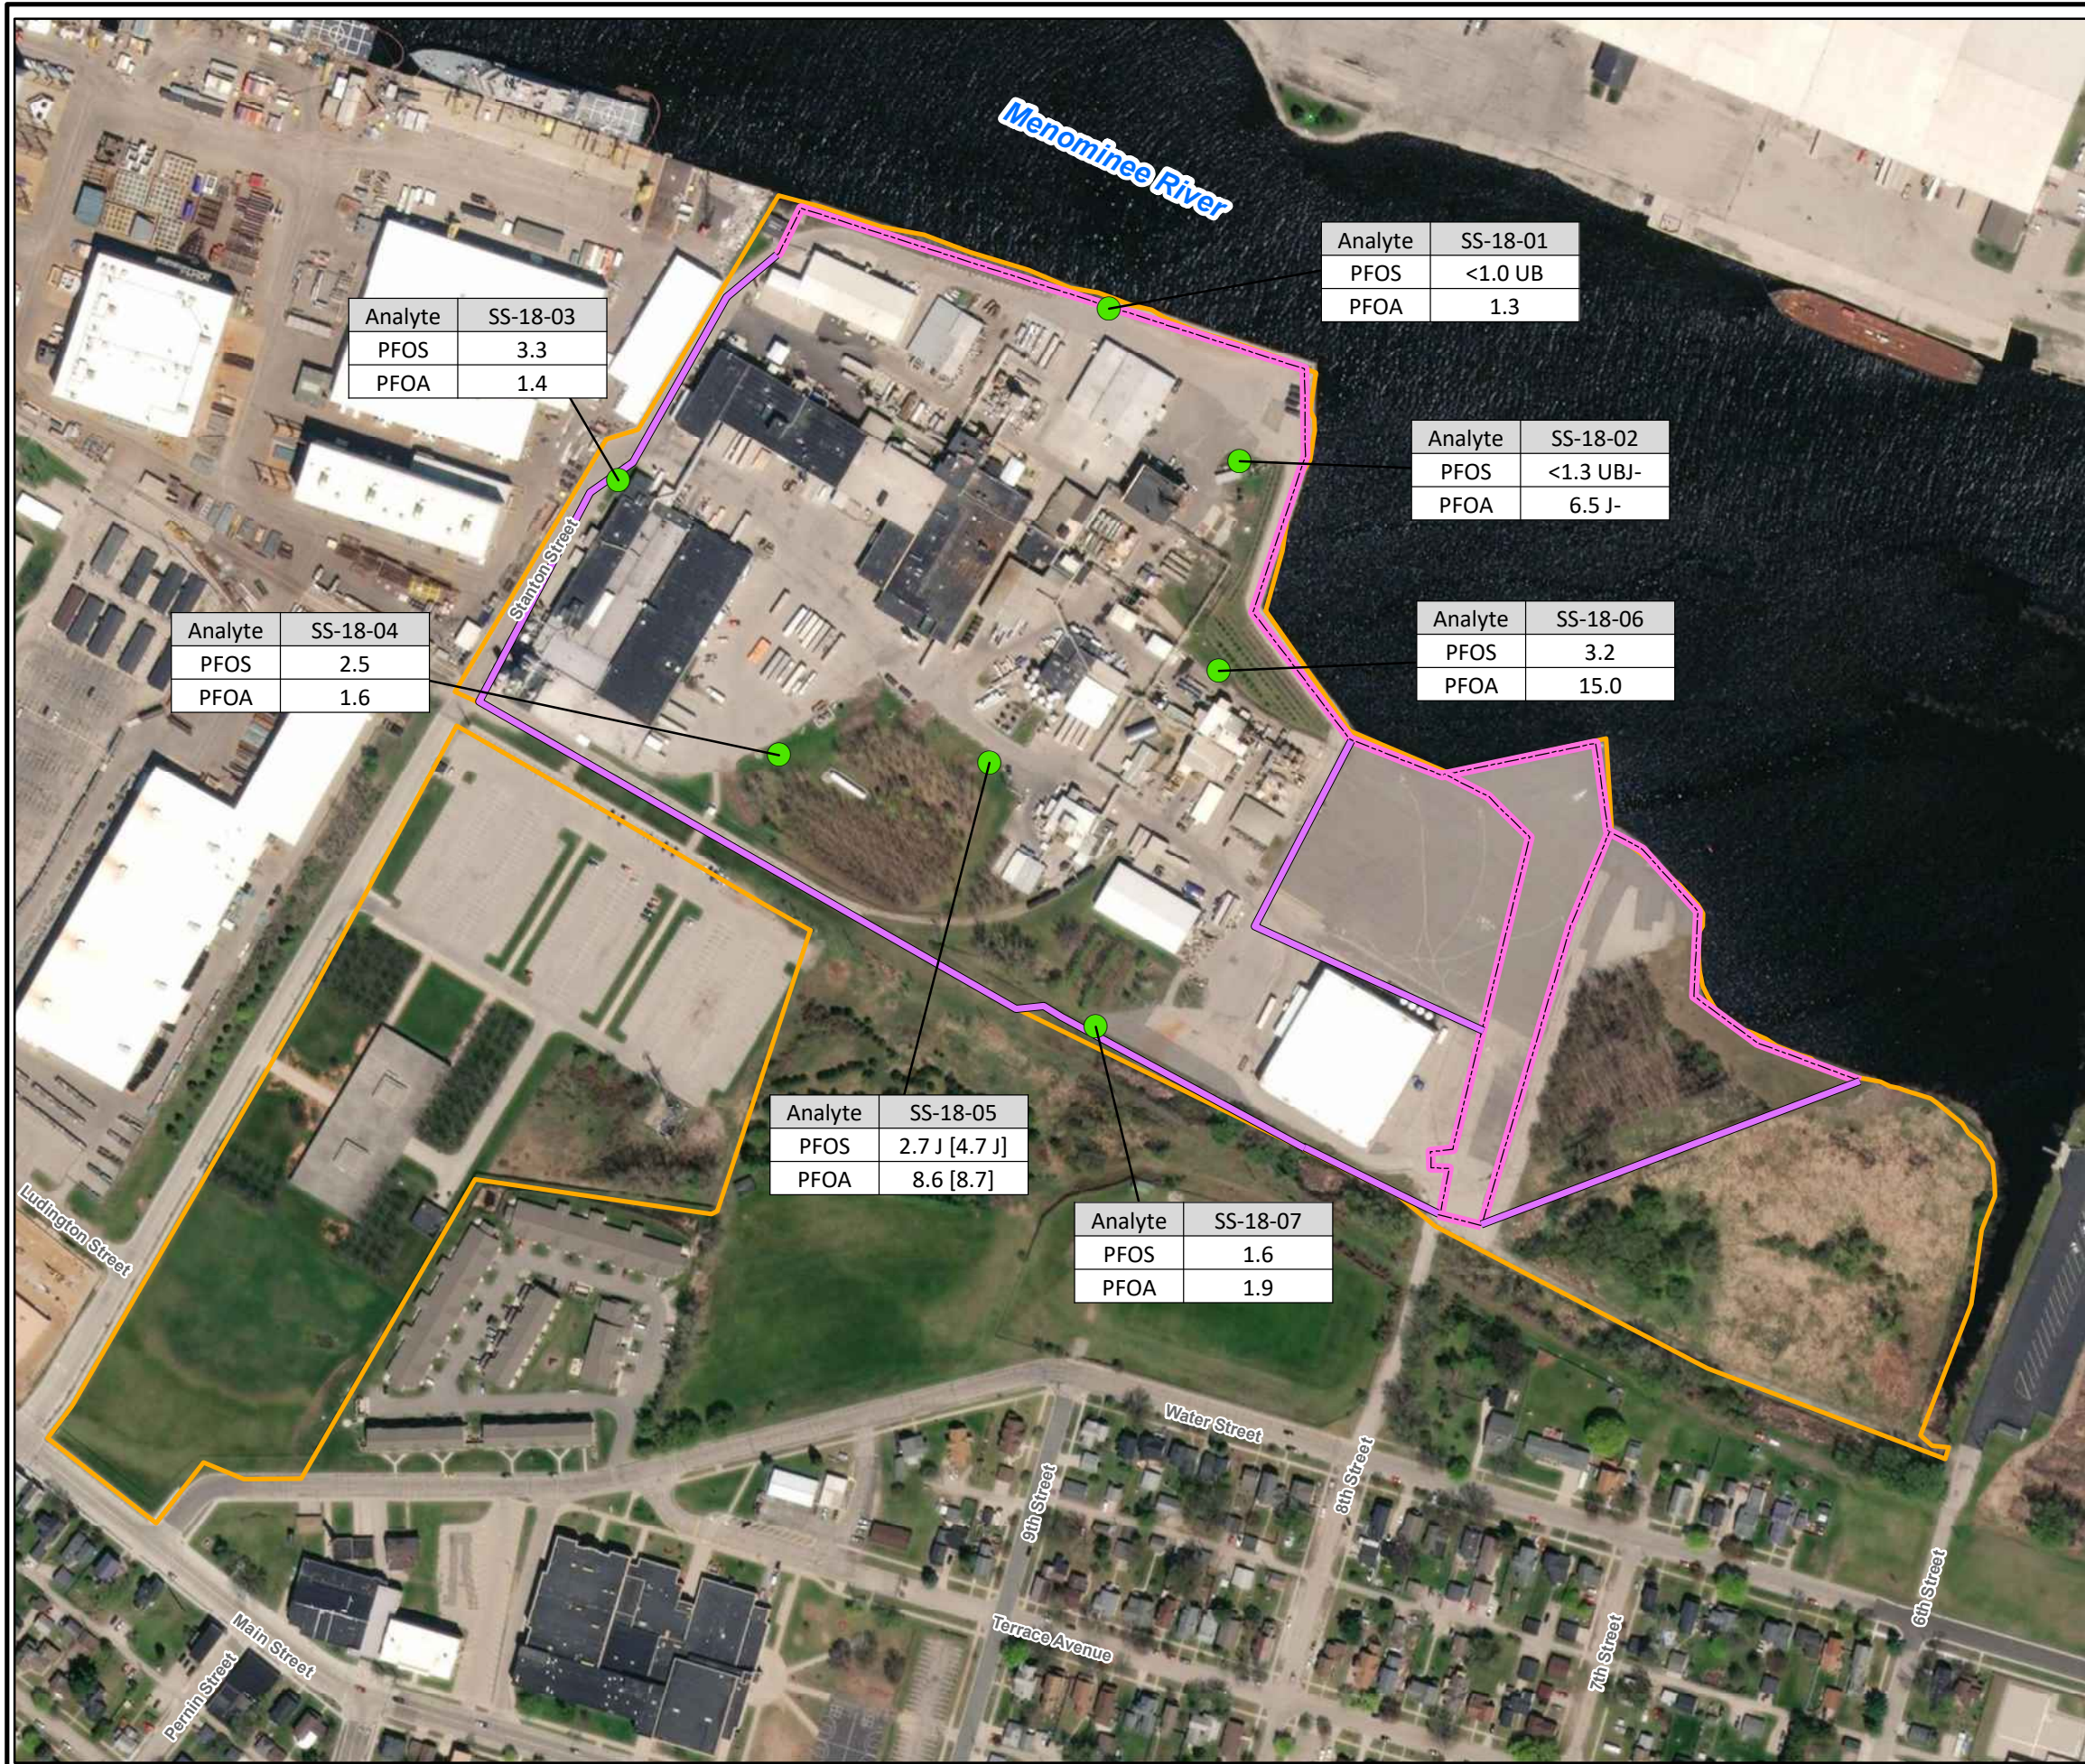
FIGURE 8

Analyte	SS-18-03
PFOS	3.3
PFOA	1.4

Analyte	SS-18-04
PFOS	2.5
PFOA	1.6

SOIL ANALYTICAL RESULTS

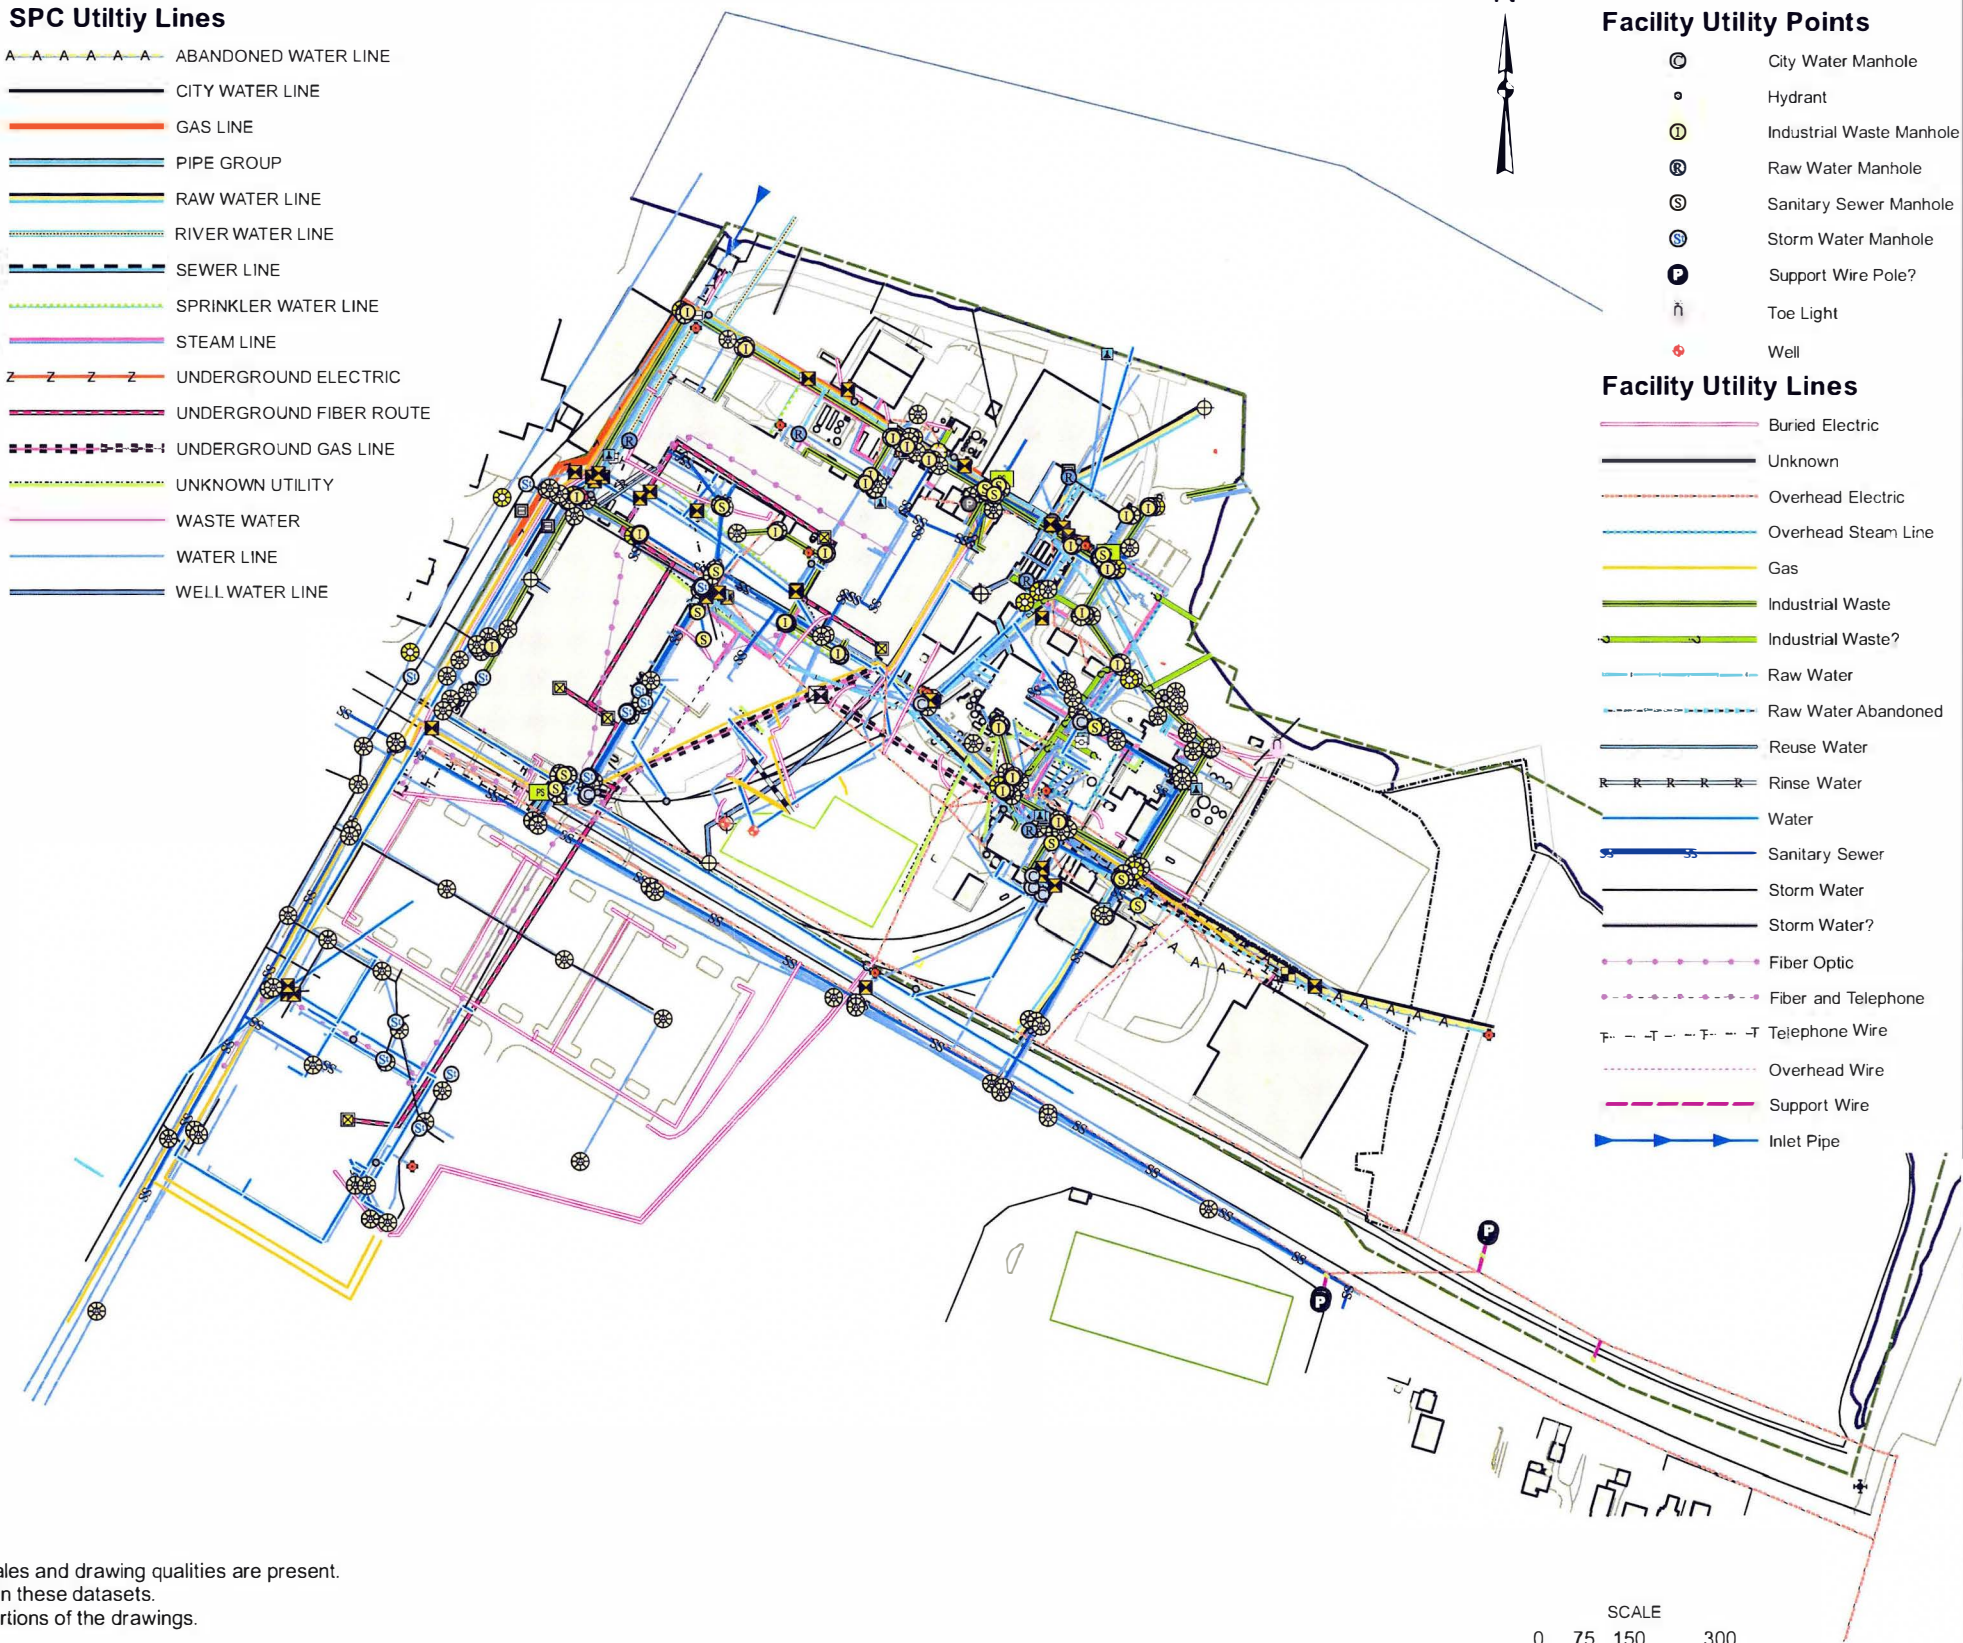
**FIGURE 3-1
 UTILITY MAP**
 TYCO SAFETY PRODUCTS - ANSUL FACILITY
 MARINETTE, WISCONSIN

Facility Utility Lines

SPC Utilities Note: Spatial errors due to variable scales and drawing qualities are present. Dimensions present in drawings were not captured in these datasets. Some attribution was irretrievable due to illegible portions of the drawings.

Data Gap #1d: Locations of the current and historical sanitary sewer system (on the property and the pathway to the wastewater treatment plant), and locations where structure defects in the sanitary sewer system were found. (A utility map from the 2007 pre-design report to U.S. EPA for the RCRA corrective action for arsenic includes some of this information – see Earth Tech Figure 3-1 in **Attachment A.**)
