SUBJECT: Response to Site Investigation Work Plan, Interim Site Investigation Report, Conceptual Site Model and Aerial Deposition Evaluation Report
JCI/Tyco Stanton (PFAS), 1 Stanton Street, Marinette, WI
BRRTS #02-38-581955

Attachment A: Referenced Figures

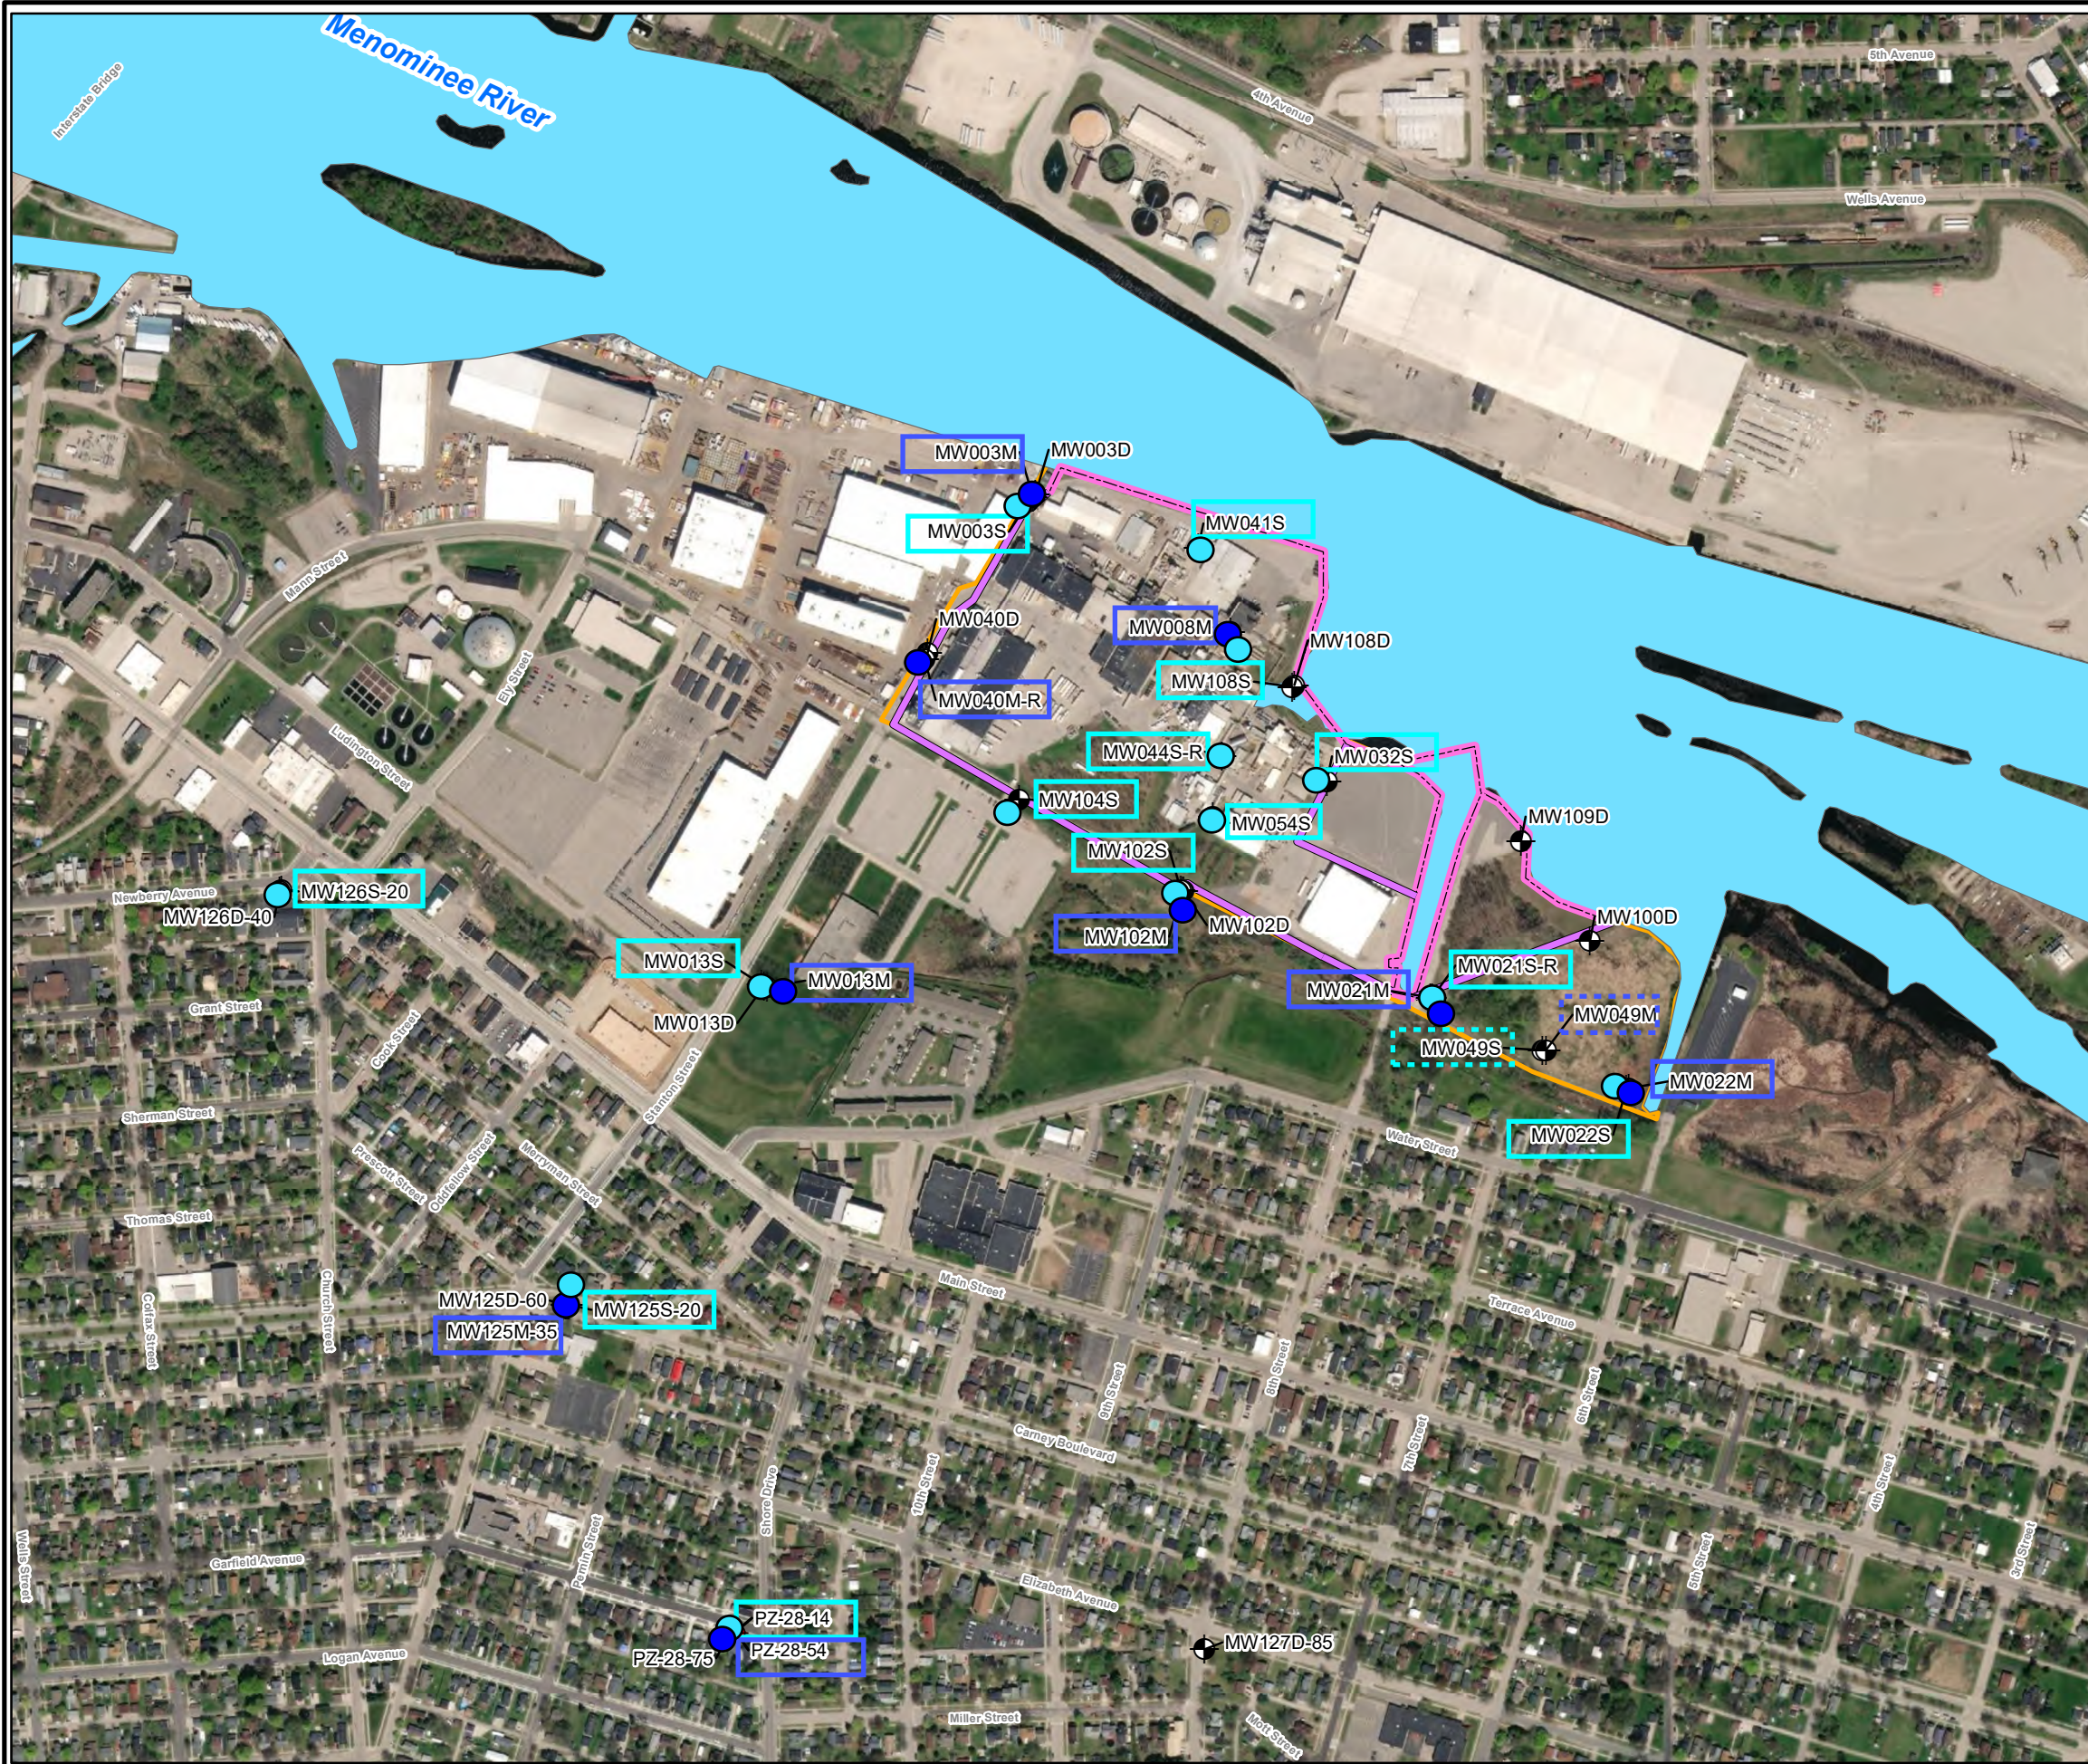
City: Minneapolis/Citrix Div/Group: IMDVC Created By: Last Saved By: MSMiller
 TYCO Stanton St, Marinette, WI
 D:\Tyco_Stanton\2021-01\Figure 5 PROPOSED MONITORING WELL LOCATIONS Stanton_01202021.mxd 1/28/2021 2:19:21 PM

1. RIVER DATA SOURCE: U.S. GEOLOGICAL SURVEY NATIONAL HYDROGRAPHY DATASET, ACCESSED FALL 2017.
2. ROAD DATA SOURCE: OPEN STREET MAP, ACCESSED FALL 2017.
3. AERIAL IMAGERY: 4/27/2016 DIGITALGLOBE, VIVID-USA.
4. WELL LETTER SUFFIXES ARE DEFINED AS:
 S = SHALLOW MONITORING WELL.
 M = INTERMEDIATE MONITORING WELL.
 D = DEEP MONITORING WELL.
 R = REPLACEMENT WELL.
5. TRANSDUCERS ARE PROPOSED TO BE DEPLOYED IN THE FOLLOWING WELLS: MW003D, MW003S, MW013D, MW013S, AND MW102D IN ACCORDANCE WITH THE MAY 2020 NEAR-TERM BEDROCK GROUNDWATER EVALUATION WORK PLAN.
6. NOT INCLUDED IN THIS FIGURE ARE SHALLOW BEDROCK WELLS PZ-01D AND PZ-04D, WHICH ARE LOCATED ON THE TYCO FIRE TECHNOLOGY CENTER (FTC) SITE. THESE WELLS ARE PROPOSED TO BE SAMPLED AS PART OF THIS WORK PLAN.
7. WELLS PZ-28-75, MW127D-85, MW125 CLUSTER, AND MW126 PAIR WERE INSTALLED IN NOVEMBER/DECEMBER 2020.
