**Subject:** Comments on GEI Draft Tables and Figures for 1300 Cleveland Ave. (SB-28)

Tom shared the draft information from GEI with the group. We were all extremely concerned about the levels and found our concerns to be not only feasible but fact based. On Google Earth, we added some relevant soil boring locations to an aerial image from 1974 that Tom says that you have. The images are attached. Looking at the past images of Connor Forest Industries in Wausau, we have the following comments:

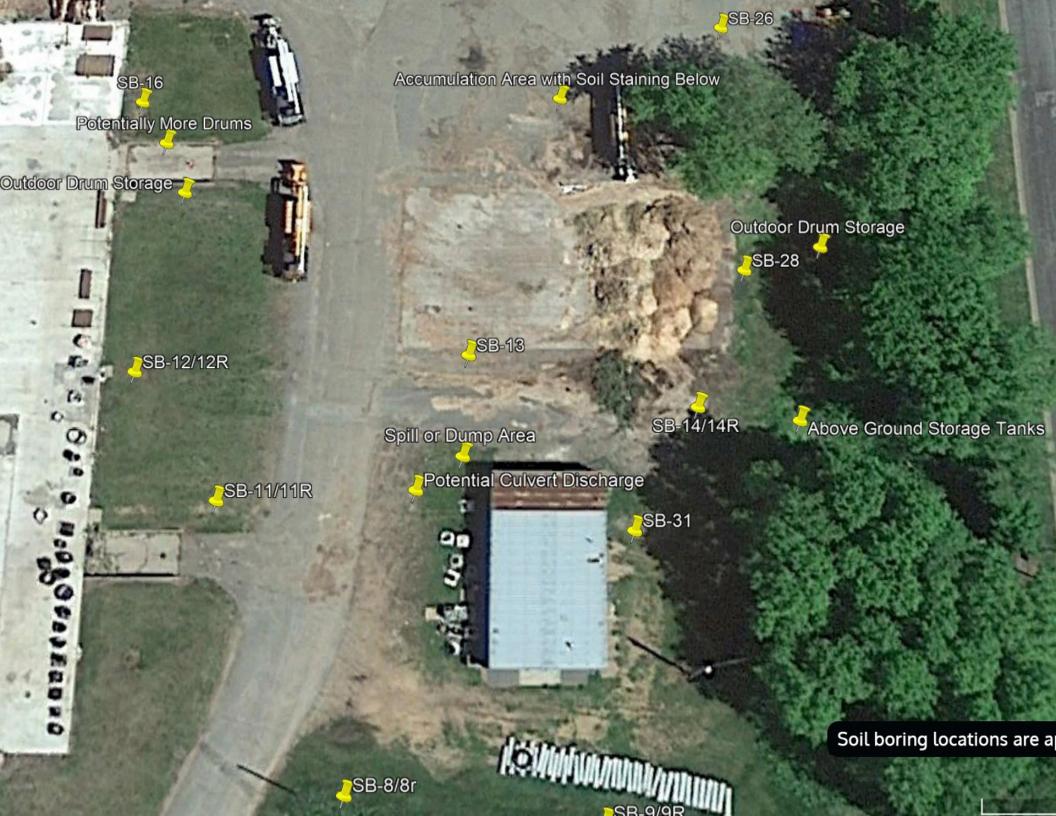
**Attachments:** CFI\_1974\_VS\_2020-2021\_Borings.jpg; CFI\_1974\_VS\_2020-2021\_Borings\_2\_Current.jpg;

- We assumed the high concentrations of PAHs at SB-28 related to the former Above Ground Storage Tanks (ASTs) until we marked its location on the 1974 image

- SB-28 is in located very close to, or possibly in, an outdoor drum and barrel storage area shown in the 1974 image
- If some of the high PAH soil concentrations turn out to be related to Connor's outdoor drum storage, there are at least three other apparent outdoor drum storage or accumulation areas in the 1974 image

- GEI performed no soil borings in the location of these other three outdoor drum storage areas
- In one large area of accumulation in the 1974 image, spillage or soil staining can be seen below the materials. SB-26 misses this potential problem area, as it is located in the former parking lot to the east instead

- SB-16 misses the two potential outdoor drum storage areas south of its location
- GEI soil borings miss the potential spill/dump area and potential culvert discharge area identified on the 1974 image, as none of their borings come close to these locations

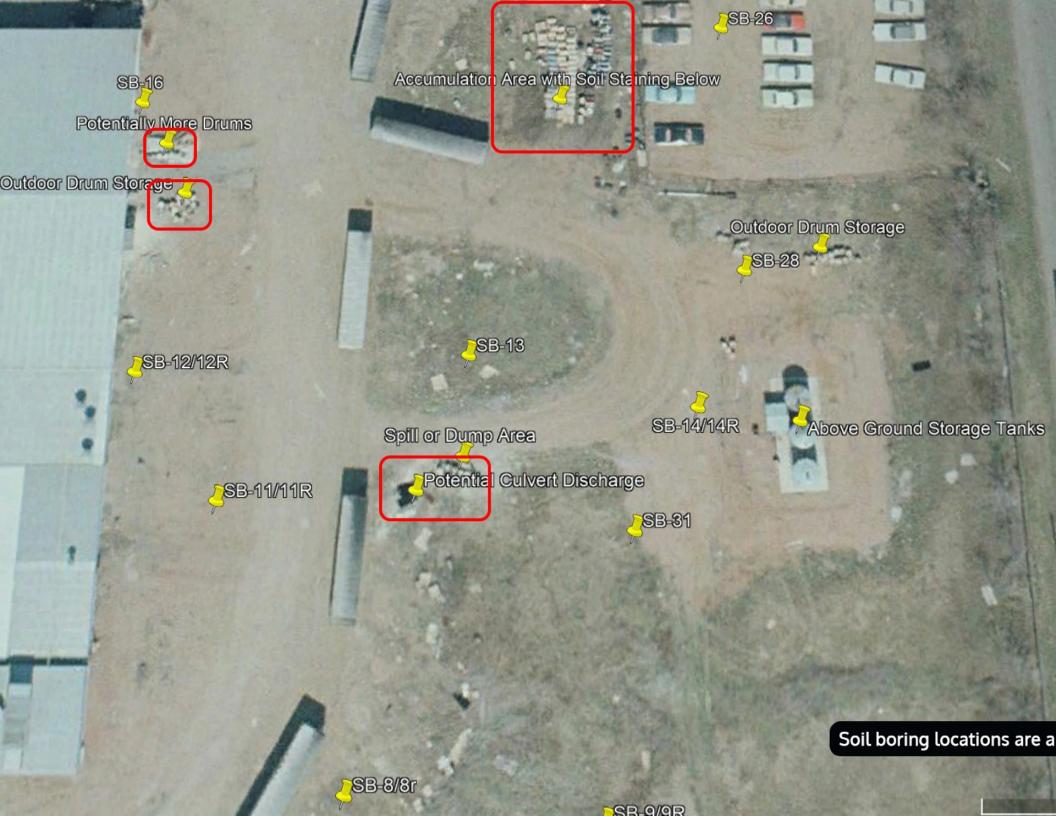
- SB-14 and other borings in the area do not necessarily come very close to the former storage tank area, so we are concerned that the contaminated area from the tanks may not be fully defined

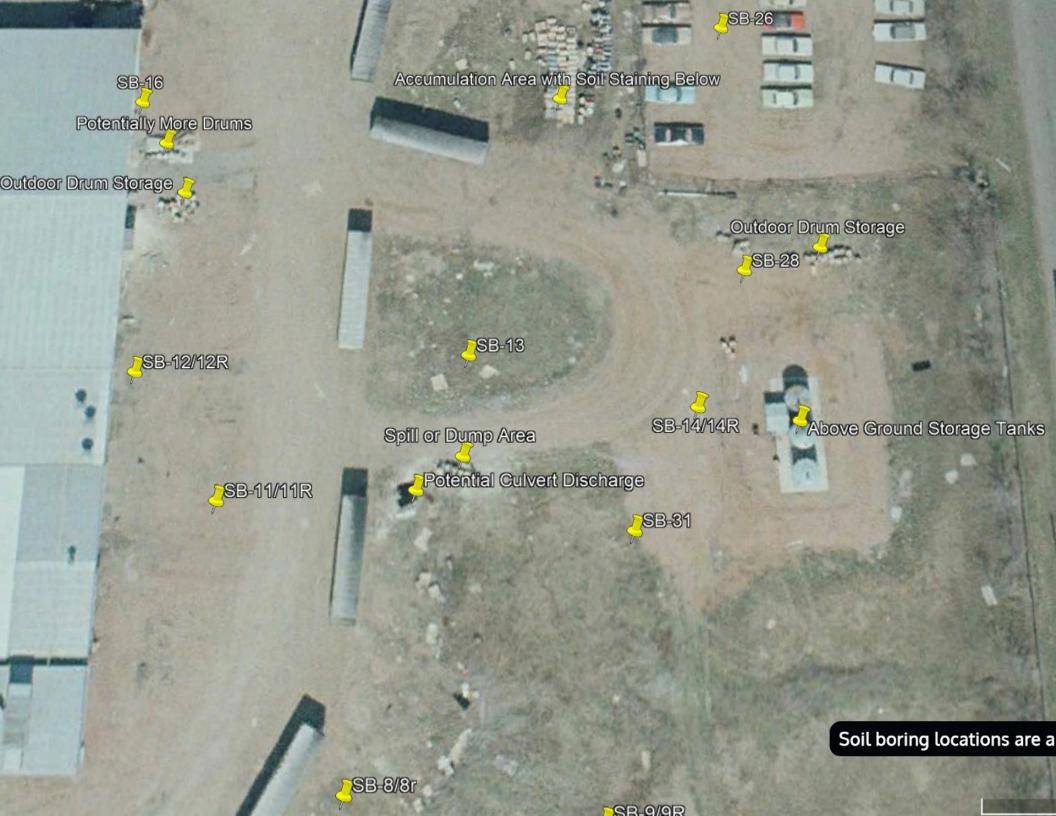
CFI\_1974\_VS\_2020-2021\_Borings\_Contamination\_Definition.jpg

- Based on the high PAH concentrations found in the vicinity of the drum storage area by SB-28 (and
  phthalate concentrations identified at SB-35 that could be from waste dumping), we circled four areas
  on the property that we thought would be useful to test to benefit GEI's definition of contaminated
  areas. They are circled in red in an attached image.

- Given the preciseness of Google Earth, we would be able to provide the exact latitude and longitude for the areas described if that would be of use to the department
