SUMMARY OF CURRENT ENVIRONMENTAL CONDITIONS

FORMER MERCURY MARINE PLANT No. 1

N49W6337 Western Avenue & N47W6300 Jackson Street, Cedarburg, Wisconsin 53012 | May 2022

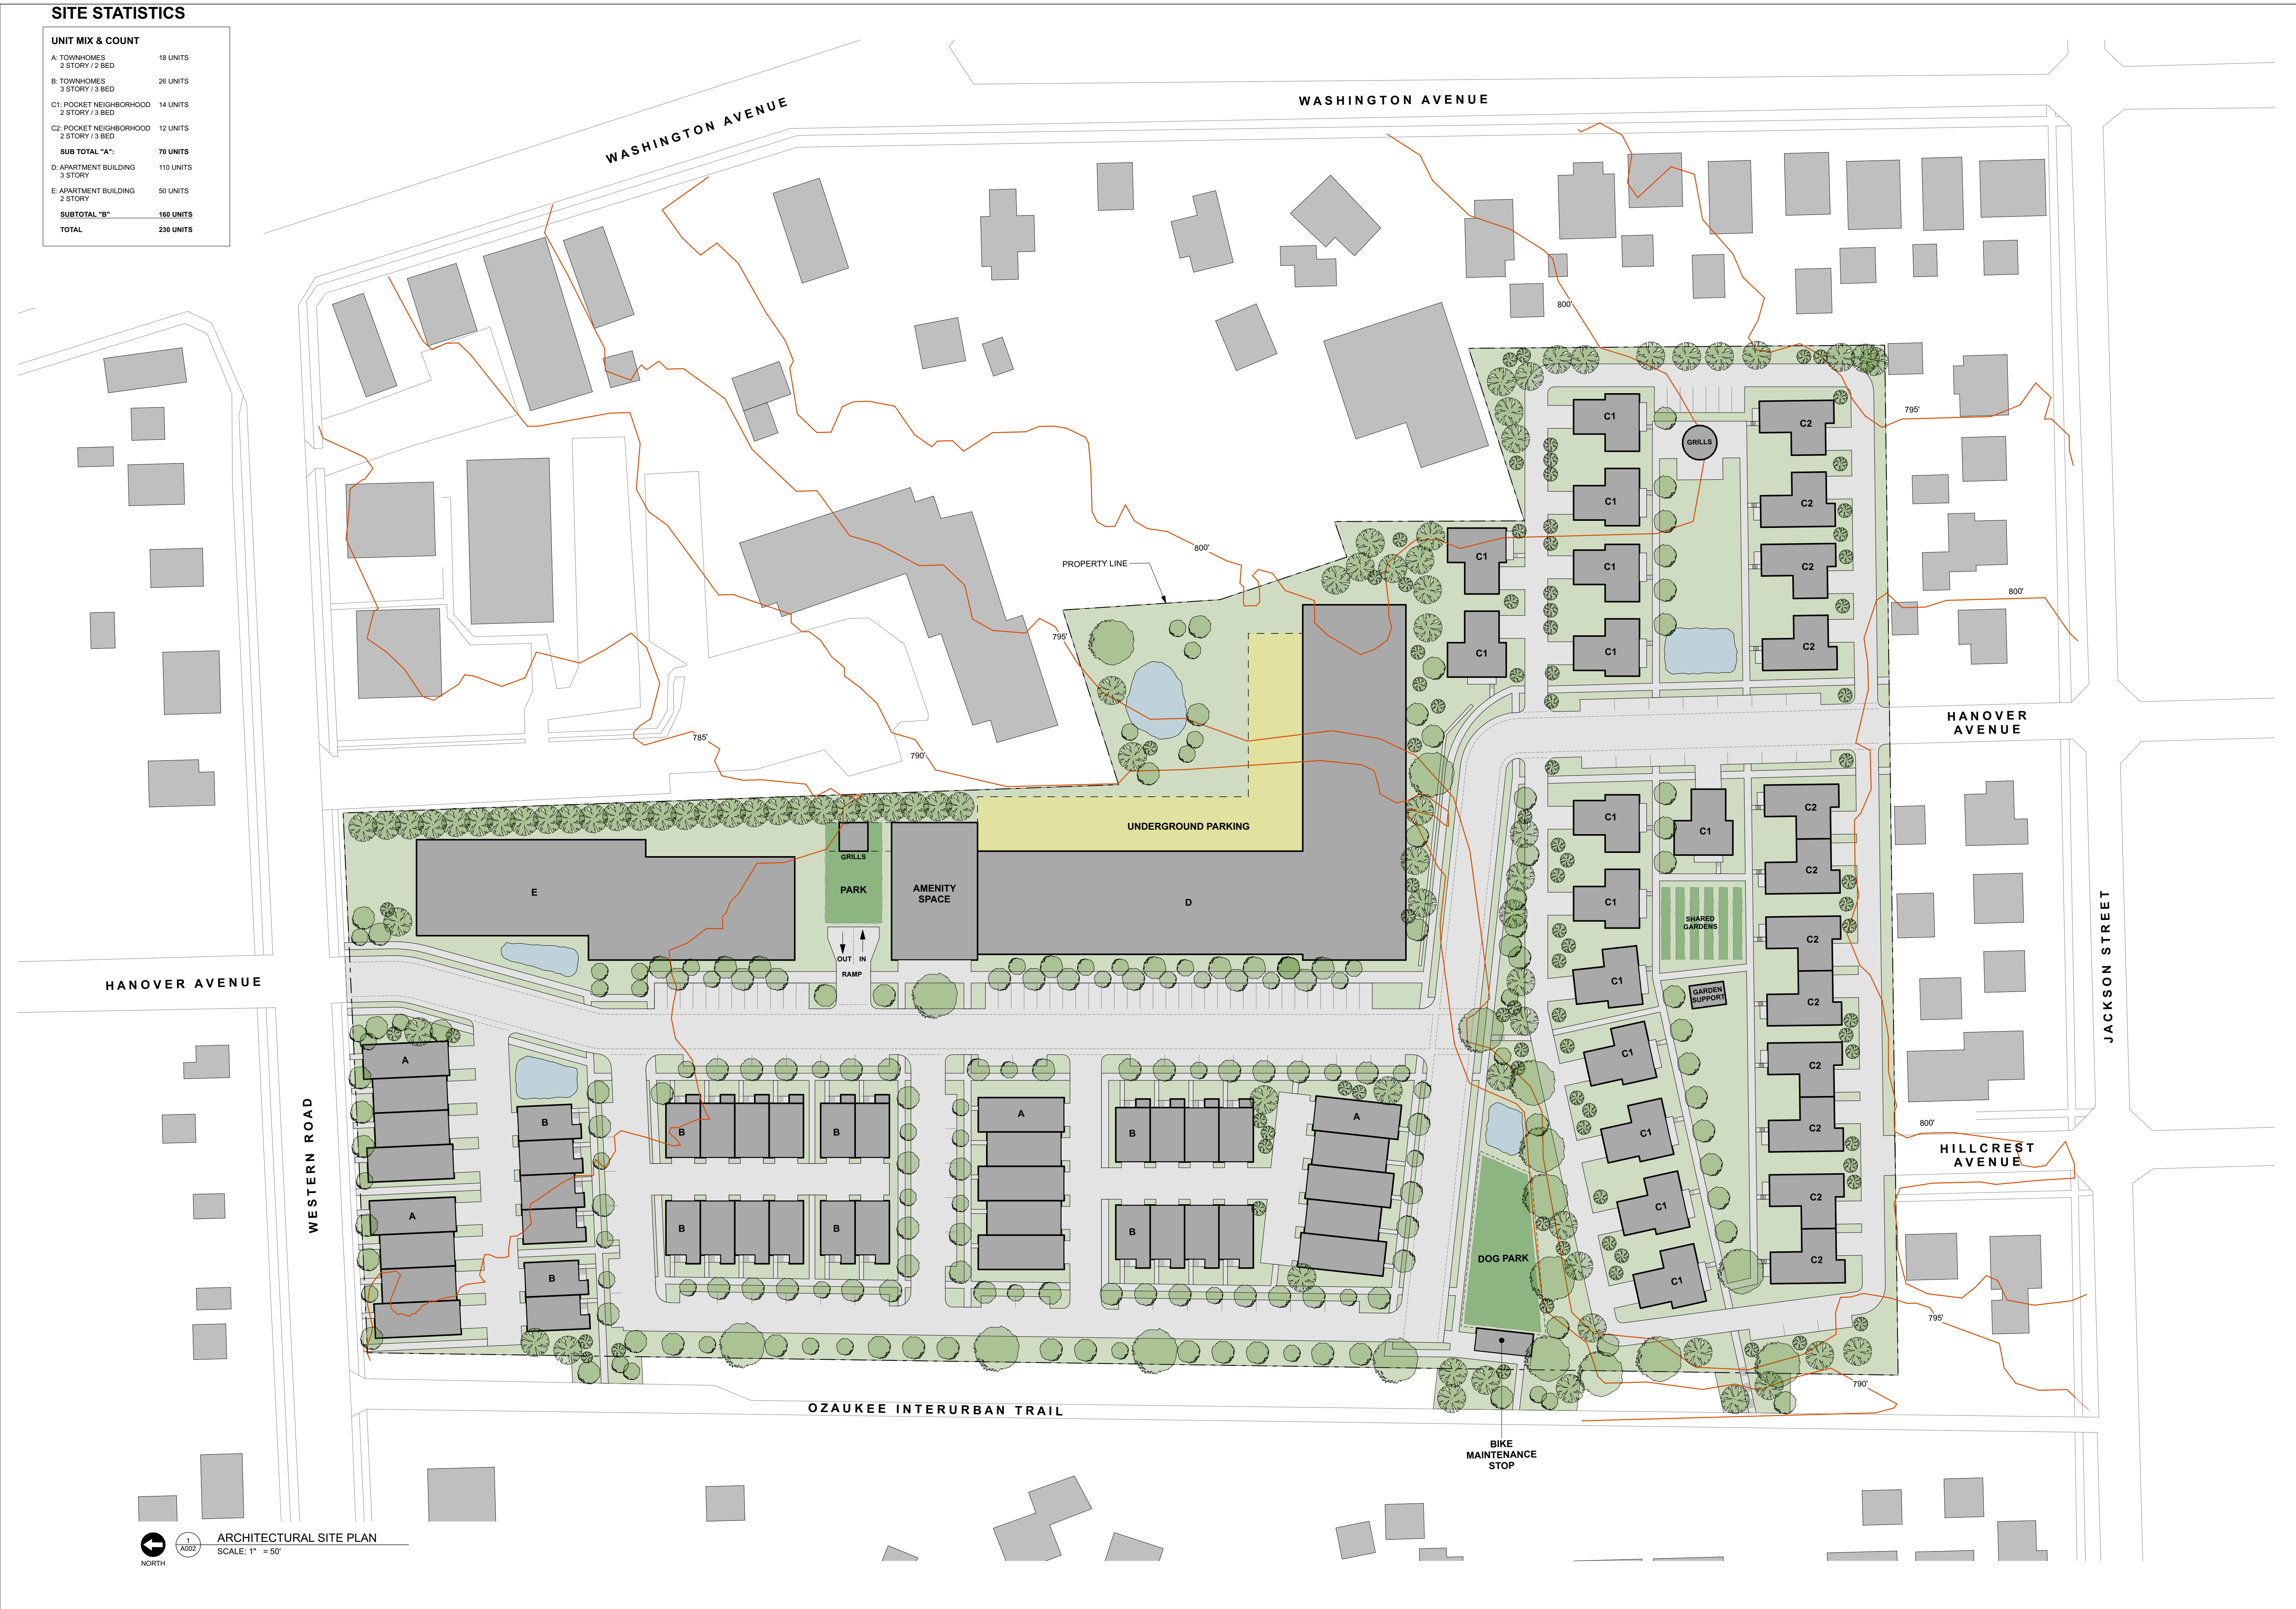
ARCHITECTURAL SITE PLAN
SCALE: 1" = 50'

A copy of the proposed site plan for the residential redevelopment of this brownfield site and the extension of Hanover Avenue is attached to this report in Attachment A.

UNIT MIX & COUNT	
A: TOWNHOMES 2 STORY / 2 BED	18 UNITS
B: TOWNHOMES 3 STORY / 3 BED	26 UNITS
C1: POCKET NEIGHBORHOOD 2 STORY / 3 BED	14 UNITS
C2: POCKET NEIGHBORHOOD 2 STORY / 3 BED	12 UNITS
SUB TOTAL "A"	70 UNITS
D: APARTMENT BUILDING 3 STORY	110 UNITS
E: APARTMENT BUILDING 2 STORY	50 UNITS
SUBTOTAL "B"	160 UNITS
TOTAL	230 UNITS
