October 31, 2023

**Project # 40443A**

Subject: **Third Round of Commissioning for Community Within the Corridor – West Block – Buildings 4 and 5 – Final Report**  
**3212 W. Center St., 2727 N. 32nd St., and 2758 N. 33rd St., Milwaukee, WI 53210**  
**BRRTS #: 02-41-587376, FID #: 341333190**

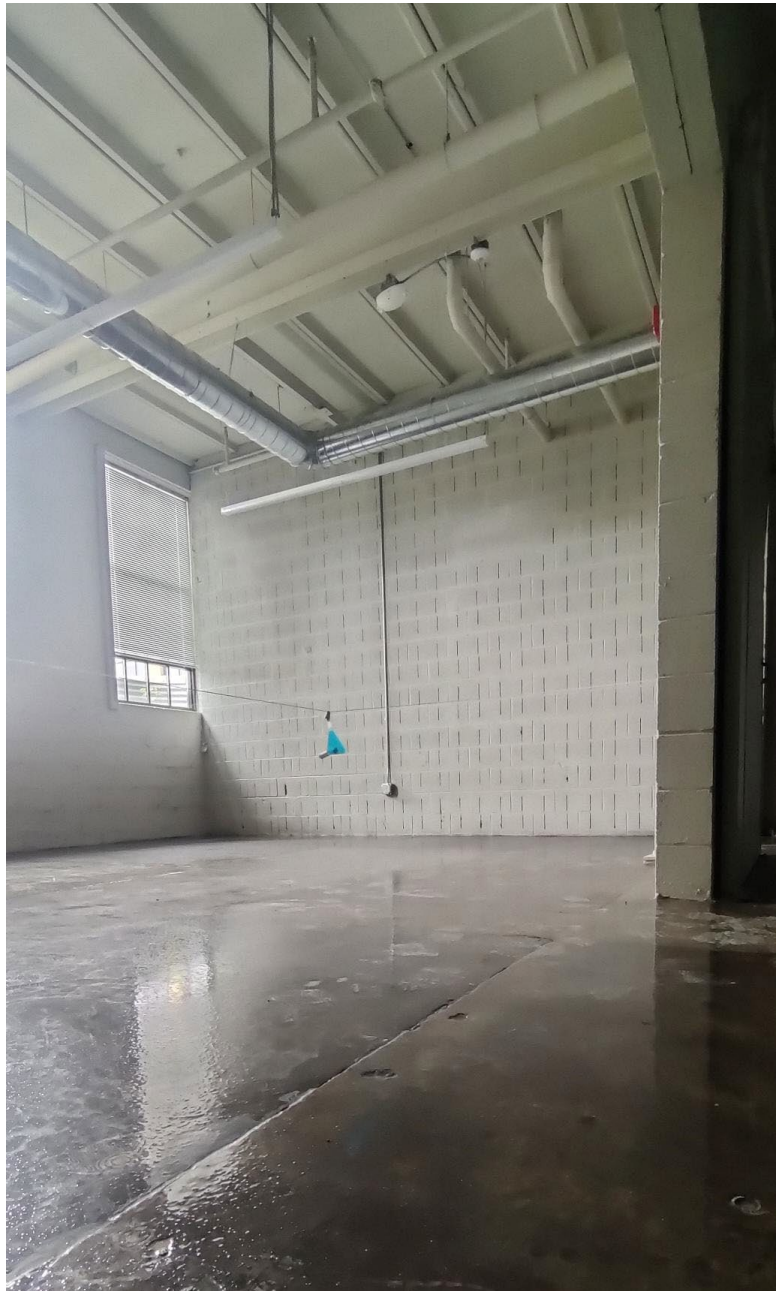
Picture1 – Location of the Passive sampler at children’s level in Play area

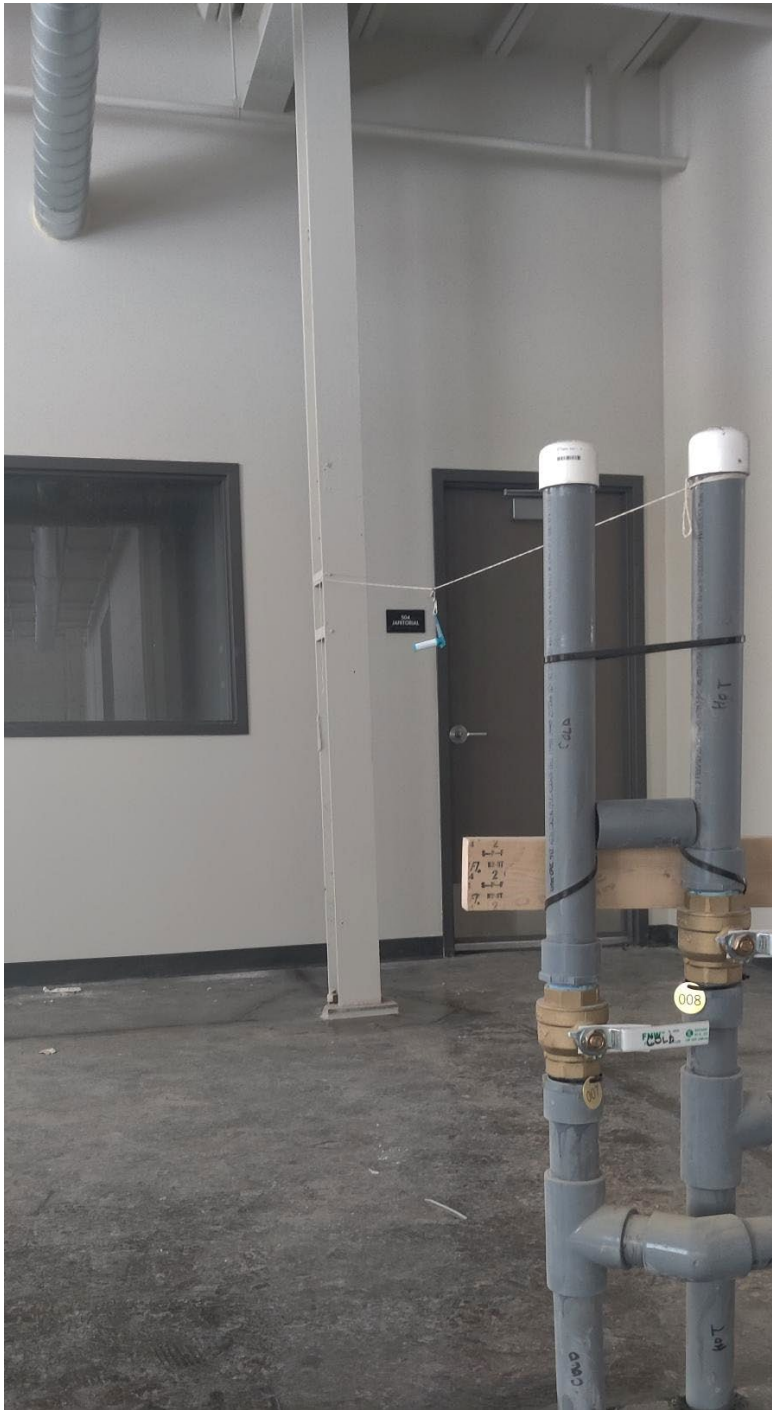
Picture 2 – Passive Sampler Location in Building 5
